# Supplemental Remedial Investigation Report

Former NOW Corporation Facility (Site No. 314008)

New York State Department of Environmental Conservation

December 2025

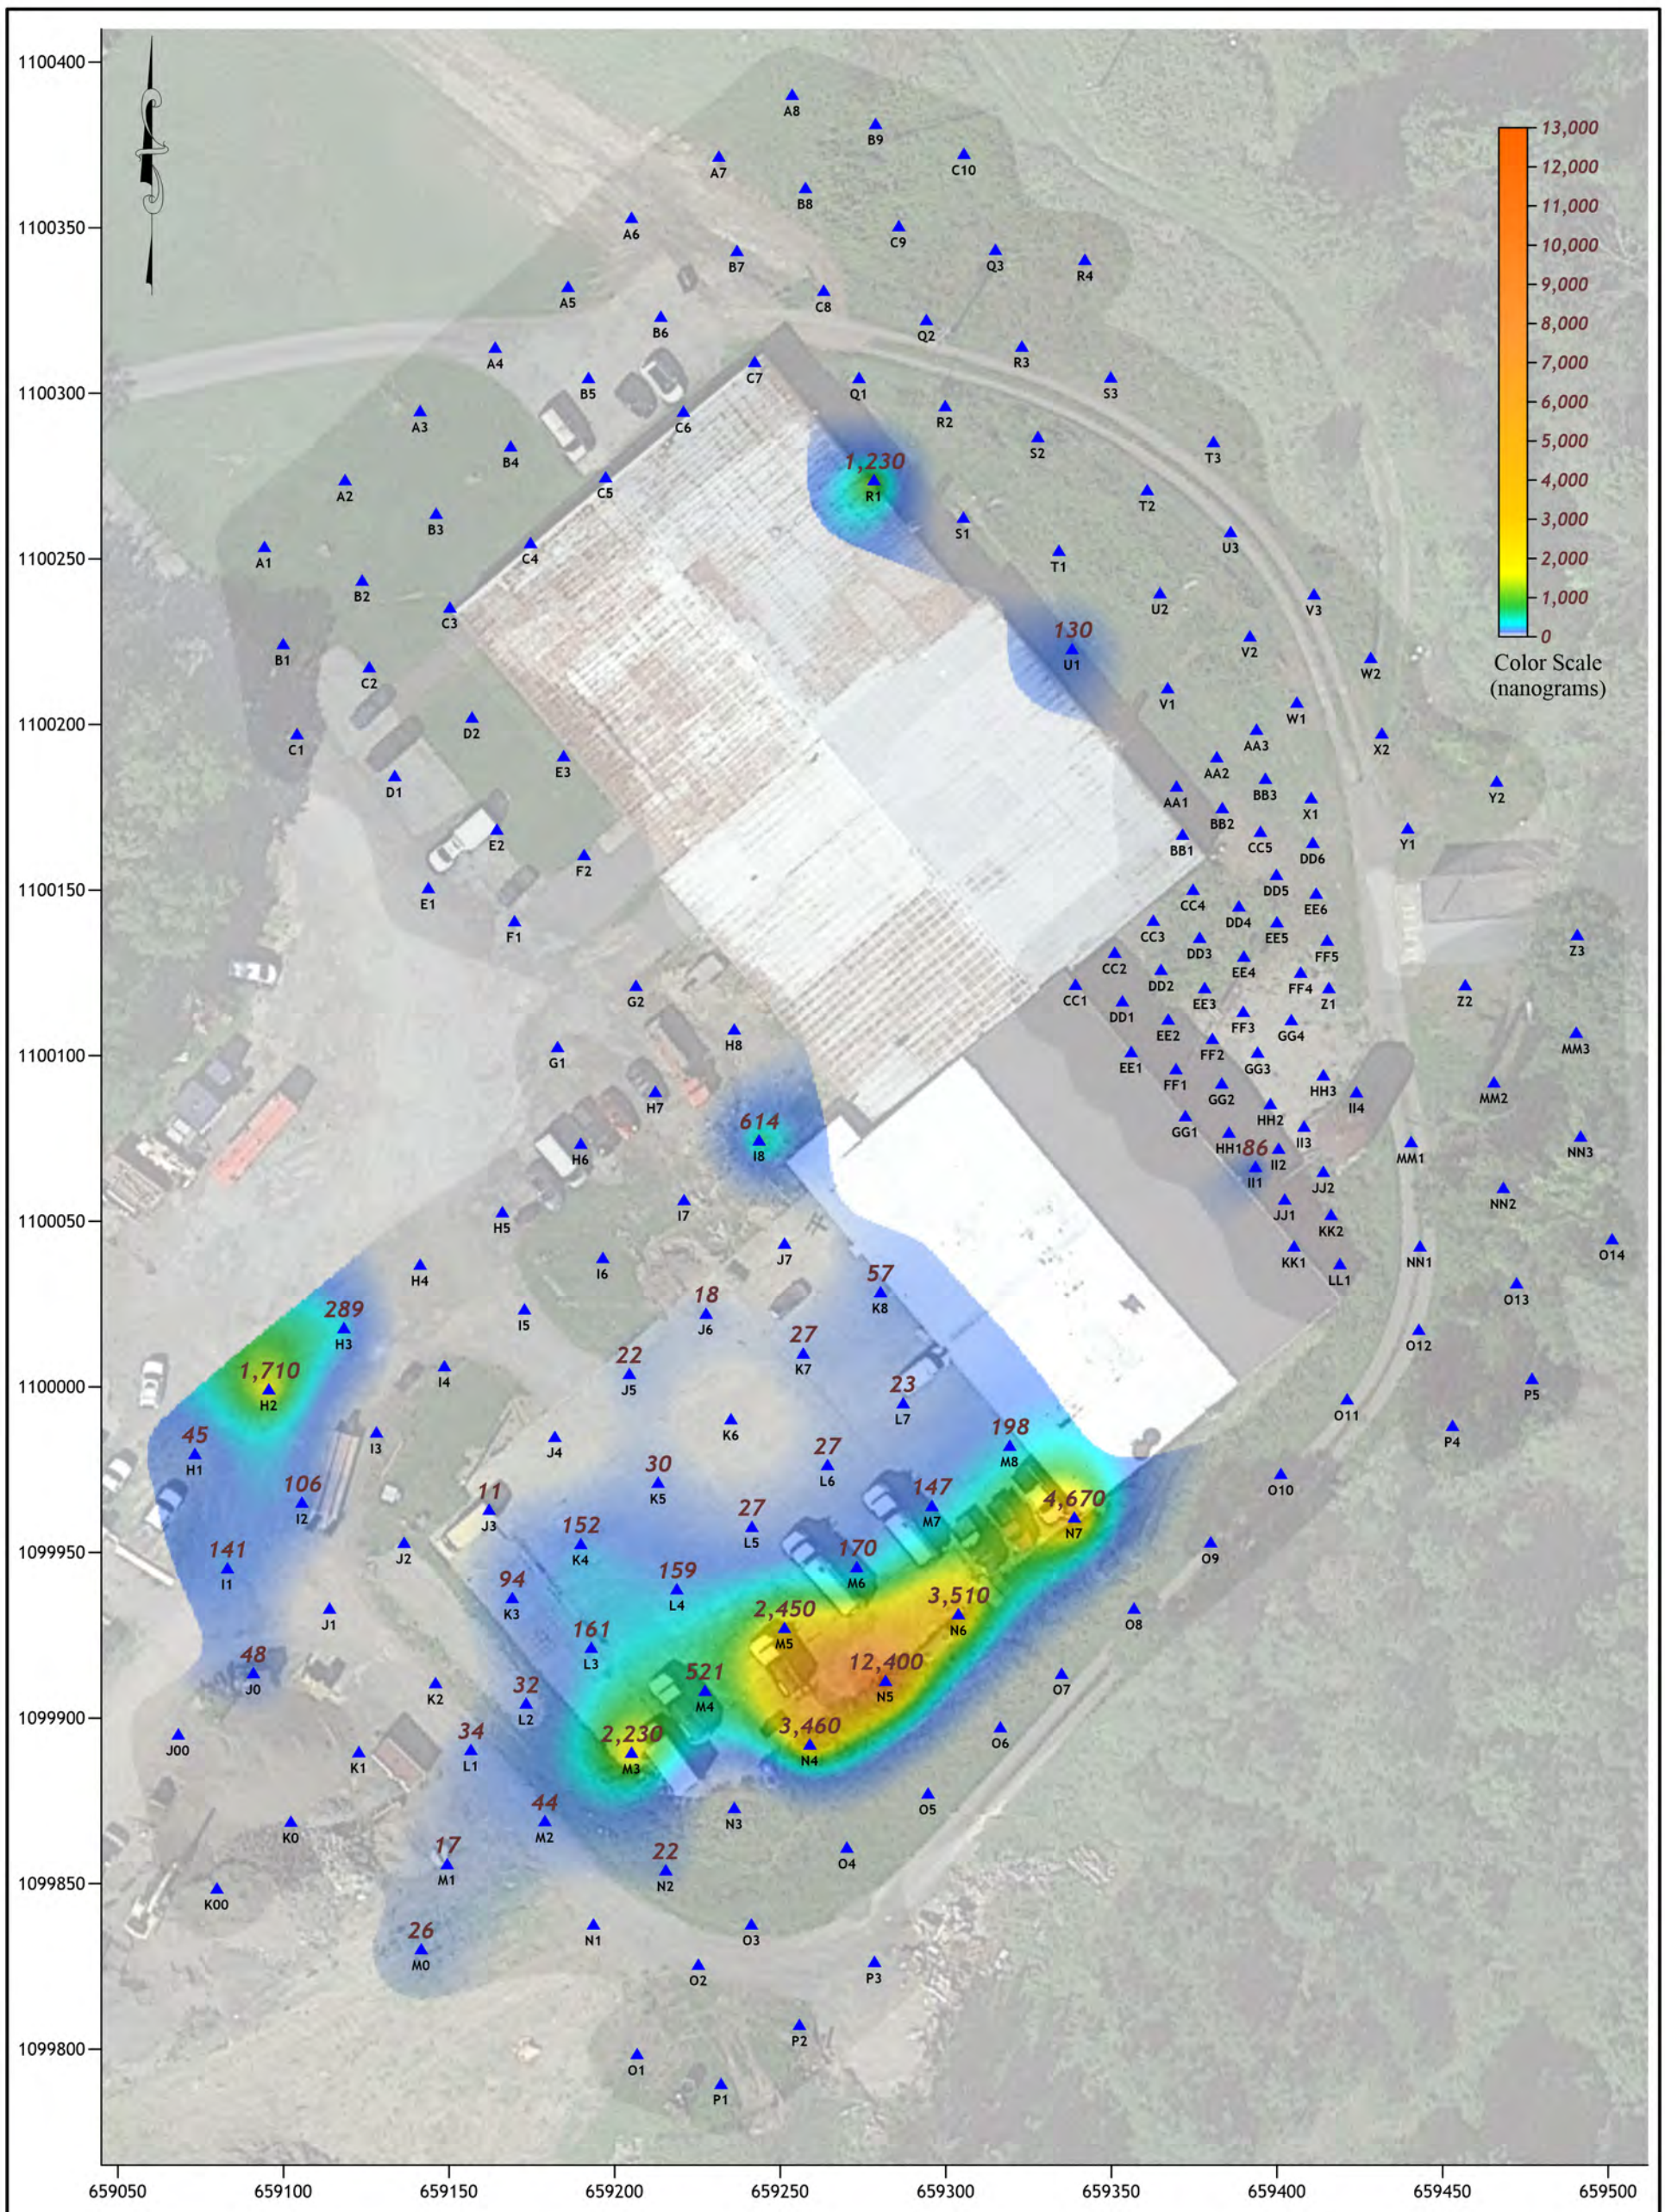
**Figure 3**
**Passive Soil-Gas Survey**
**1,1,1-Trichloroethane**

Detections of analyzed VOCs were highest to the northeast of Area C, and appear to be localized along the edge of the concrete slab. This is also the area with the highest 1,1,1-TCA mass results, as indicated on Figure 3 of **Appendix F**.

1,1,1-TCA is of particular interest because it was a significant component of the VOC fingerprint in recovery well TW-2A while the groundwater treatment system was operational. The previous excavation activities at Area A appear to have been moderately successful in removing and treating VOCs. As noted on Figure 3 of **Appendix F**, 1,1,1-TCA soil gas values in the vicinity of Area A were low or non-detect. While other VOCs were present in soil gas within the excavated area (with TCE ranging from a low of 272 ng at location AA2 to a high of 1,010 ng at V2), the highest mass was noted just to the southeast of Area A, at point BB1. This location contained a TCE mass value of 38,300 ng and a cis-1,2-DCE result of 5,730 ng, along with significantly lower or non-detect concentrations of the other VOCs analyzed. Based on available data, it is likely that a considerable portion of the source of the elevated soil gas values lies under the slab of the existing building.
