WALDEN ENVIRONMENTAL ENGINEERING

September 16, 2019
iPARK0118.33

Re: iPark 84, Former IBM East Fishkill Facility
Building 700 (Formerly 330D)
Crepini Space
Hopewell Junction, New York 12533
Indoor Air Quality Testing Summary Report

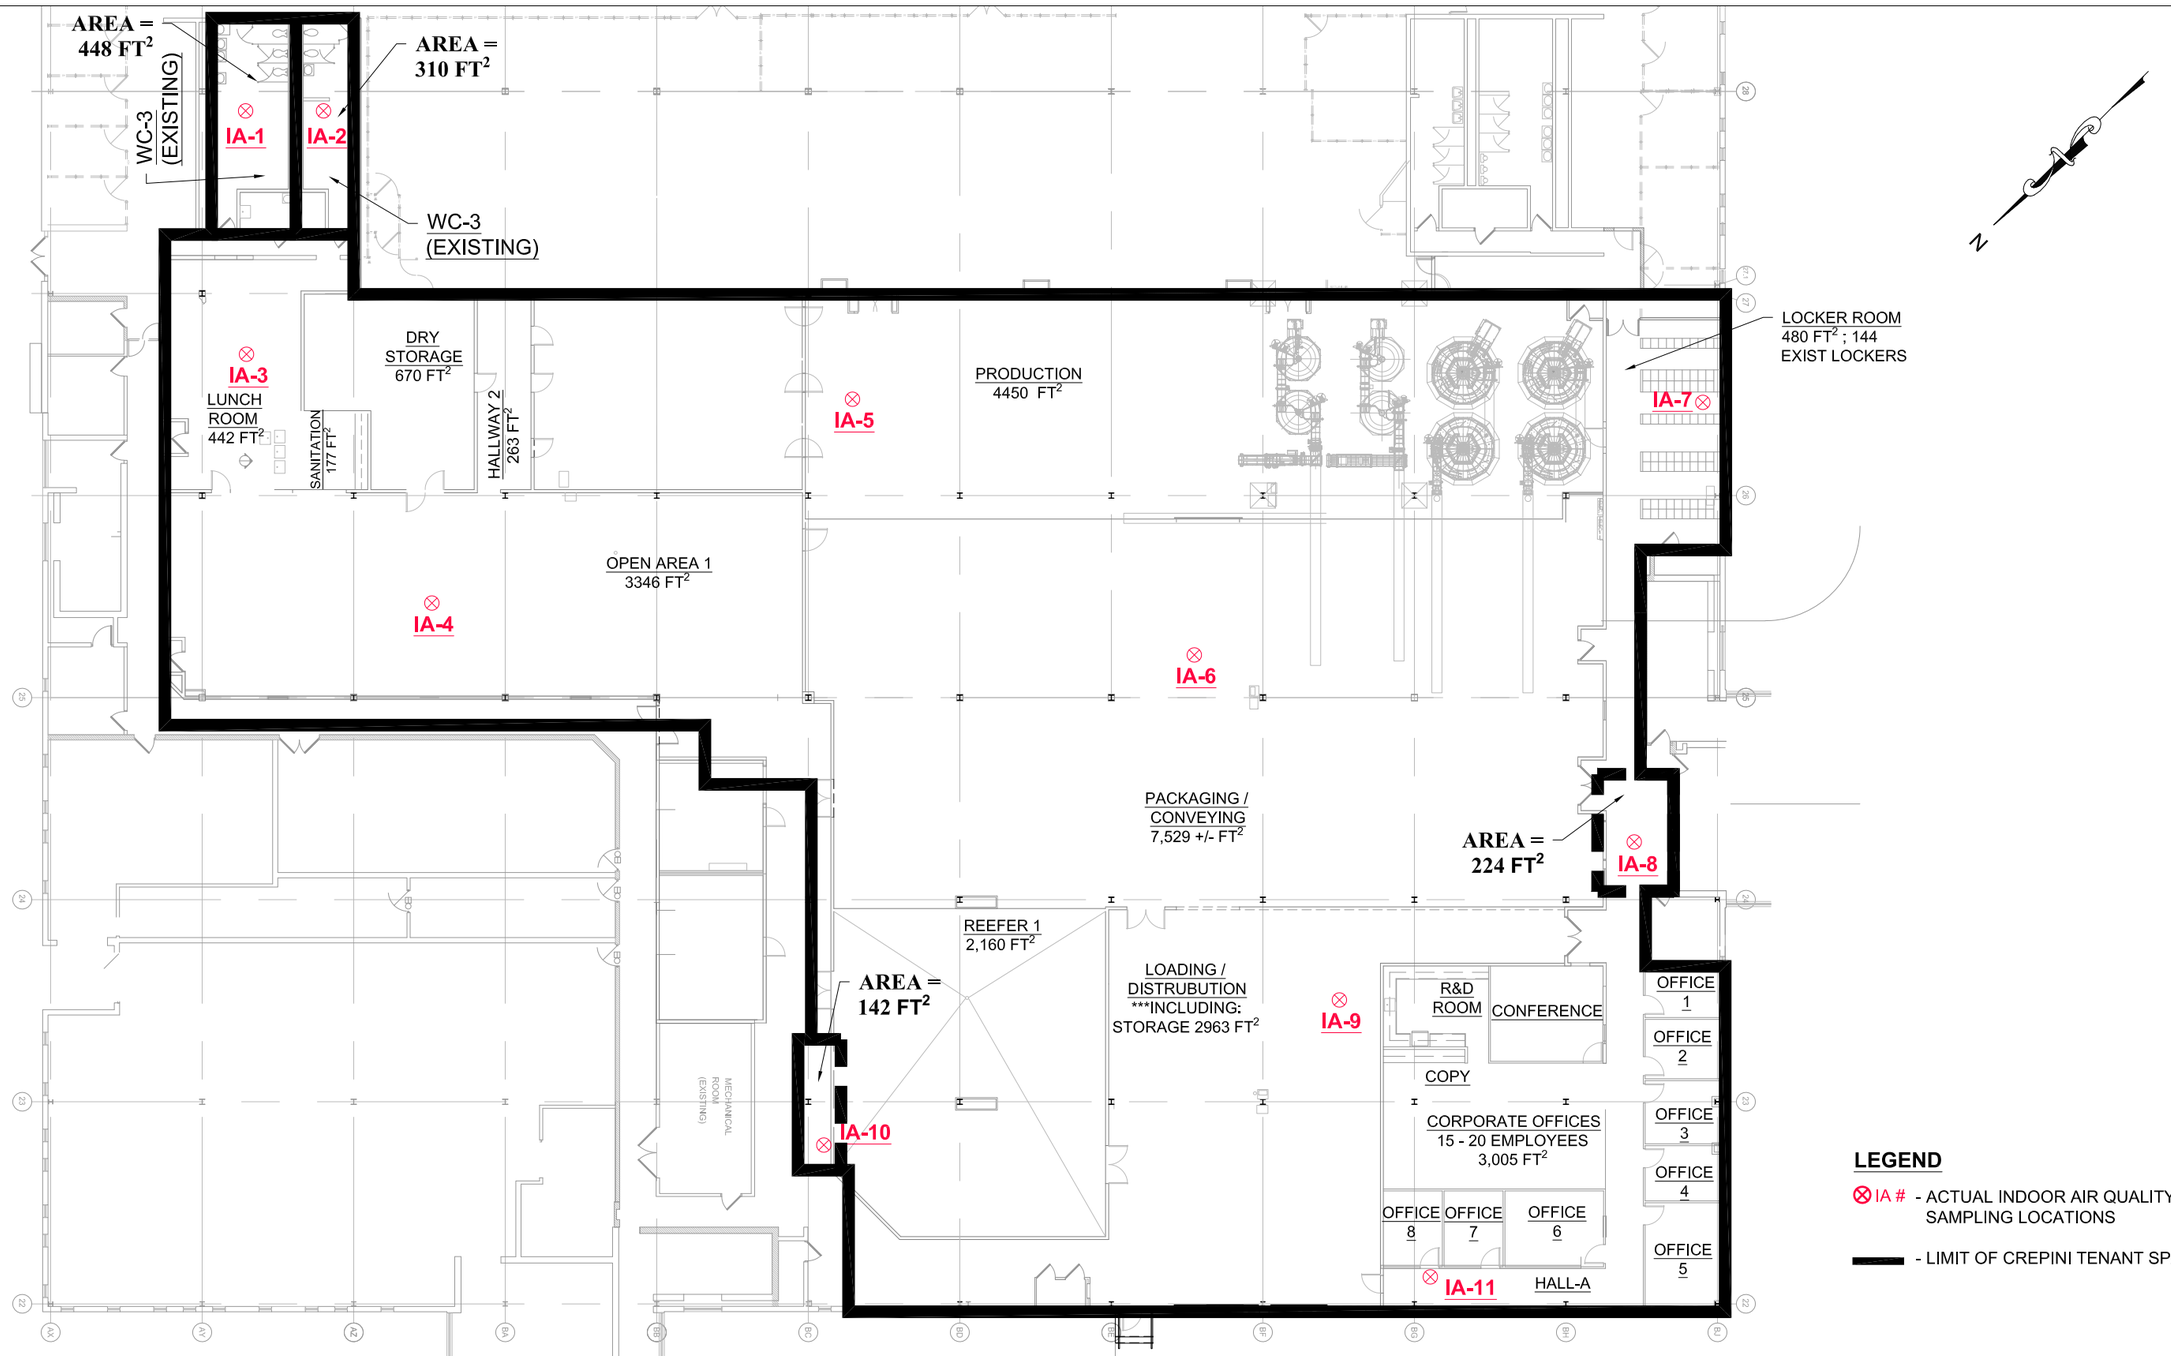
FIGURE NO: 2

IAQ testing was conducted in accordance with the procedures outlined in the NYSDEC-approved RFI Work Plan and Testing Plan. Samples were collected using 6-liter, individually certified clean, stainless-steel Summa® canisters (Summa® Canisters). The Summa® Canisters were calibrated by the laboratory with flow controllers to obtain 8-hour time-averaged samples. Indoor air samples were collected from a height of two and a half (2.5) to six (6) feet above the ground surface at the following eleven (11) locations throughout the Crepini space, which are depicted on Figure 2:

- IA-1: Men's Restroom
- IA-2: Women's Restroom
- IA-3: Lunch Room
- IA-4: Open Area
- IA-5: Production Room
- IA-6: Packaging Room
- IA-7: Locker Room
- IA-8: Entrance
- IA-9: Loading/Distribution Room
- IA-10: Hallway
- IA-11: Corporate Office

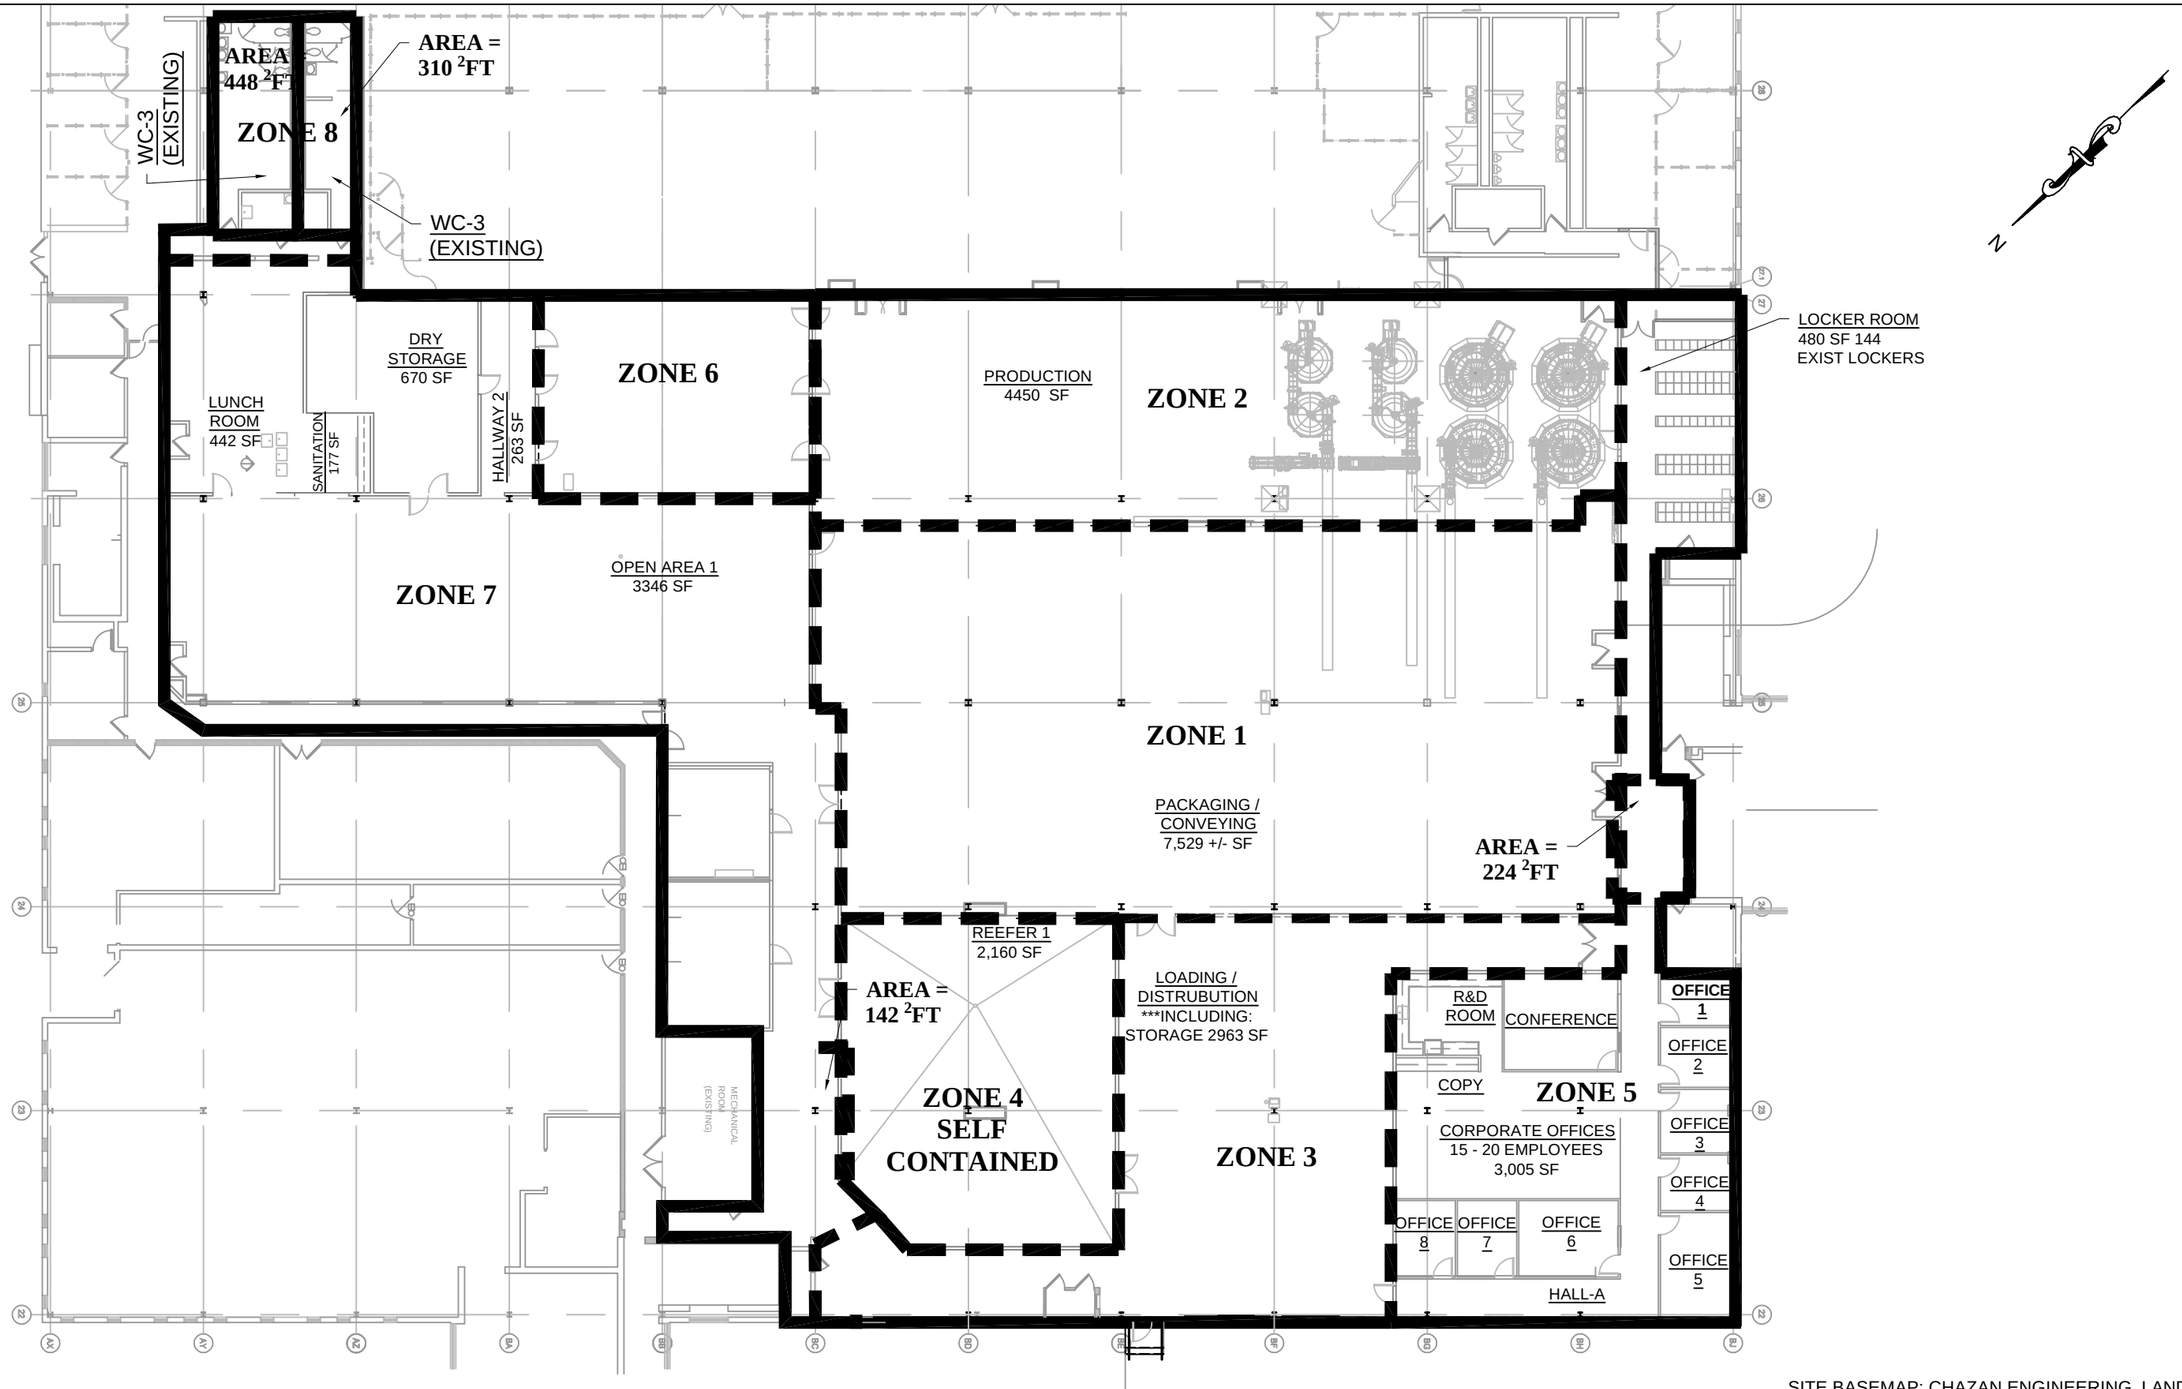
DRAWING NO: 3

The Crepini space within Building 700 is served by rooftop handling units (RTUs) that were installed during the recent renovation of the tenant space, prior to occupation. The Crepini HVAC system is divided into eight (8) separate zones as shown on Figure 3. The HVAC system is comprised of 100 supply diffusers with a total cooling capacity of 23,800 CFM, and a calculated 5 air changes per hour for the space as a whole. During the August 26th IAQ sampling, the newly installed Crepini equipment was being tested and National Resources operated the HVAC system under the same conditions anticipated during normal operations once the tenant takes occupancy.

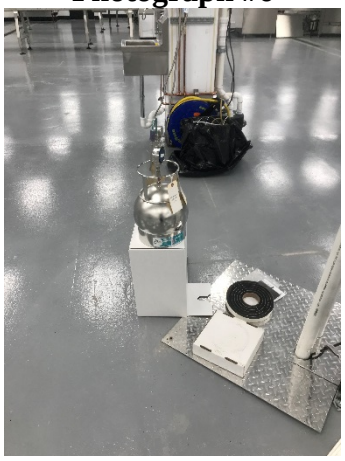
Photograph #6

Sample Location IA-6, located in Packaging Room

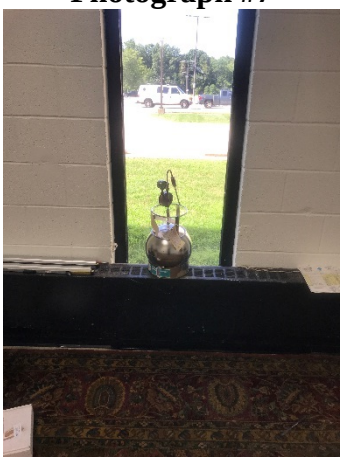
Photograph #7

Sample Location IA-7, located in Locker Room

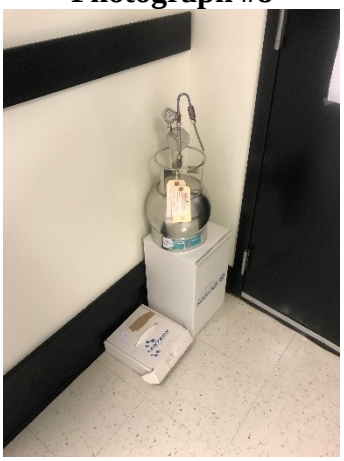
Photograph #8

Sample Location IA-8, located in Entrance

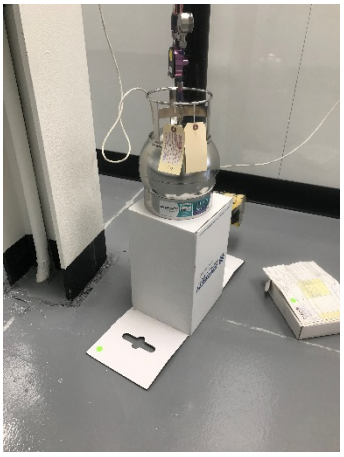
Photograph #10

Sample Location IA-10, located in Hallway

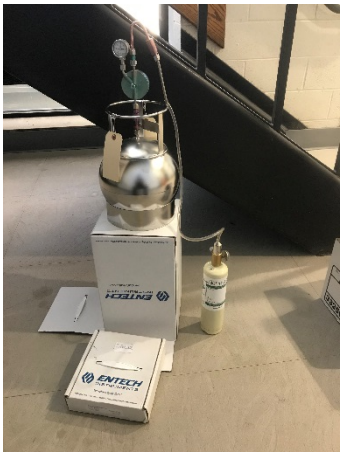
Photograph #12

Sample Location FIELD BLANK
