PERIODIC REVIEW REPORT

Watervliet Arsenal

Site No. 401034A

March 2019

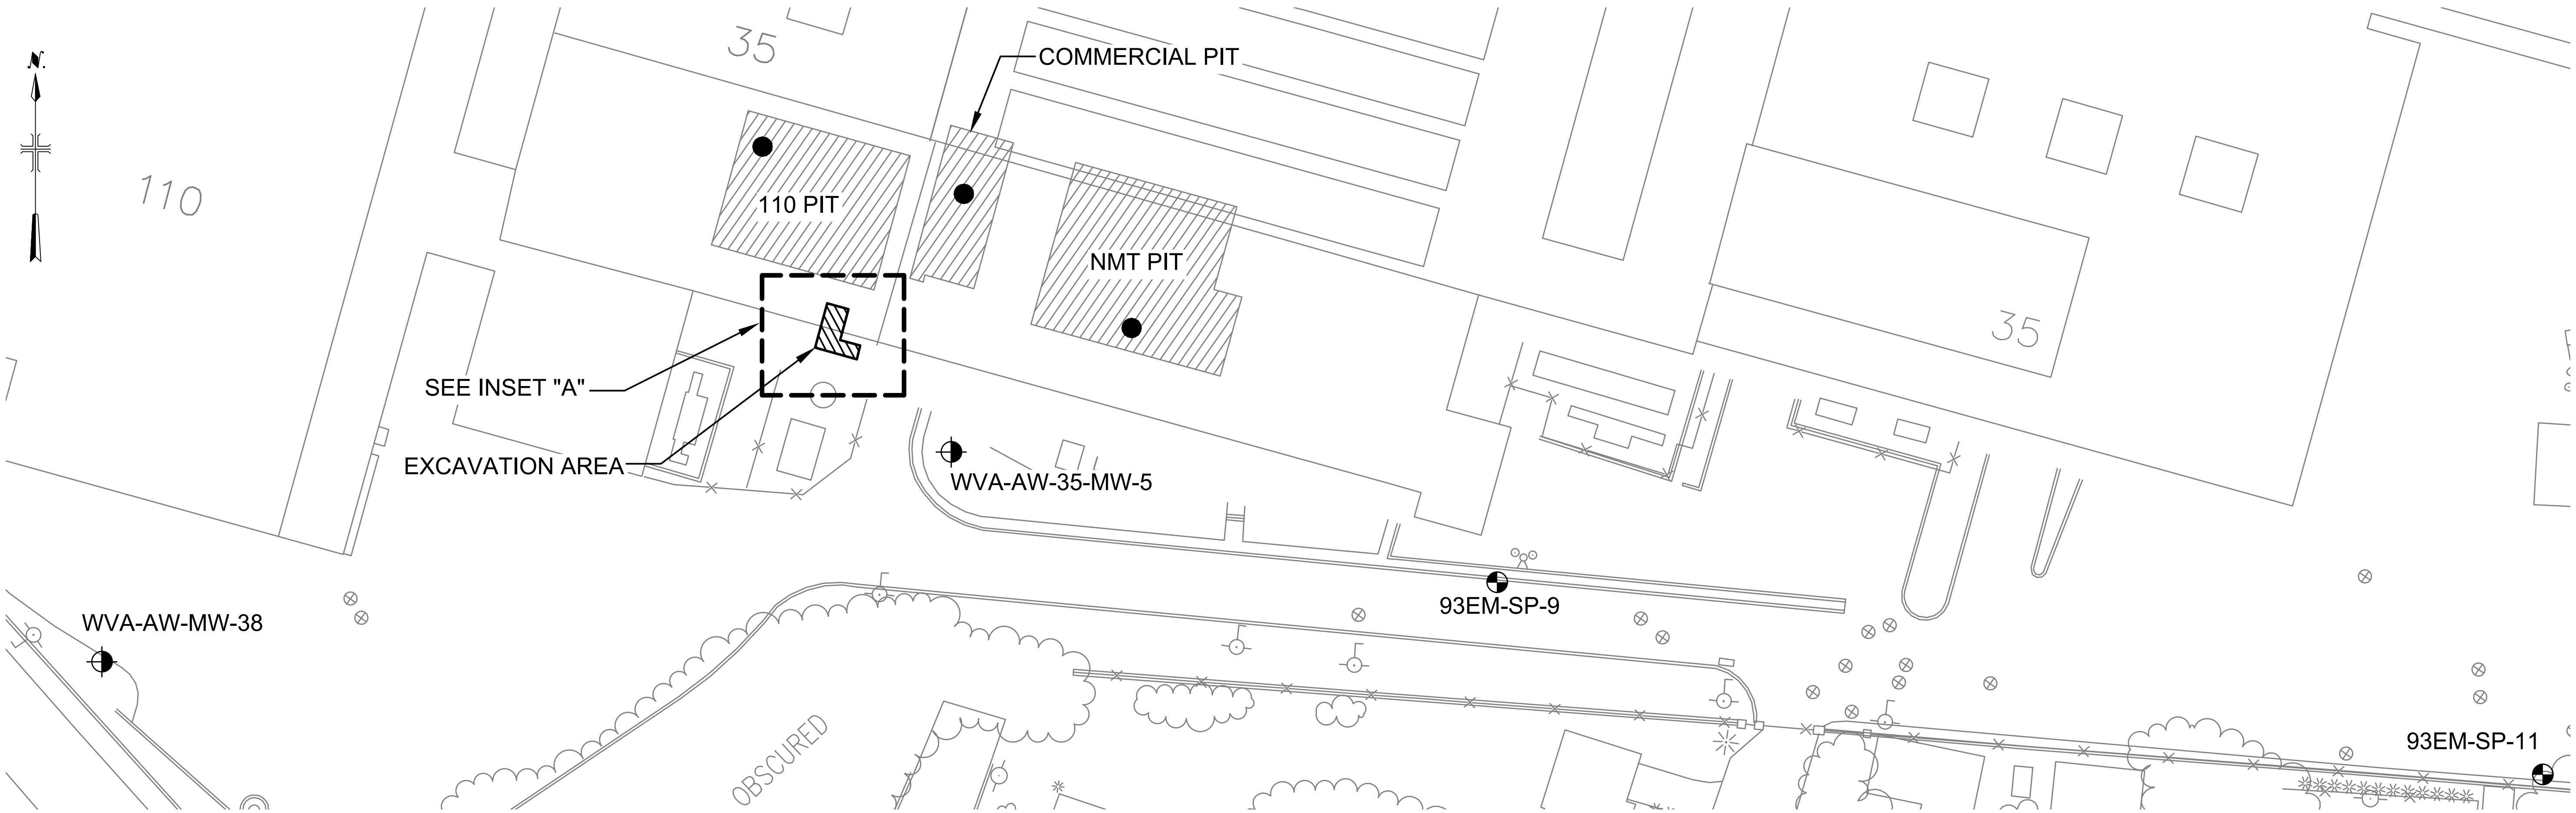
FIGURE 3

The WVA recently discovered a subsurface release of chromic acid plating solution in the area next to the 110 Plating Pit in Building 35 (**Figure 3**). The release was associated with ventilation duct work that runs underground from the plating area to the air scrubber system. In order to restart plating operations as soon as possible, the WVA conducted initial source removal activities required to complete the necessary repairs to the plating ventilation systems. These activities included soil excavation and focused groundwater dewatering that were conducted in consultation with NYSDEC Region 4 and Central Office personnel. The excavation area and associated soil and groundwater sampling locations are illustrated on **Figure 3** and summarized in **Tables 1 and 2**. Observations of groundwater and initial sampling activities have confirmed that groundwater is impacted by hexavalent chromium in the area of the release. Based on the results of the initial source removal activities, and in accordance with a request from the NYSDEC, the WVA will conduct a groundwater site investigation to evaluate whether the chromic acid release has impacted groundwater quality beyond the release area. Following the investigation, the WVA will prepare a Focused Feasibility Study (FFS) to assess potential remedial alternatives for hexavalent chromium in groundwater, if warranted based on the investigation results.

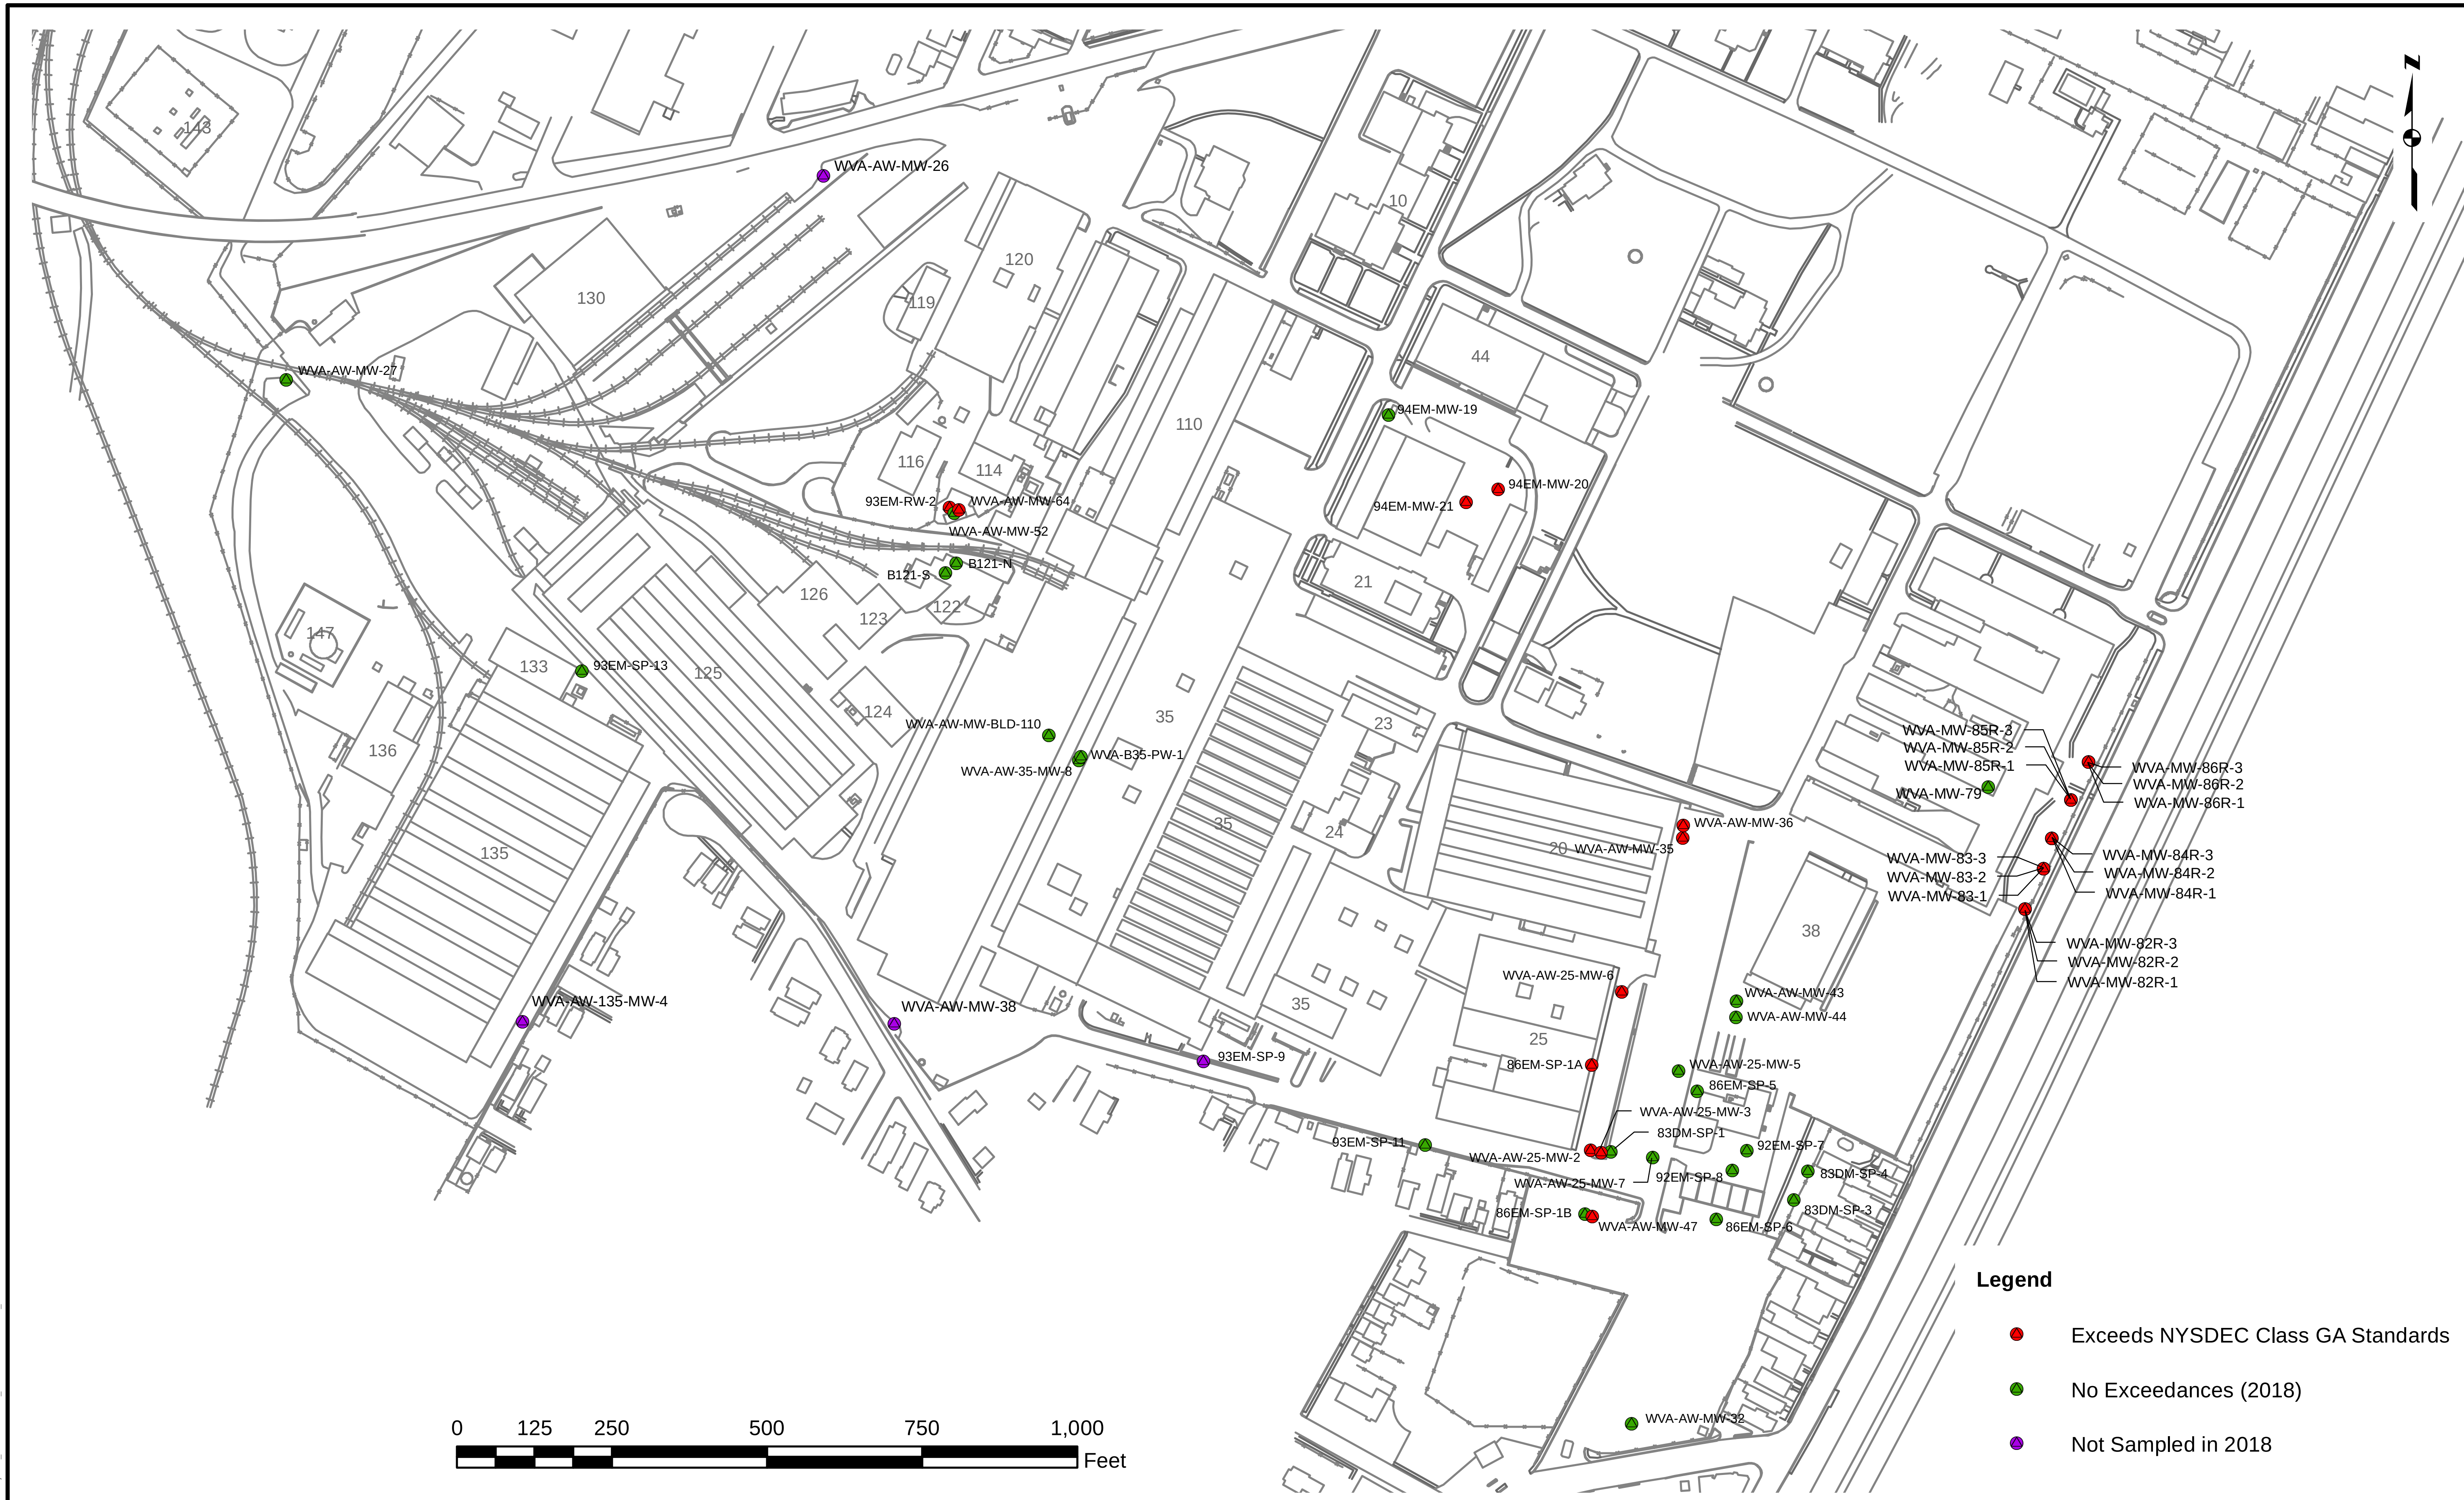
FIGURE 5

During the reporting period, groundwater sampling was conducted in October 2018 using both USEPA Low Stress (Low Flow) Purging and Sampling (USEPA, 1998) and passive diffusion bags (PDBs). The results of the sampling are summarized on **Figure 5**. More detailed description of the LTM sampling event are provided in the 2018 Long-Term Monitoring Data Summary Report. As described in the 2018 report, no changes to the LTM Program are recommended at this time.

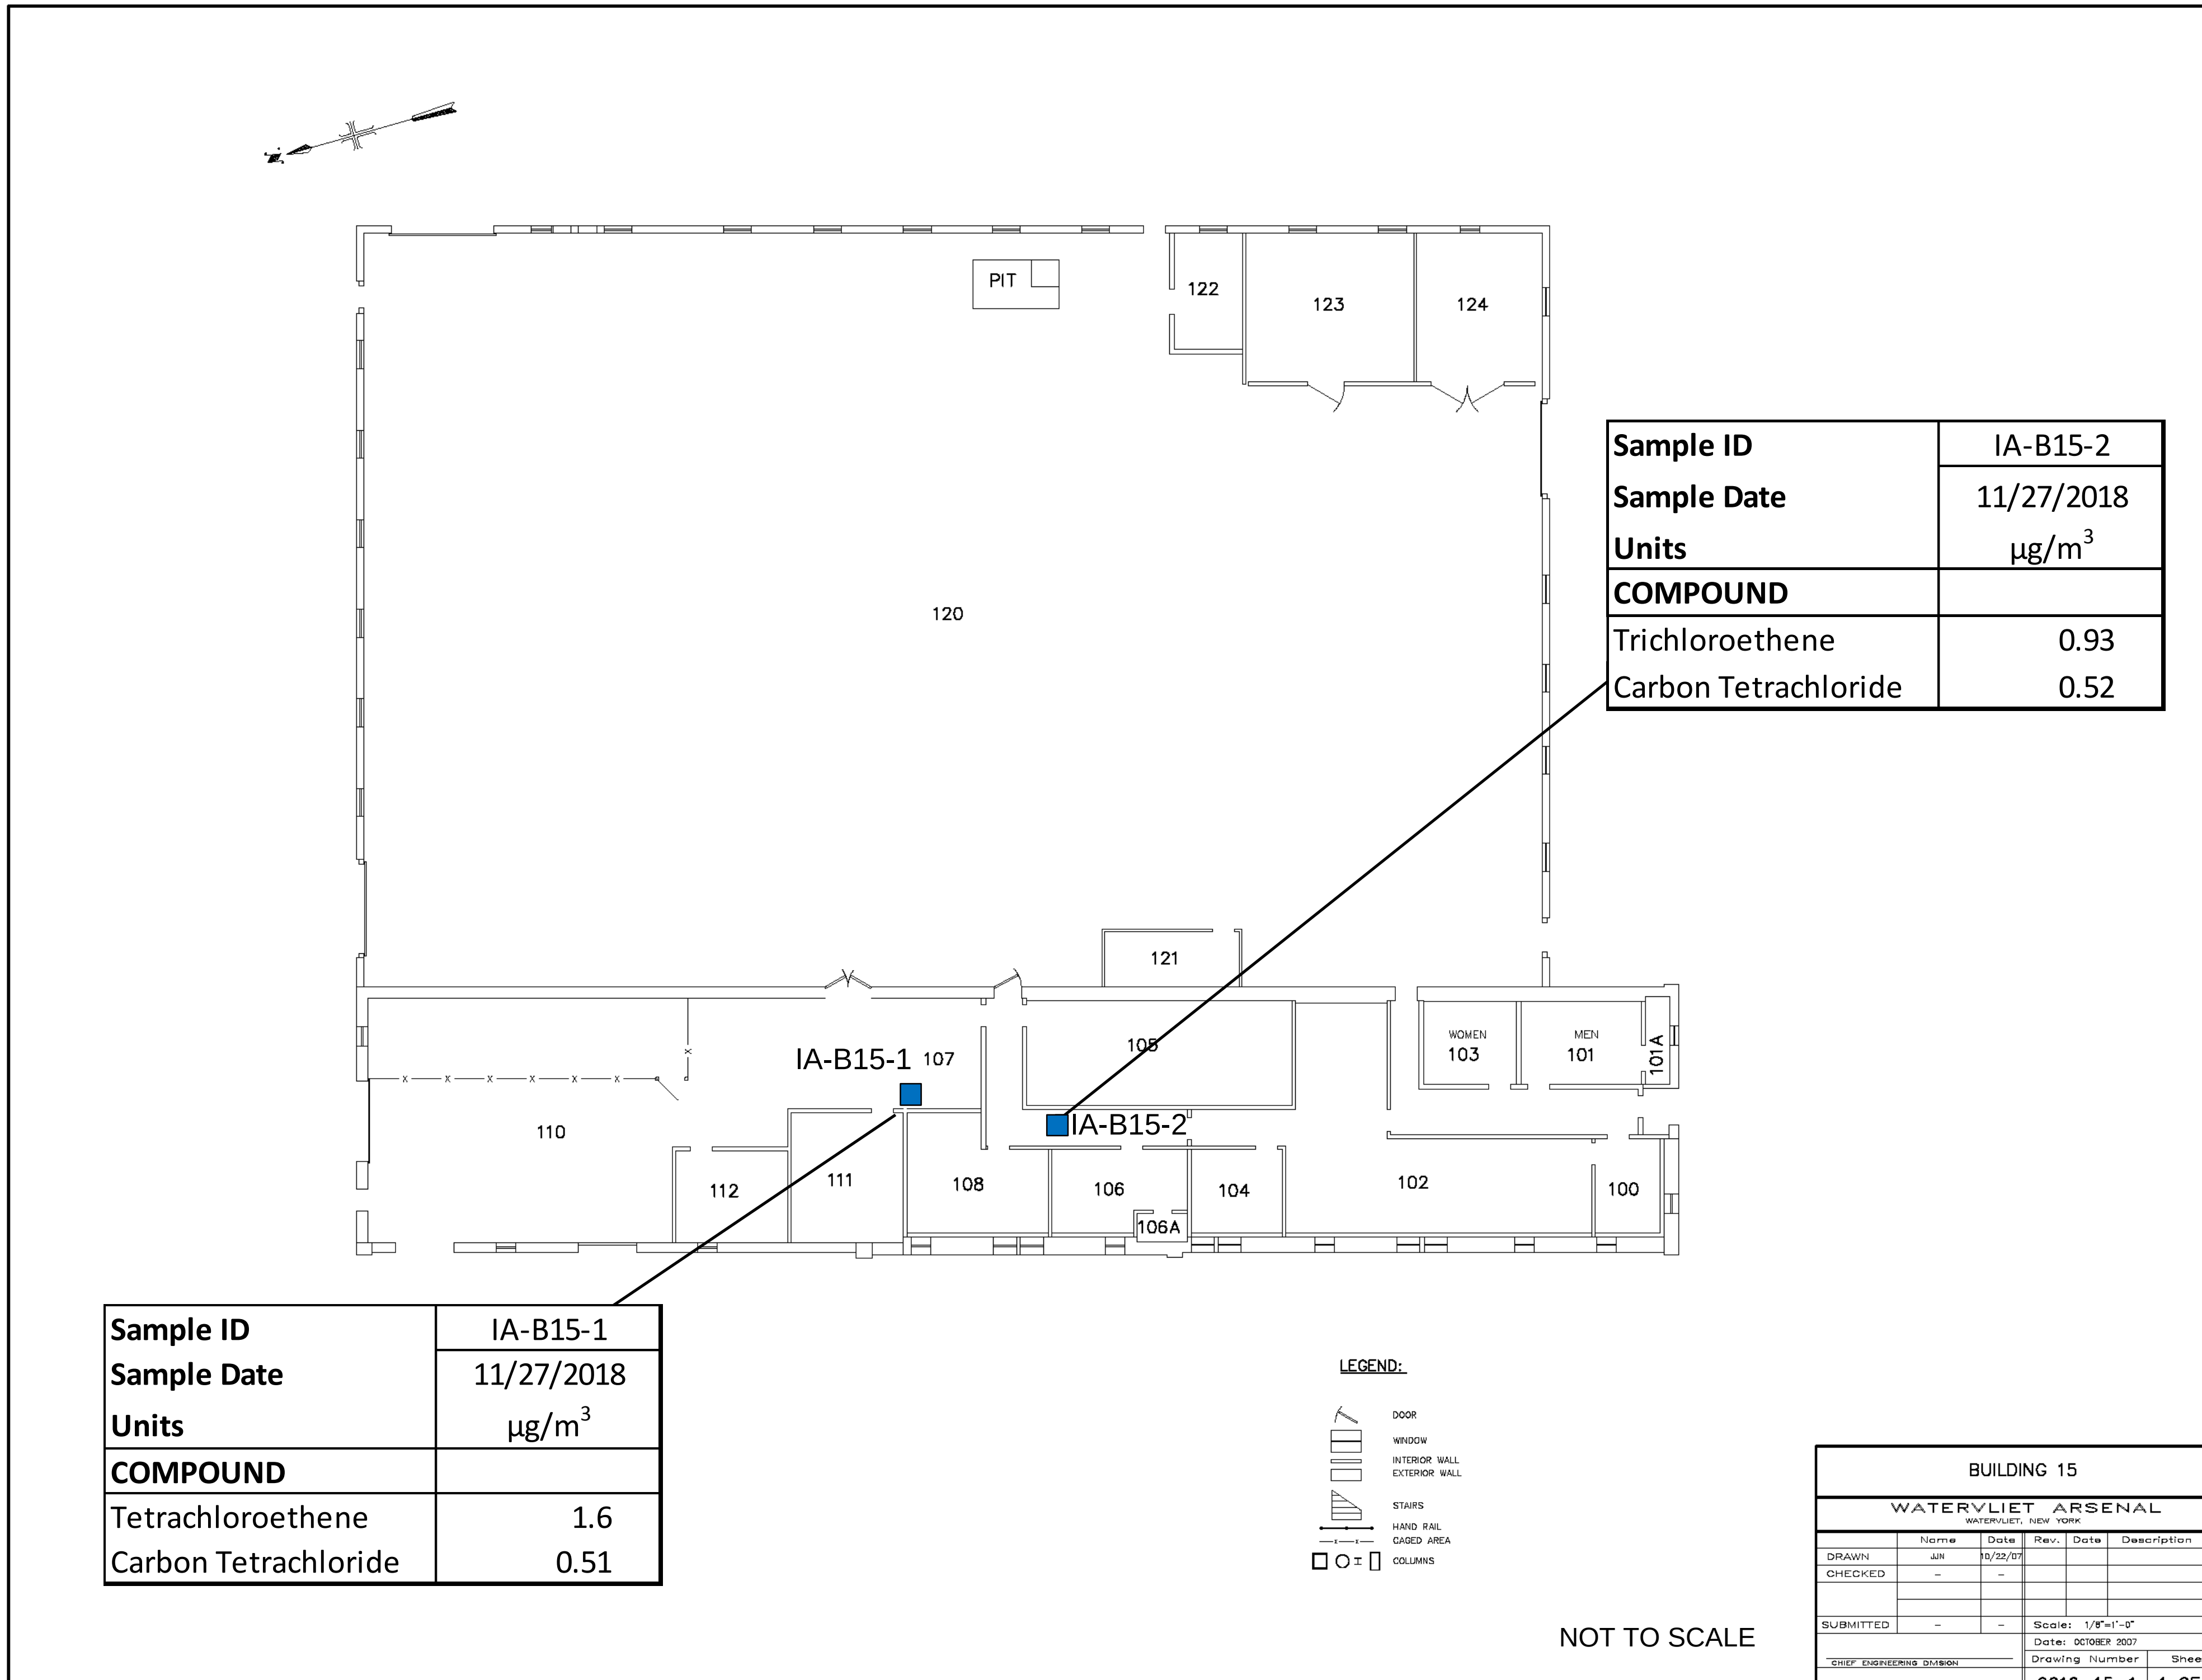
Figure 6
Indoor Air VOC Concentrations
Building 15 - No SSDS

Sample ID	IA-B15-2
Sample Date	11/27/2018
Units	µg/m^3
COMPOUND	
Trichloroethene	0.93
Carbon Tetrachloride	0.52

Sample ID	IA-B15-1
Sample Date	11/27/2018
Units	µg/m^3
COMPOUND	
Tetrachloroethene	1.6
Carbon Tetrachloride	0.51

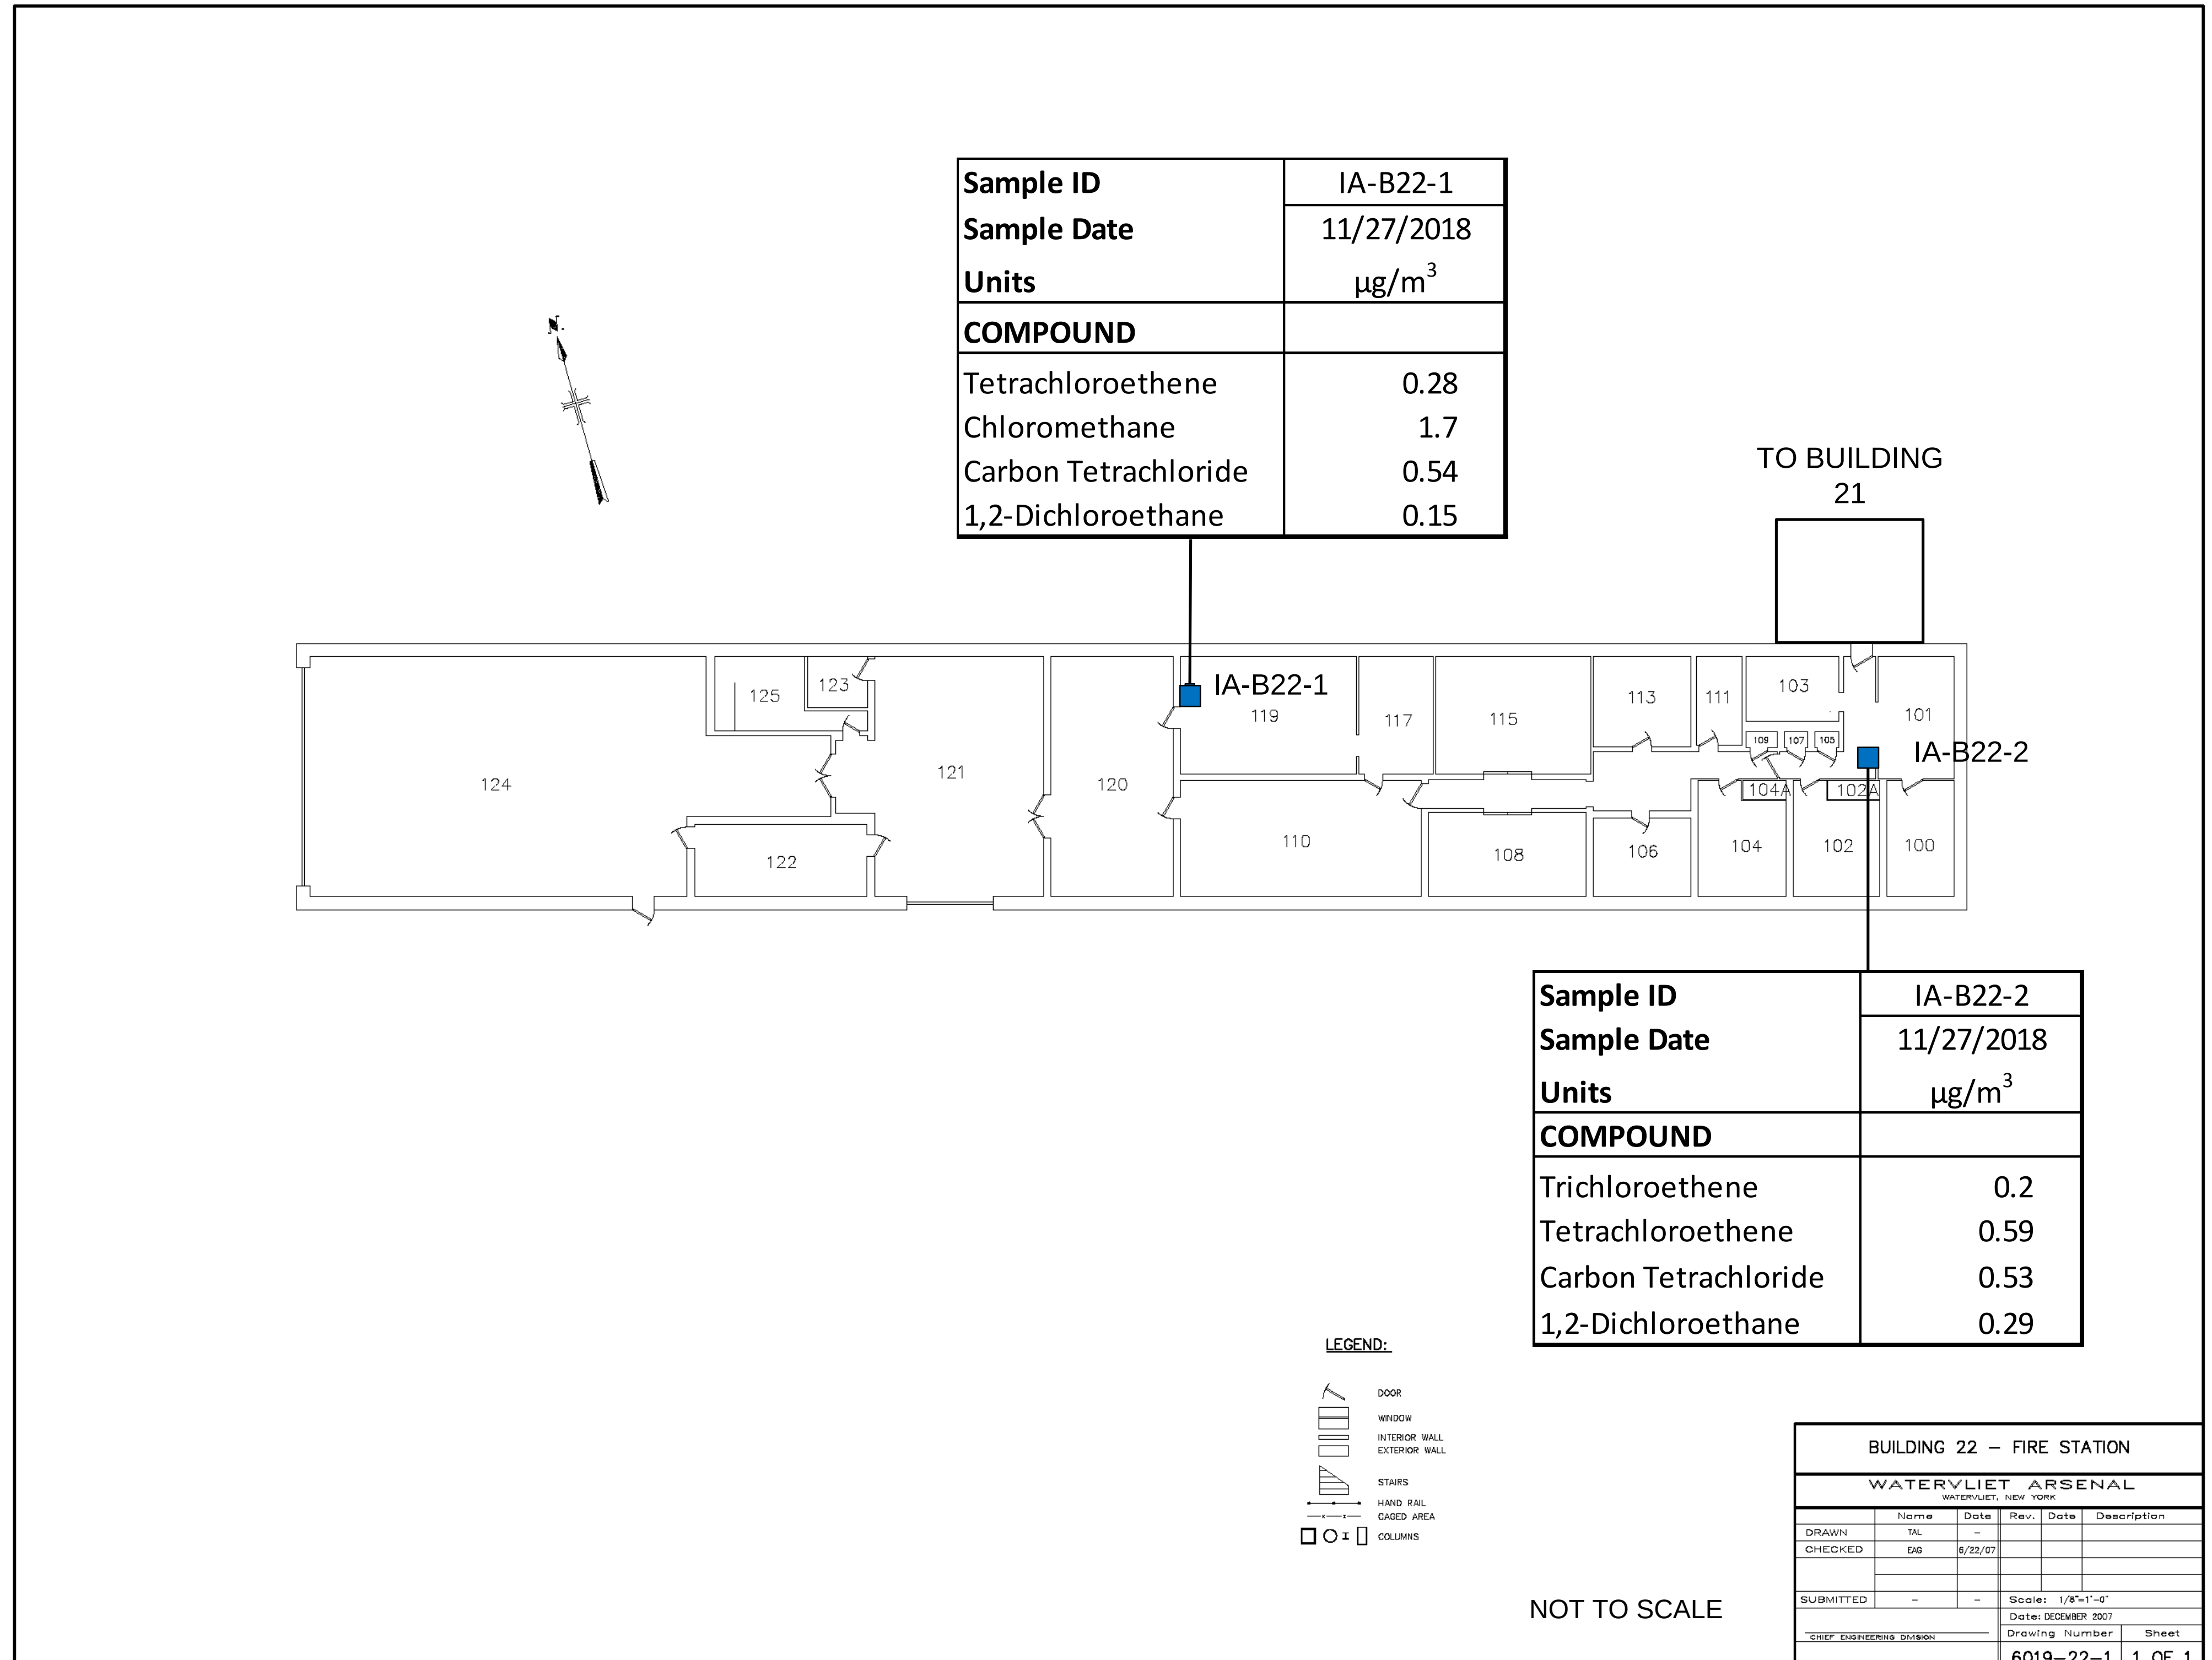
Figure 9
Indoor Air VOC Concentrations
Building 22 – Type C SSDS

Sample ID	IA-B22-1
Sample Date	11/27/2018
Units	µg/m^3
COMPOUND	
Tetrachloroethene	0.28
Chloromethane	1.7
Carbon Tetrachloride	0.54
1,2-Dichloroethane	0.15

Sample ID	IA-B22-2
Sample Date	11/27/2018
Units	µg/m^3
COMPOUND	
Trichloroethene	0.2
Tetrachloroethene	0.59
Carbon Tetrachloride	0.53
1,2-Dichloroethane	0.29

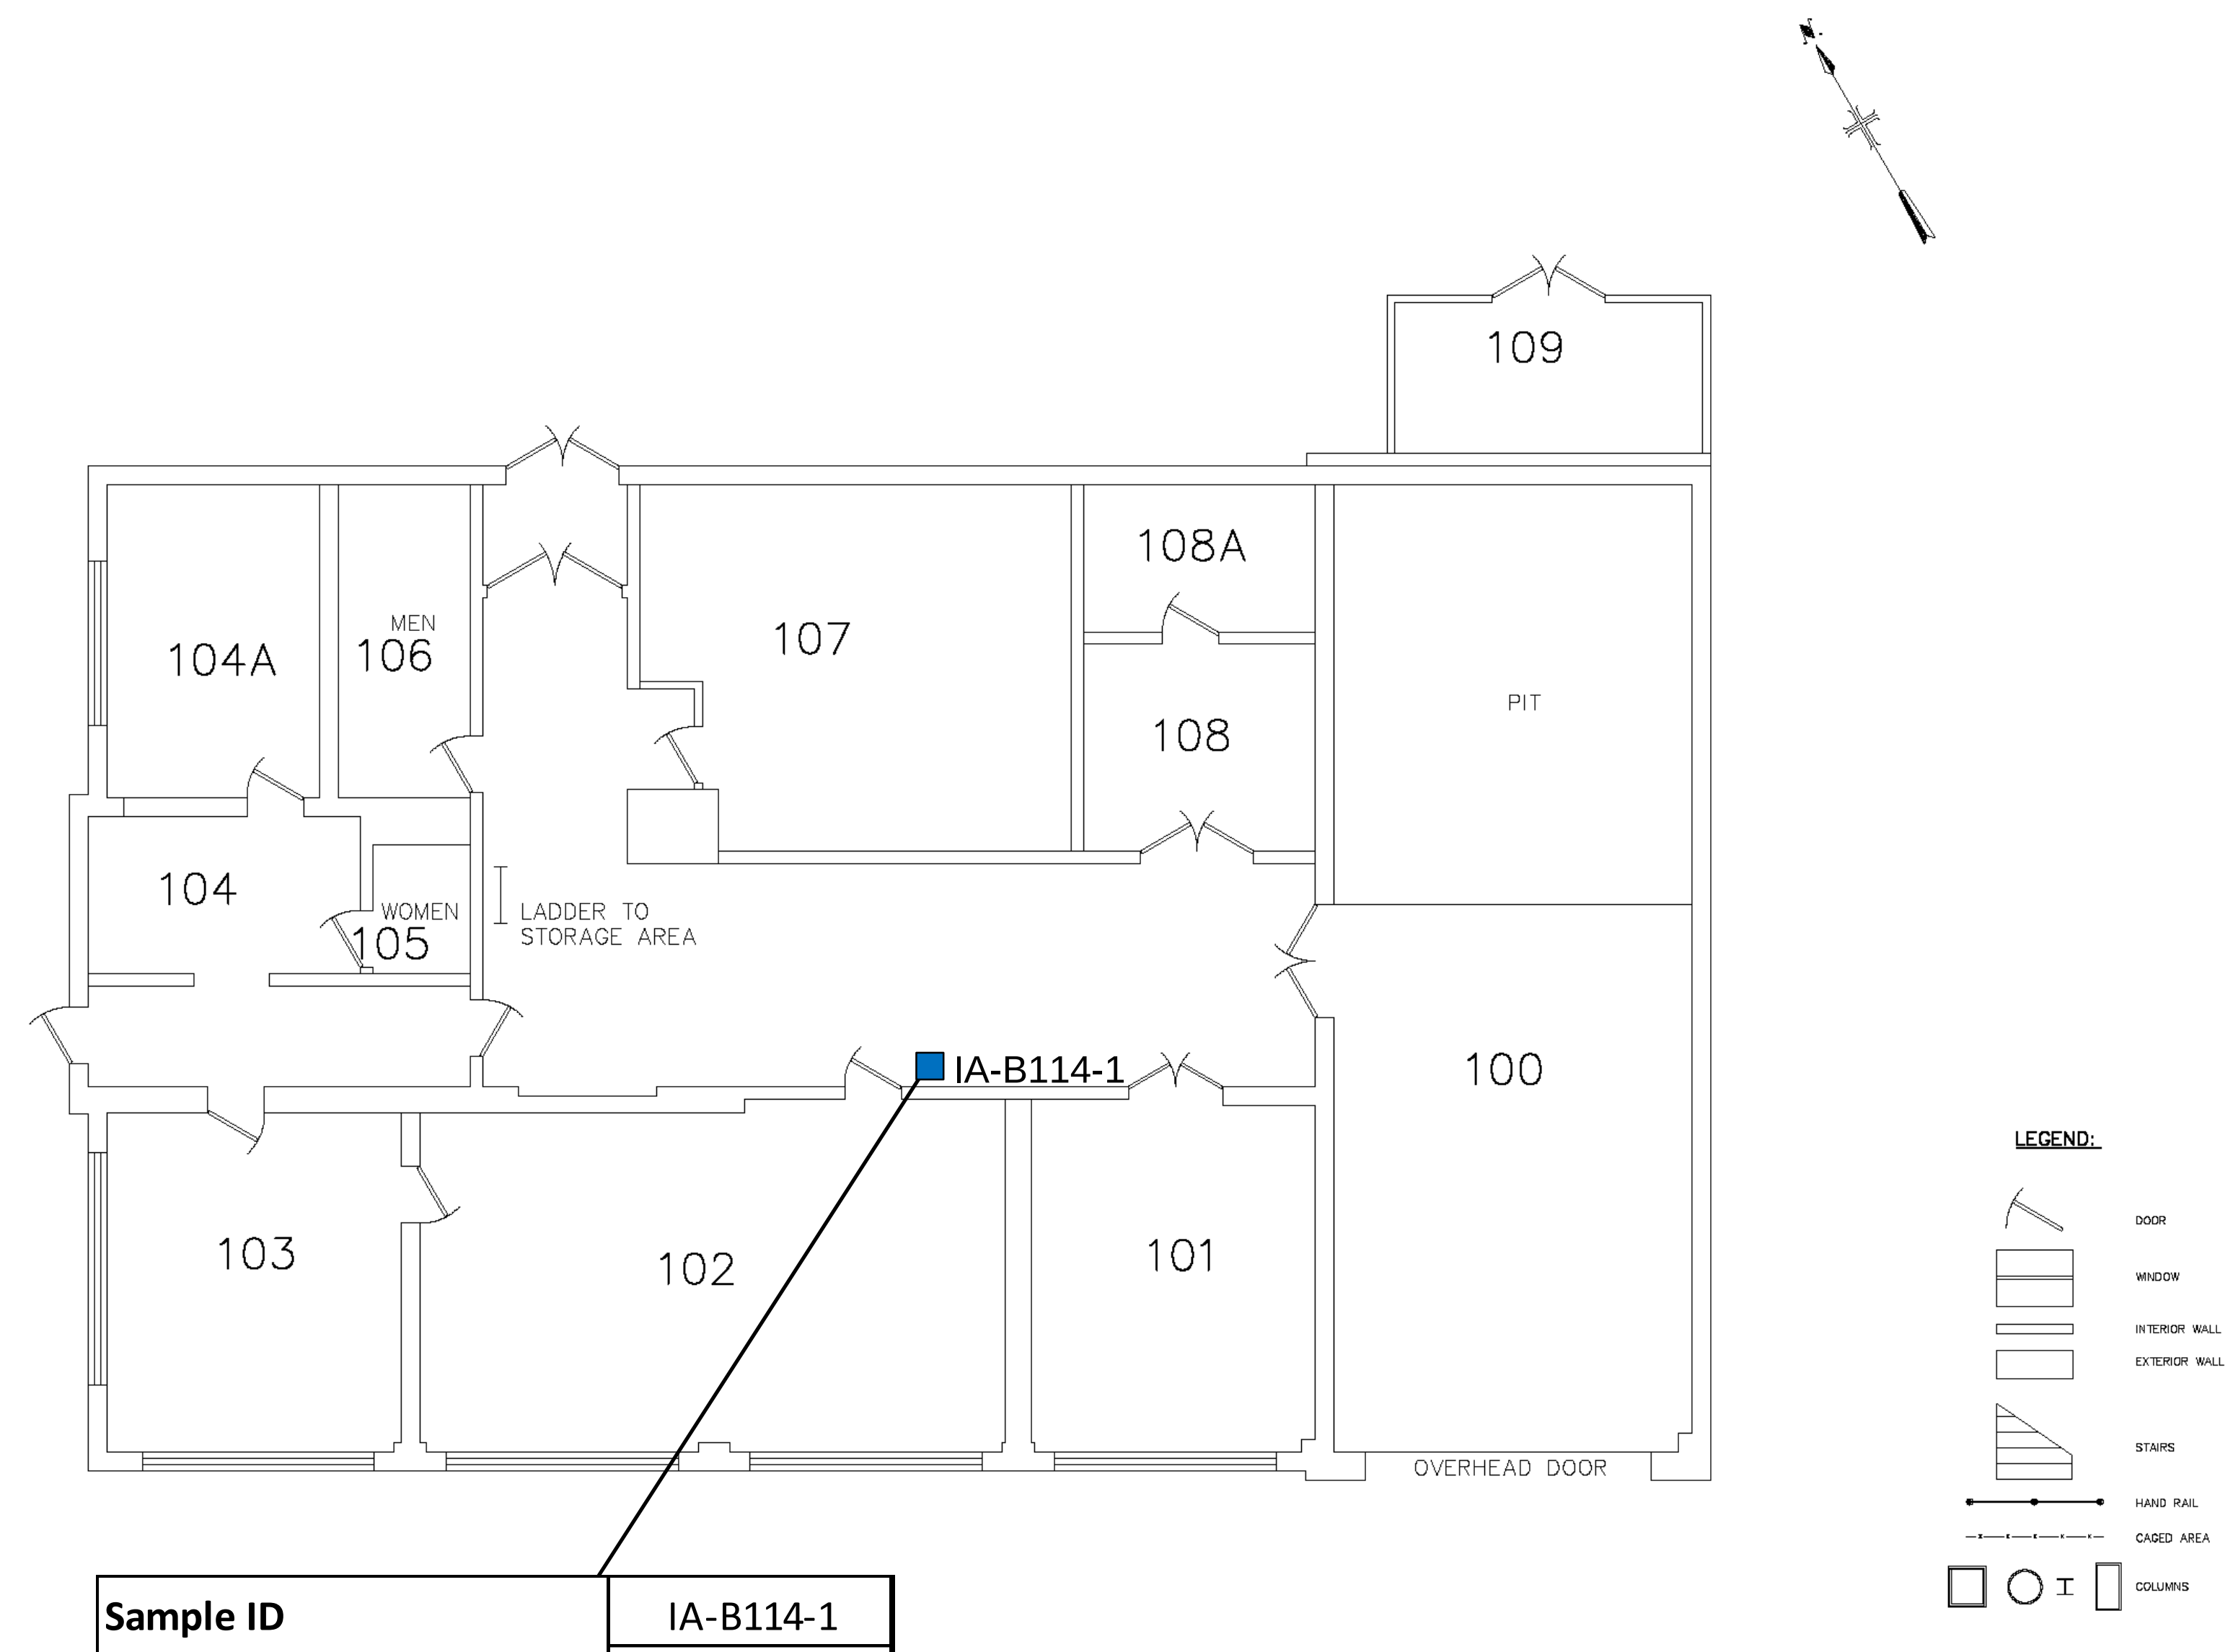
Figure 11
Indoor Air VOC Concentrations
Building 114 – Type A SSDS

Sample ID	IA-B114-1
Sample Date	11/27/2018
Units	µg/m^3
COMPOUND	
1,1,1-Trichloroethane	0.65
Tetrachloroethene	0.48
Carbon Tetrachloride	0.37

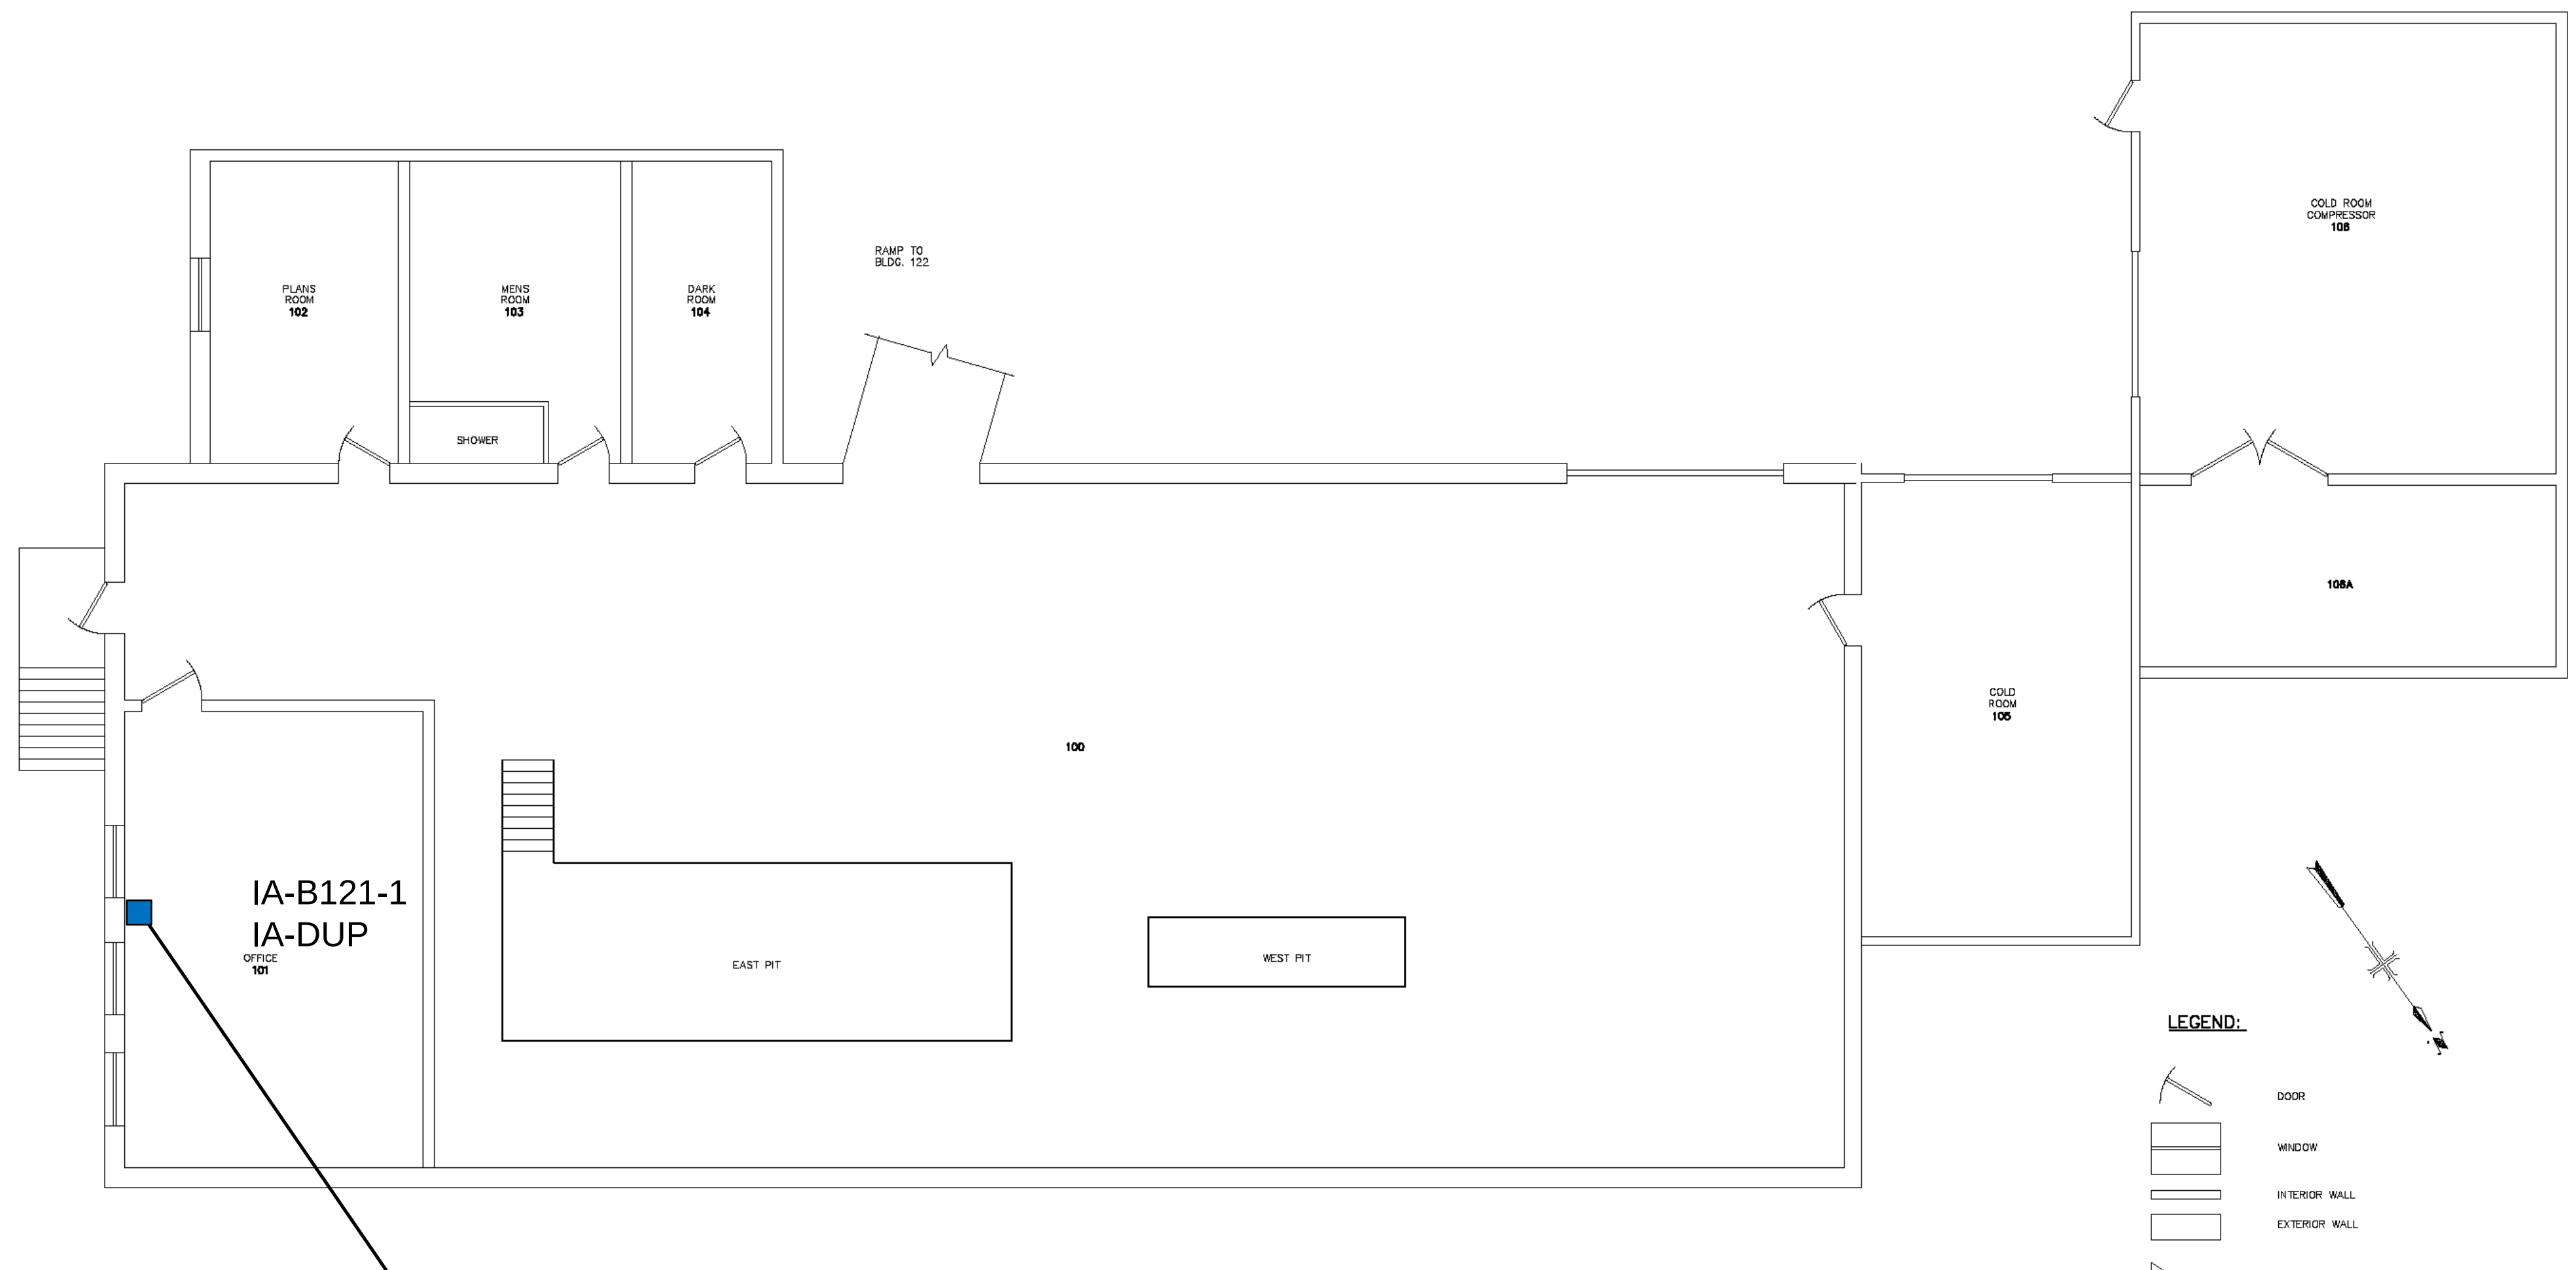
Figure 13
Indoor Air VOC Concentrations
Building 121 – Type C SSDS

Sample ID	IA-B121-1
Sample Date	11/27/2018
Units	µg/m³
COMPOUND	
Carbon Tetrachloride	0.28

Sample ID	IA-DUP
Sample Date	11/27/2018
Units	µg/m³
COMPOUND	
Carbon Tetrachloride	0.32
