PERIODIC REVIEW REPORT

Watervliet Arsenal

Site No. 401034A

March 2019

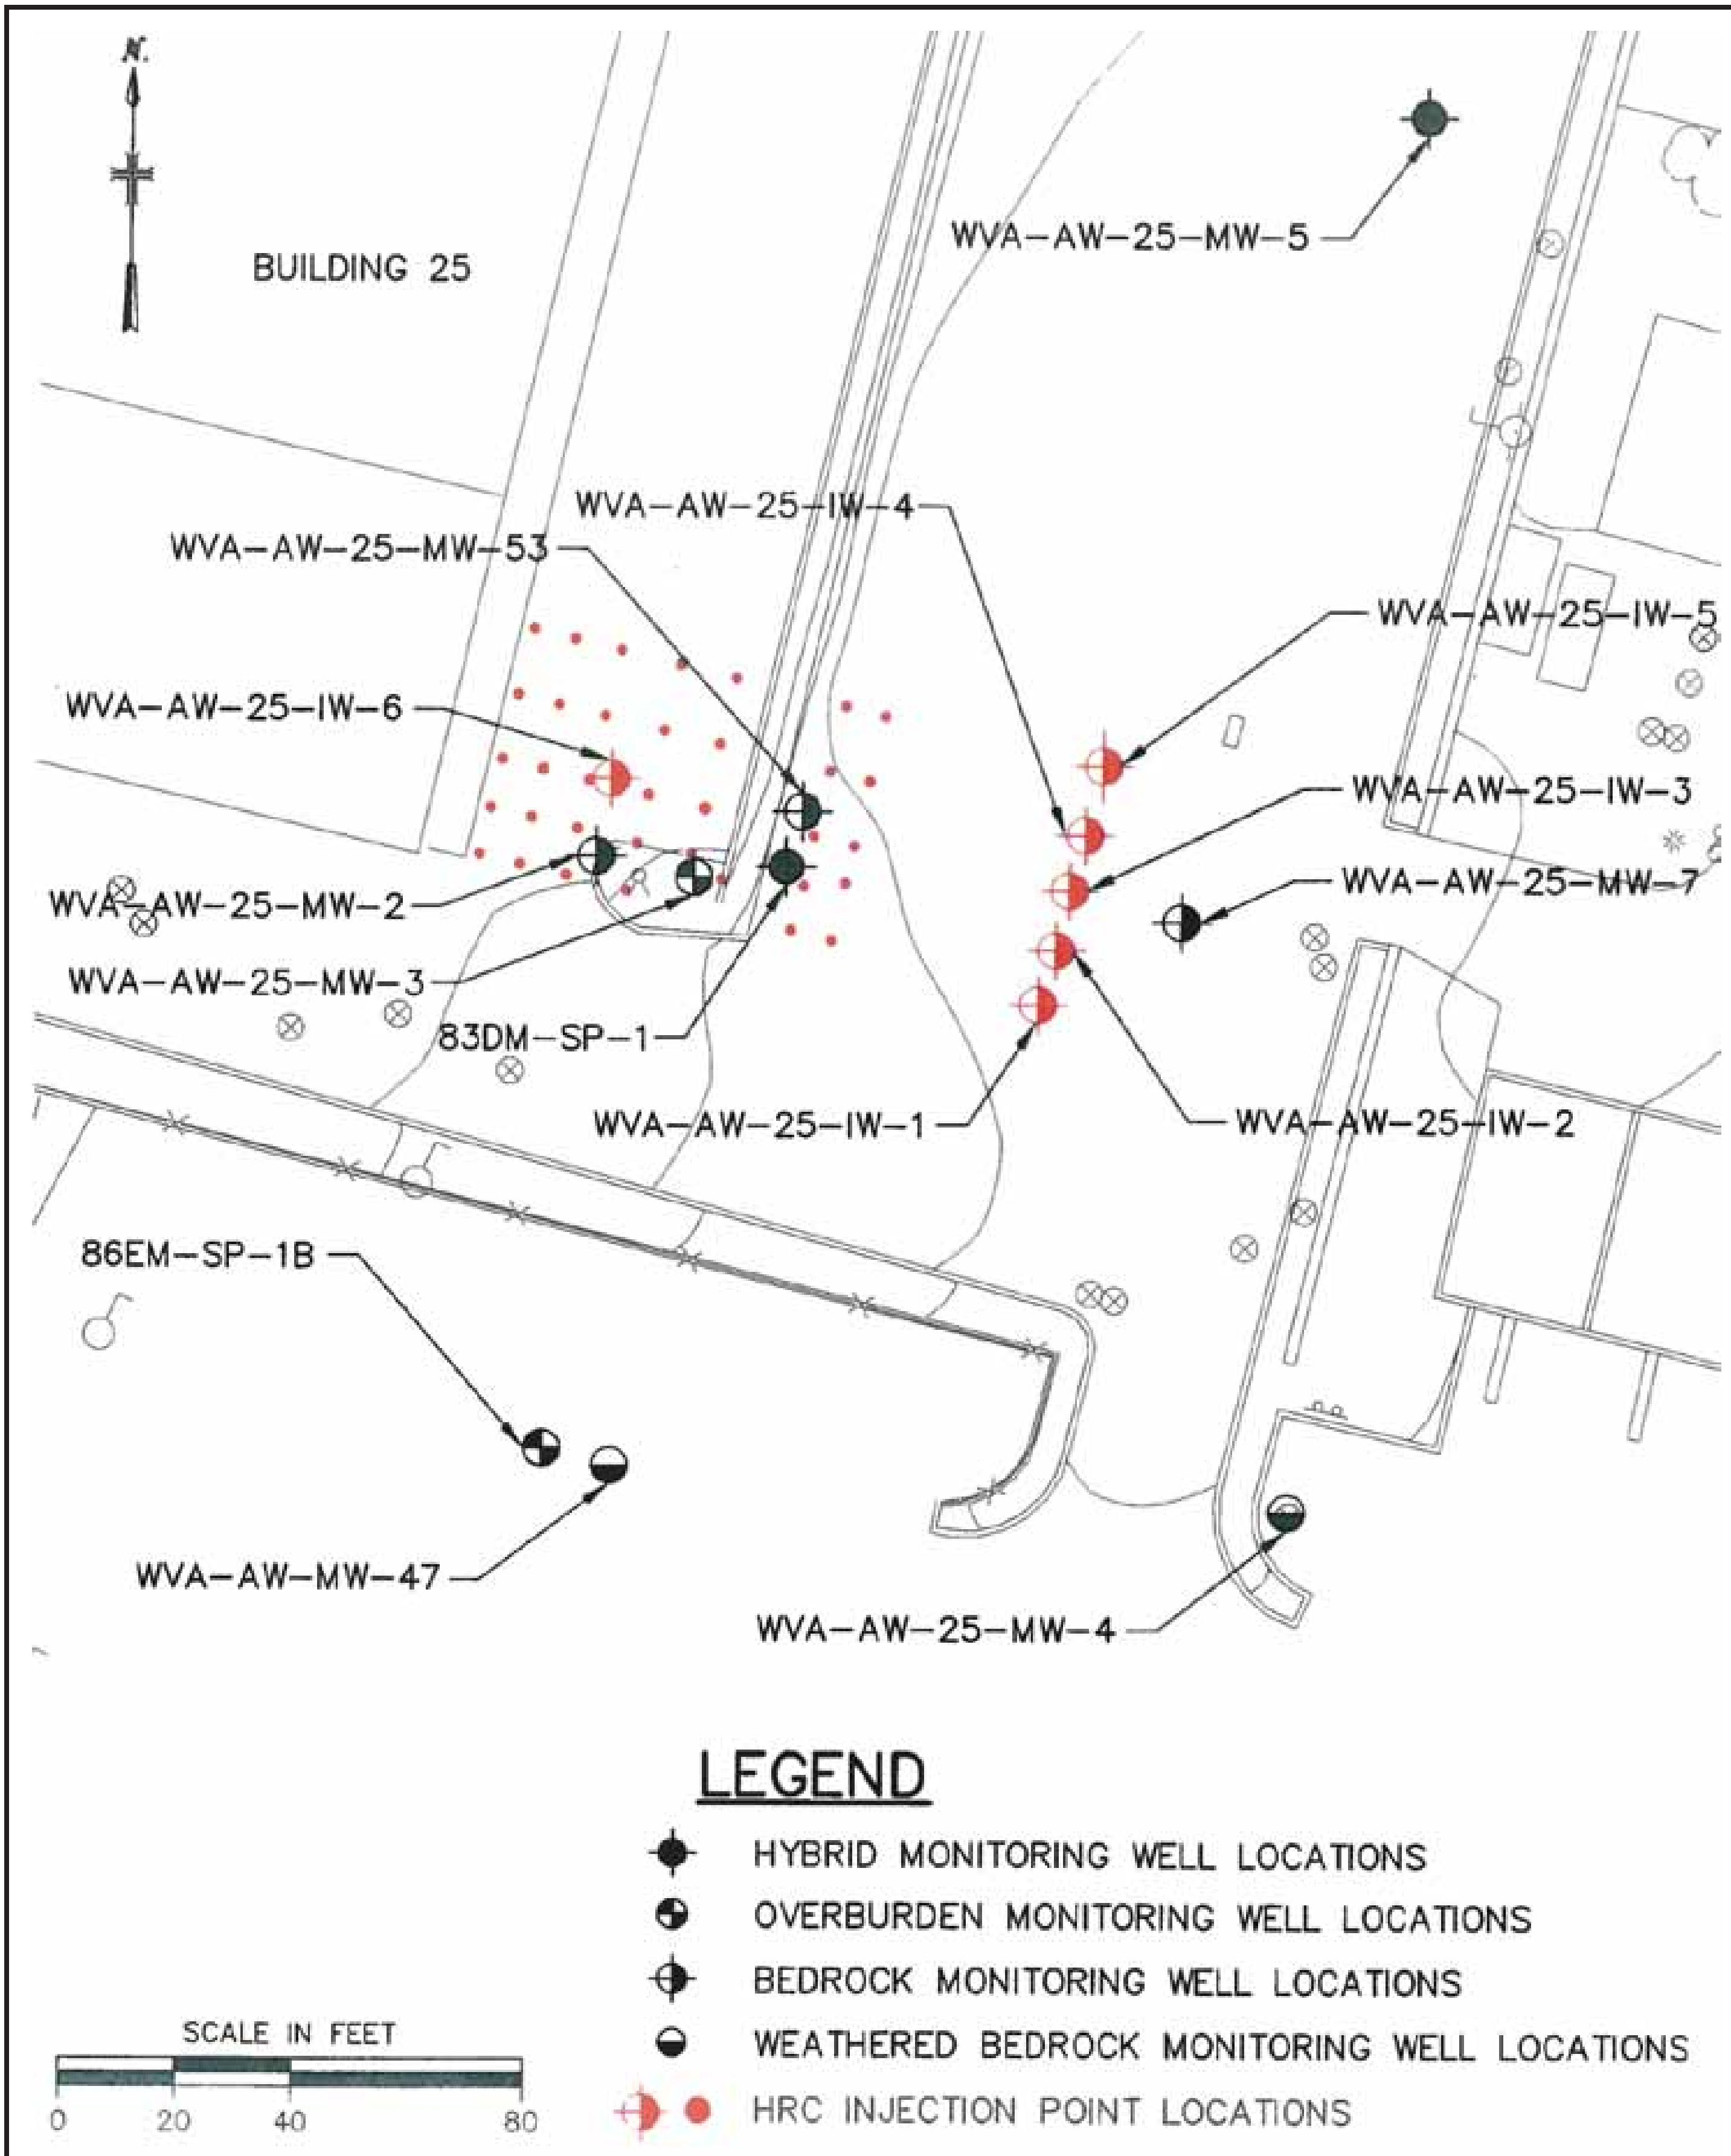
FIGURE 3

The HRC® was successfully delivered and distributed into the overburden and bedrock groundwater as shown by the detection of HRC® at the most downgradient well (MW-7) (Figure 3). The ICM results showed that the geochemistry and presence of electron donors in the groundwater at Building 25 after the completion of the injections were adequate for reductive dechlorination. The concentrations of CVOCs in the groundwater decreased by 31 to 99 percent, depending on the sampling location. In addition, the relative proportion of the parent CVOC (i.e., tetrachloroethene or trichloroethene) decreased by more than 38 percent at all locations. Based on the data collected during and after the ICM, the injection of HRC® was successful in promoting the biodegradation of CVOCs in both the overburden and bedrock groundwater through reductive dechlorination. Trends in the concentration of daughter products and the concentrations of dissolved gases in the groundwater indicate that complete degradation of the

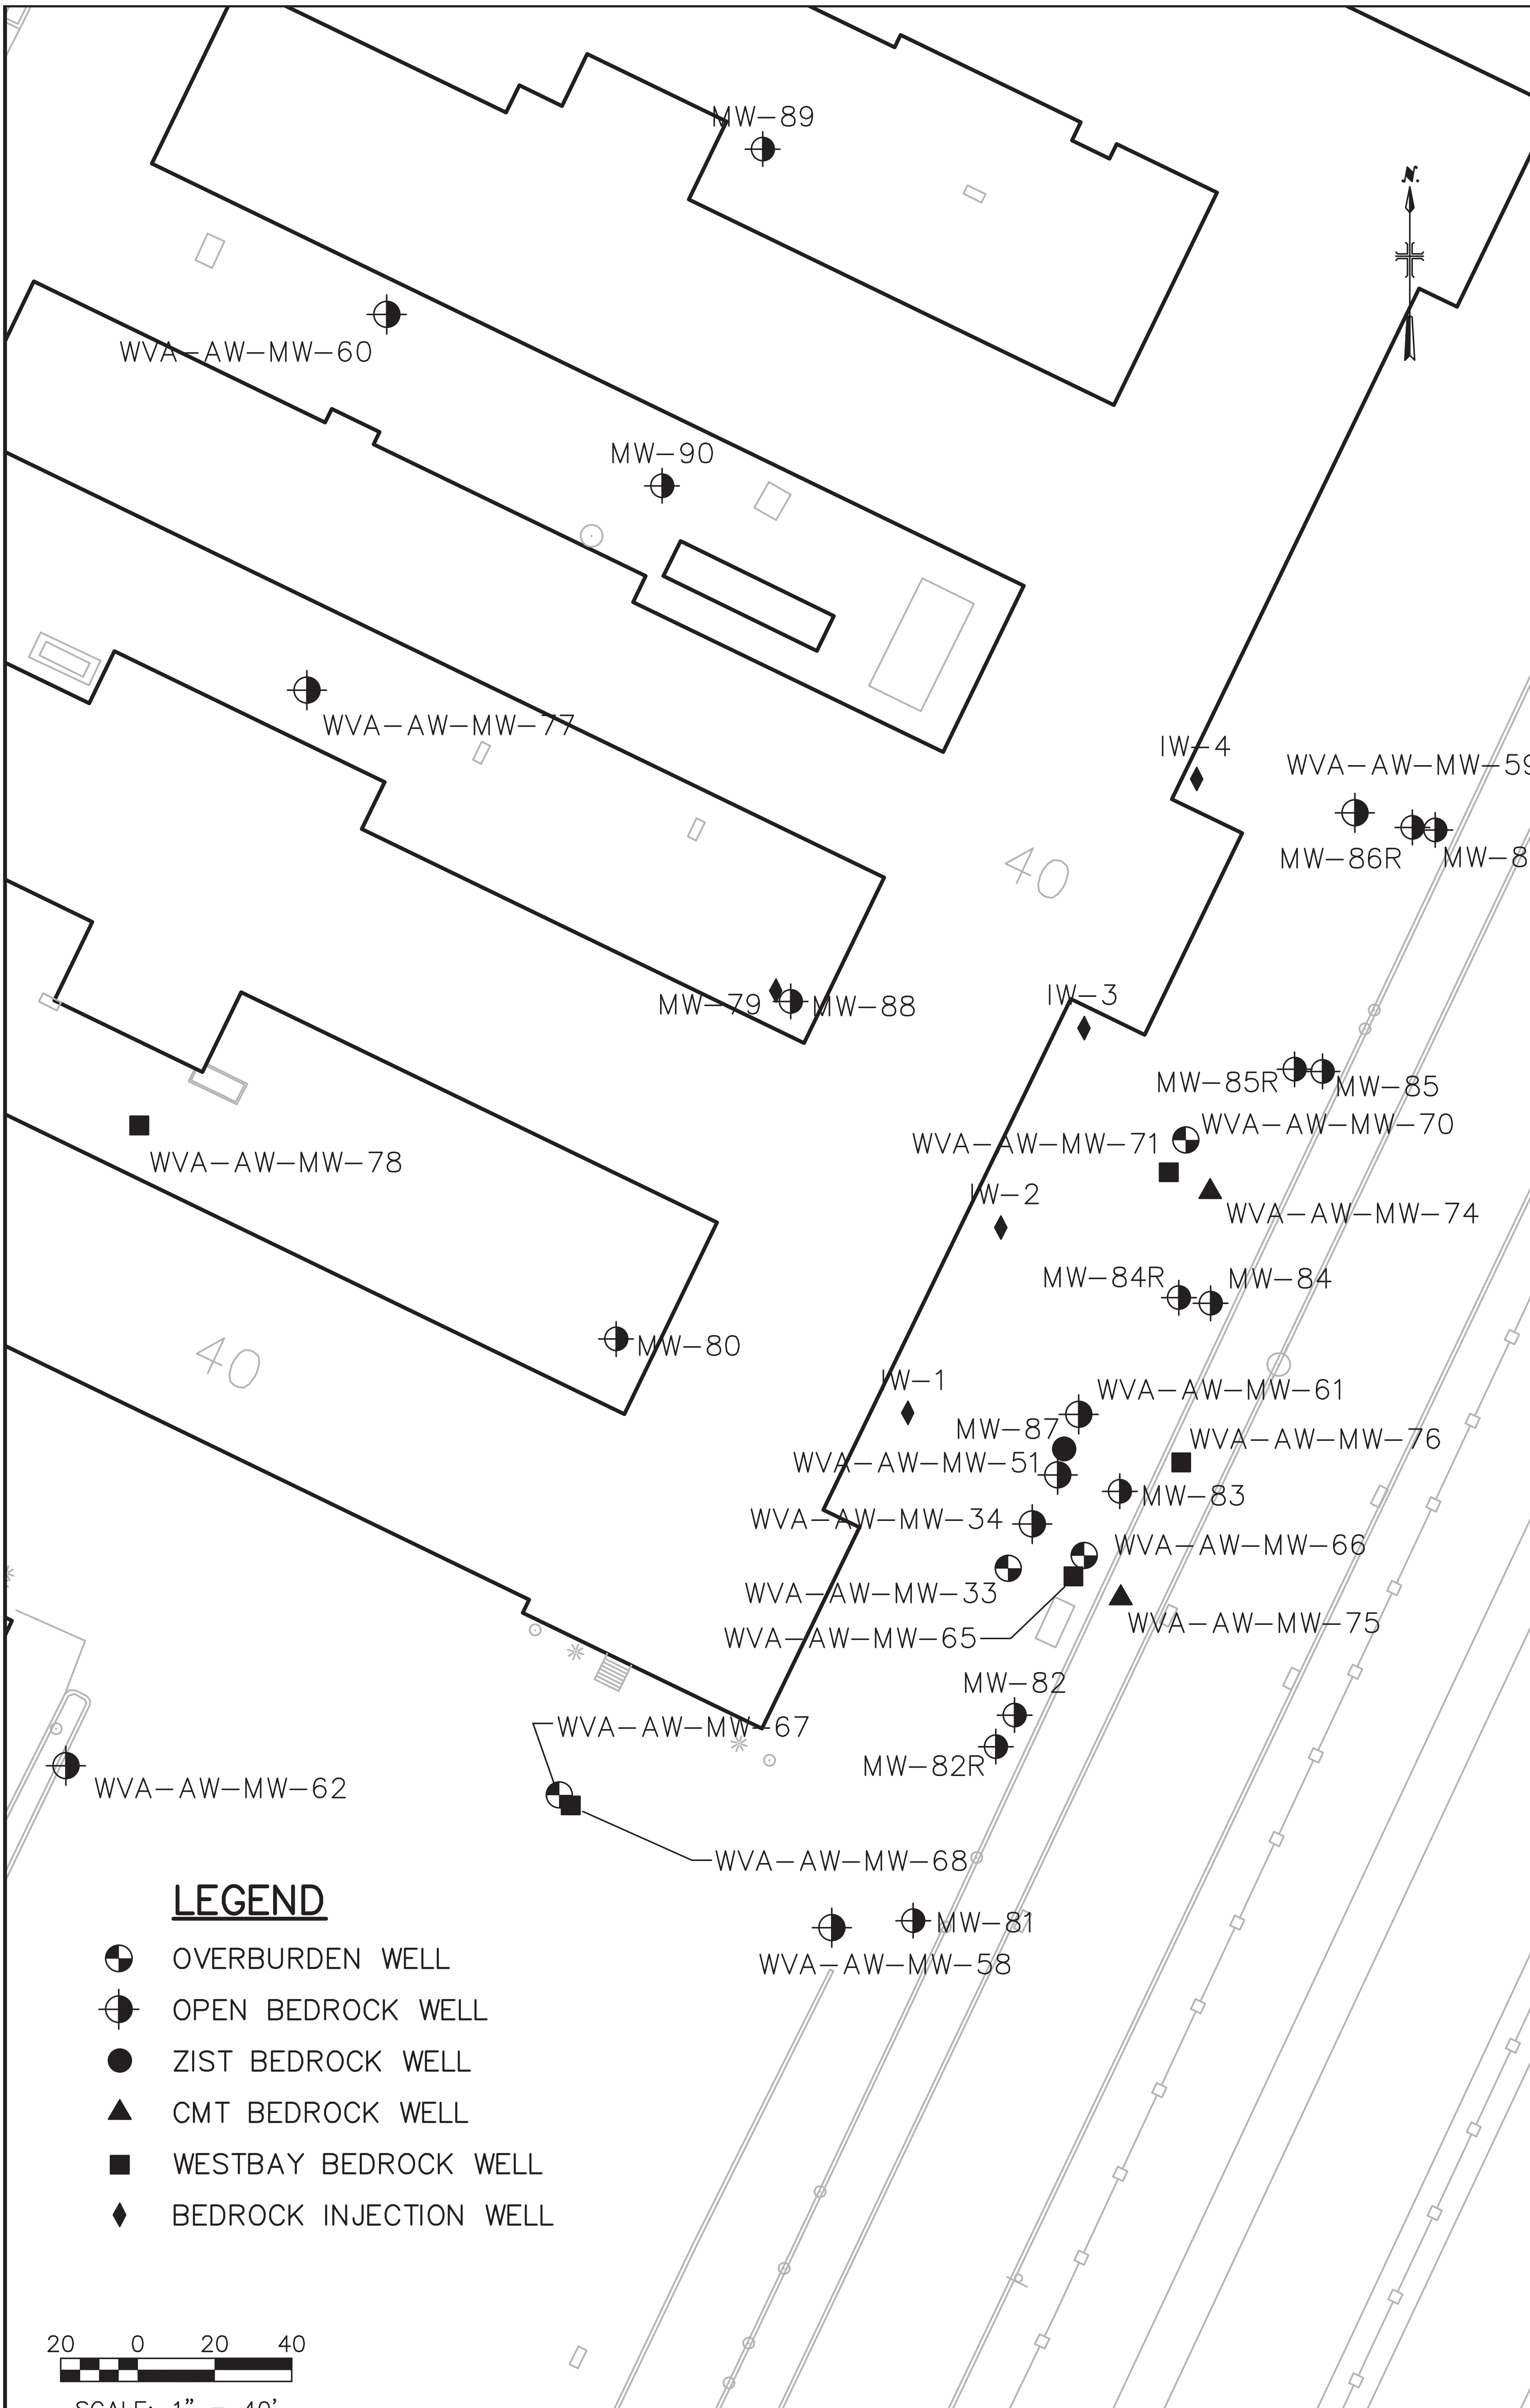
FIGURE 4

The Building 40 bedrock groundwater in-situ chemical oxidation (ISCO) ICM included injections of sodium permanganate (hereafter referred to as permanganate) and groundwater sampling at the WVA property boundary (Figure 4). The Corrective Action Objective (CAO) for the ICM was to reduce the concentration of hazardous constituents (CVOCs) in groundwater migrating from the site to New York State Class GA Standards. However, given the likely presence of DNAPL in the fractured rock at the site, it was recognized that the achievement of the CAO may require an extensive time period and may not be achievable using currently available technologies.

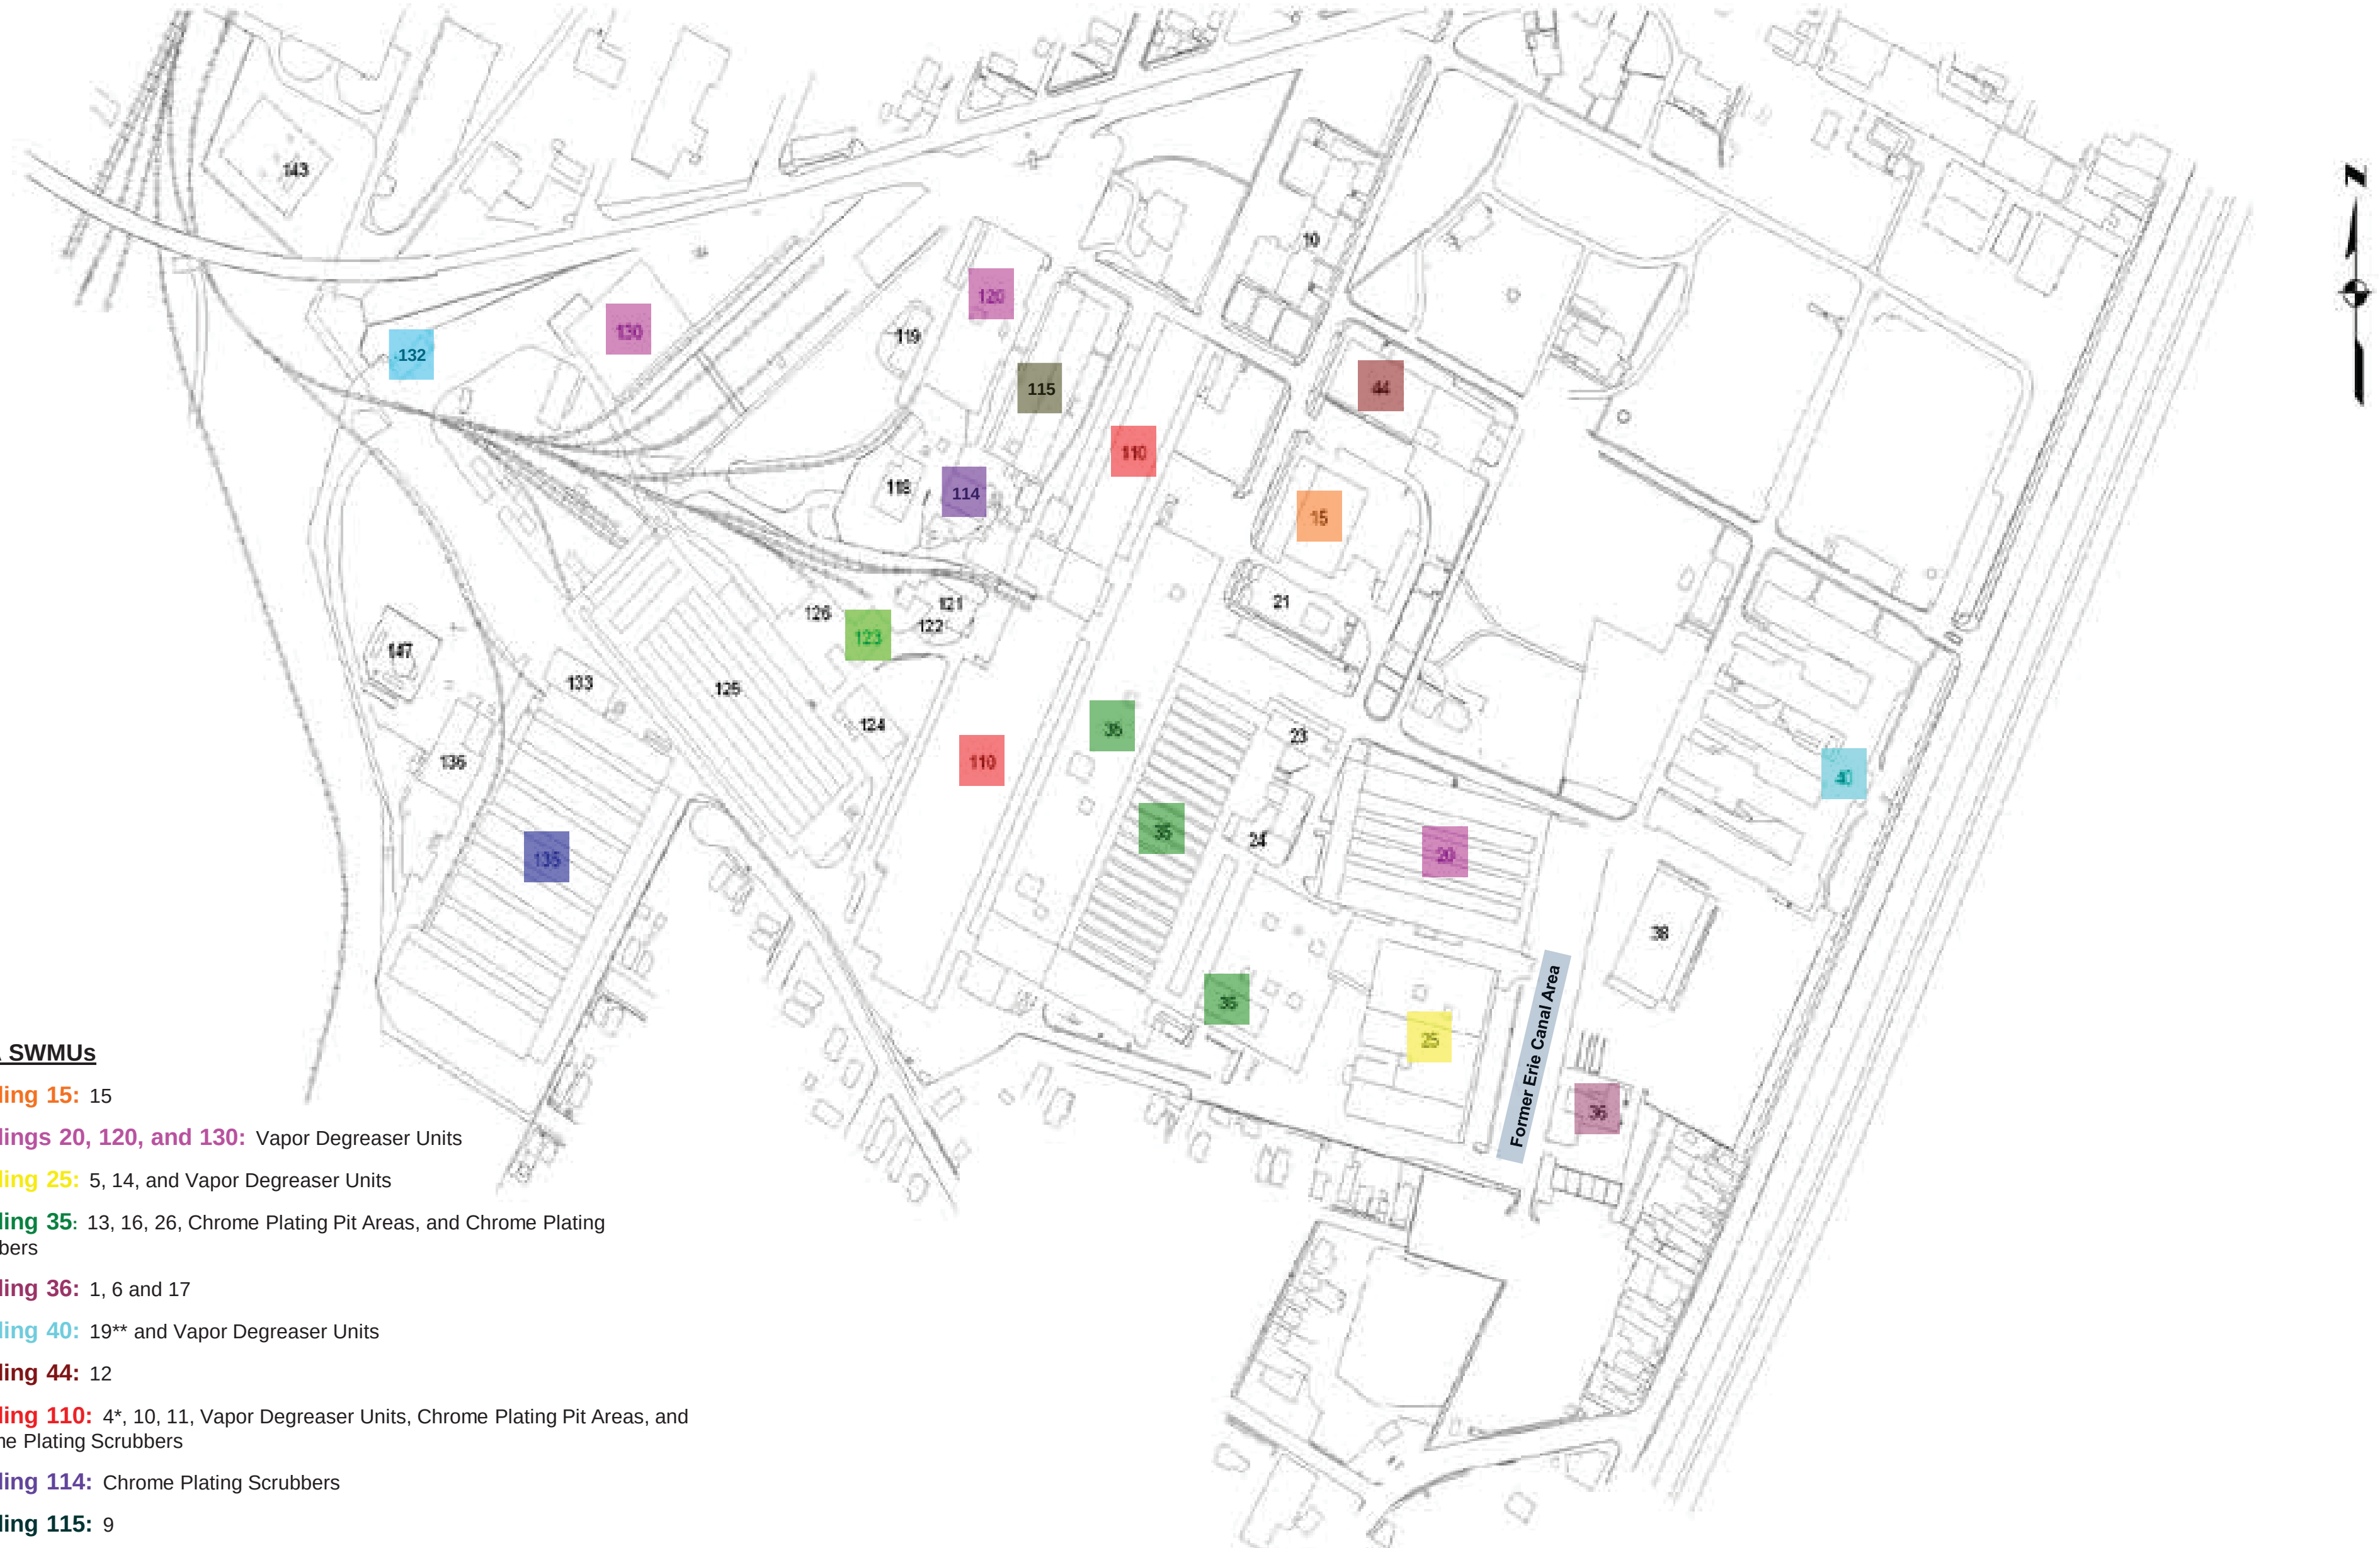
FIGURE 6

There were 24 Solid Waste Management Units (SWMUs) identified the MMA (Figure 6). The nature and extent of contamination at the MMA SWMUs is discussed below.
