CONSTRUCTION COMPLETION REPORT - SEDIMENT BASIN MAINTENANCE

WARD PRODUCTS SITE
NYSDEC SITE NO. 429004
AMSTERDAM, NEW YORK

PREPARED FOR:
NEW YORK STATE DEPARTMENT OF ENVIRONMENTAL CONSERVATION

NATURAL SYSTEMS ENGINEERING, PLLC
120 EAST WASHINGTON ST., SUITE 700
SYRACUSE, NEW YORK 13202

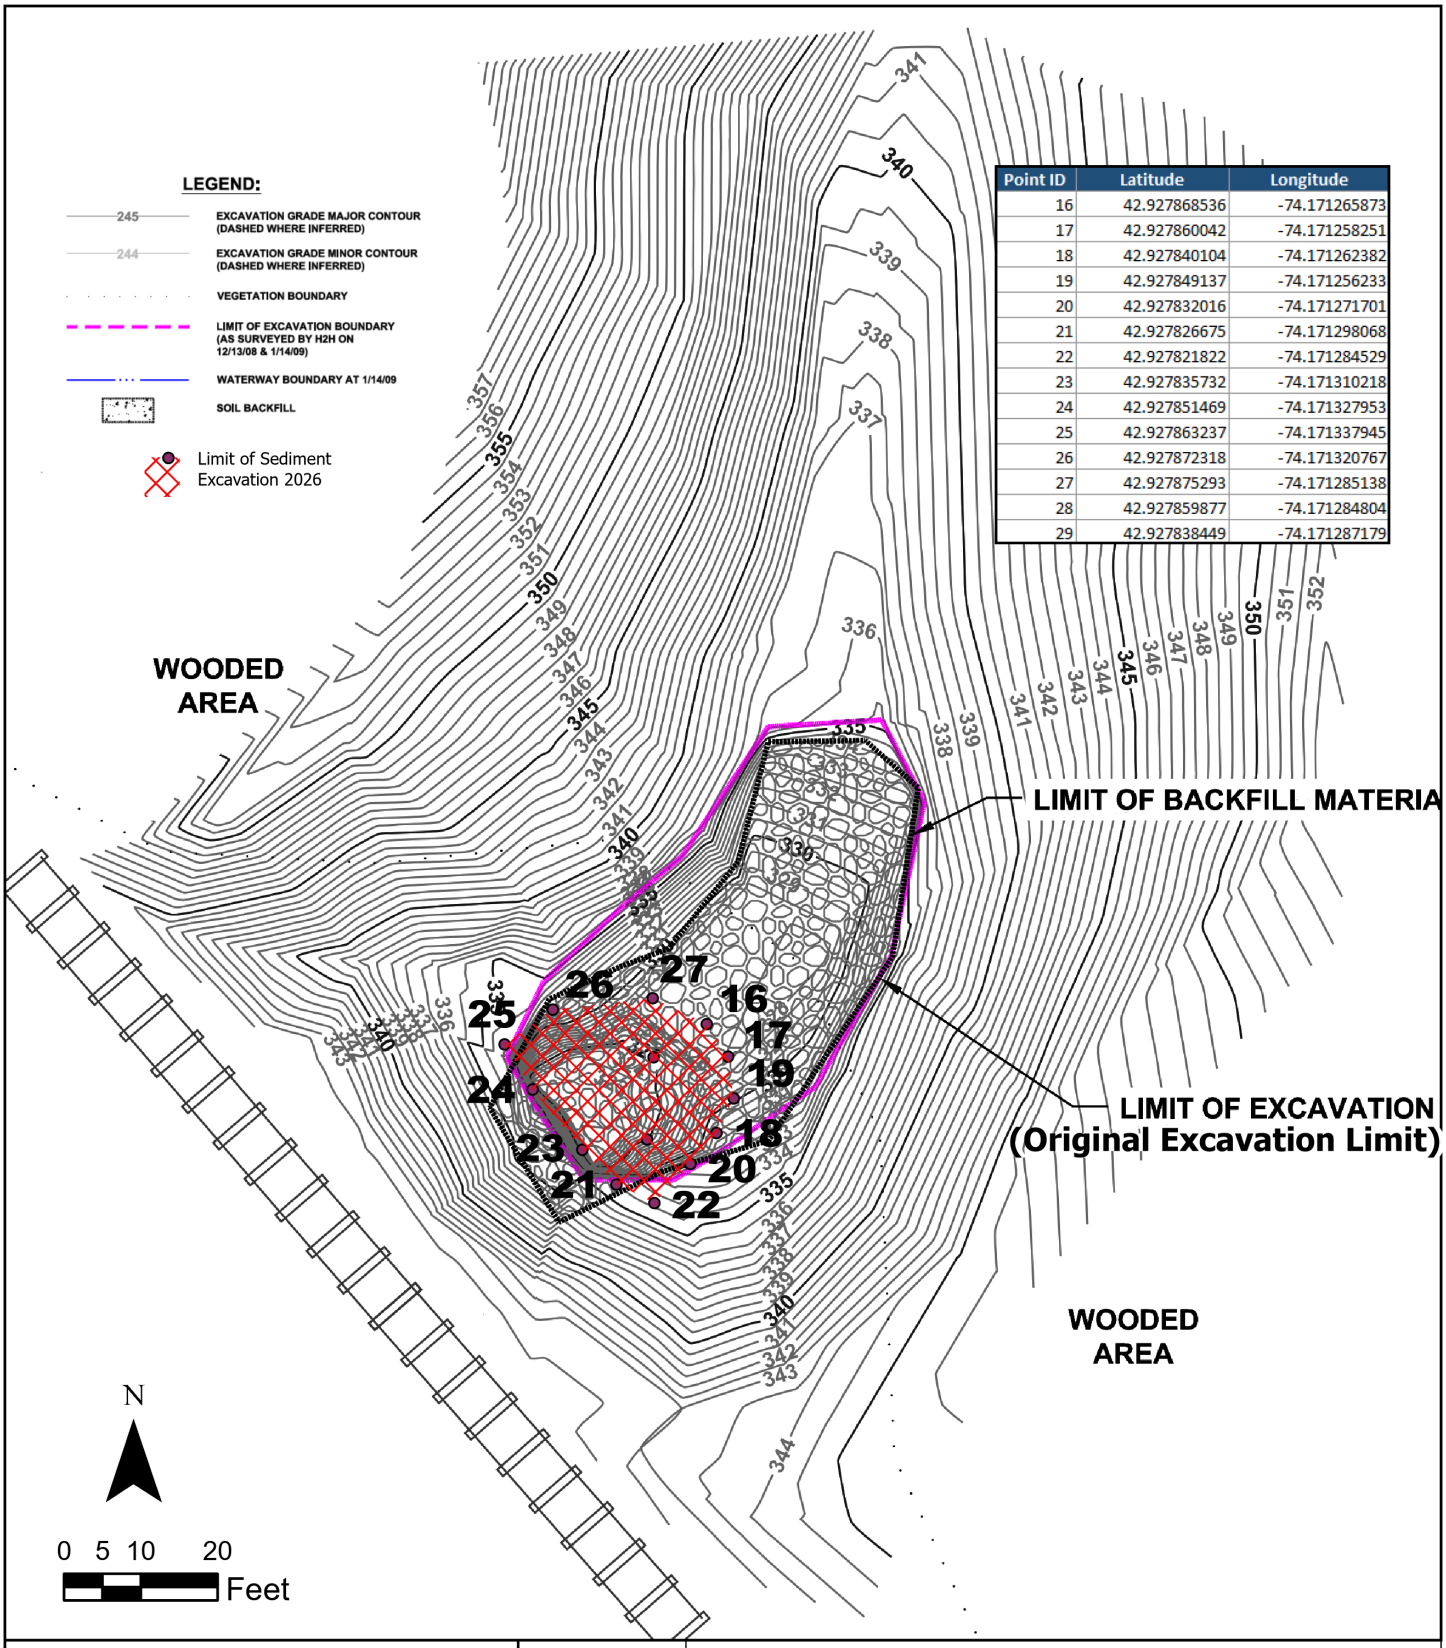
FIGURE : 2

On August 24, 2026 21.55 tons of sediment was removed from Sam Stratton Sediment Basin. The sediment was removed from an area with dimensions of approximately 27 ft x 17 ft to a depth of approximately 18-24 inches where a layer of gravel and coarse stone was observed and excavation terminated. Final condition of the sediment excavation area can be viewed in the Photographic Log in Appendix B.

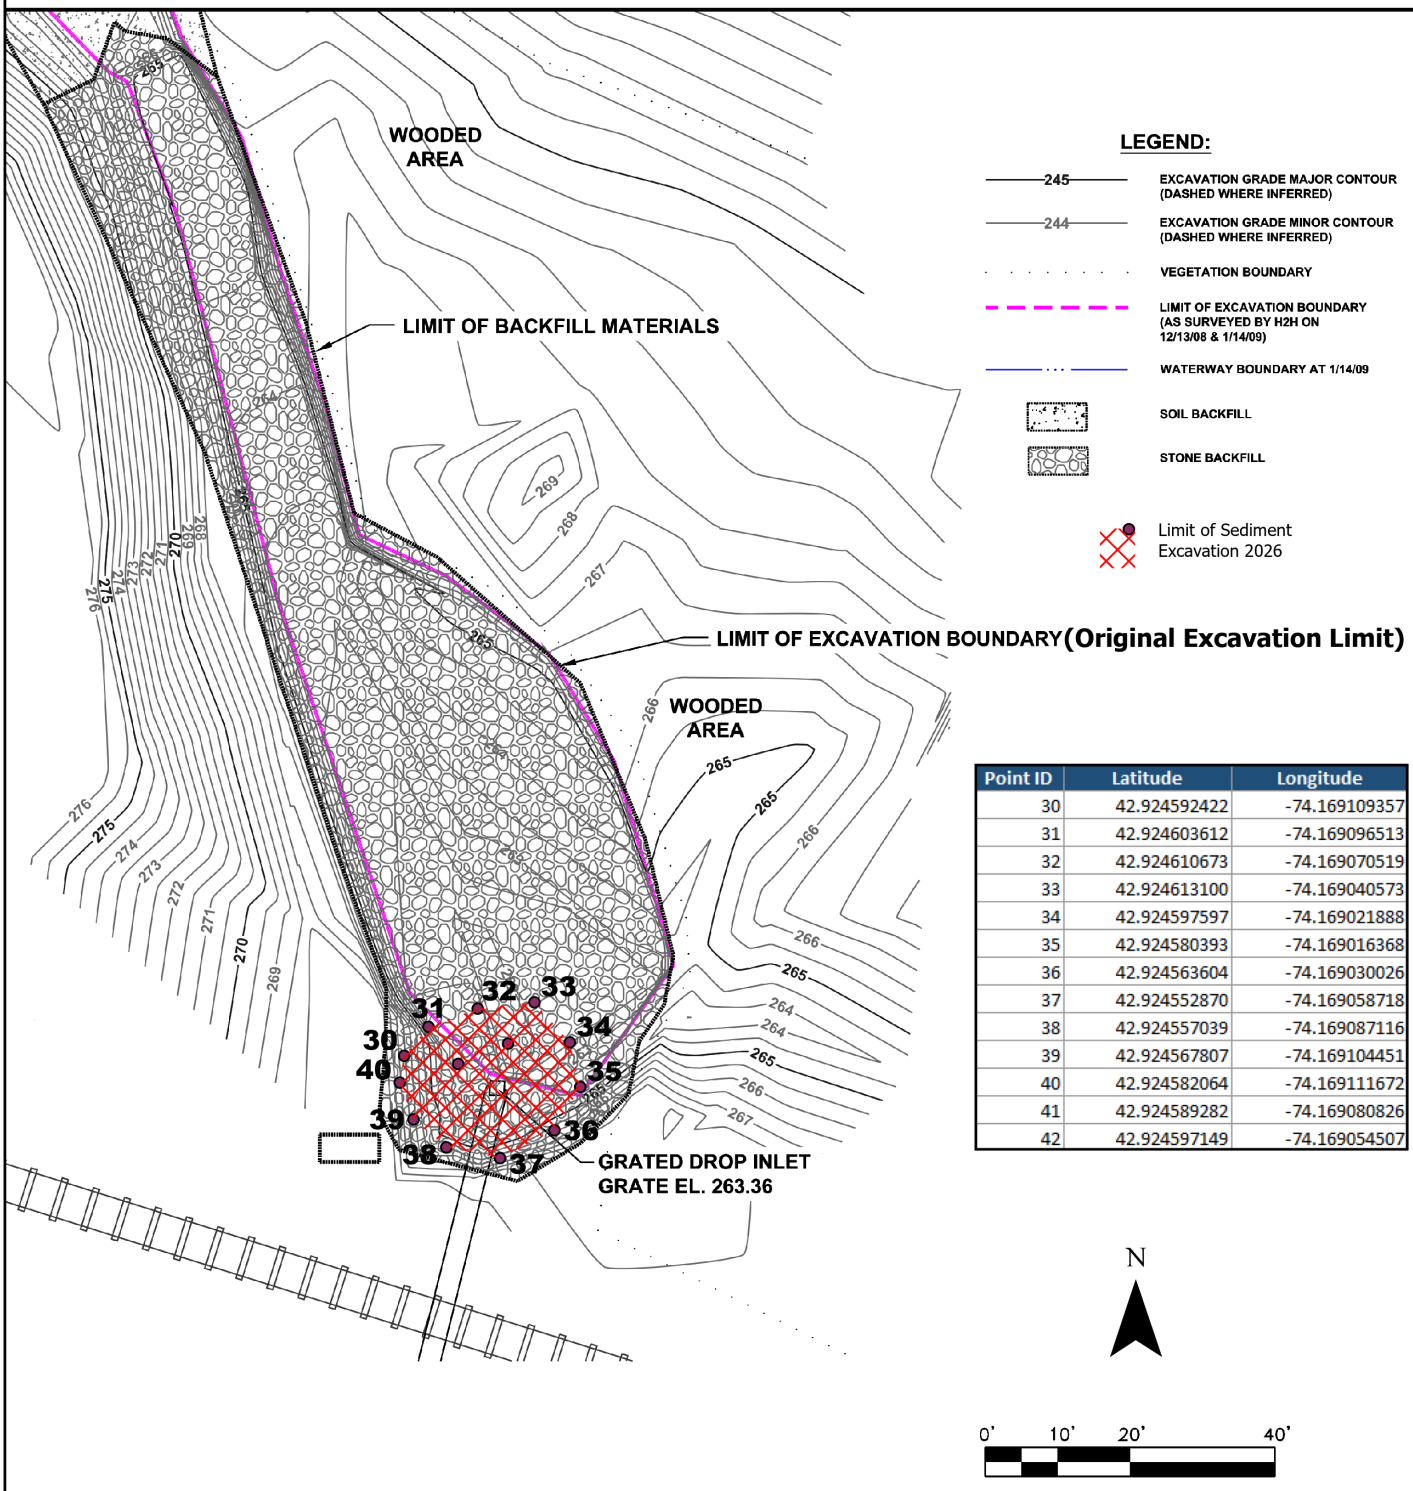
FIGURE : 3

Sediment was removed from an area 21 ft by 16 ft to a depth of 6-17 inches at the Chapman Drive Sediment Basin on August 26, 2026. Sediment removal depth and extent were determined based on the observance of the original gravel layer above geotextile fabric. Sediment depth was observed to decrease toward the drop inlet located at the approximate center of the excavation area. Approximately 14.24 tons of sediment was excavated from the basin and transported off-site for disposal. Final condition of the sediment excavation area can be viewed in the Photographic Log in Attachment B.
