REMEDIAL INVESTIGATION REPORT

Malone (Amsden Street)
Former Manufactured Gas Plant Site
Site # V00469
Malone, Franklin County, New York

August 2017

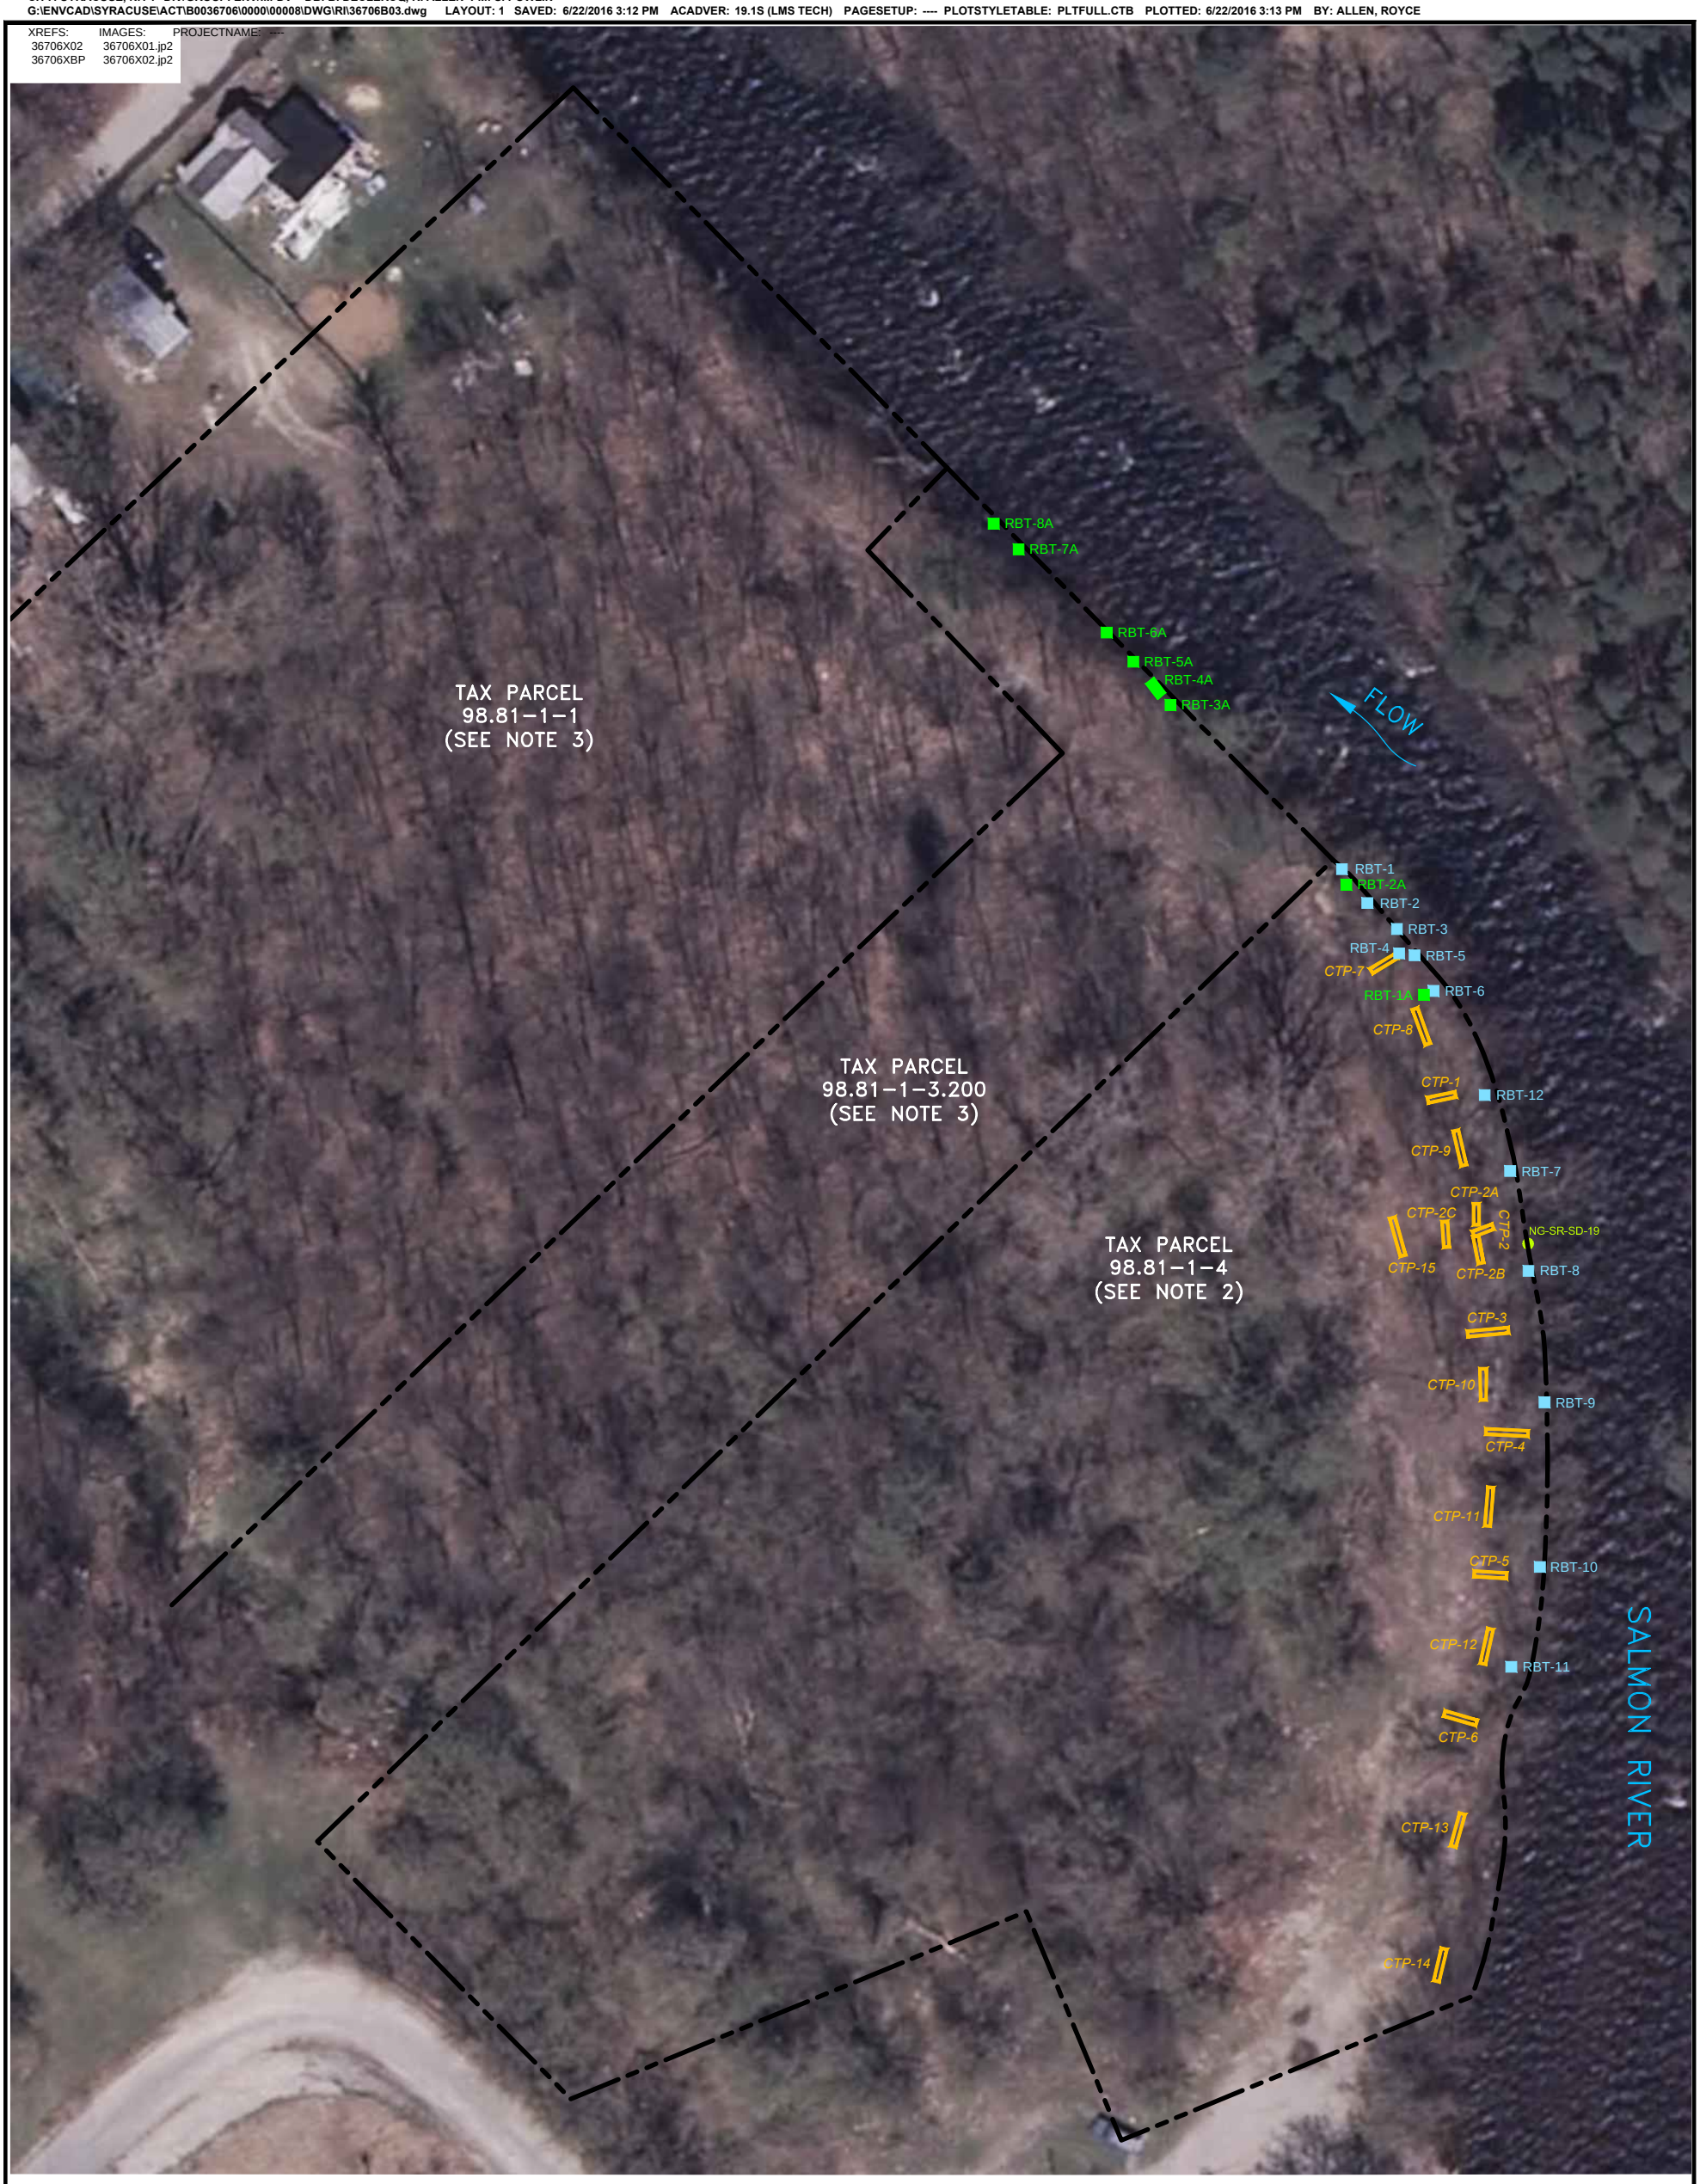
Small, isolated pieces of MGP-related tar have been observed on two parcels of land located approximately 300 to 700 ft downstream from the site and adjacent to the western riverbank of the Salmon River (Figure 3). These parcels (Tax Parcels 98.81-1-4 and 98.81-1-3.200; hereafter referred to as the Pritchard Property) are approximately 3.6 acres in size and are owned by Mr. Travis Pritchard and Mr. Timothy Carter. Based on observations made during test pit excavations and an Interim Remedial Measure (IRM) completed by National Grid on this property in 2014, it is apparent that the property has been the historical location of uncontrolled dumping by the public. In addition to MGP-related tar, observations documented during the excavations completed on this property consistently revealed a varying degree of anthropogenic materials, such as glass, wood, brick, plastic, and metal. The Pritchard Property is not considered part of the site but is considered an off-site area that is covered by this RI Report.

- Due to the high stream energy within the investigated reaches, very little fine-grained sediment is present in the riverbed.
- A total of 22 outfalls were identified upstream from the site, and two were identified on the site. None were identified downgradient from the site.
- MGP impacts (i.e., tar material) were not observed in any sediment samples collected for laboratory analysis.
- Possible MGP-related impacts have been observed in two areas of the river: 1) a hardened tar deposit located at the river level and on a bedrock face within fractures along the river's edge adjacent to the site (Figure 5B and Figure 10); and 2) solidified pieces of tar on and embedded within the western bank of the Salmon River on the Pritchard Property (Figure 3).

National Grid concluded that, given the proximity of the MGP site to the Pritchard Property, the former MGP cannot be ruled out as the source of the tar on the Pritchard Property. National Grid conducted an IRM on a portion of the Pritchard Property (i.e., on Tax Parcel 98.81.1.4) in September 2014 to remove the tar observed on the property; however, as of the date of this report, the tar observed on and embedded within the western riverbank of Tax Parcel 98.81-1-3.200 remains in place.

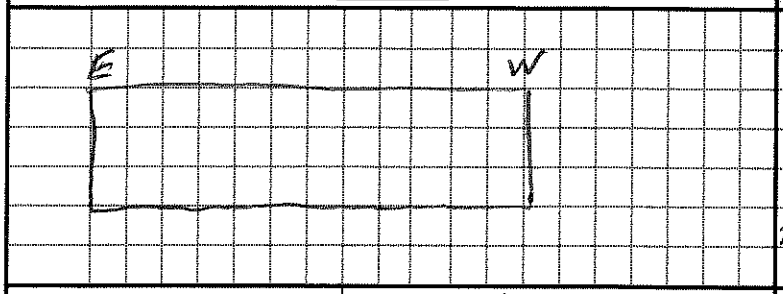
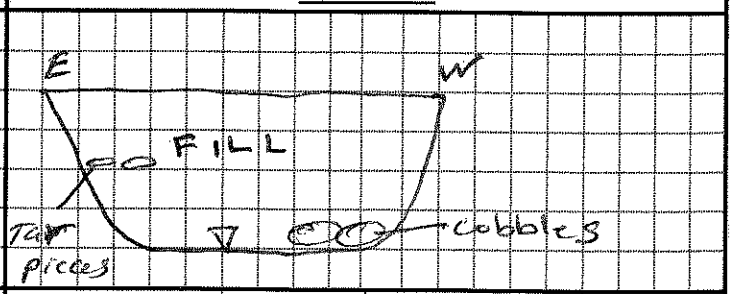
Depth Interval (feet)	PID Screening Result (ppm)	Description of Soil/Material	Samples Collected
0-4	0.0	Fill comprised of F-C sand, cobbles, gravel, trace glass, ceramic, brick, roots; trace highly weathered tar – two softball size pieces at 2' bgs at east end of pit.	None.

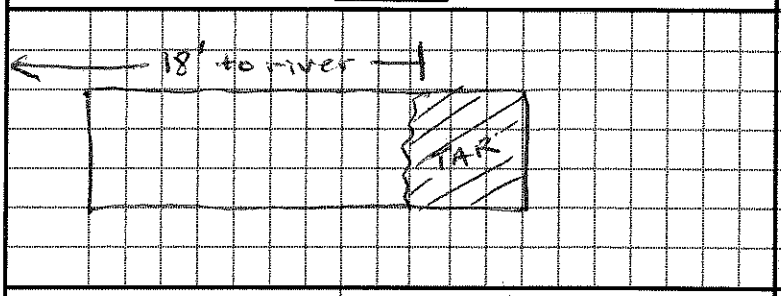
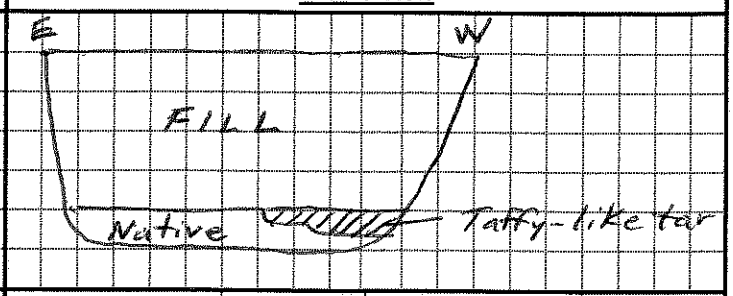
Depth Interval (feet)	PID Screening Result (ppm)	Description of Soil/Material	Samples Collected
0-4	0.0	Fill composed of Fr. Sand, gravel; some glass, paper, white ash-like material; trace brick, metal, roots.	None
4-5	0.0	Brown F-M Sand, Silt, decayed wood. Taffy-like tar observed in bottom 6-inches; bar is 6 inches thick.

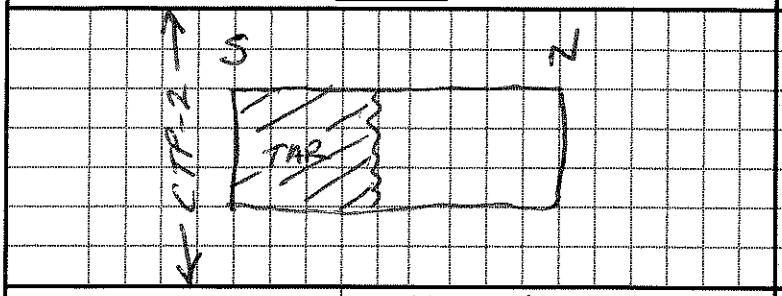
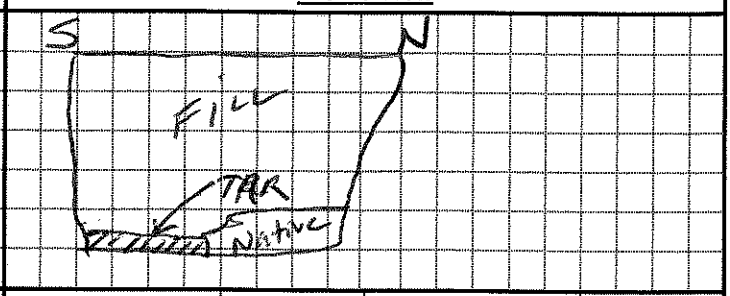
Depth Interval (feet)	PID Screening Result (ppm)	Description of Soil/Material	Samples Collected
0-4	0.0	F-C sand, gravel, cobbles; some glass, trace ash-like material, cinders	
4-5	0.0	F-M sand + silt, organics - Taffy-like tar	
		on top of native material - 6-inches thick

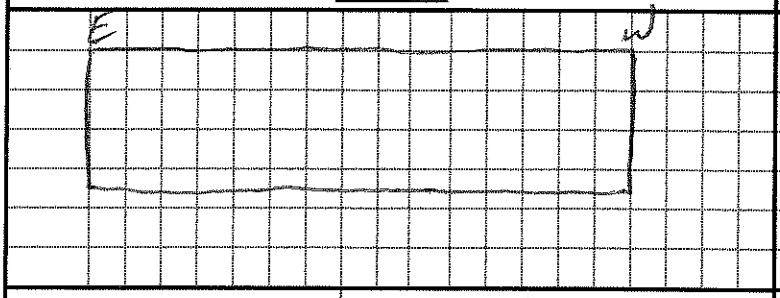
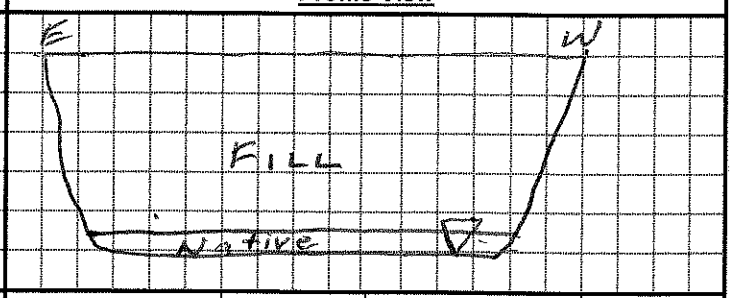
Depth Interval (feet)	PID Screening Result (ppm)	Description of Soil/Material	Samples Collected
0-4.5	0.0	Fill composed of F-c Sand, gravel, cobbles; trace metal, glass, cinders, roots; Faint	
		degraded petroleum-like odor at east end of	None
		pit at 4' bgs, Soil was stained black.	
4.5-5	0.0	F-M sand and silt, organics

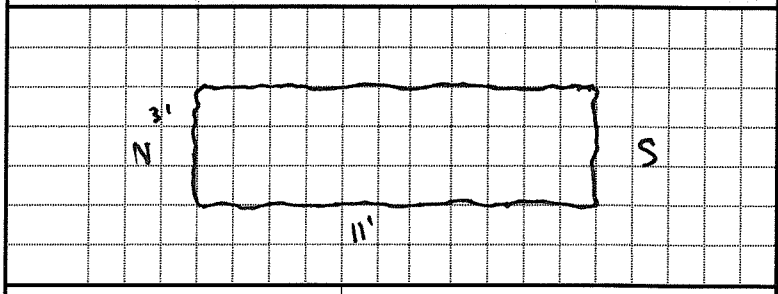
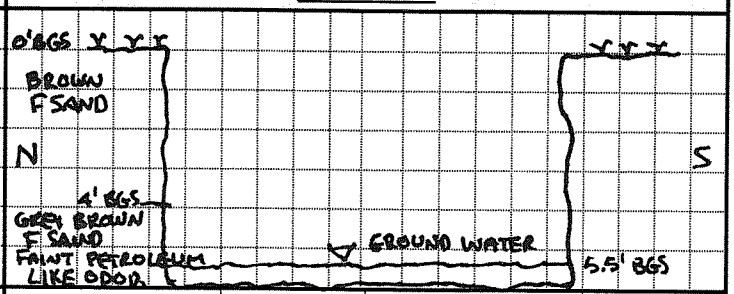
Depth Interval (feet)	PID Screening Result (ppm)	Description of Soil/Material	Samples Collected
0.0 – 4.0	0.0	Brown fine SAND, little fine to coarse subangular to subrounded Gravel, Glass, Metal, Asphalt (shingles), Organics (roots, wood) (M,NP).	NA
4.0 – 6.0	0.0	Grey/brown fine SAND, little to some Silt, Organics (roots) (M,NP). *faint Petroleum-like odor, trace Grey/dark staining.	NA
