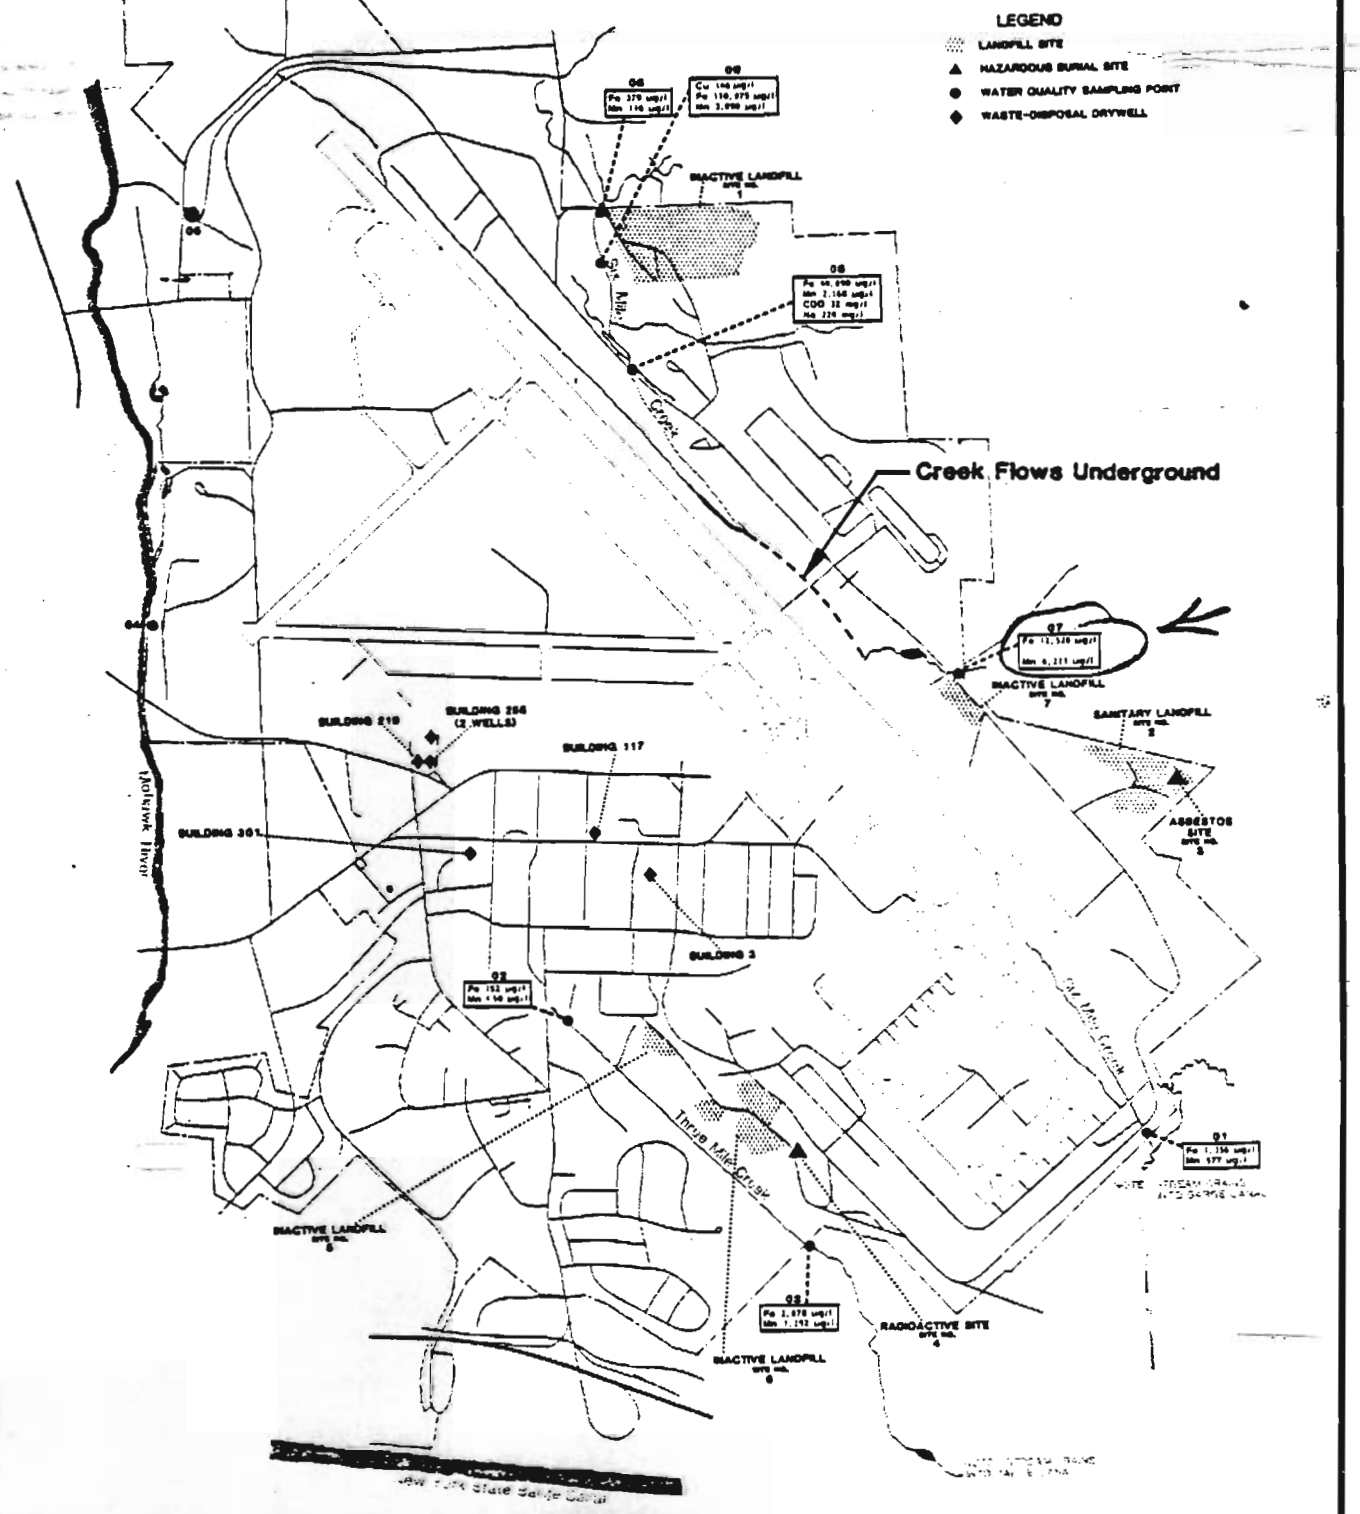
Prior to renewal of the installation SPDES permit, surface waters at Griffiss Air Force Base were sampled at locations shown on Figure 3.5. A review of water quality data indicates probable degradation at

These data suggest the degradation of Six Mile Creek by leachate emanating from Landfill No. 1 at sampling points 08 and 09. However, it must be noted that water entering the installation at sampling points 06 and 07 contains elevated levels of iron and manganese and may impact water quality observed at sample point 01. Baseline data relative to regional surface water quality for local streams is required to investigate this point further, but is not available. Data reported from sample point 03 (Three Mile Creek Exit) does indicate an increase in iron and manganese levels over point 02, the headwaters of the same stream. The cause for the increase in contaminant levels may be related to base activities. Water quality observed at sampling points 04 and 05 is generally good.

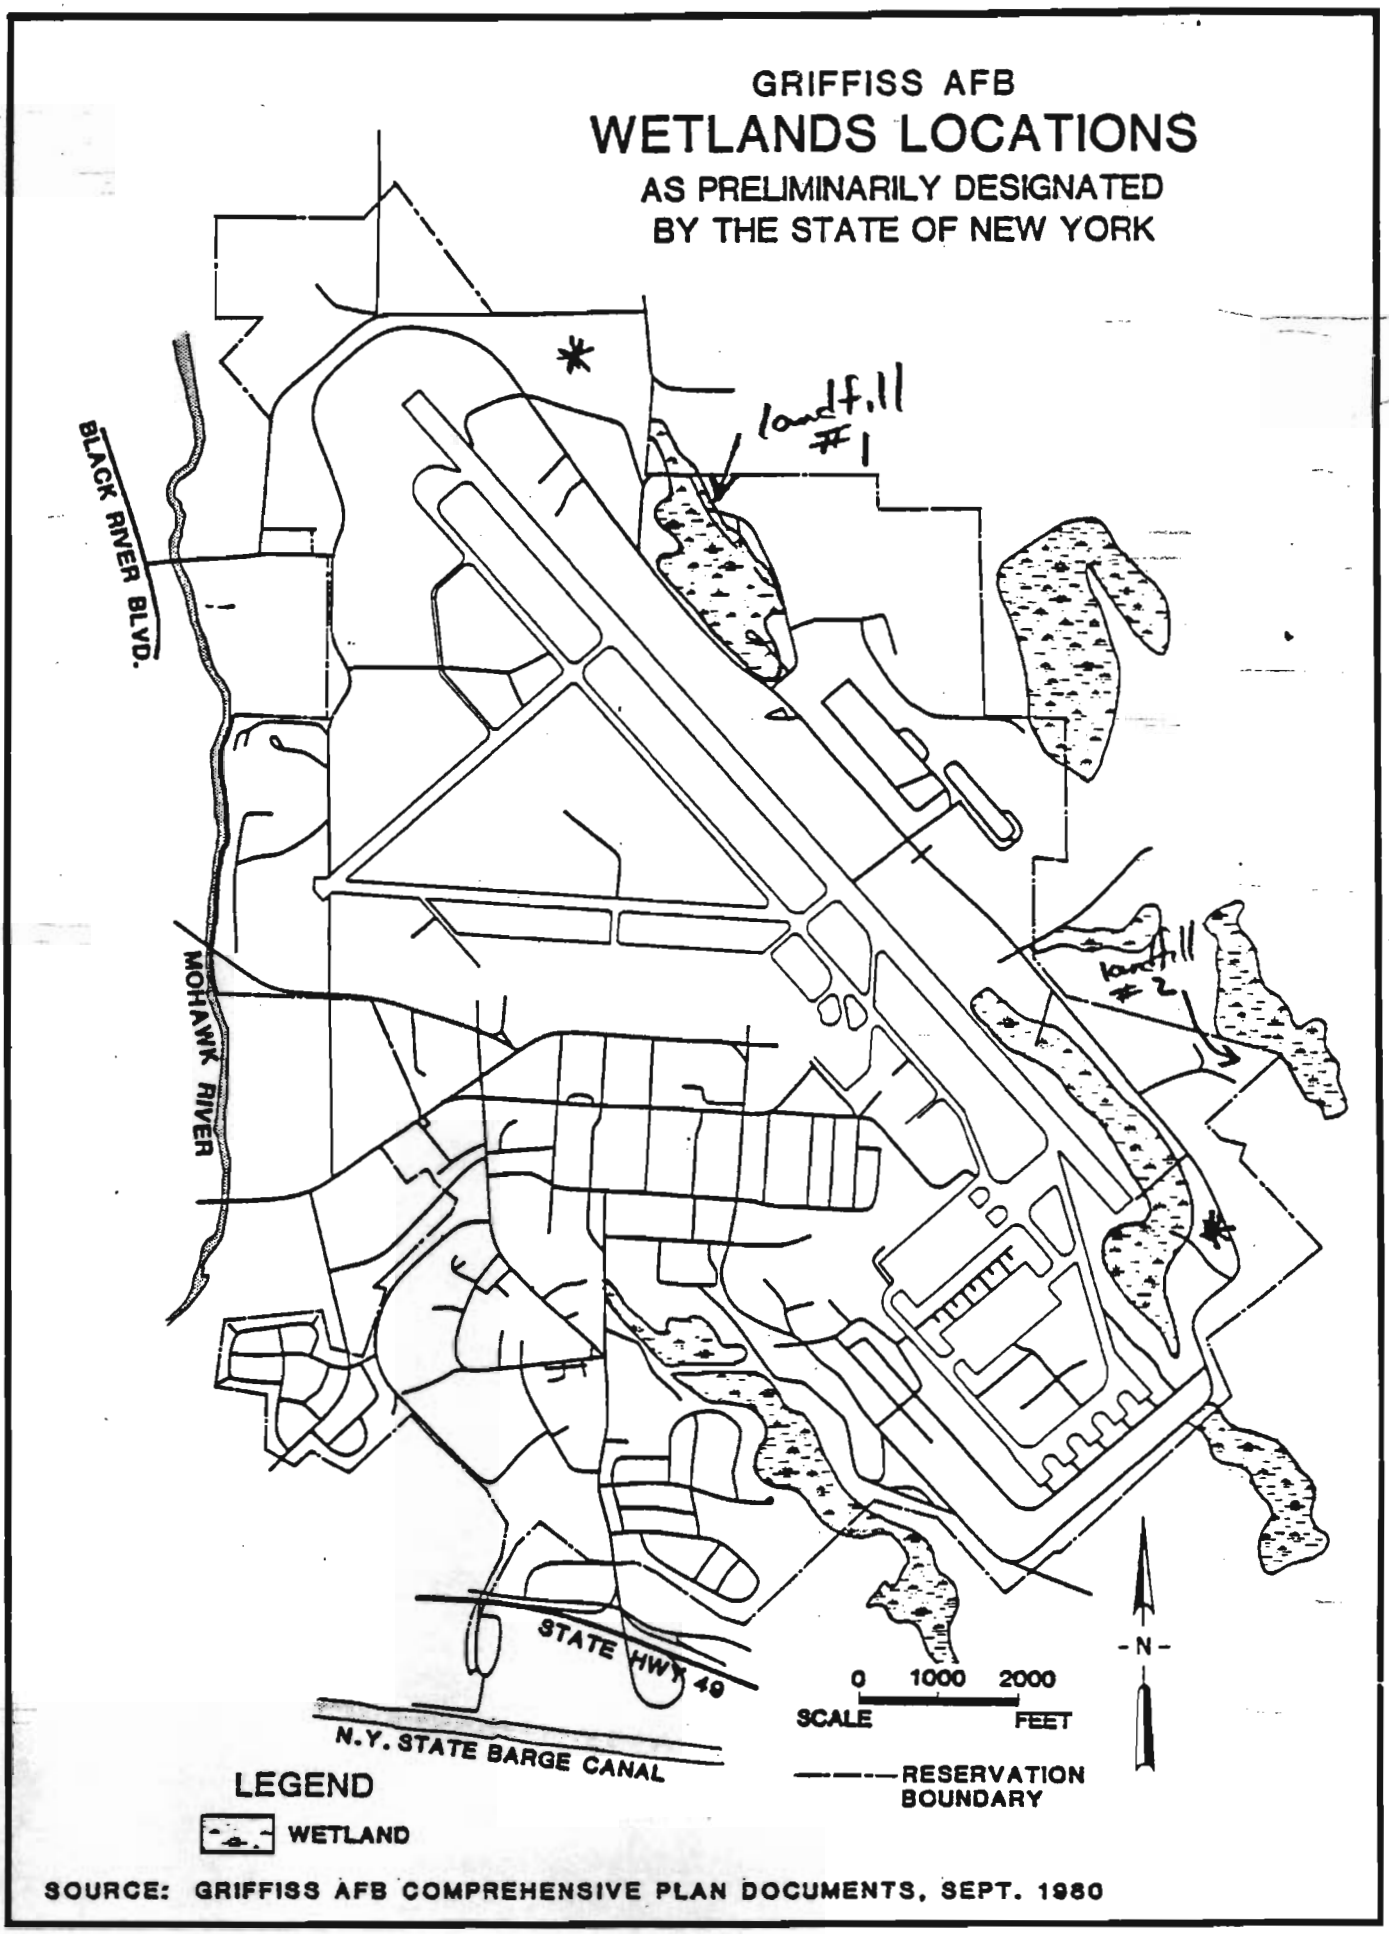
FIGURE 3.6

4. Several areas preliminarily designated as wetlands by New York State have been identified on the base (Figure 3.6).
5. Surface waters (Six Mile Creek) are presently affected by leachate generated by Landfill No. 1. The problem has existed since 1974 and may be expected to continue until adequate closure measures are implemented.

6. Active water wells in the local area could be contaminated by pollutants emanating from waste disposal areas. A potable water supply for the RADC site is obtained from a well (construction data unavailable) located at Building 875. This well is approximately 1500 feet northwest of the general limits of Landfill No. 1. A second water well (construction data unavailable) is currently in service at Building 798. This well is located approximately 1000 feet south of Landfill No. 2. The existance and use of water wells on property adjacent to the base are uncertain.

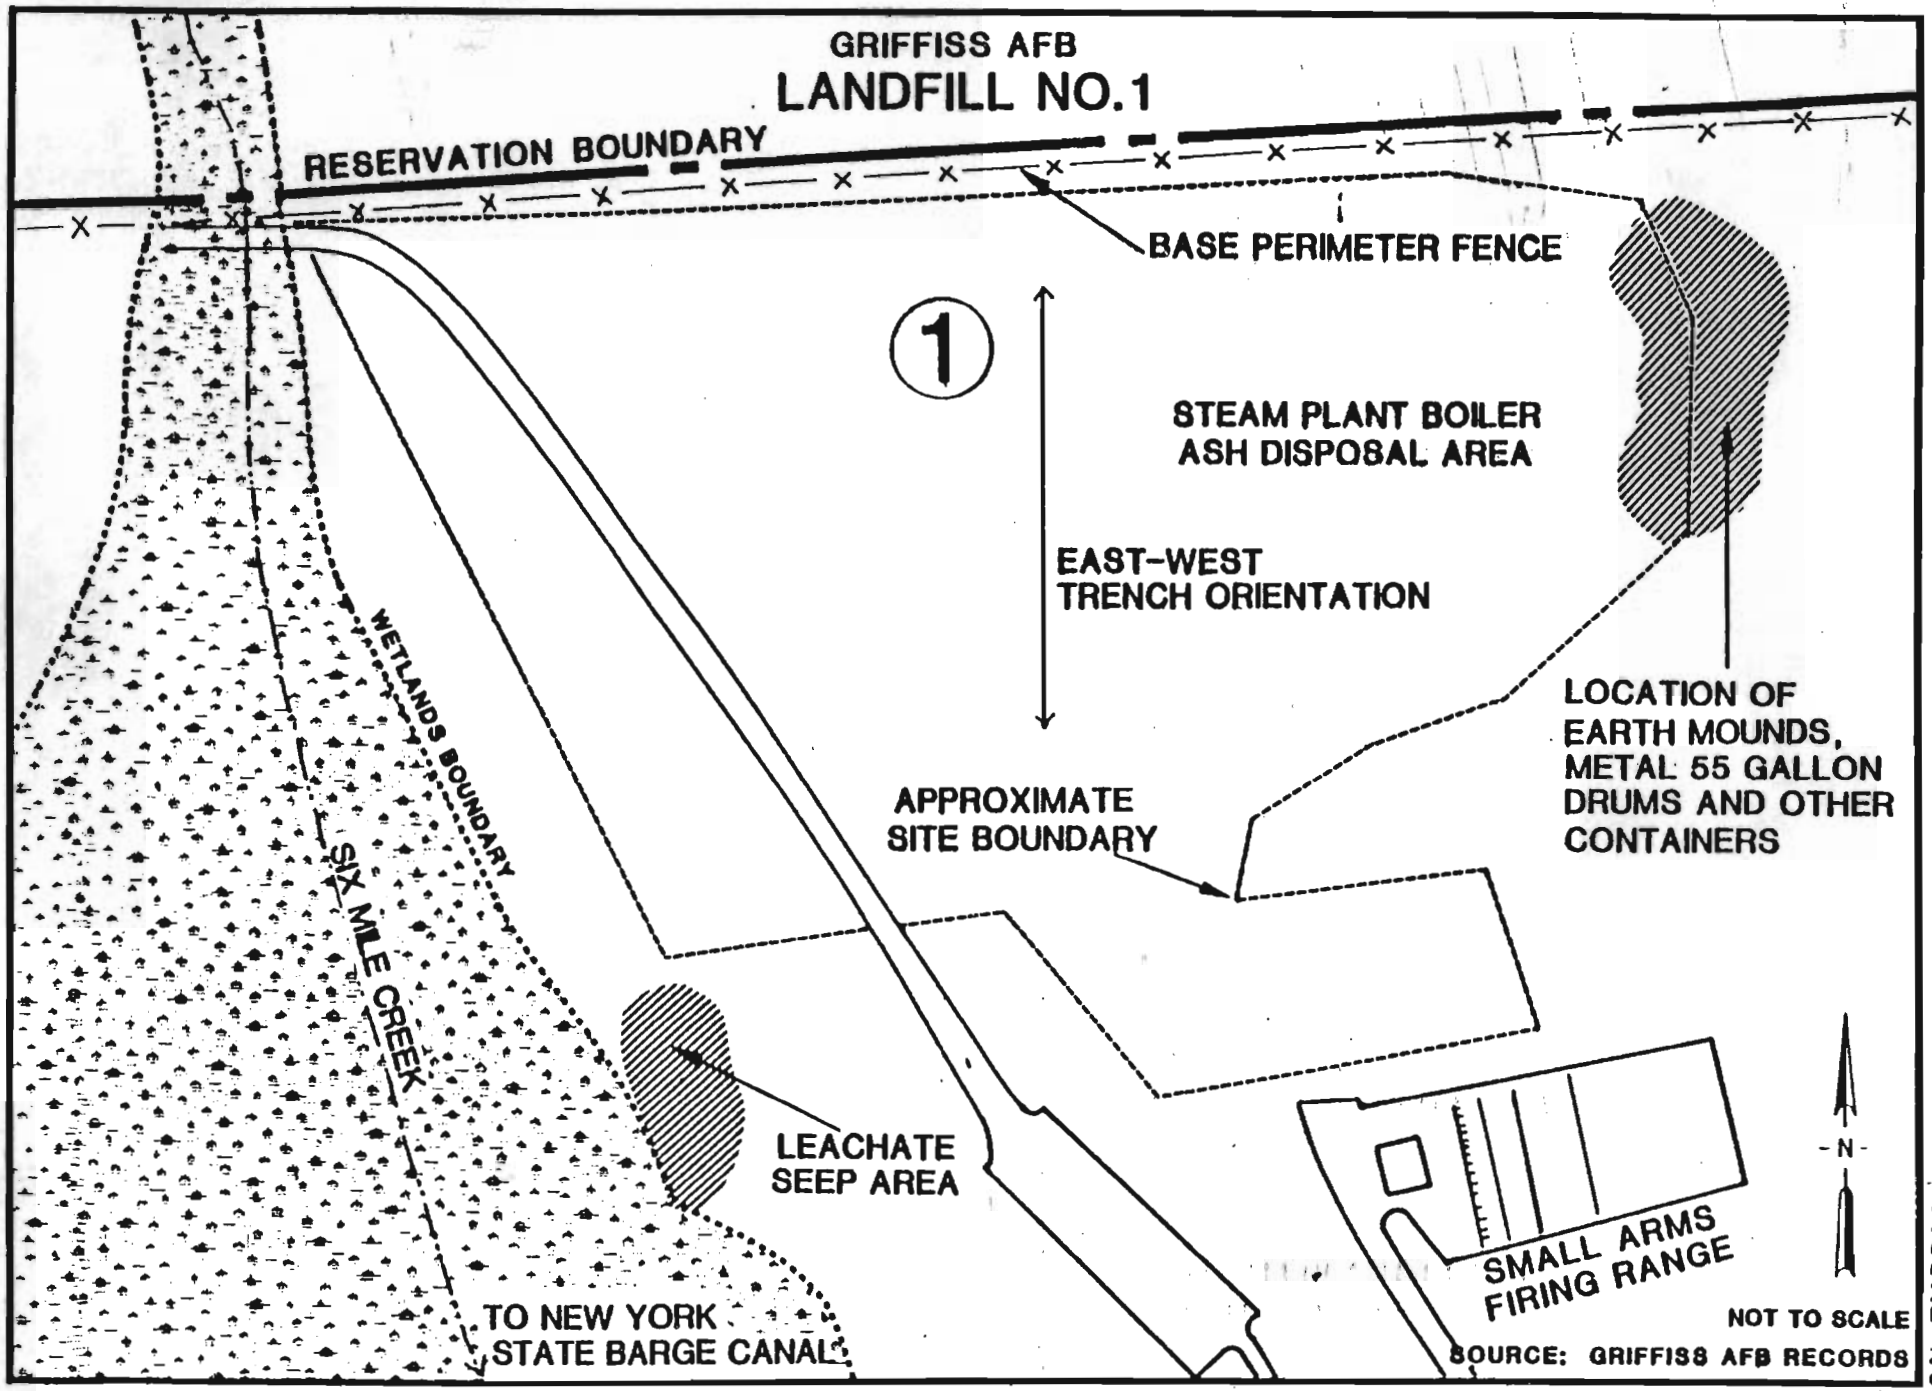
FIGURE 4.3

Limited surface water quality information has been developed as a result of the leachate flowing to Six Mile Creek from Landfill No. 1. A EPA Region II letter report (10 July 1980) describing conditions at the landfill and proximate environs noted that the leachate was degrading the quality of Six Mile Creek with the following contaminants:

GRIFFISS AFB
LANDFILL NO.1
RESERVATION BOUNDARY
BASE PERIMETER FENCE
1
STEAM PLANT BOILER
ASH DISPOSAL AREA
EAST-WEST
TRENCH ORIENTATION
LOCATION OF
EARTH MOUNDS,
METAL 55 GALLON
DRUMS AND OTHER
CONTAINERS
APPROXIMATE
SITE BOUNDARY
WETLANDS BOUNDARY
SIX MILE CREEK
LEACHATE
SEEP AREA
TO NEW YORK
STATE BARGE CANAL
SMALL ARMS
FIRING RANGE
N
NOT TO SCALE
SOURCE: GRIFFISS AFB RECORDS

1) Initiate temporary remedial measures for landfill closure at Landfill No. 1 and No. 2. Improve cover at both sites (grade to eliminate ponding, provide plant cover) and construct leachate collection sump for surface runoff at Landfill No. 1.
2) Discontinue the use of dry wells for disposal of hazardous material.
3) Sample soil from Building 112's PCB dump area and analyse for PCB concentration.
4) Perform periodic analyses (Interim Primary Drinking Water Standards and Priority Pollutants and TOC) on water produced by on-base water wells.

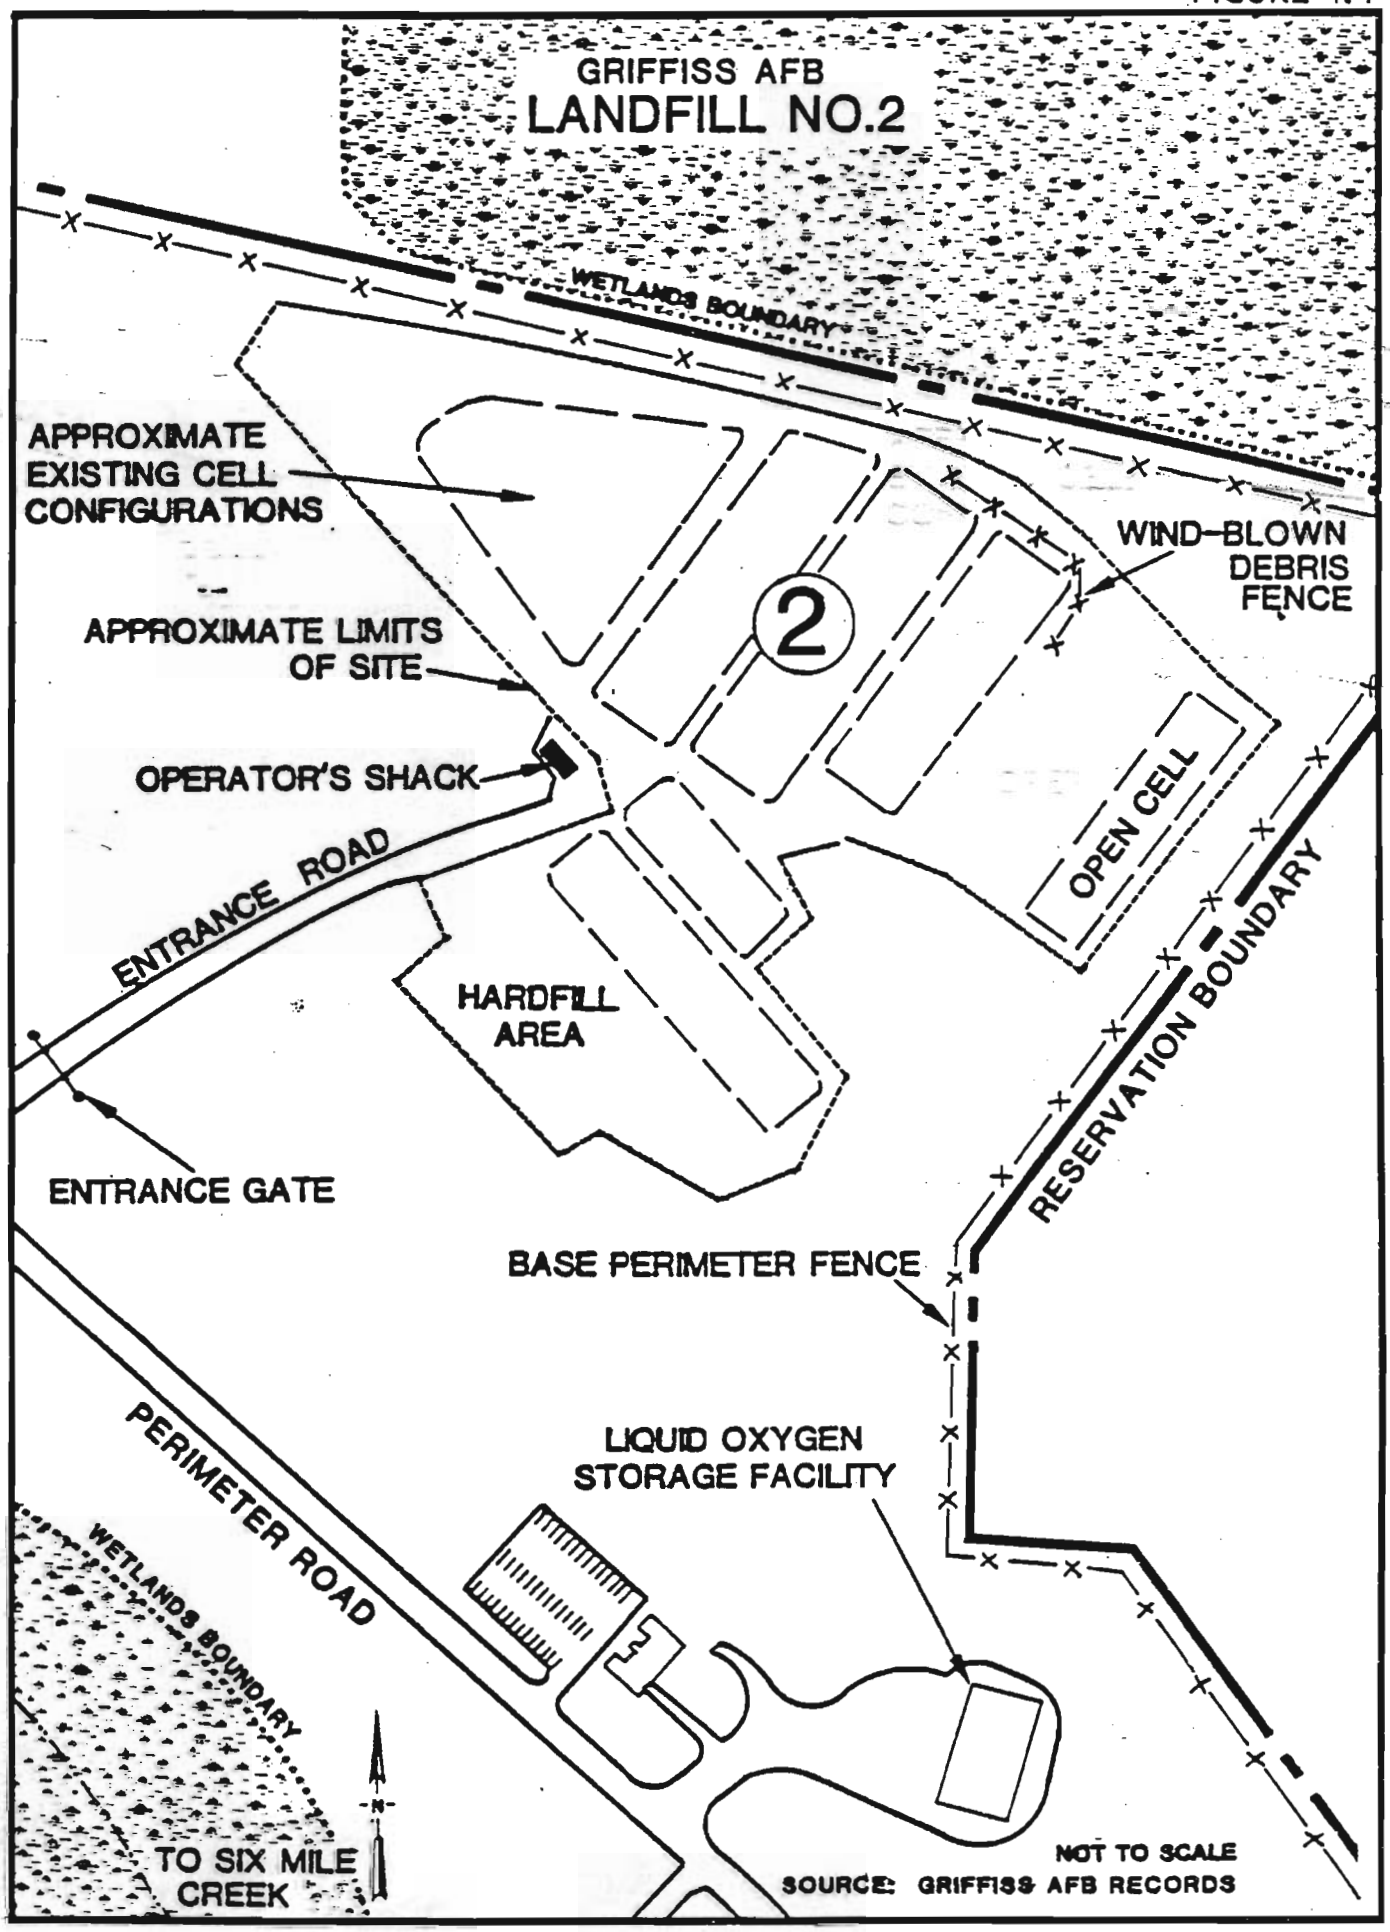
FIGURE 4.4

Landfill No. 2 is situated in the eastern-most region of the base as shown in Figure 4.2. The boundaries of this 60-acre site are shown

At the time of the site visit, closure of the landfill was not complete. Some surface grading had been done; however, a number of stagnant ponded areas of discolored water were in evidence. During rainfall events this water would likely overflow to surrounding waterways, and during dry periods, these ponded waters would both percolate into the waste deposits or evaporate. No vegetative stabilization of the landfill has occurred.

A permanent wire mesh fence about 25 feet high by 150 feet long has been installed in the northeast area of the landfill as a wind blown refuse stop. While the fence may have been partially effective, some wind blown refuse paper and plastic could be seen on the edge of the surrounding woods. It is understood that during operation of this landfill, portable fences about six feet high surrounded the disposal areas. Security at the landfill consists of a gate across the entrance road and a three foot high perimeter security fence that borders the site on the southeast and north sides.

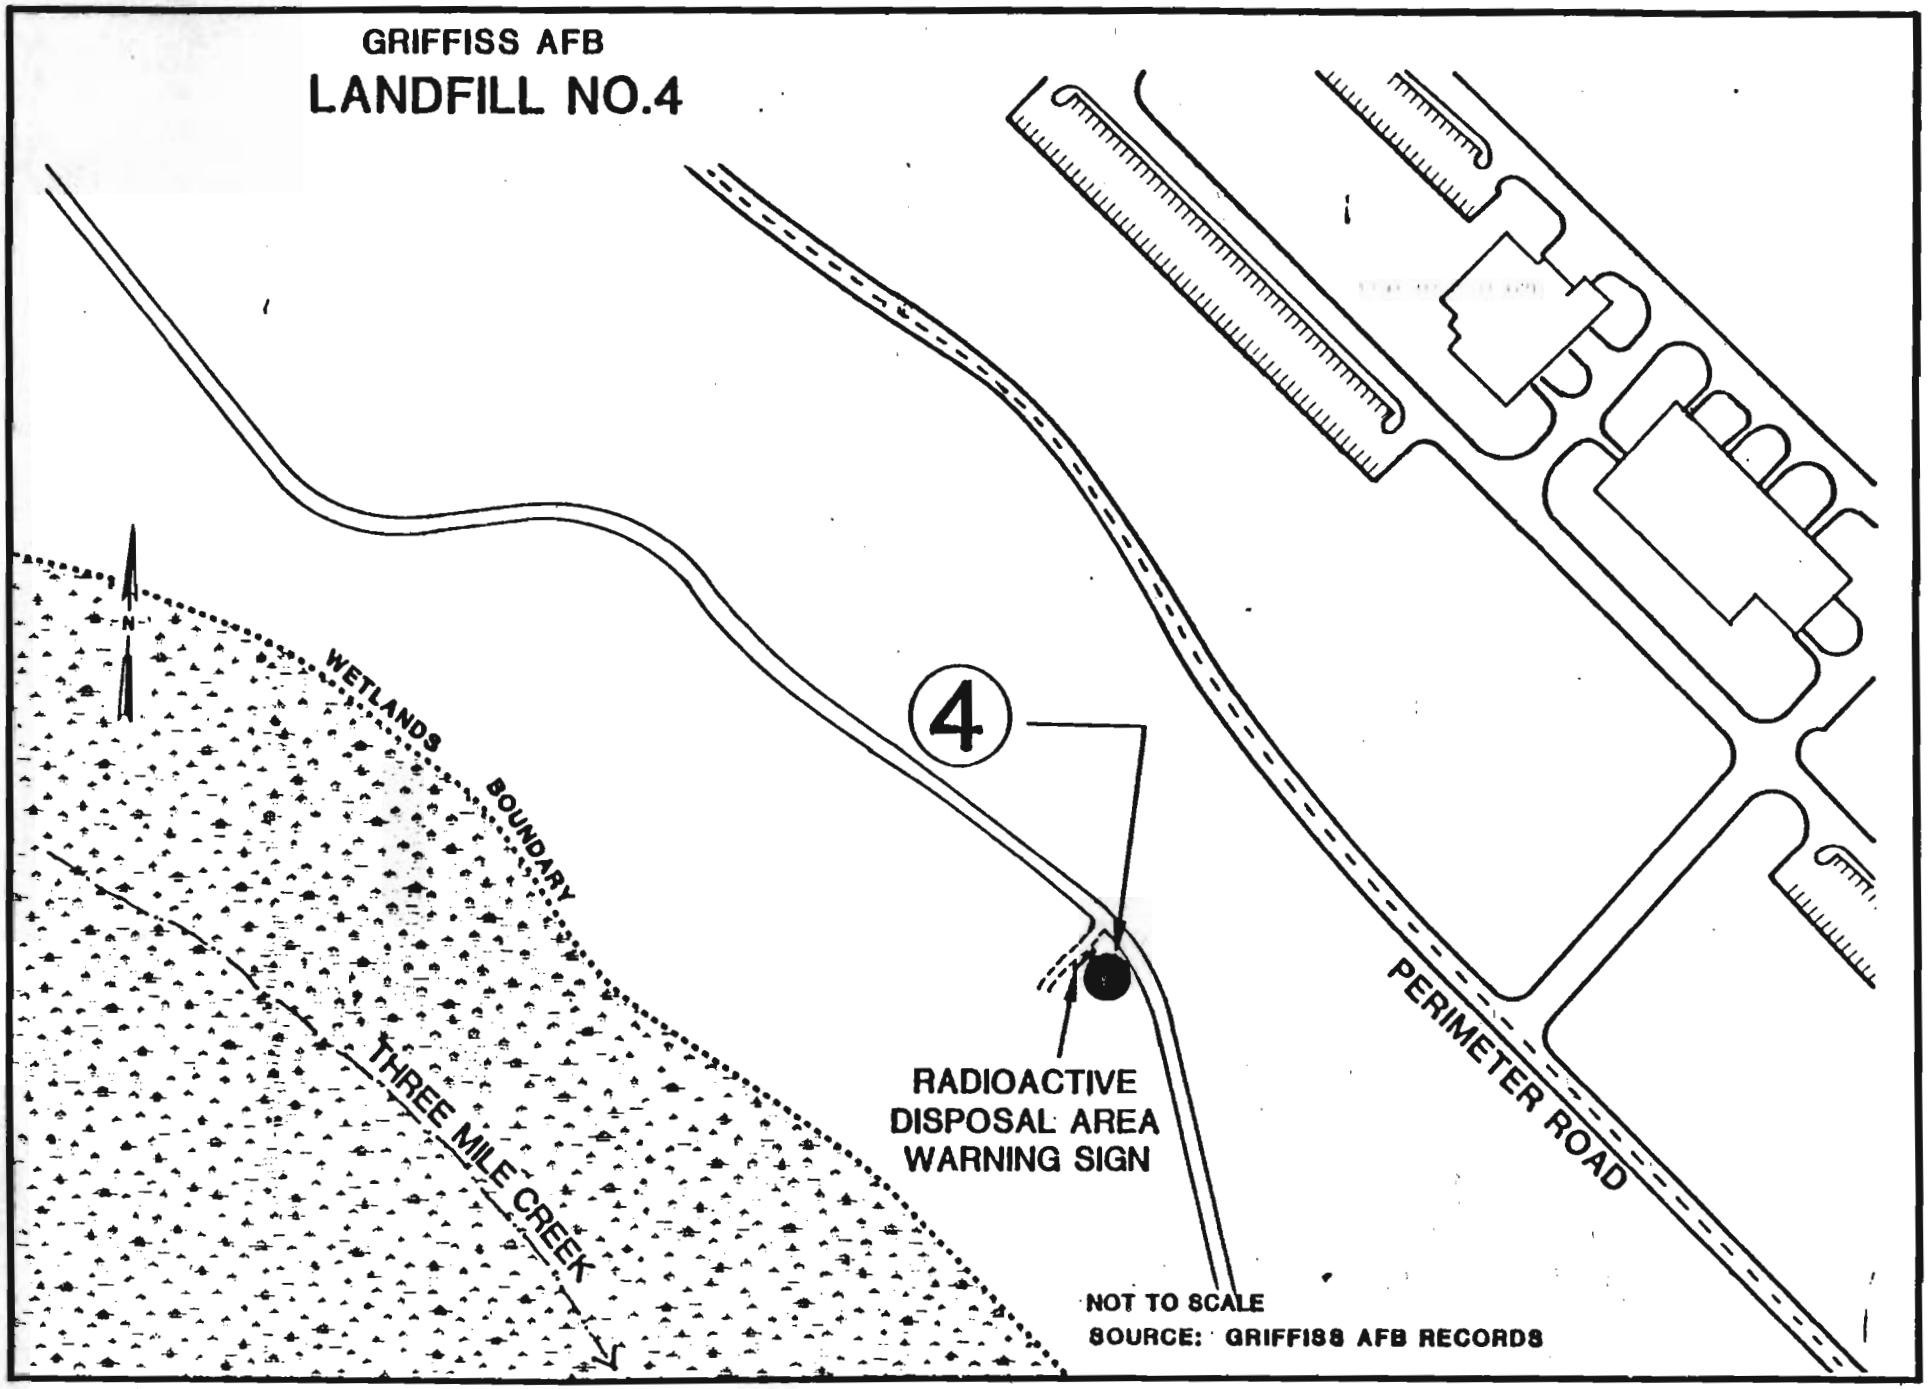
FIGURE 4.6

The location of Landfill No. 4 is shown in Figure 4.6. This landfill was used in the mid 1950's for disposal of low level radioactivity vacuum tubes. One person indicated that acid waste had been disposed of near this site. The site was initially an open vertical pipe four feet in diameter which was filled with concrete in 1977. The site drains 600 feet to Three Mile Creek which in turn flows another 4000 feet to the New York State Barge Canal. Tests of the air above the site indicate no radioactivity escape. There has been no ground water sampling for radioactivity in the area. A posted sign indicates a radioactive waste disposal site.

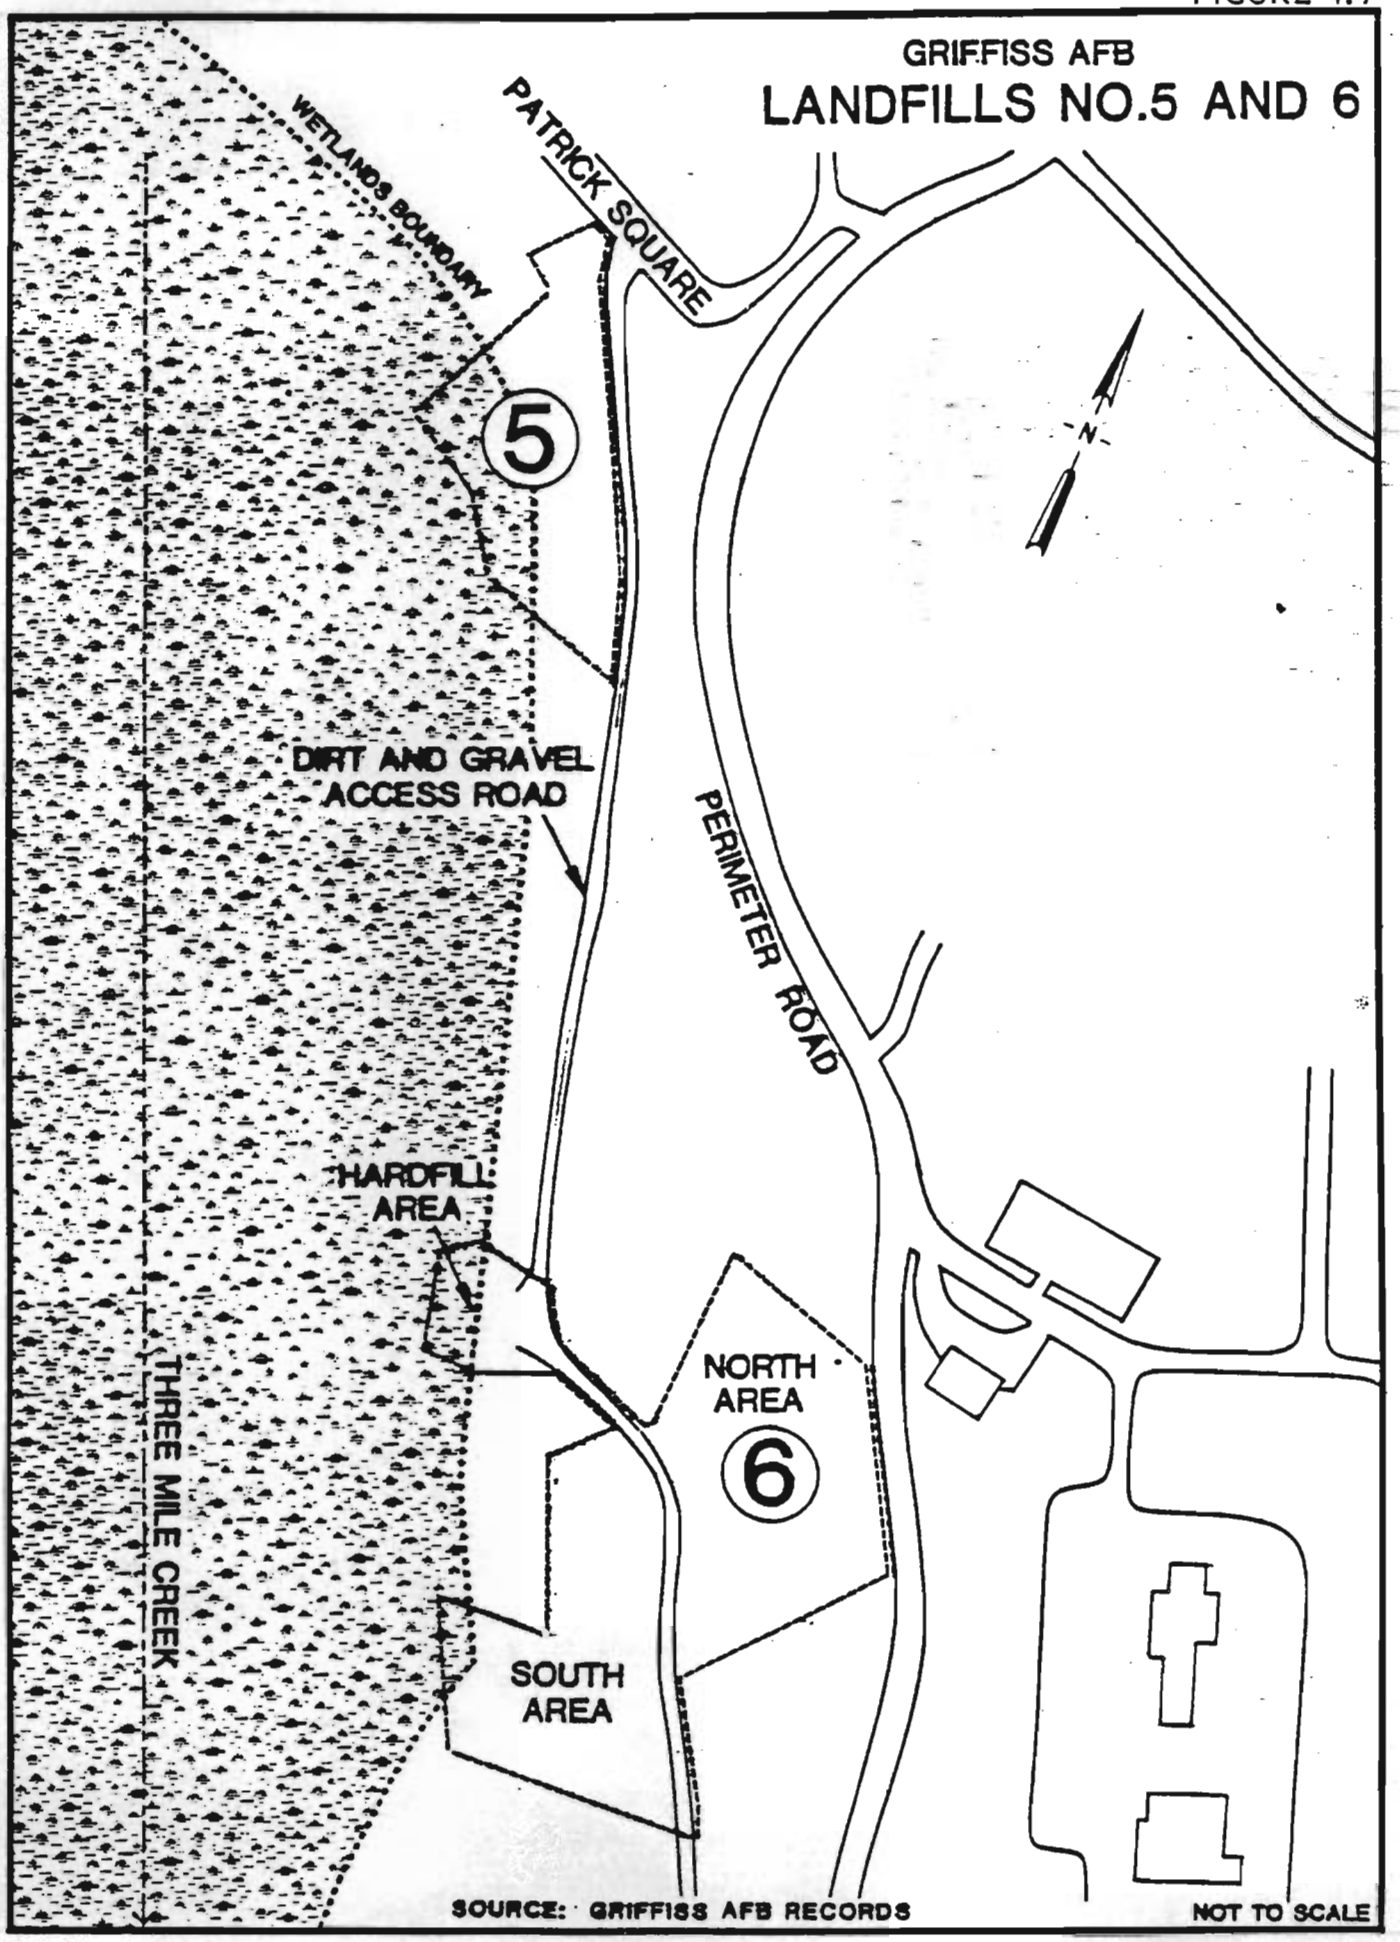
FIGURE 4.7

Landfill No. 5 is situated on about four acres near the intersection of Patrick Square Road and Perimeter Road (Figure 4.7). Patrick Square Road and an unnamed dirt access road border the site to the north and east, respectively. The landfill operated for about a year following the abandonment of Landfill No. 6 in 1959. The southern part of the site was constructed in the Three Mile Creek designated wetland area, and the site drains south to Three Mile Creek near its confluence with the New York State Barge Canal.

The landfill was constructed using an area type method to a total depth of about six feet. Wastes hauled to the site were burned at the landfill and then covered. A number of persons interviewed recalled underground fires that were difficult to extinguish. The site is now well vegetated in grass and small hardwoods, and to the southwest, the area is heavily wooded in medium to large hardwoods.

Landfill No. 6 is located on about eight acres between Perimeter Road and Three Mile Creek as shown on Figure 4.7. The landfill operated from 1955 until 1959, receiving hardfill (construction/demolition debris, wooden pallets, etc.) as well as municipal solid wastes (MSW)

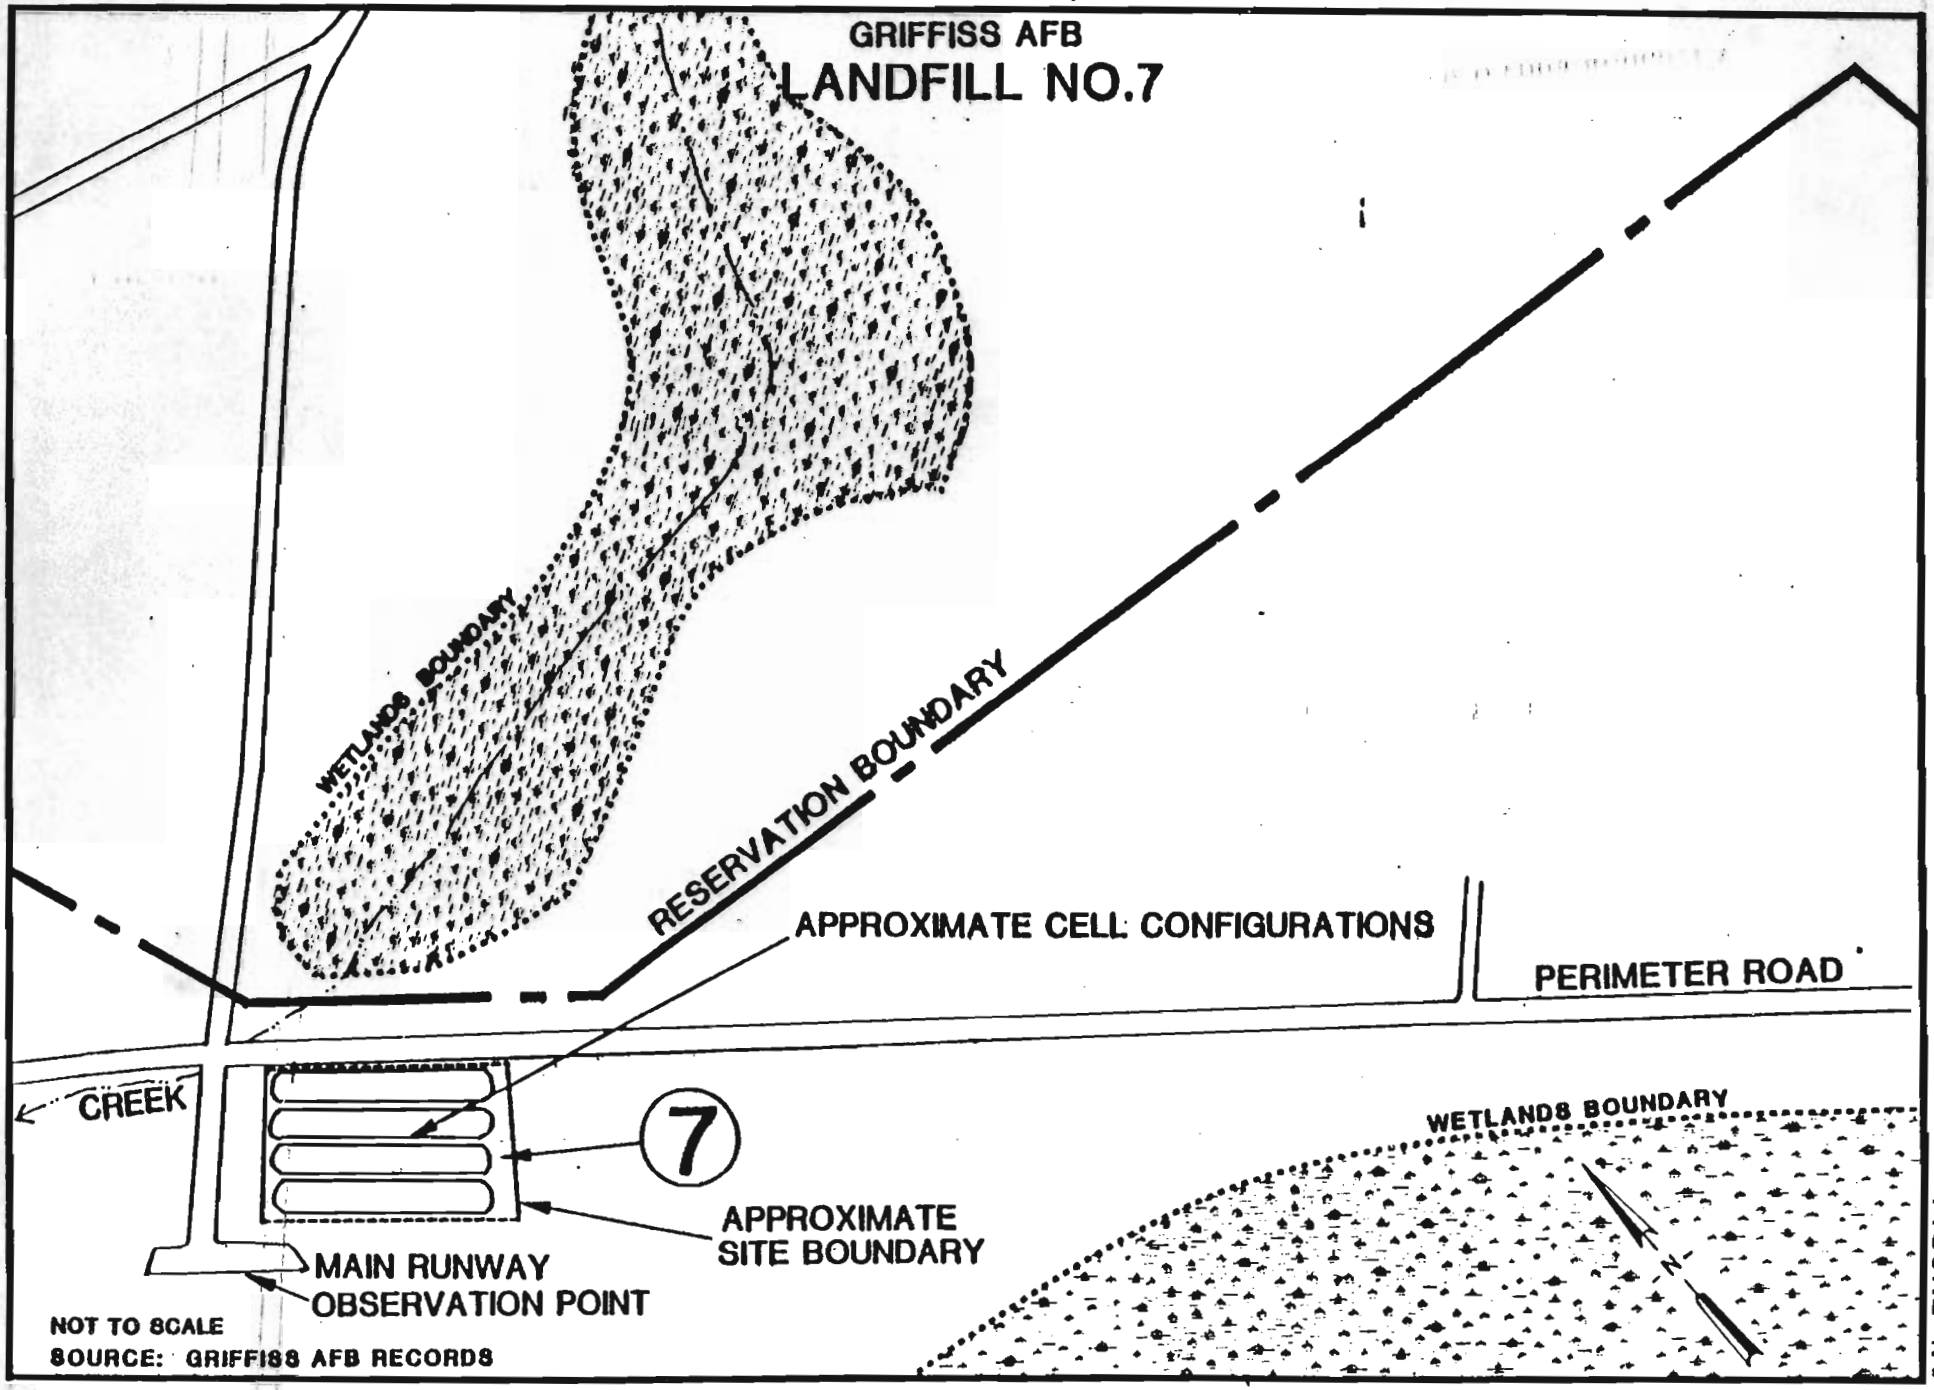
FIGURE 4.8

Landfill No. 7 is located on about 4.5 acres to the east of the public runway observation point (Figure 4.8). This landfill was the first operated at Griffiss, opening in 1950 and closing in 1954. The landfill was operated using a trenching method with approximately four 20-foot deep trenches cut 50 to 60 feet wide and about 400 feet long, running parallel to the main runway. Waste collection vehicles entered the trenches alternately from one end and then the other from one day to the next. On any given day, one end of the trench would be in a waste burning phase while the other would be in a receiving phase. Persons interviewed recall liquid wastes being occasionally disposed of in the trenches. Liquids were buried in small pits dug in the bottom of the trenches.

When the landfill was closed, the area was vegetated with a thick grass cover. The surface now has numerous depressions and burrowing animal holes. Around the entrances to the burrows is evidence of charred wood and ashes apparently displaced from the waste material below. The site drains to a low area to the southeast which drains to Six Mile Creek. There was no evidence of leachate along the toe of fill, or surface ponding on the landfill cover. No fence, gates, signs or markers exist to indicate the location or extent of the landfill.

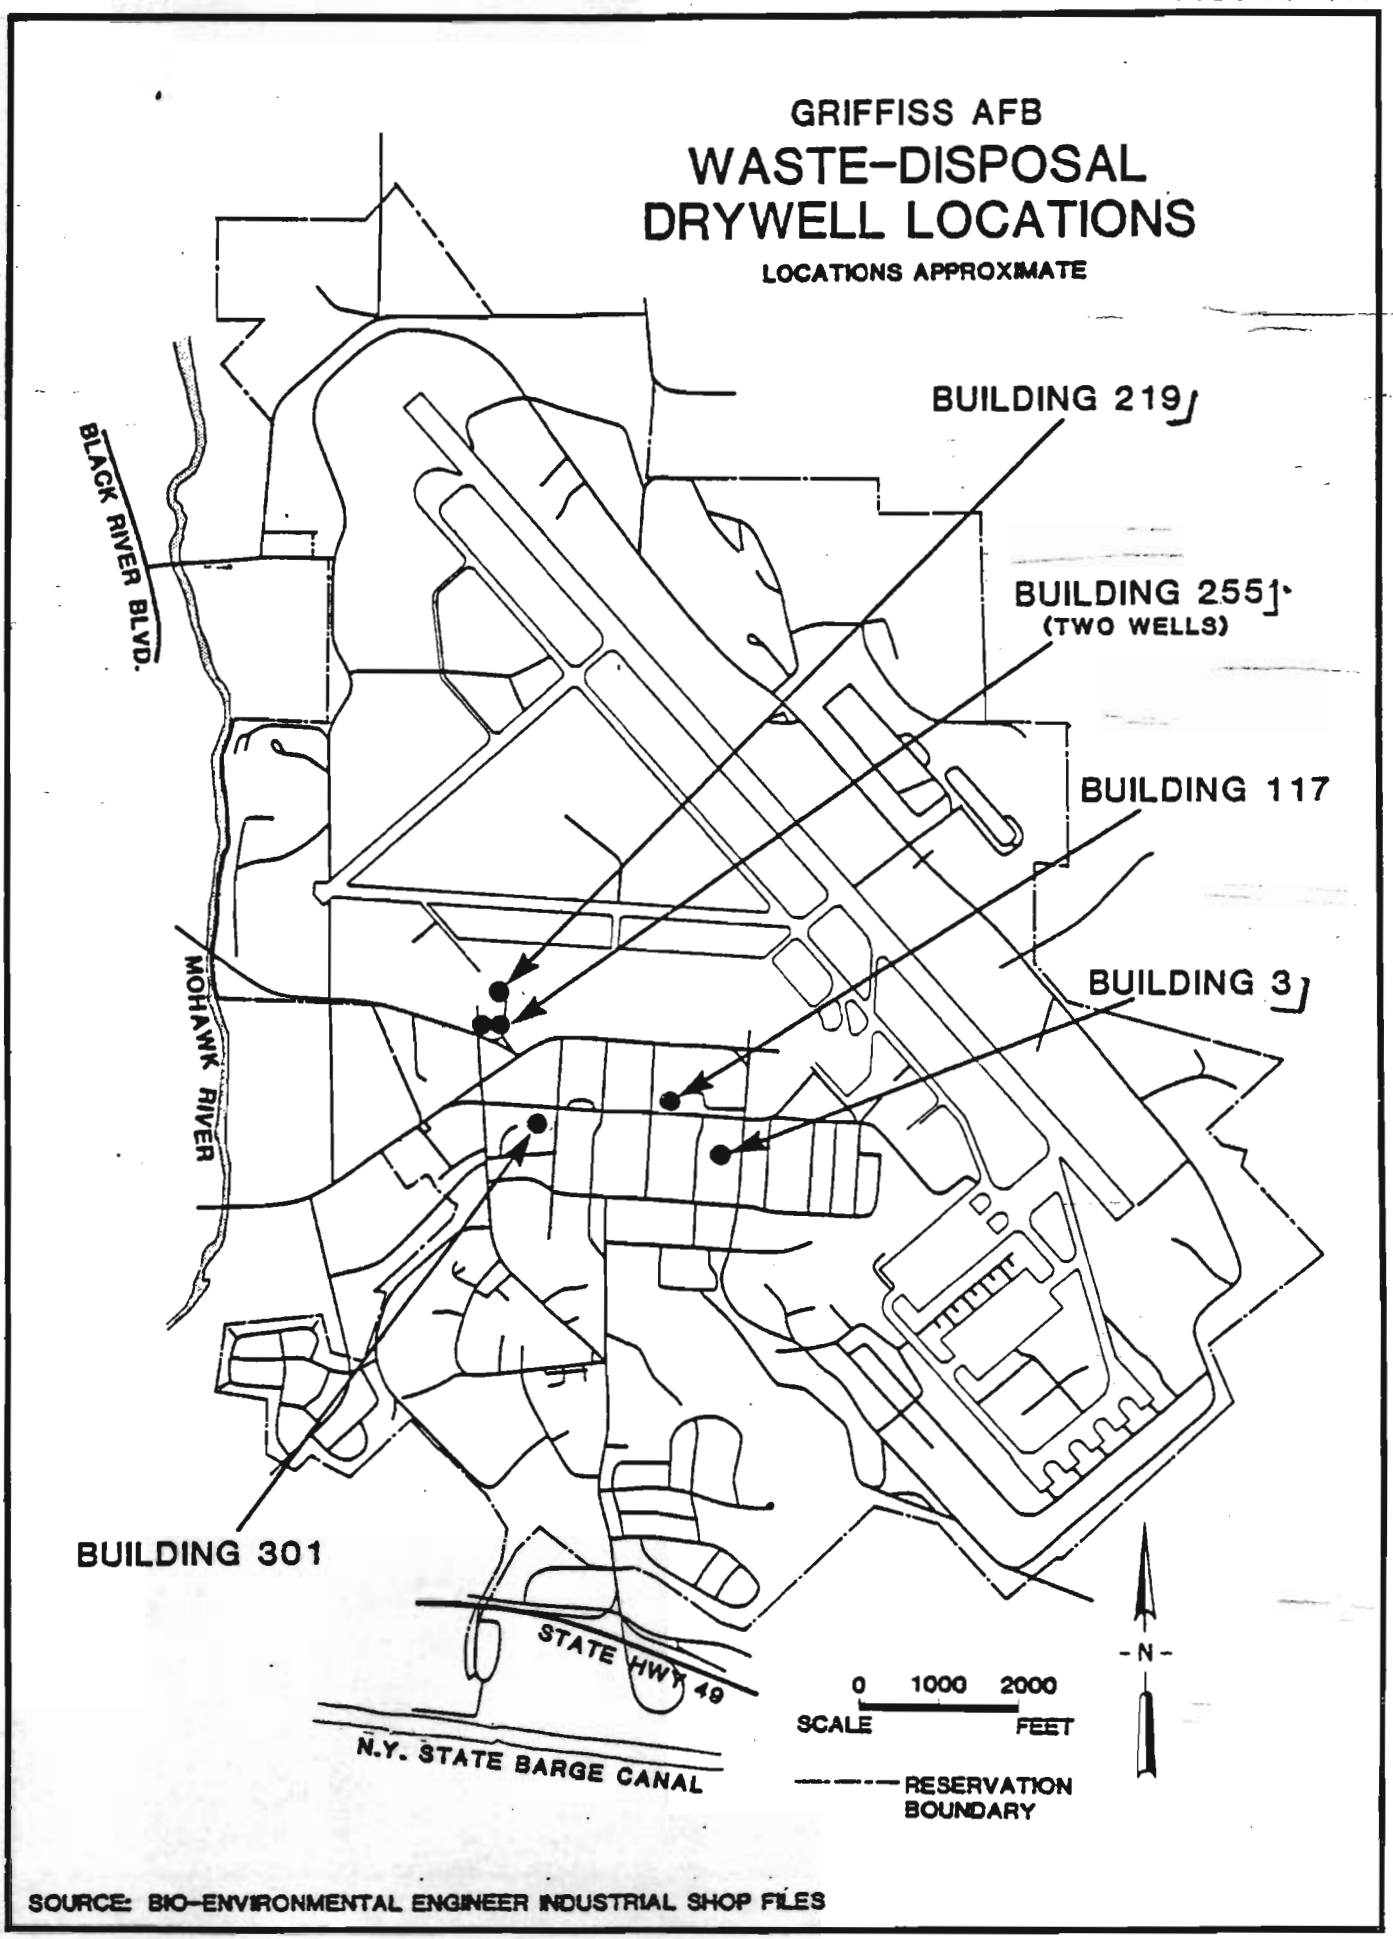
FIGURE 4.11

2) Drywells
   a) Drywells at Buildings 117, 3, 301, 225, and 219 (ranked in descending priority) have been used to dispose of hazardous materials which may have resulted in ground-water contamination.

Dry Wells. Figure 4.11 shows the location of a number of direct-disposal dry wells located in the industrial shop area. These wells are stone and gravel filled pits, roughly three or four feet square and ten feet deep.

Liquid wastes, some of which are hazardous, have been placed in these dry wells and allowed to infiltrate directly to the ground-water system. Table 4.7 lists the active dry wells and summarizes information concerning the types and amounts of wastes disposed of through them.
