Installation Restoration Program

Final Report
Phase II - Problem Confirmation and Quantification Study
Griffiss Air Force Base
Rome, New York

United States Air Force
Occupational and Environmental Health Laboratory (OEHL)
Brooks Air Force Base, Texas

December 1982

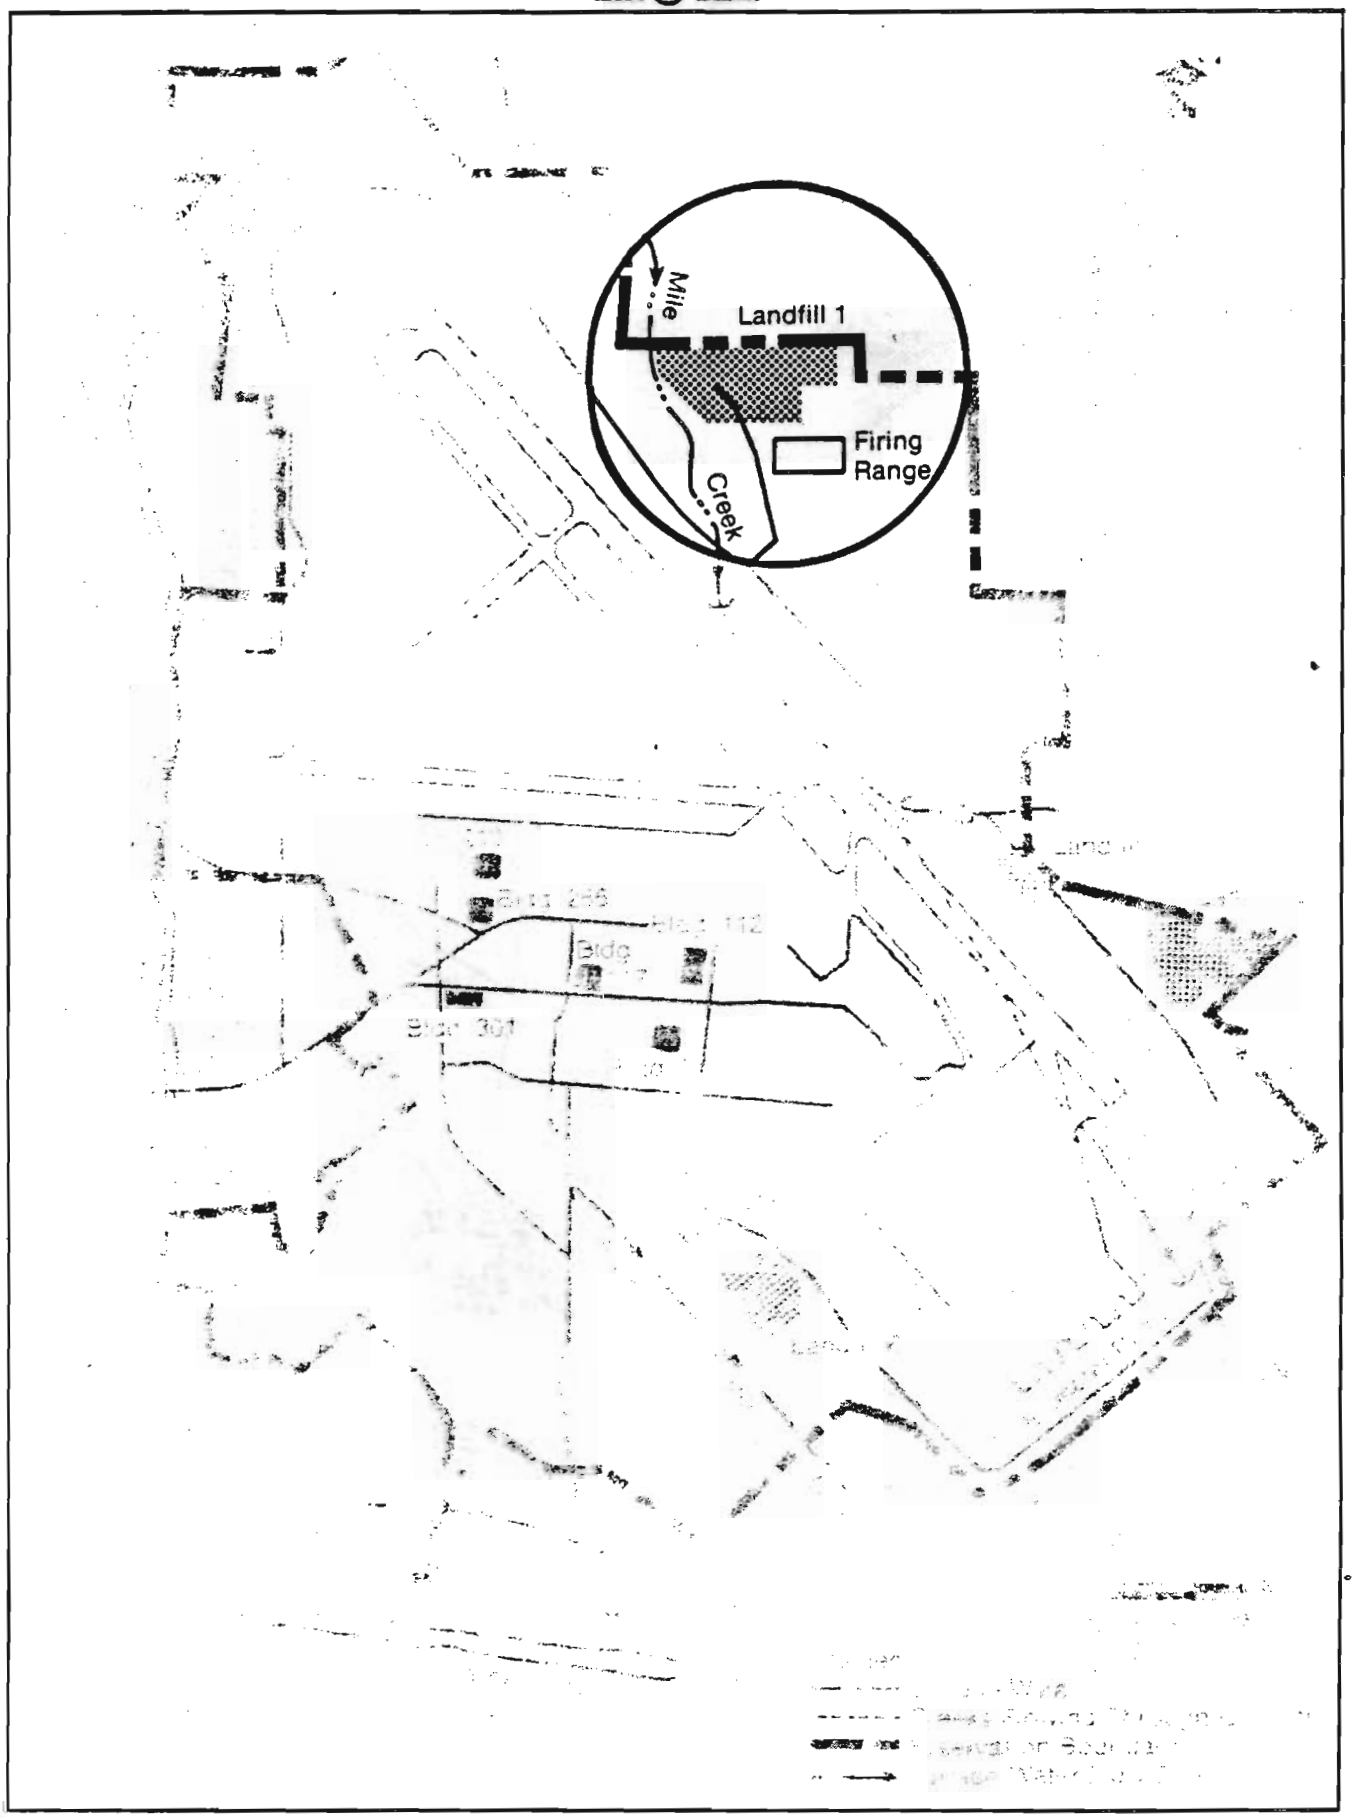
FIGURE 5 LOCATION OF LANDFILL NO. 1, GRIFFISS AIR FORCE BASE, ROME, NEW YORK

At the base of the slope adjacent to Six Mile Creek, southwest of the landfill, there is a perennial seep. It emerges from several points along a short (approximately 150 feet) front of the slope, where it feeds a wet area adjacent to the creek. Eventually it enters the creek principally through two rivulets having a combined flow of about five gallons per minute. The discharge point of the seep into the creek was slightly foamy for a few yards downstream. The seep has a rust red tint and has stained the ground it has flowed over; small deposits of white crystalline material were also observed. The seep appears to be fed by water percolating through the landfill. There is a concrete structure near the seep outlet which apparently was a springhouse. The date "1934" is etched on the wall. It seems likely that the seep is, at least in part, a spring that existed before the landfill, and that it receives at least some of its recharge

from the area now occupied by the landfill. Inspection of vegetation around the entire site revealed almost no stressed vegetation. Only in the immediate vicinity of the leachate seep was vegetative stress obvious, and at least some of that stress could be attributable to continuous inundation of plant root systems. Most of the vegetation growing within the seep area is, however, vigorous and luxuriant.

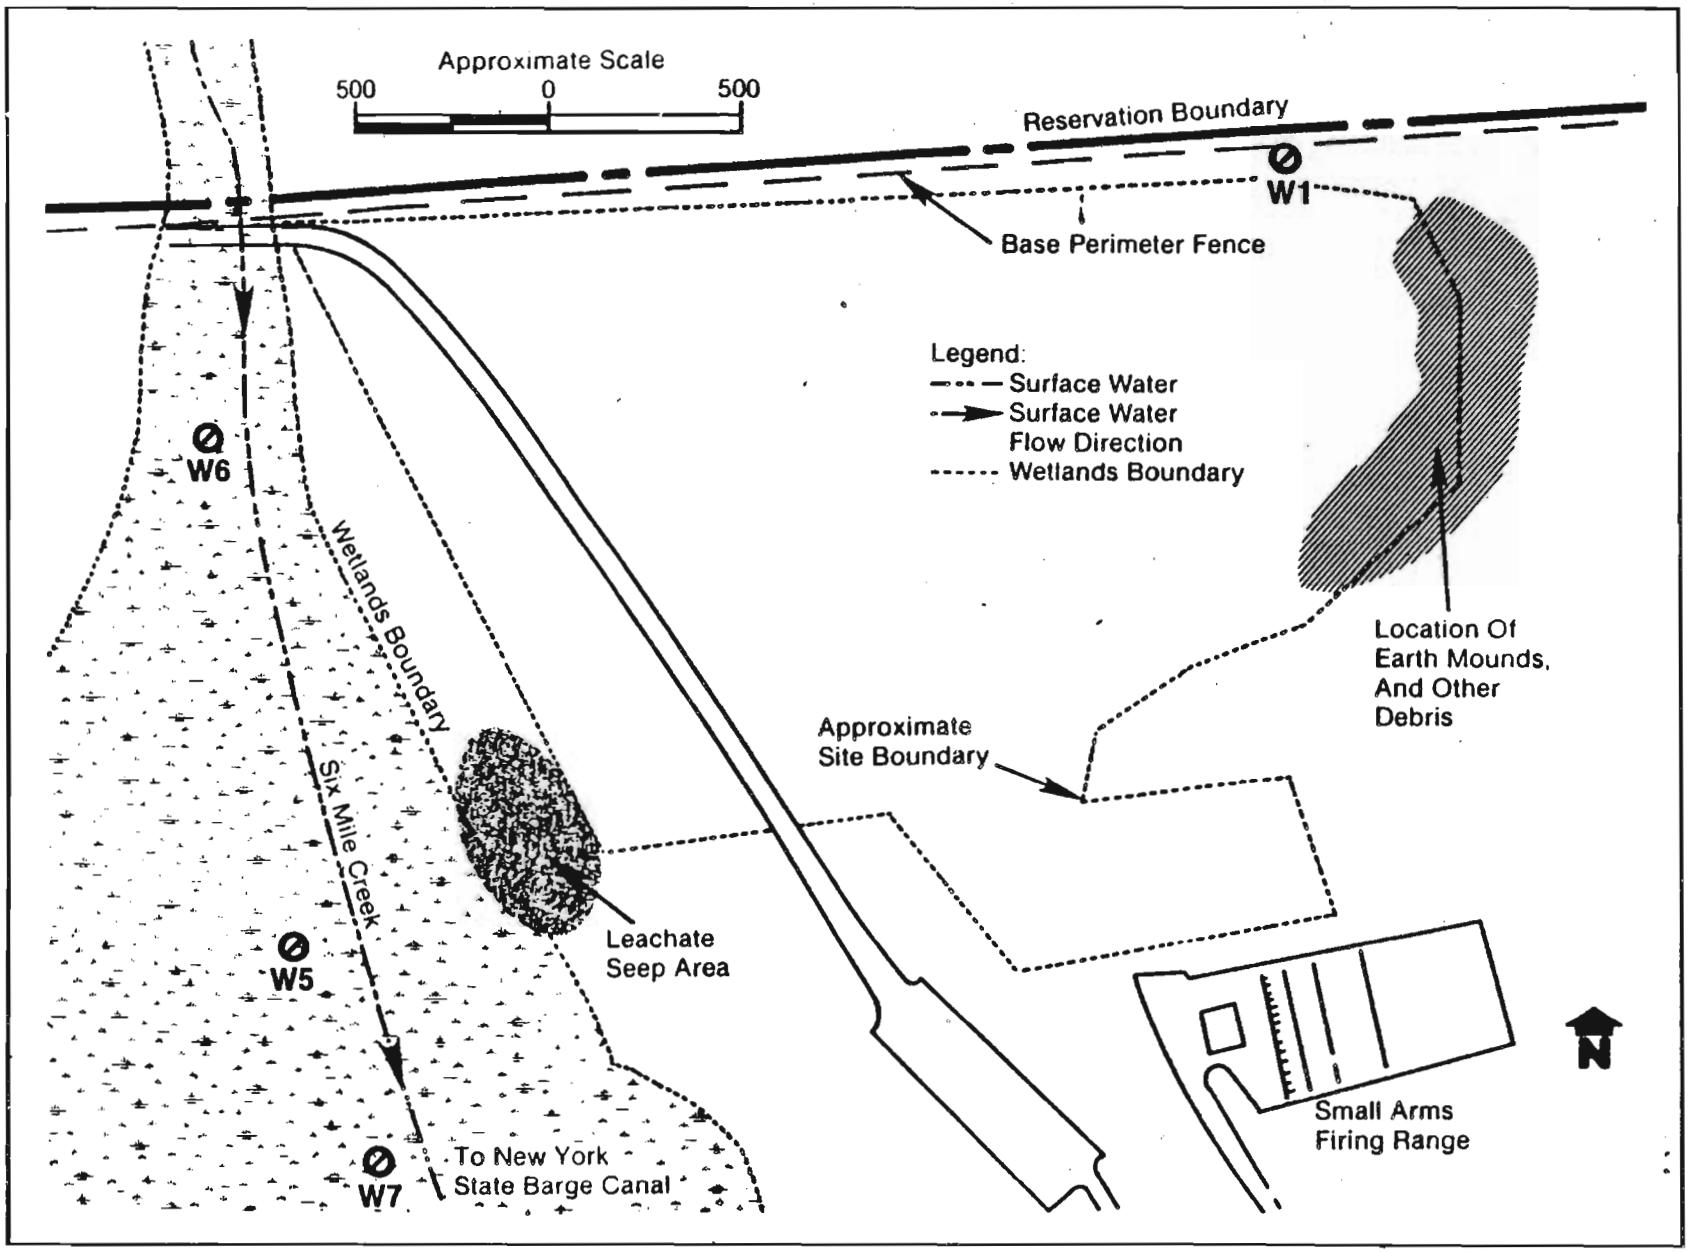
FIGURE 7 LOCATIONS OF FOUR CONFIRMATION STAGE MONITOR WELLS, LANDFILL NO. 1, GRIFFISS AIR FORCE BASE, ROME, NEW YORK

Well W5 is directly across Six Mile Creek from the seep, and contained quantifiable benzene (11 ppb) and ethylbenzene (92 ppb). Well W1, the background well, contained zinc in what appeared to be an anomalously high concentation. Well W6 contained elevated soluble chromium and W7 contained elevated zinc. No other compounds were detected at quantifiable concentrations. Several other compounds were detected in trace amounts, most notably some of the phthalates. WESTON's Quality Assurance (QA) Officer was of the opinion that a possible QA problem existed, due to the relatively low concentrations of those contaminants detected and due to the relatively high degree of scatter in the

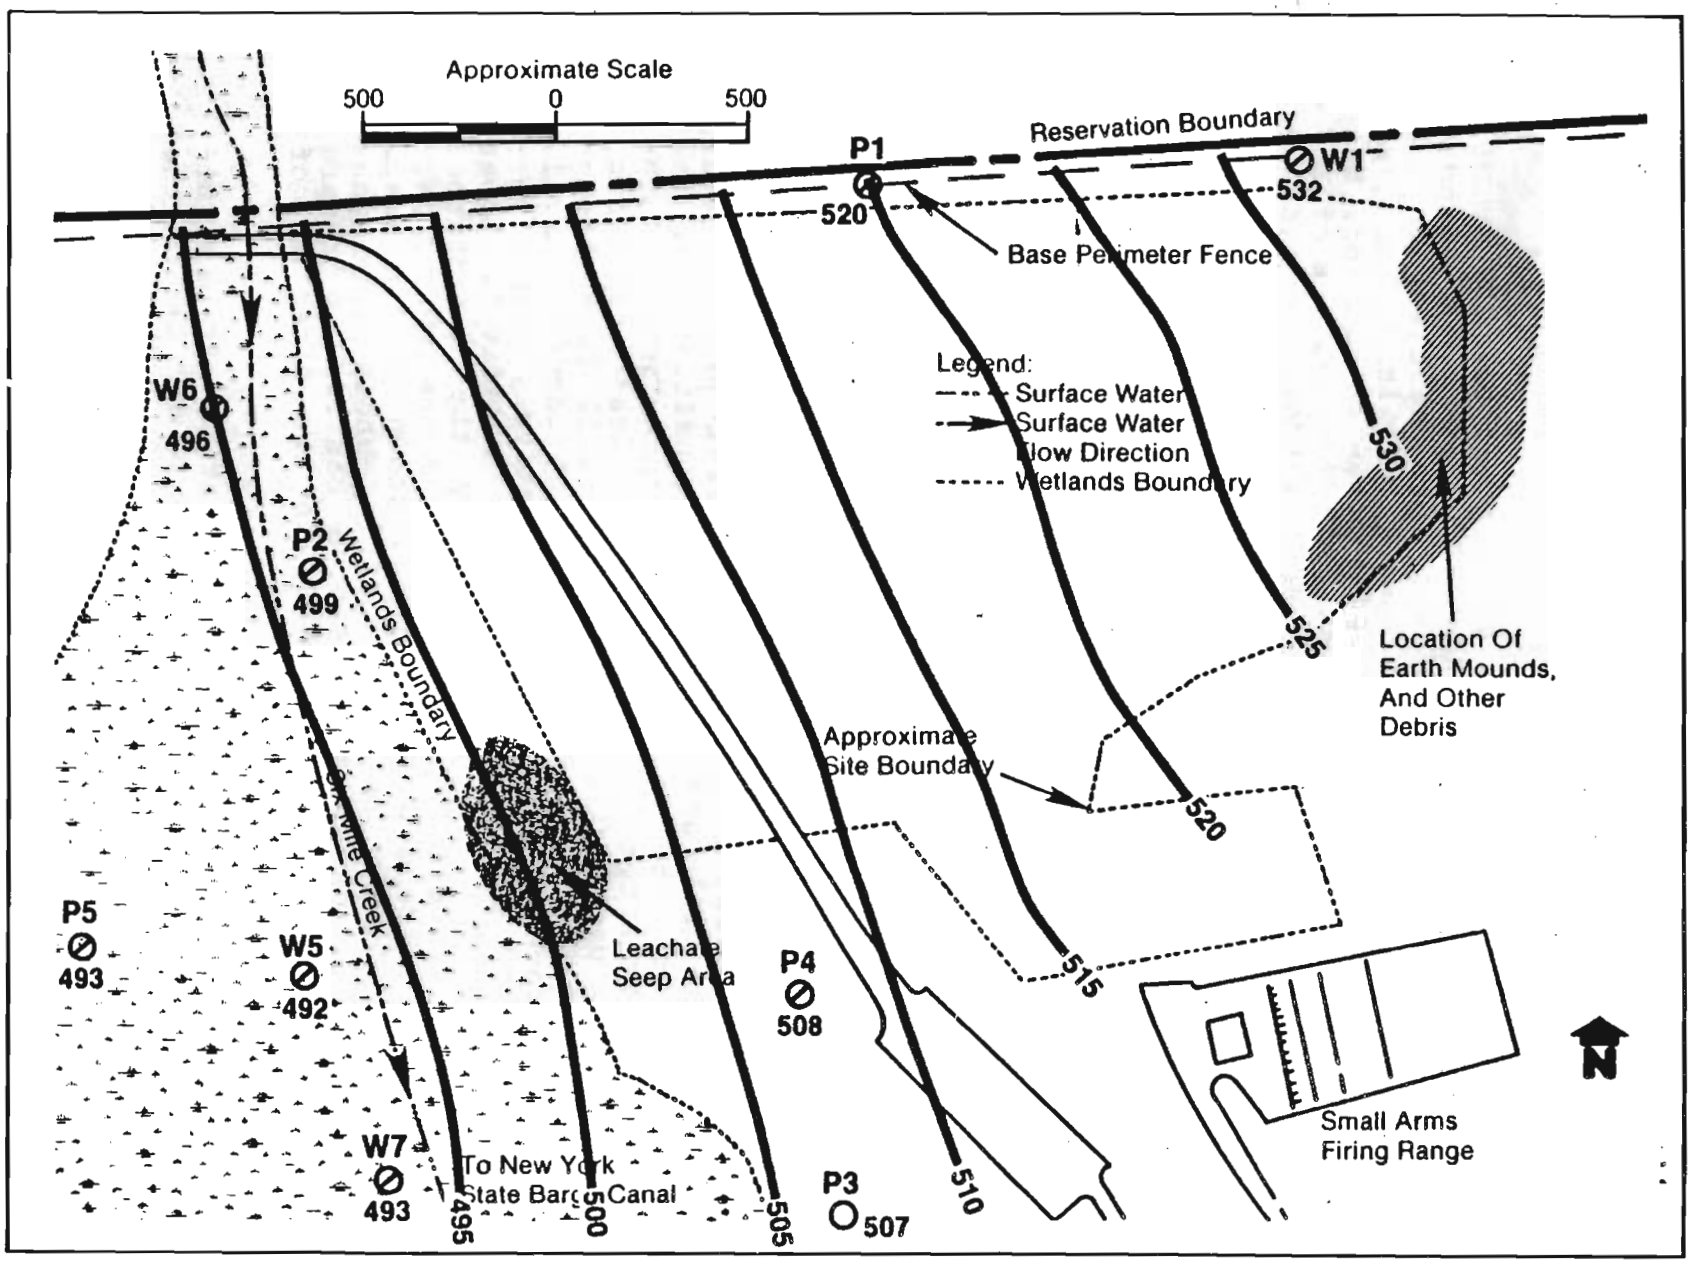
FIGURE 10 MAP OF WATER TABLE CONFIGURATION, LANDFILL NO. 1, 18 APRIL 1982, GRIFFISS AIR FORCE BASE, ROME, NEW YORK

Tables 2 and 5 contain ground water elevation data, as measured on 18 April 1982. Surveyed elevations were keyed to Well W-5, an arbitrary benchmark for relative elevations. The elevation of Well W5 was based upon a nearby spot elevation from the base facilities plan map. Water level elevations from all nine Landfill No. 1 wells were used to construct the water table contour map shown in Figure 10. Contouring of this map took into consideration that the water table should also intersect the elevations of both the seep and Six Mile Creek. From Figure 10 it can be seen that the ground-water flow direction is to the southwest toward the creek from the landfill. Several other observations may be made based upon Figure 10.

- The average gradient across the site (head drop versus distance of flow) is approximately 0.02 feet per foot.

- Ground-water levels in the wetland wells (W5, W6, W7 and P5) were lower than the creek surface indicating a discharge gradient from the creek to the water table to the southwest. This is an expected condition at the onset spring-thaw conditions, but it is probably not typical for other seasons of the year. With the Creek and Aquifer under the hydraulic conditions as measured in April, 1982, flow lines do not converge upon the Creek, with the Creek acting as a hydrodynamic barrier to further migration, but will pass beneath the Creek allowing migration to occur. During periods of higher water Table elevations in these wells, the Creek will act as an effective hydrodynamic barrier to further contaminant migration in the water table.

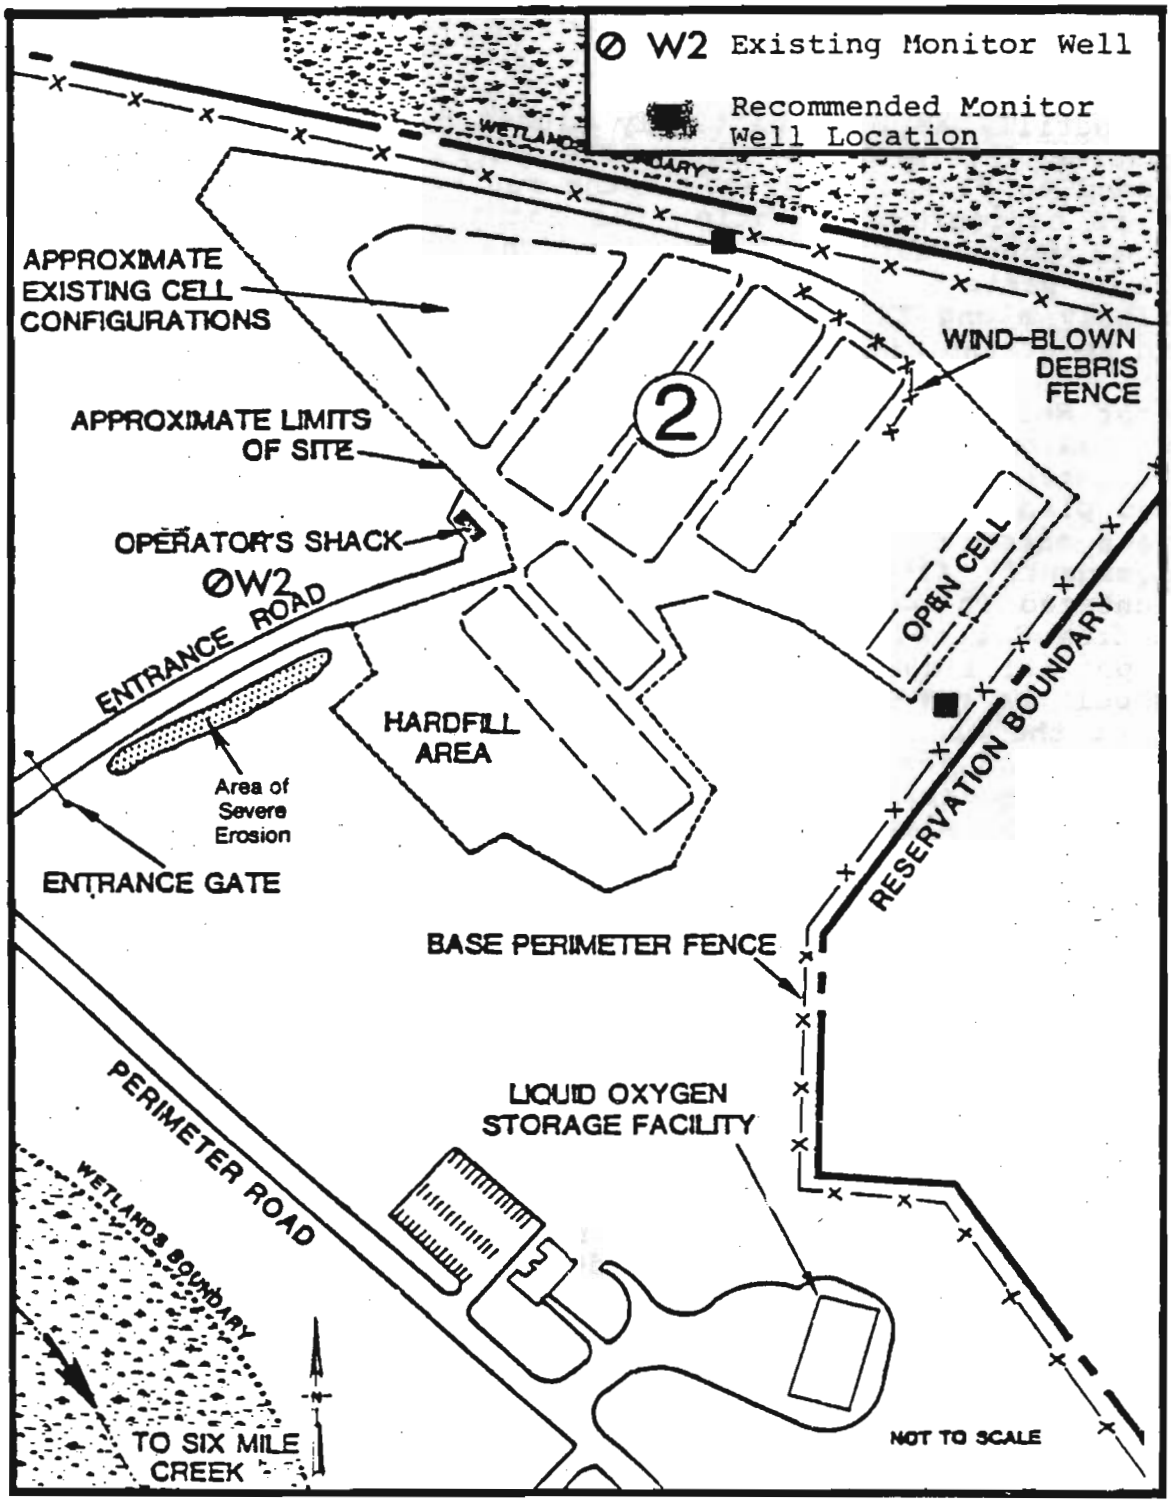
Expanded Plan View of Landfill No. 2,
Griffiss Air Force Base, Rome, New York

The landfill has been partially closed by placement of a layer of coarse intermediate cover. The surface has been partially regraded to direct drainage to the southeast and southwest. The site is barren; revegetation has not yet been established and no soil cover has been emplaced. There is a scant growth of weeds on parts of the surface. Erosion gullies are present, particularly along the access road. Miscellaneous debris is scattered about the site.

Monitor Well W2 was installed adjacent to the landfill toe in a down gradient direction between the landfill and Perimeter Road. The location of Well W2 is shown on Figure 17, which is an expanded plan view of the Landfill No. 2 site configuration. Subsurface materials sampled during monitor well construction were predominantly fine- to coarse-grained sands. Bedrock was not encountered in boring W2. Groundwater quality analyses of samples from Well W2, as summarized in Tables 13 and 14, detected some potential contaminants at very low concentrations. However, it should be noted that this is the most recently active landfill at the base, and, as such, it has the highest probability of generating leachate in the near future of any of this group of sites. Recently deposited refuse is probably undergoing rapid decomposition with the landfill. Decomposition products and unrestricted infiltration of precipitation (due to the absence of a final cover) will combine to form this leachate. Therefore, the Air Force should complete closure of Landfill No. 2 in accordance with State regulations prior to the advent of major leachate generation from the filled materials.

Landfill No. 2 will require proper closure when use is permanently discontinued. This site was used for waste disposal as recently as 1980 and has not yet been completely closed. Methane accumulation in the nearby buildings is not expected, but remains a possibility due to the porous nature of the native soils and the absence of a liner under the landfill. Unauthorized dumping does not appear to be a current problem at Landfill No. 2. Future problems of this sort can be detected quickly with a regular inspection program.

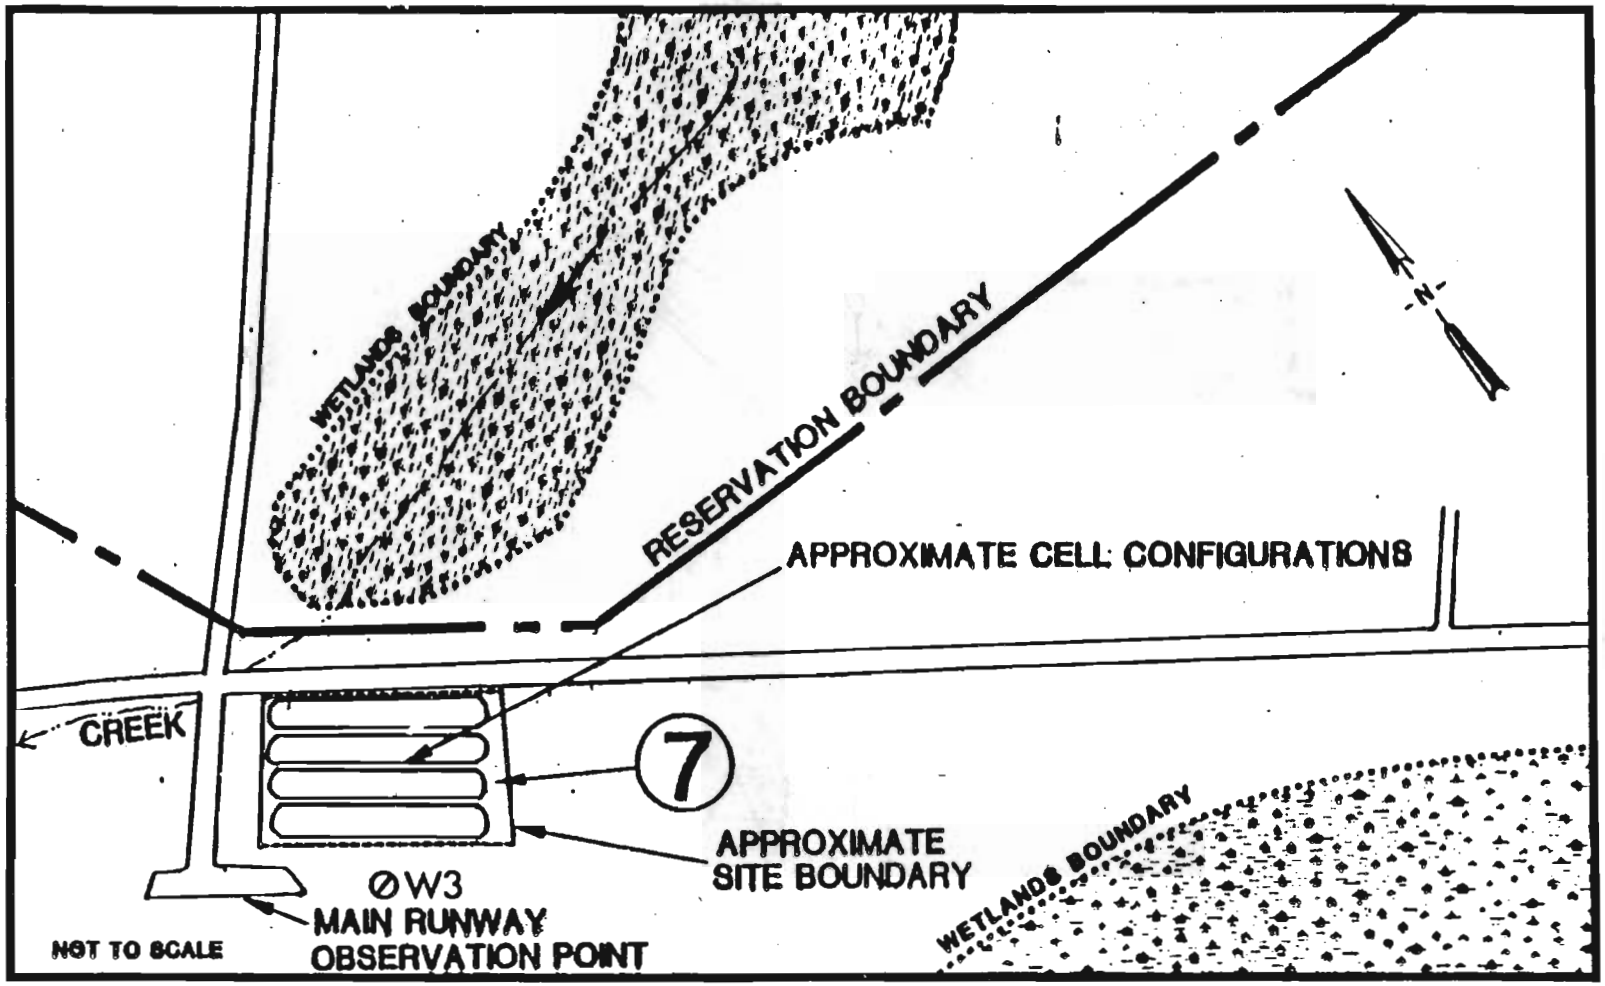
Figure 22: Expanded Plan View of Landfill No. 7, Griffiss Air Force Base, Rome, New York

Monitor Well W3 was installed adjacent to the toe of Landfill No. 7 in a down gradient direction between the landfill and Six Mile Creek. The location of Monitor Well W3 is shown on Figure 22, which is an expanded plan view of Landfill No. 7. Subsurface materials sampled during monitor well construction were predominantly fine- to coarse-grained sands. Bedrock was not encountered at this boring site. Groundwater quality analyses of samples from Well W3, as summarized in Tables 13 and 14, detected no compounds at concentrations which will cause immediate environmental concern. Due to the age of this landfill, the probability that significant leachate generation will occur in the future is low. No further actions are recommended at Landfill No. 7.

- No further actions are recommended for Landfill No. 5, 6, or 7.

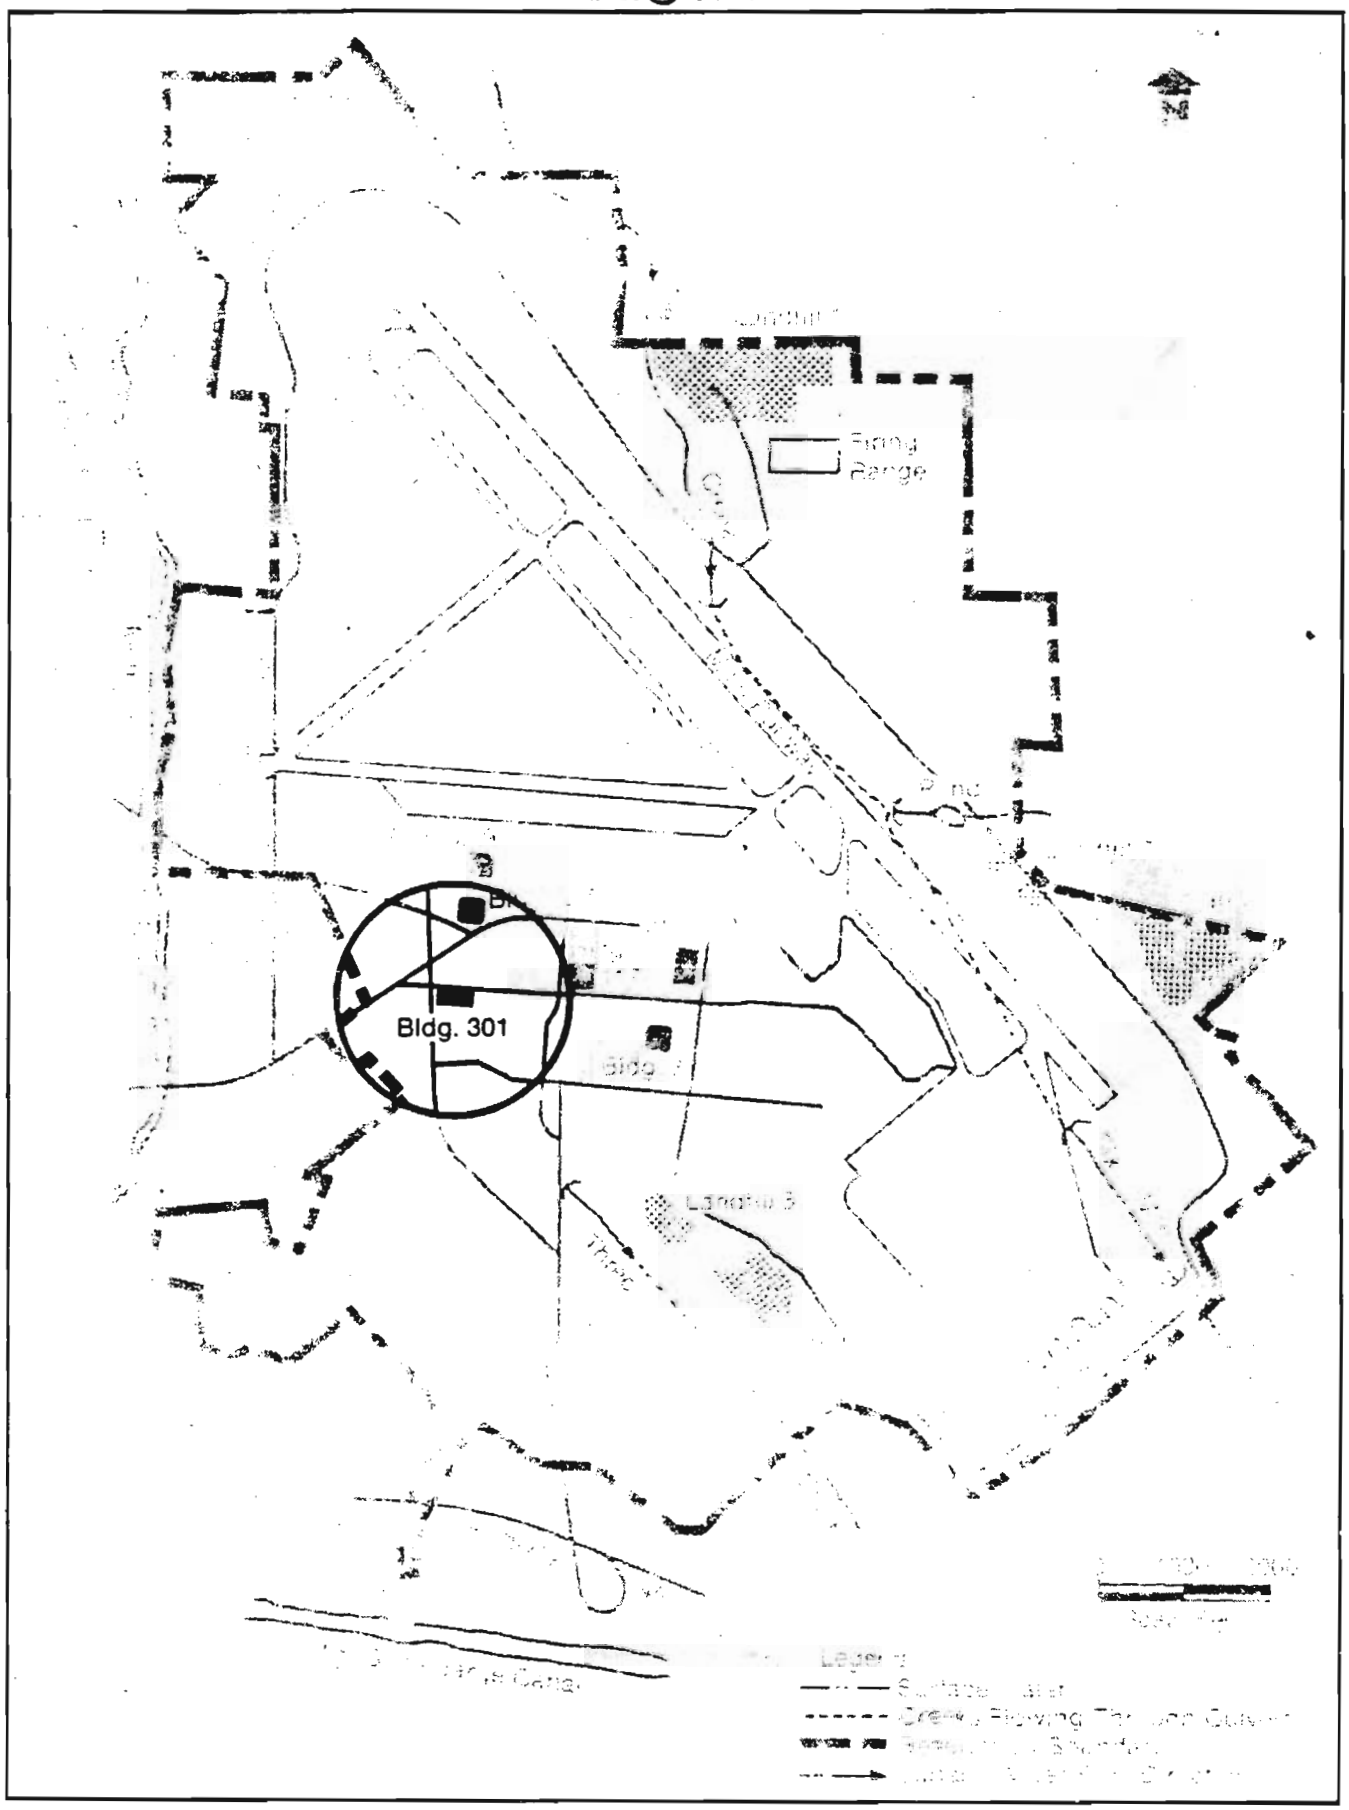
FIGURE 23 LOCATION OF ENTOMOLOGY LABORATORY, BUILDING 301, GRIFFISS AIR FORCE BASE, ROME, NEW YORK

Of particular importance to this study is the dry well located adjacent to Building 301, the Entomology Laboratory. Small quantities of pesticides have been disposed of in this dry well and allowed to infiltrate into the groundwater. Because of the porous sand and gravel subsoil percolation of liquid wastes can be expected to be rapid. The dry well was not accessible for inspection, although its position is well documented. This Drywell was evaluated as a surrogate for other higher priority drywells whose positions are either unknown or are inaccessible for evaluation.

The location of this facility within the main developed part of the base is shown on Figure 23. This dry well was used for an unknown number of years for the disposal of small quantities of water used for washing pesticide containers (<1 gallon per day of rinsewater) and for small quantities of off-specification pesticides (<2 gallons per year).

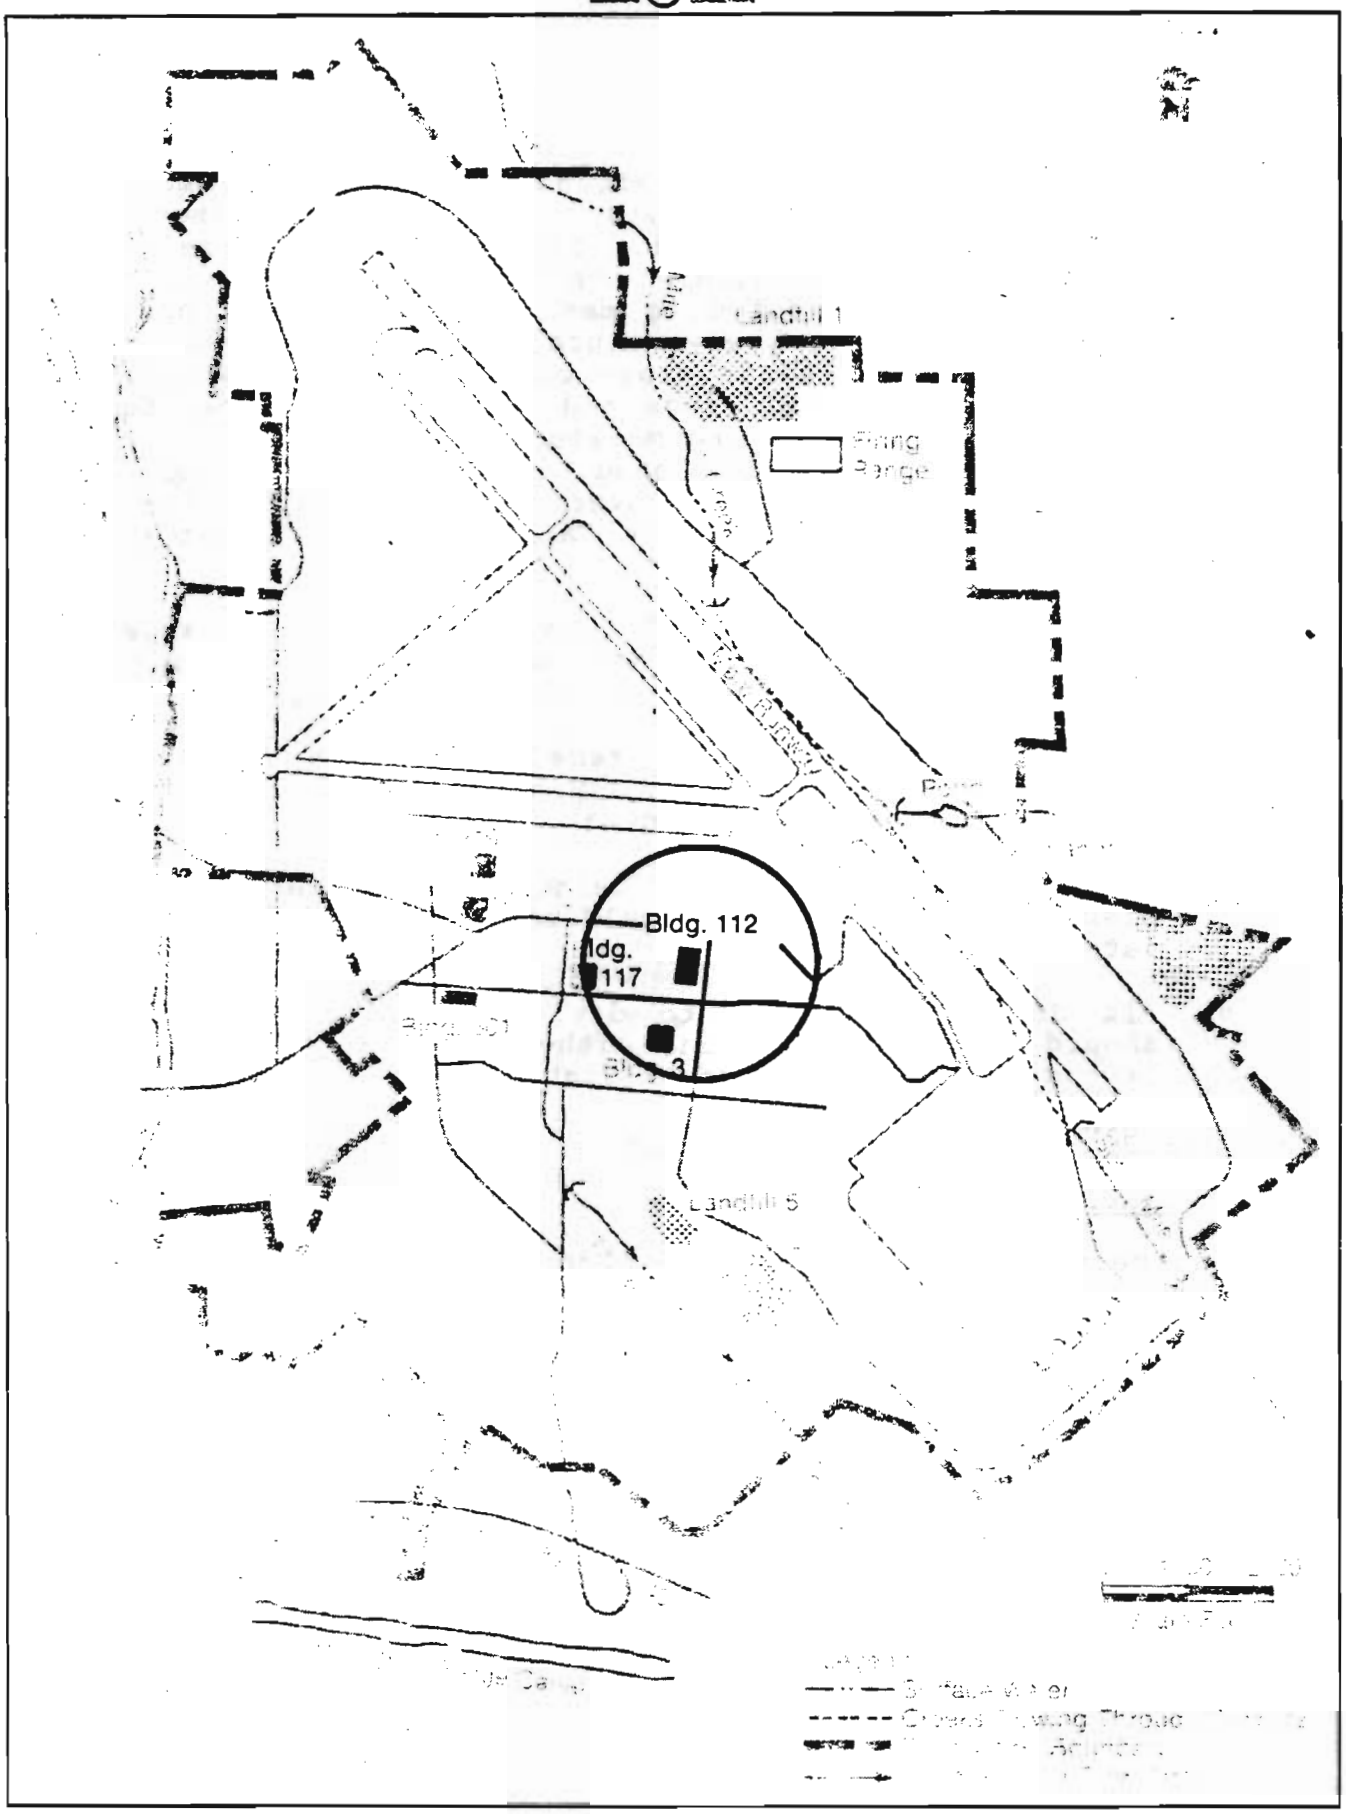
FIGURE 24 LOCATION OF PCB SPILL AREA, BUILDING 112 GRIFFISS AIR FORCE BASE, ROME, NEW YORK

Soil PCB contamination in the vicinity of the High Power Laboratory, Building 112, appears to be limited to areas "d" and "e" adjacent to the building. Roof material near the leaking transformer is contaminated with PCB at levels in excess of the U.S. EPA action levels. All roofing and soils contaminated with PCB at levels in excess of the 50 mg/kg Action Level should be removed and properly disposed of in either an Annex I incinerator or an Annex II chemical waste landfill.

PCB has been handled at the loading docks at Building 112, the High Power Laboratory. In the past spills are known to have occurred in this area. In addition, leakage from a transformer on the roof of Building 112 has caused contamination of roof materials. The location of Building 112 is shown on Figure 24.

- The leaking transformer at Building 112 should be repaired as soon as possible.

- As soon as possible after repair of the leaking transformer, soils and roof materials at Building 112 having PCB concentrations in excess of the 50 mg/kg Action Level should be removed for proper disposal in either an Annex I incinerator or an Annex II chemical waste landfill.

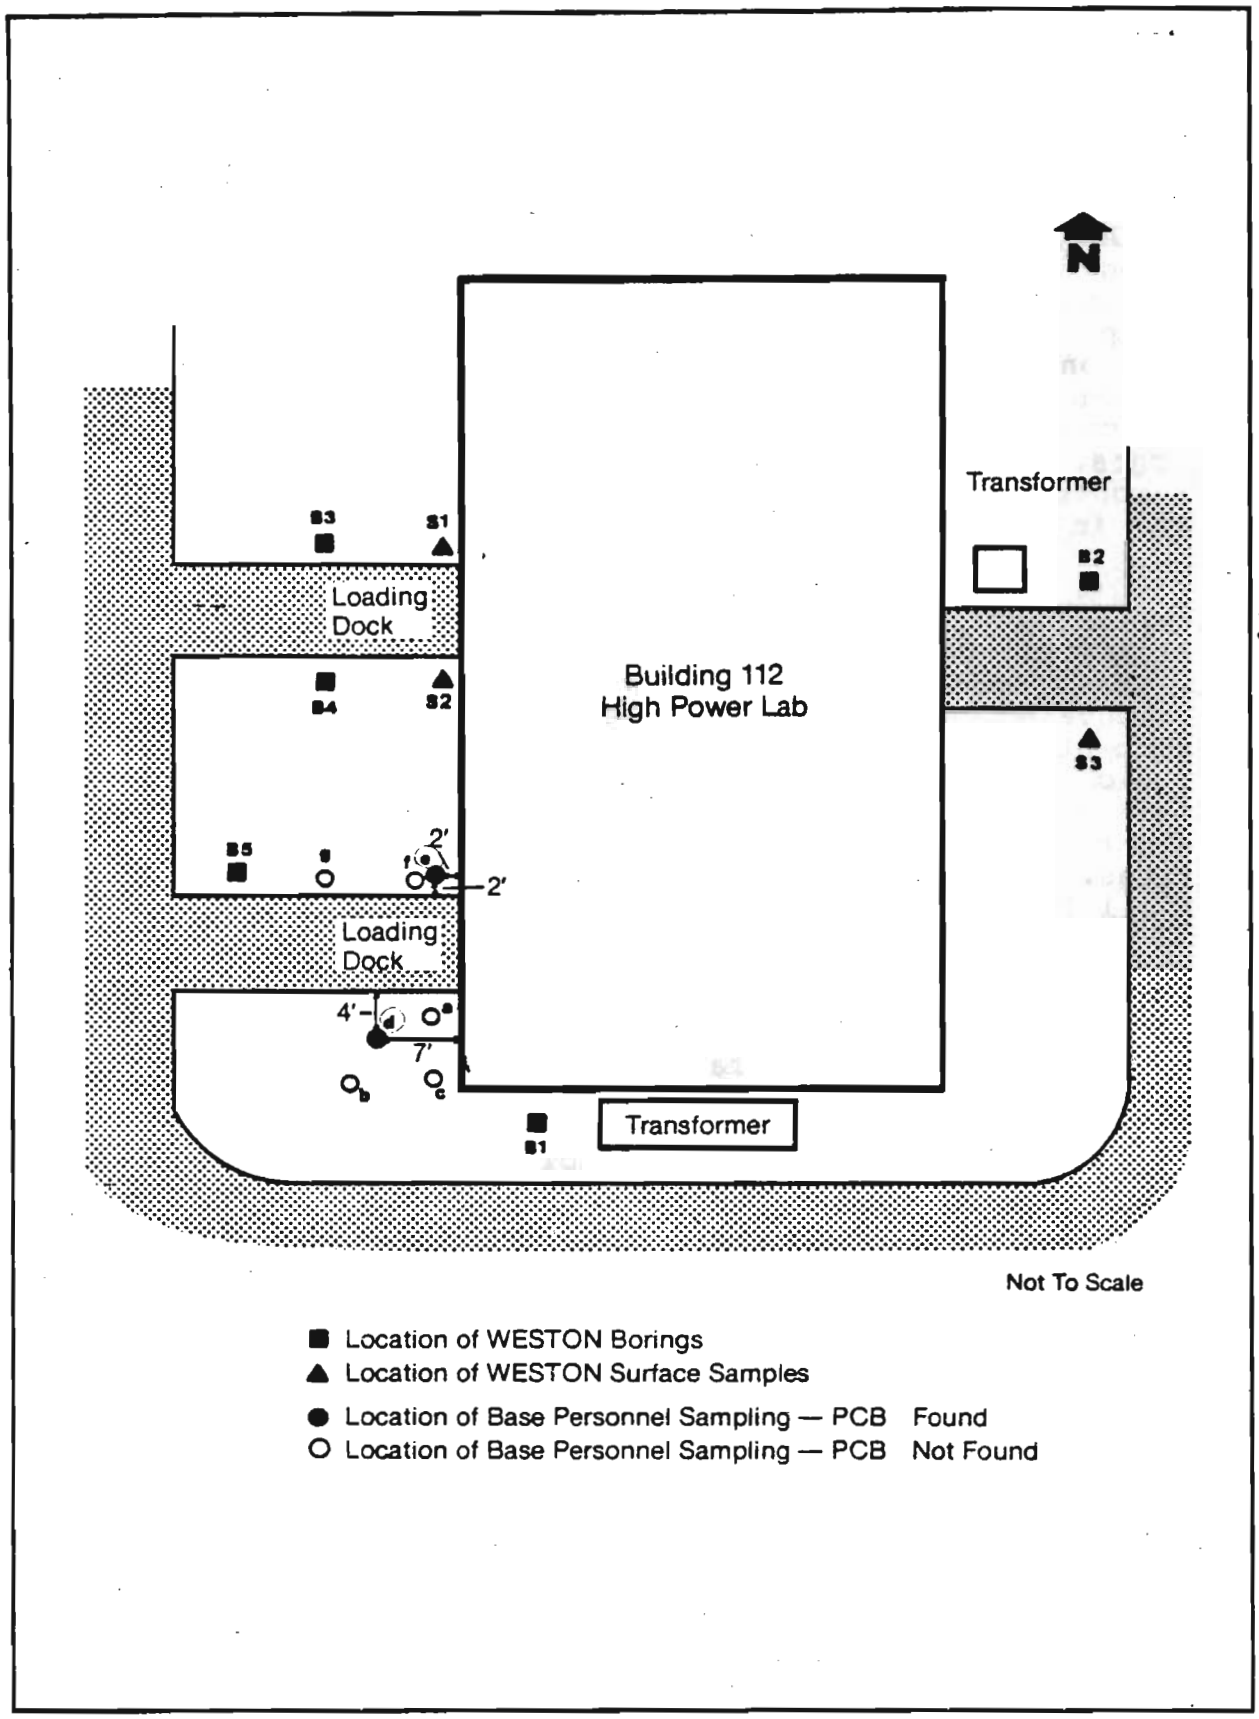
Locations of Soil Samples for PCB Analysis,
Building 112, Griffiss Air Force Base, Rome, New York

During July and August 1981, Base Bioenvironmental Engineers conducted a program of soil sampling and testing for PCB that included areas by the loading docks on the west side of Building 112. Sampling was done in seven locations, labelled A through G, as shown on Figure 25. PCB was found at locations D and E adjacent to the loading dock near the southwest corner of the building, in concentrations of from 5 to 530 mg/kg at depths of up to 40 inches. Table 16 presents the results obtained by the Air Force contract laboratory. WESTON's investigation was to test for PCB in other areas not already identified in the Air Force Study.

Boring and grab-sampling locations are shown on Figure 25. Boring B-1 was advanced to three feet, while Borings B-2 through B-5 each were advanced to five feet. Samples from locations S-1, S-2 and S-3 are surface grab samples. The results of WESTON's analyses of these soil samples for PCB are in Table 17. Analyses were planned to be done in a step-wise schedule commencing with the shallowest sample from each site. If PCB concentrations were above the USEPA Action Level of 50 mg/kg in any sample, the next lower sample would also be analyzed. Since all concentrations of PCB in the surface samples were below the USEPA Action Level, no analyses were run on deeper samples. Analysis of the sample for Boring B-1 detected no measurable PCB, while analyses of samples from Borings B-2 through B-5 detected PCB at the lower limit of detection. Analyses of surface grab samples A, B and C detected 6.6, 9.6 and 7.0 mg/kg of PCB, respectively.

- Roof materials at Building 112 are contaminated with PCB from a leaking transformer.

- The leaking transformer at Building 112 should be repaired as soon as possible.

- As soon as possible after repair of the leaking transformer, soils and roof materials at Building 112 having PCB concentrations in excess of the 50 mg/kg action level should be removed for proper disposal in either an Annex I incinerator or an Annex II chemical waste landfill.
