SUPPLEMENTAL INVESTIGATION REPORT ADDENDUM

BUILDING 817/WEAPONS STORAGE AREA AND LANDFILL 6
FORMER GRIFFISS AIR FORCE BASE
ROME, NEW YORK

DECEMBER 2015

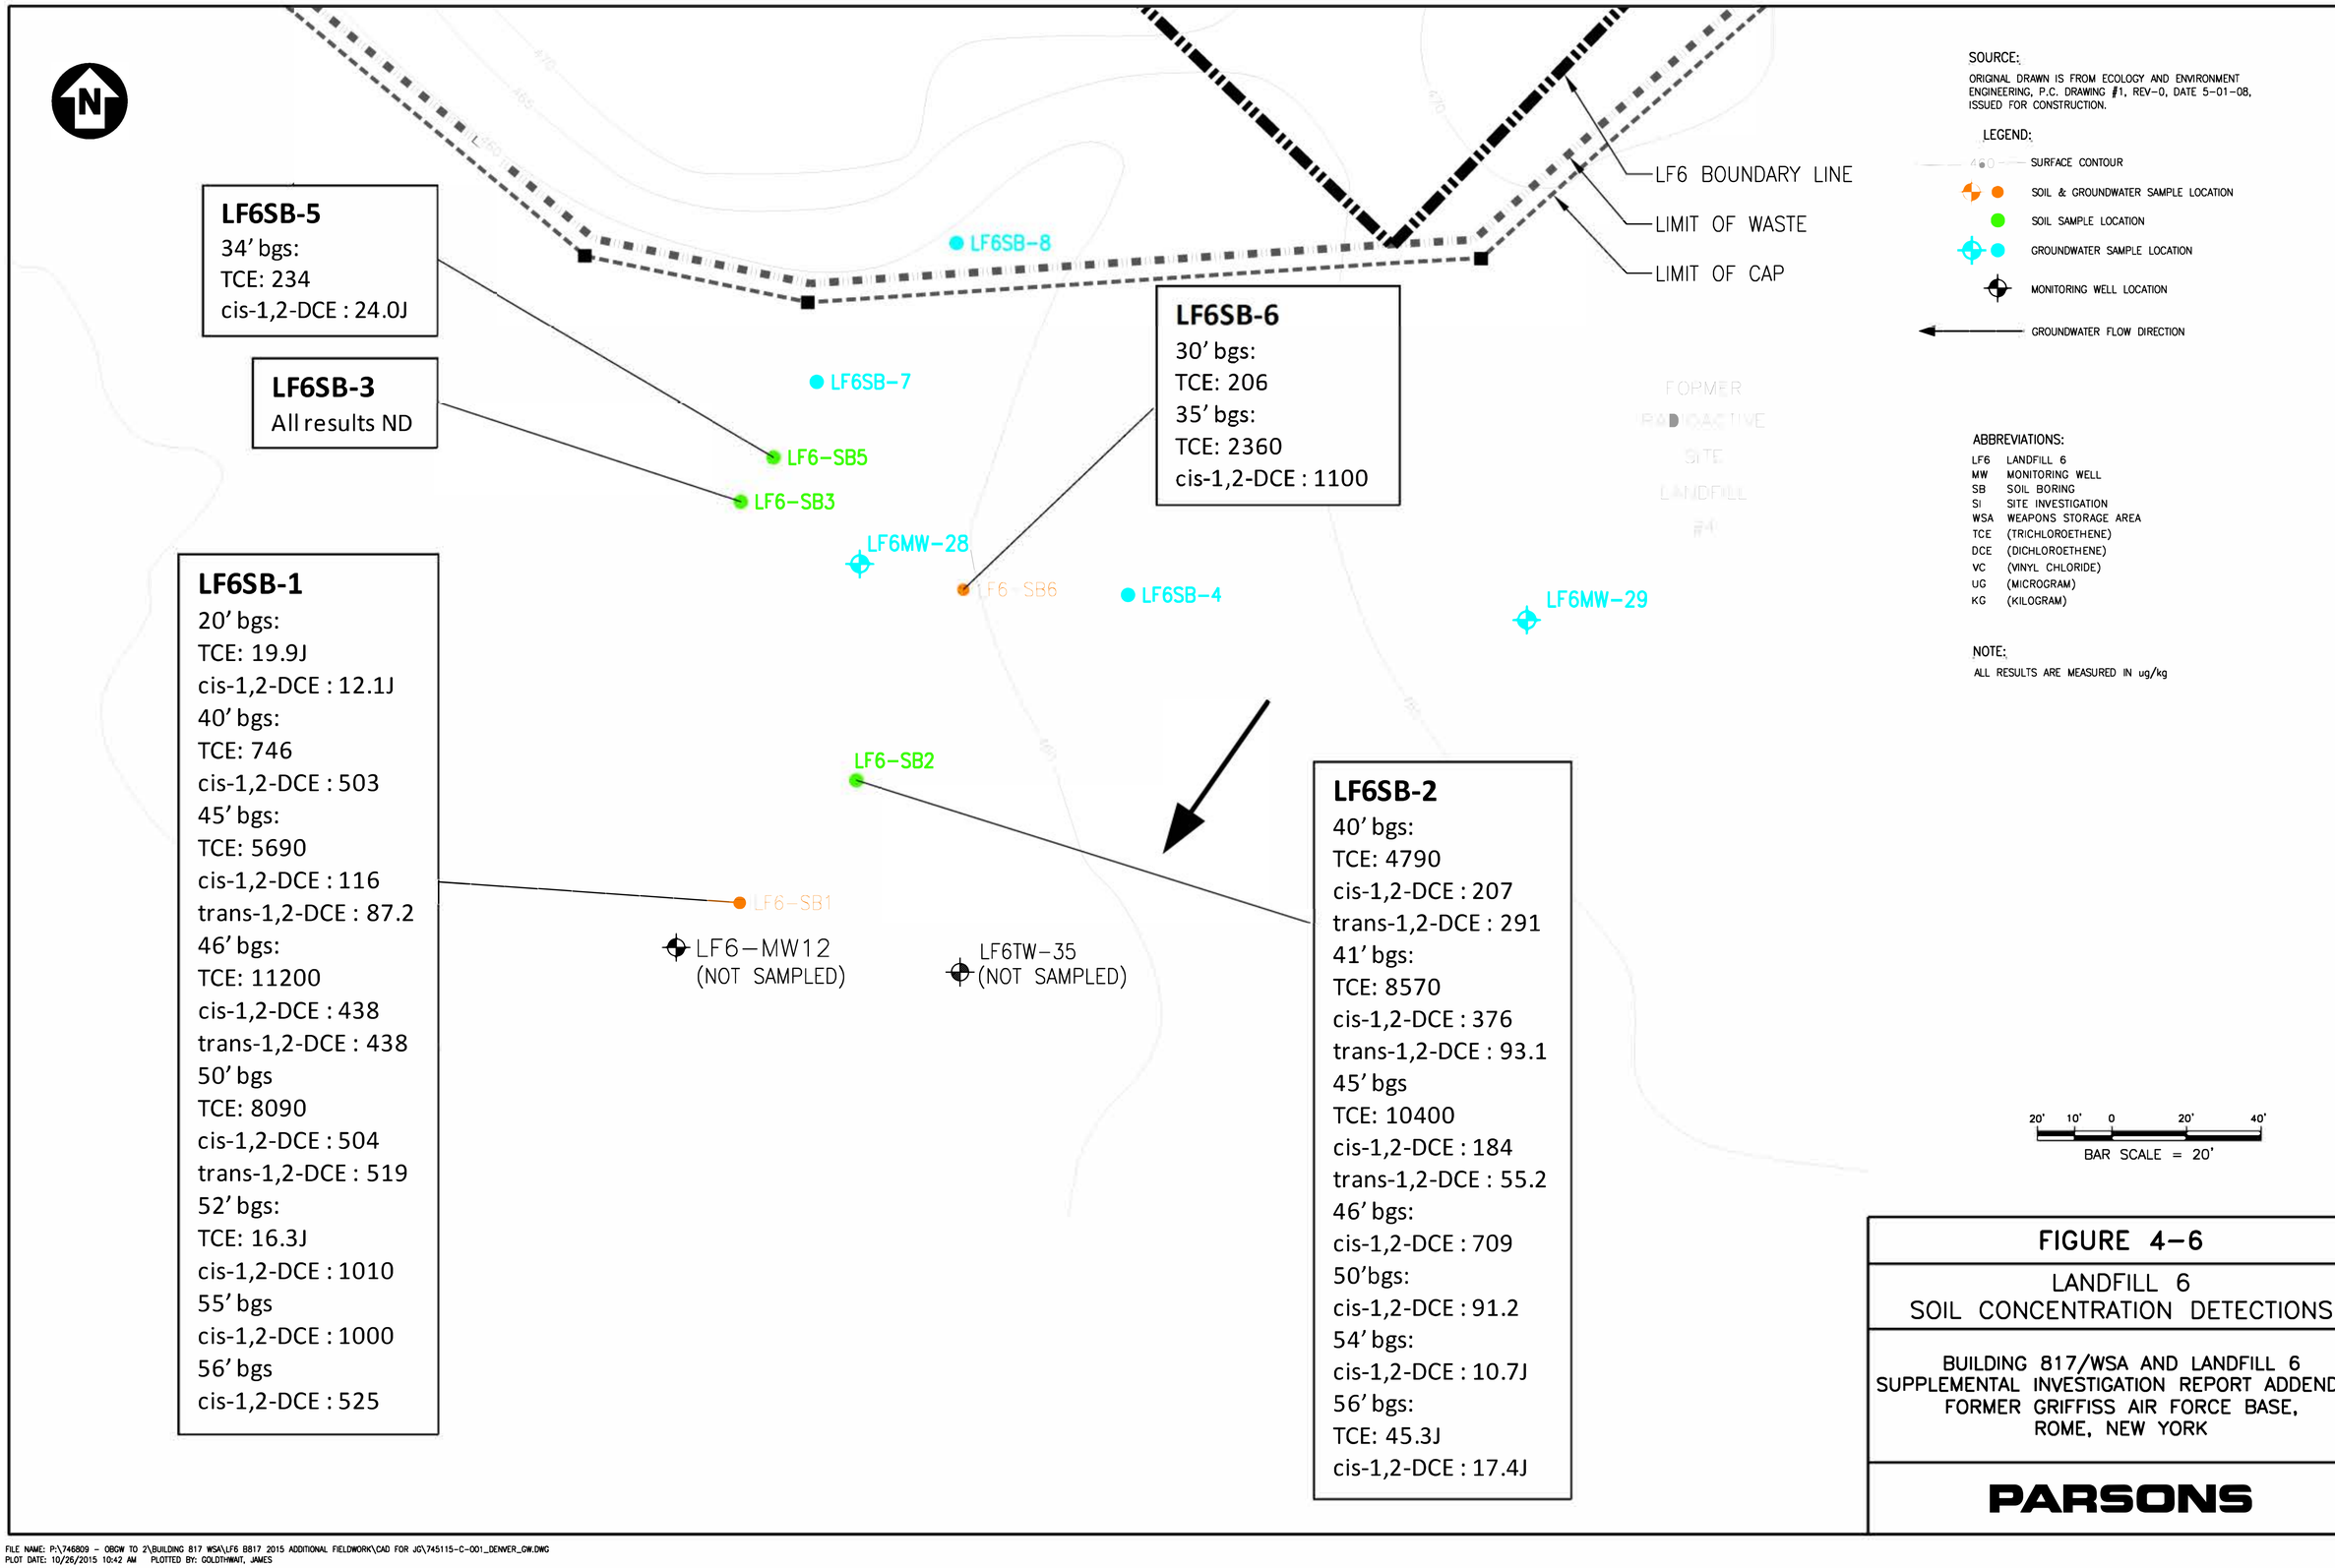
FIGURE 4-6

Soil profiling activities were conducted at LF6 in order to better characterize the subsurface materials. Soil borings advanced at Landfill 6 and provided in **Appendix A** did not lead to any revisions in the conceptual site model. Sand, gravel and, occasionally, cobbles were found in the upper several feet, followed by silty sands. The geoprobe encountered refusal at approximately 34 feet bgs at boring location LF6SB-5 and at approximately 58 feet bgs at boring location LF6SB-2. At boring location LF5SB-4, the core barrel was lost at 40 feet bgs; the core got stuck in the barrel at boring LF6SB-1 at 50 feet bgs. No subsurface heterogeneities (e.g., clay lenses) were discovered that would cause contaminants to sorb to certain areas and diffuse slowly, contributing to plume persistence.

LANDFILL 6
SOIL CONCENTRATION DETECTIONS

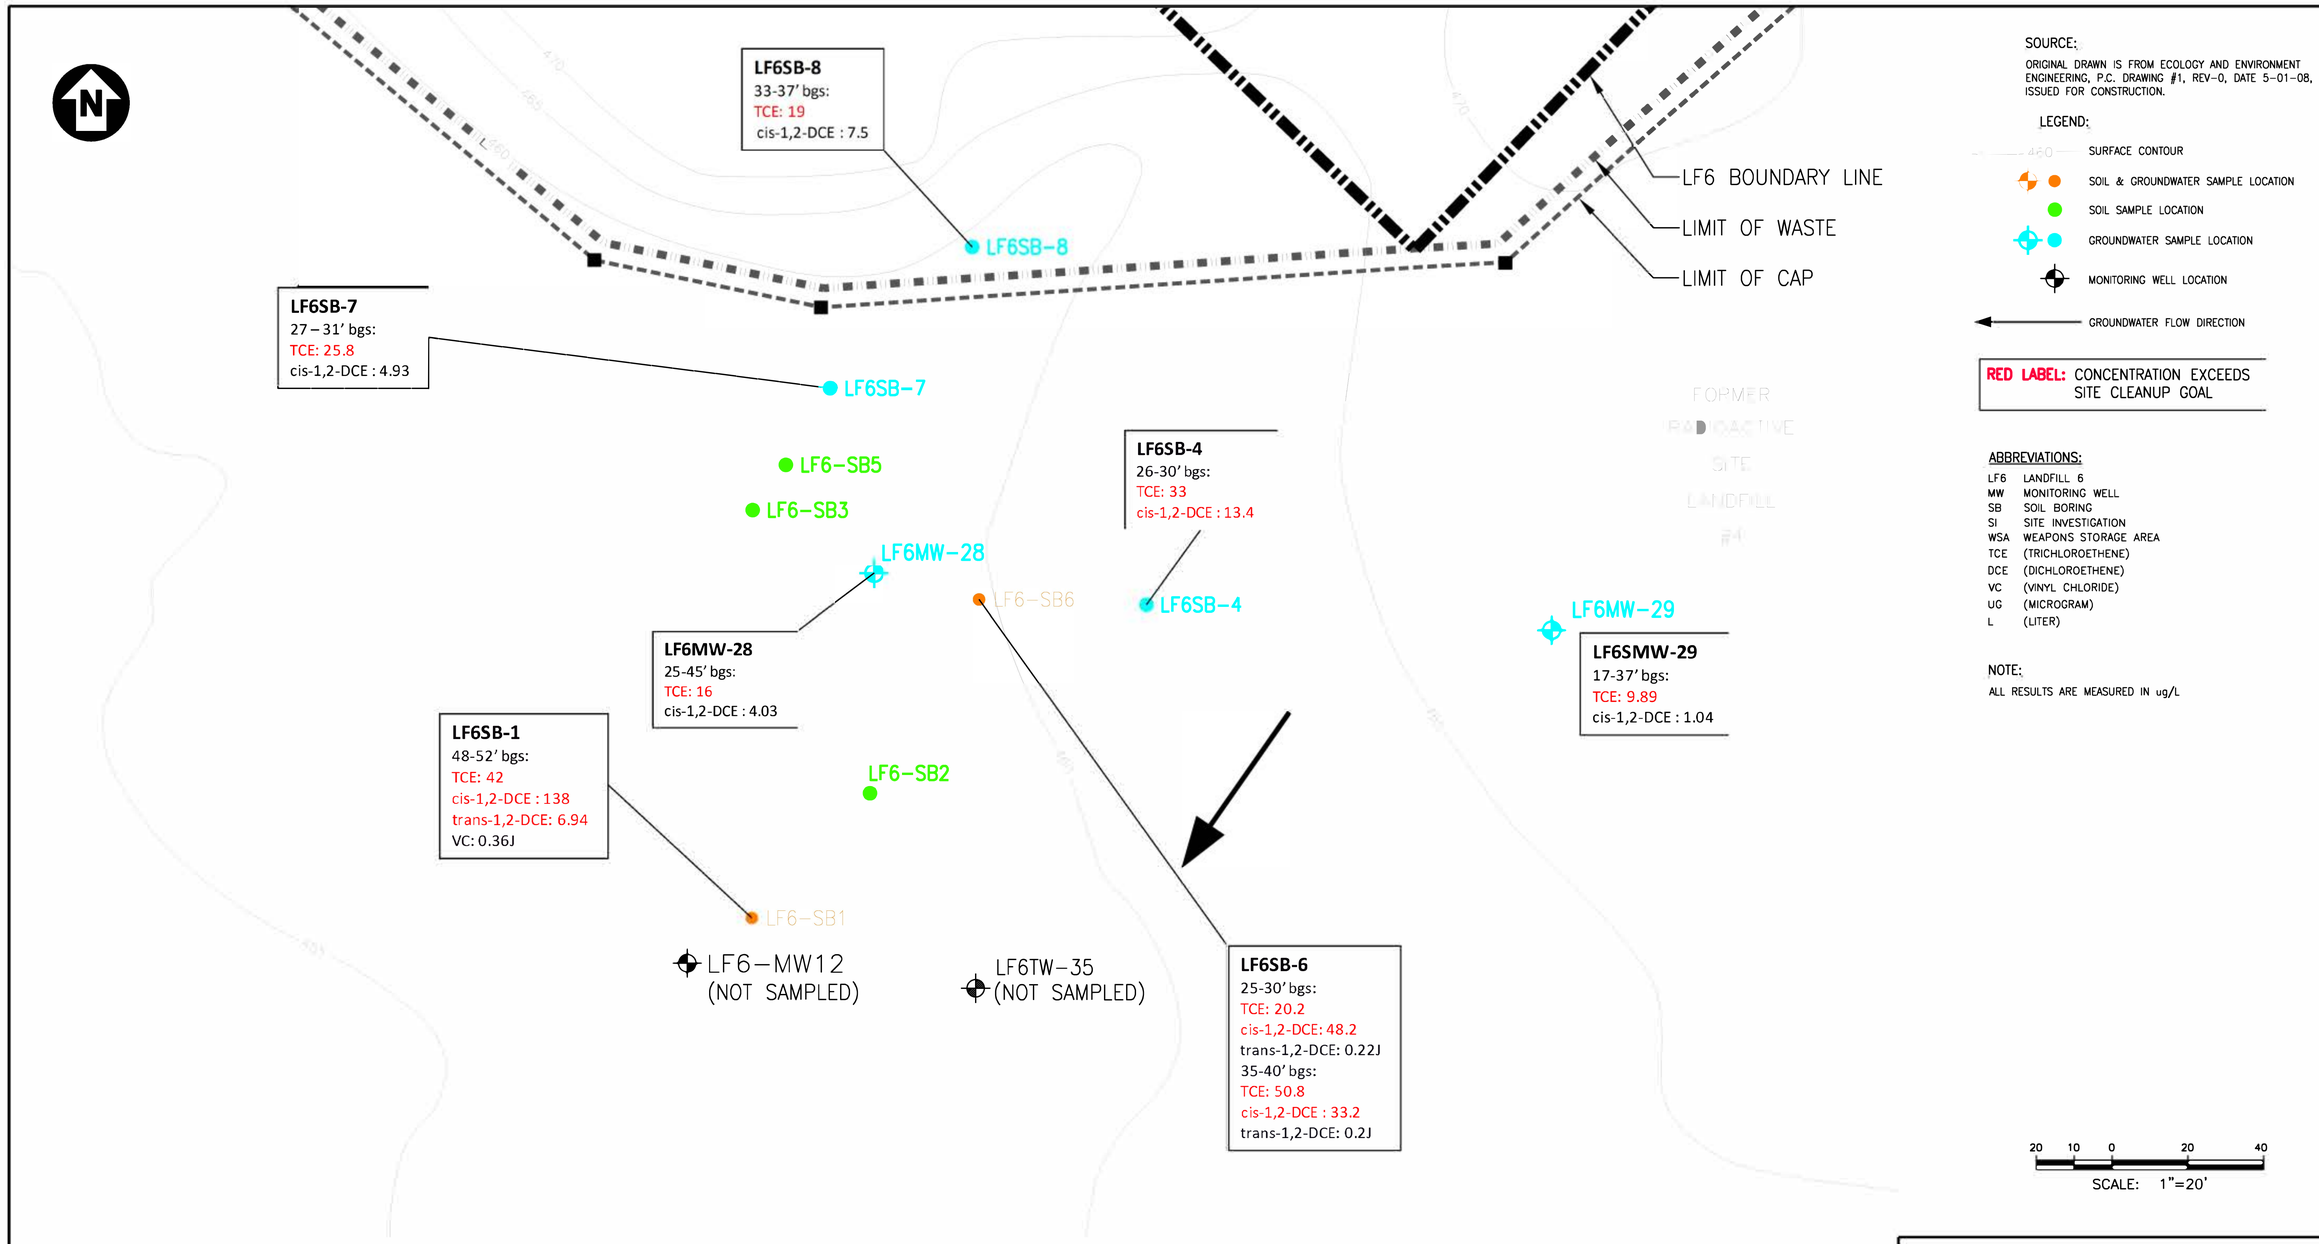
FIGURE 4-7

A tabulated summary of groundwater results is provided in **Table 4-4** and illustrated in **Figure 4-7**. Eight groundwater samples were collected from five Geoprobe® borings (LF6SB-1, LF6SB-4, LF6SB-6, LF6SB-7, and LF6SB-8) and two monitoring wells (LF6MW-28 and LF6MW-29), at depths between 17 to 52 feet bgs. The monitoring wells were chosen due to their proximity to the boring locations. The analyte TCE was found above its site cleanup goal in all 8 samples; the highest value, 50.2 µg/L, was found at LF6SB-6, close to the center of the plume, in the 35-40 ft bgs depth. DCE was found in levels exceeding its site cleanup goal in five of eight samples. PCE was not detected in any samples; VC was detected in one boring, LF6SB-1, but below its site cleanup goal. Wells LF6MW-28 and LF6MW-29 are not included in the Performance Monitoring Reports since they are beyond the well selected to monitor the upgradient extent (e.g., well LF6TW-35, see **Figure 3-2**); therefore, no recent sampling of these wells have occurred. However, concentrations in the two monitoring wells are lower than during the 2006 sampling event.

LANDFILL 6 GROUNDWATER CONCENTRATION DETECTIONS
