SUBJECT: July 2015 Operating Report for the Vestal Well Field 1-1 Superfund Site, Area 4, Vestal, New York

SUBJECT: July 2015 Monthly Report on Activities at the Vestal Well field 1-1 Superfund Site, Area 4, Vestal, New York

LATA Project # 11202
Contract # W912DQ-09-D-3003,
Task Order # 008

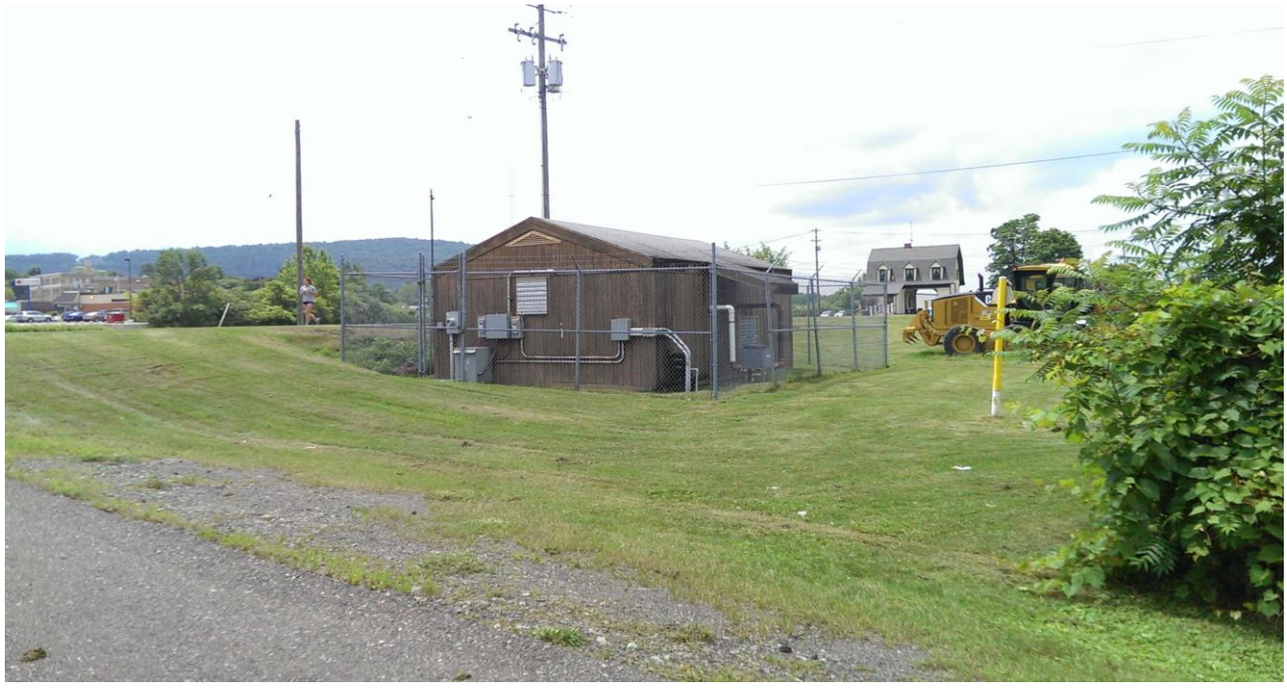
Main Building

No other operational issues were noted during the inspection. Both the distribution buildings and the adjacent parking lot area were inspected and no issues were noted.

Comments
Grass and shrubs were trimmed around main building, cell 1, and cell 2. Interior of buildings were also swept.
