December 20, 2017

RE: Former Accurate Die Casting Site, Fayetteville, NY (Site #7-34-052)
FILE: 3902.45845

This letter serves as the sixth annual *Periodic Review Report* (PRR) to document the implementation of, and compliance with, Site Management (SM) requirements under the Order on Consent (#A7-0318-94-10) and the December 1994 *Record of Decision* (1994 ROD) for the Former Accurate Die Casting Site (Site) in Fayetteville, New York (Site #7-34-052) (Figure 1). This PRR is accompanied by the Site Management Periodic Review Report Notice and Institutional and Engineering Controls Certification Form (Attachment 1). The reporting period for this PRR is December 1, 2016 through November 30, 2017.

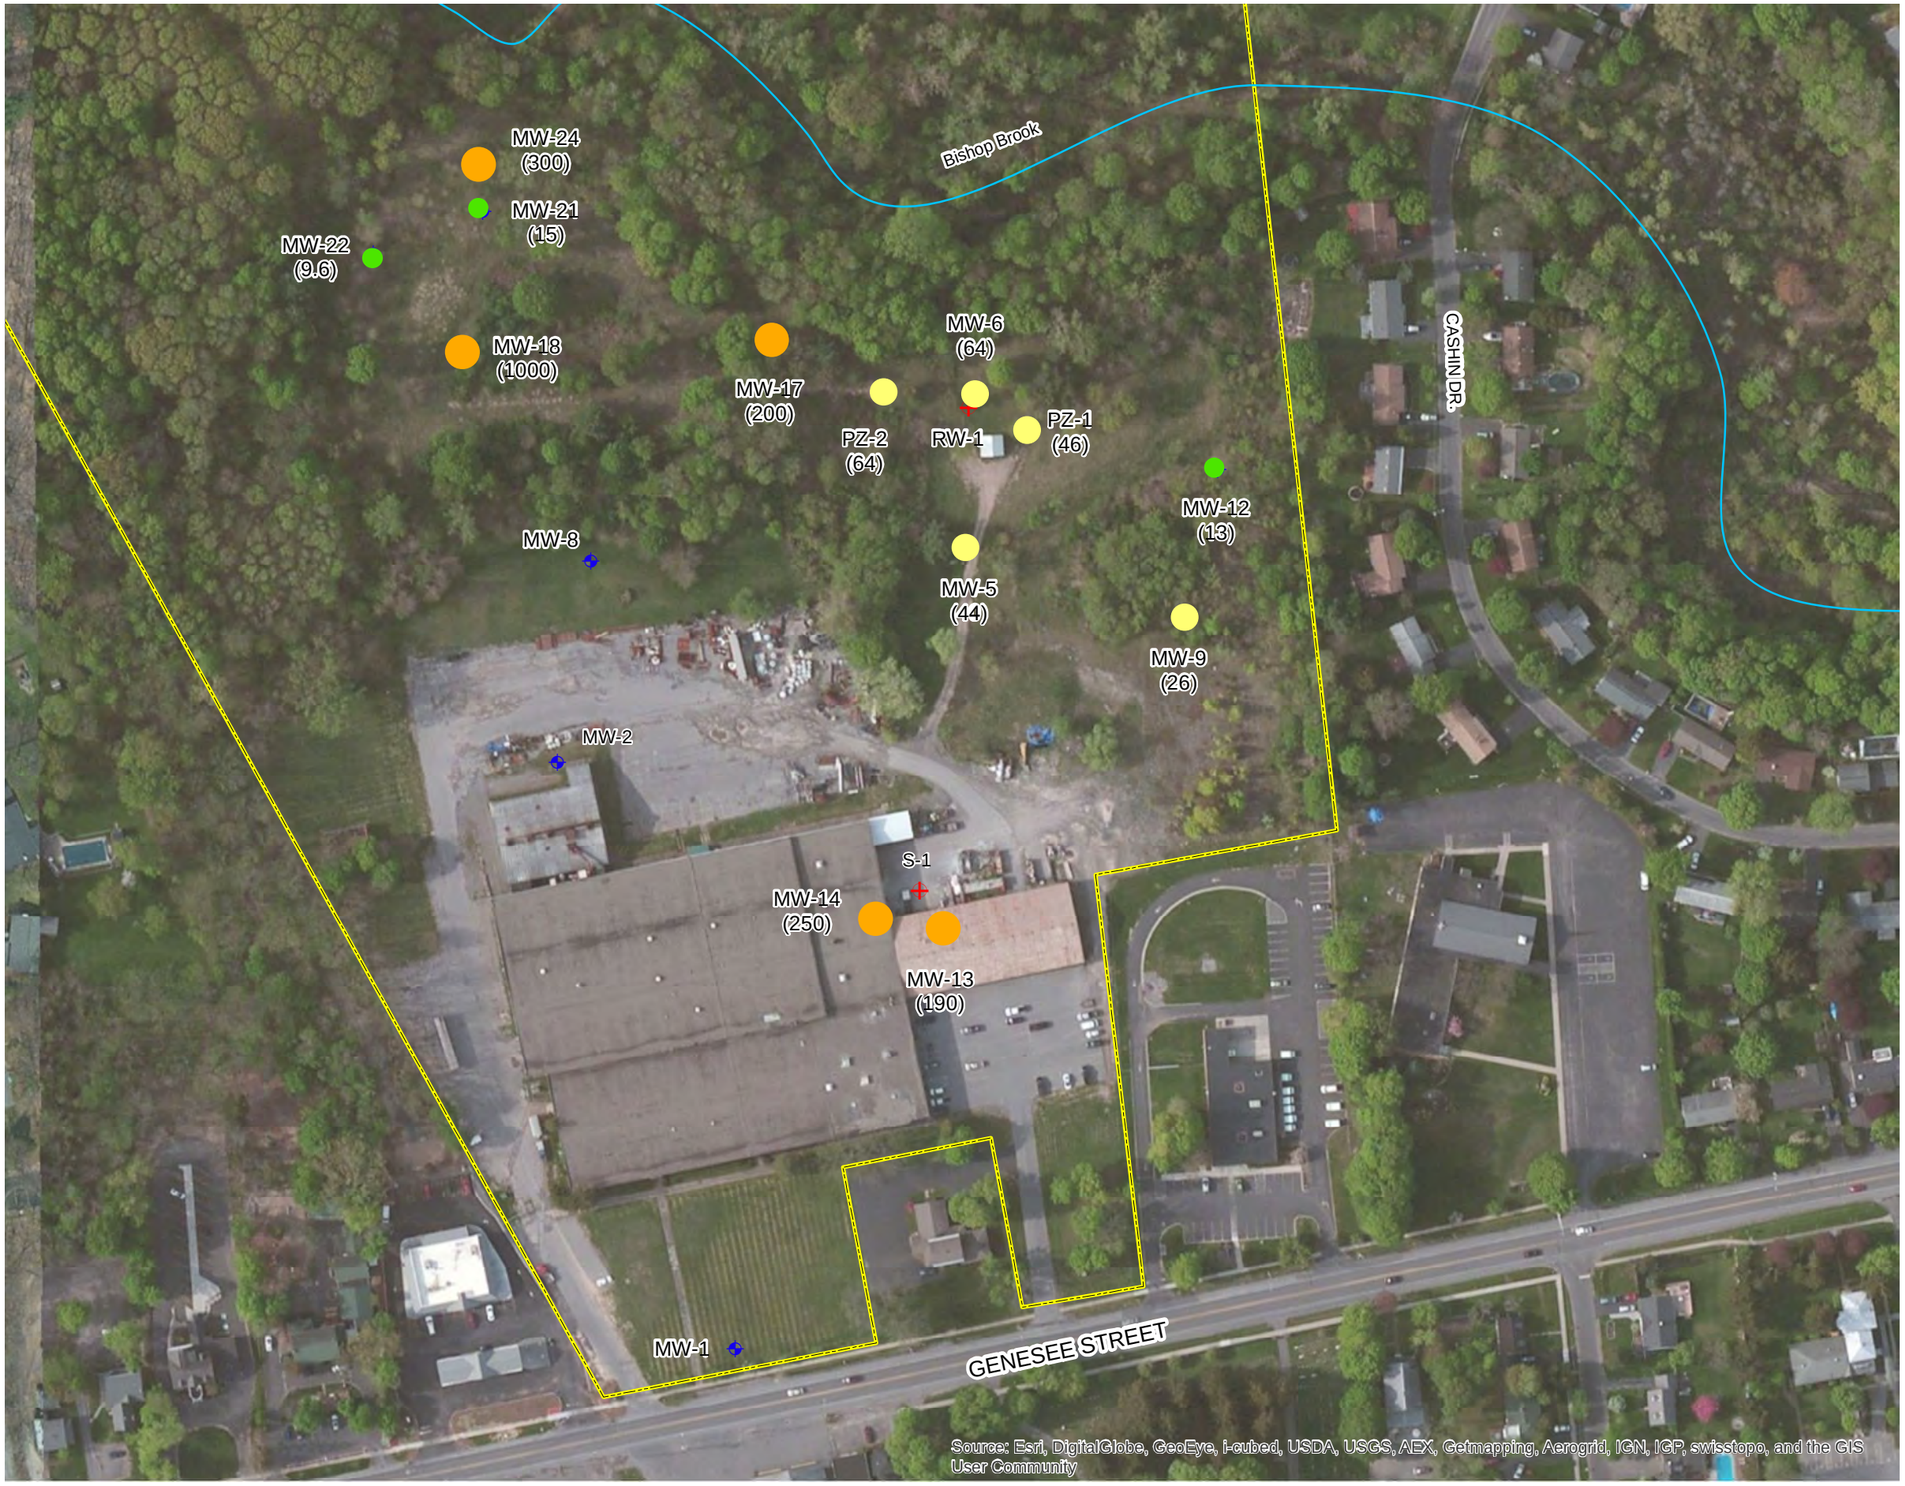
Tables 2 and 3 provide a record of the groundwater quality for the monitoring wells, and Figures 4 and 5 depict the October 2017 TCE concentrations in the overburden and bedrock groundwater respectively. There are three areas on site during October 2017 where TCE concentrations are notable.

- One area, below the existing building, is evidenced by monitoring wells MW-13 and MW-14 which exhibited TCE concentrations of 220 micrograms per liter (µg/L) and 250 µg/L respectively.
- Another area is evidenced by monitoring well MW-17 which exhibited a TCE concentration of 200 µg/L.
- The third area is evidenced by monitoring wells MW-18 and MW-24, which exhibited TCE concentrations of 1,000 µg/L and 300 µg/L respectively.

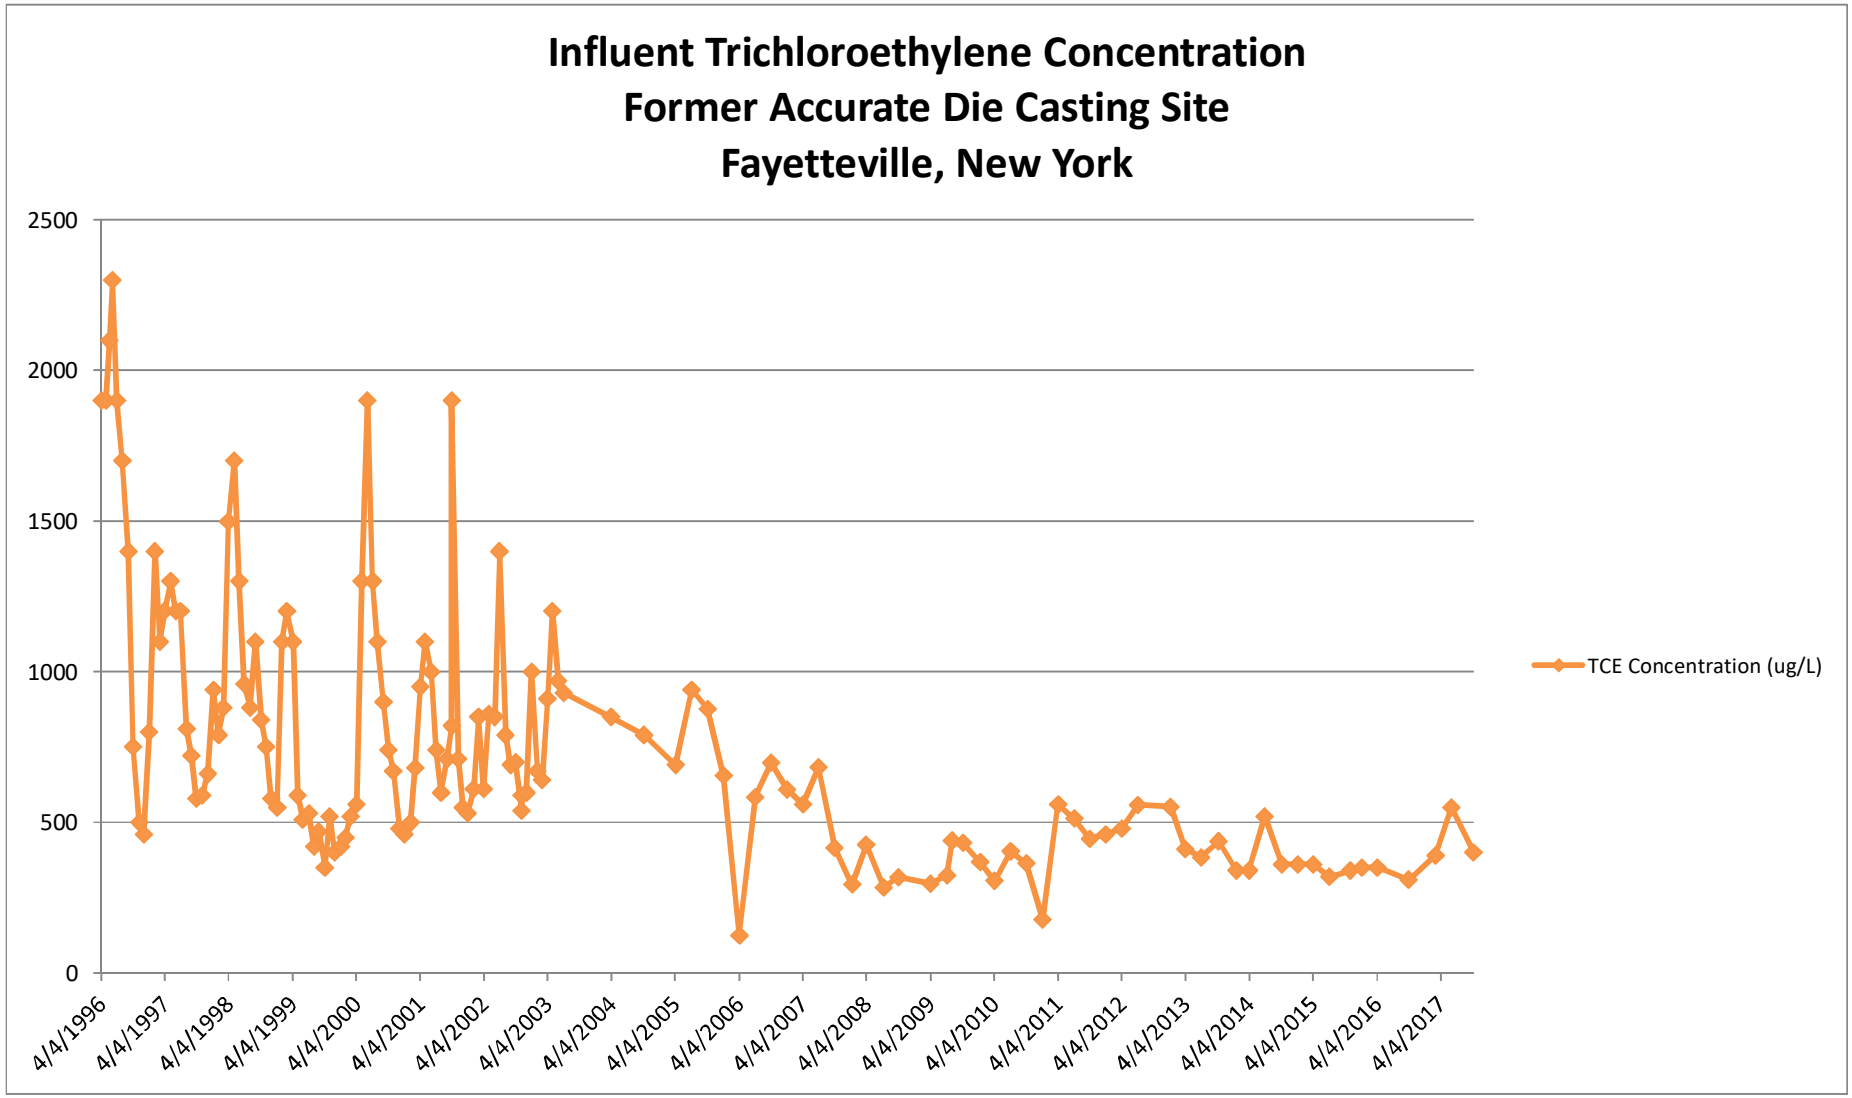
Groundwater Treatment System Influent TCE Concentration Trend Graph

Table 5 provides a summary of the influent concentrations of TCE to the System. Attachment 5 provides a graph depicting the concentrations and trend of TCE quantified at the influent of the System over time. As indicated in the trend graph, between 1997 and 2003 the TCE concentrations fluctuated, ranging between 350µg/L and 2,300 µg/L. A decreasing trend with considerably less fluctuation is observed after 2003.
