SITE ID 249: SOLVENTS & PETROLEUM SERVICE, INC.

SITE SUMMARY REPORT
REVISION 2

Onondaga Lake Project
Task 5: 104(e) Review

Site No. 734030-002
Work Assignment Number D003060-9

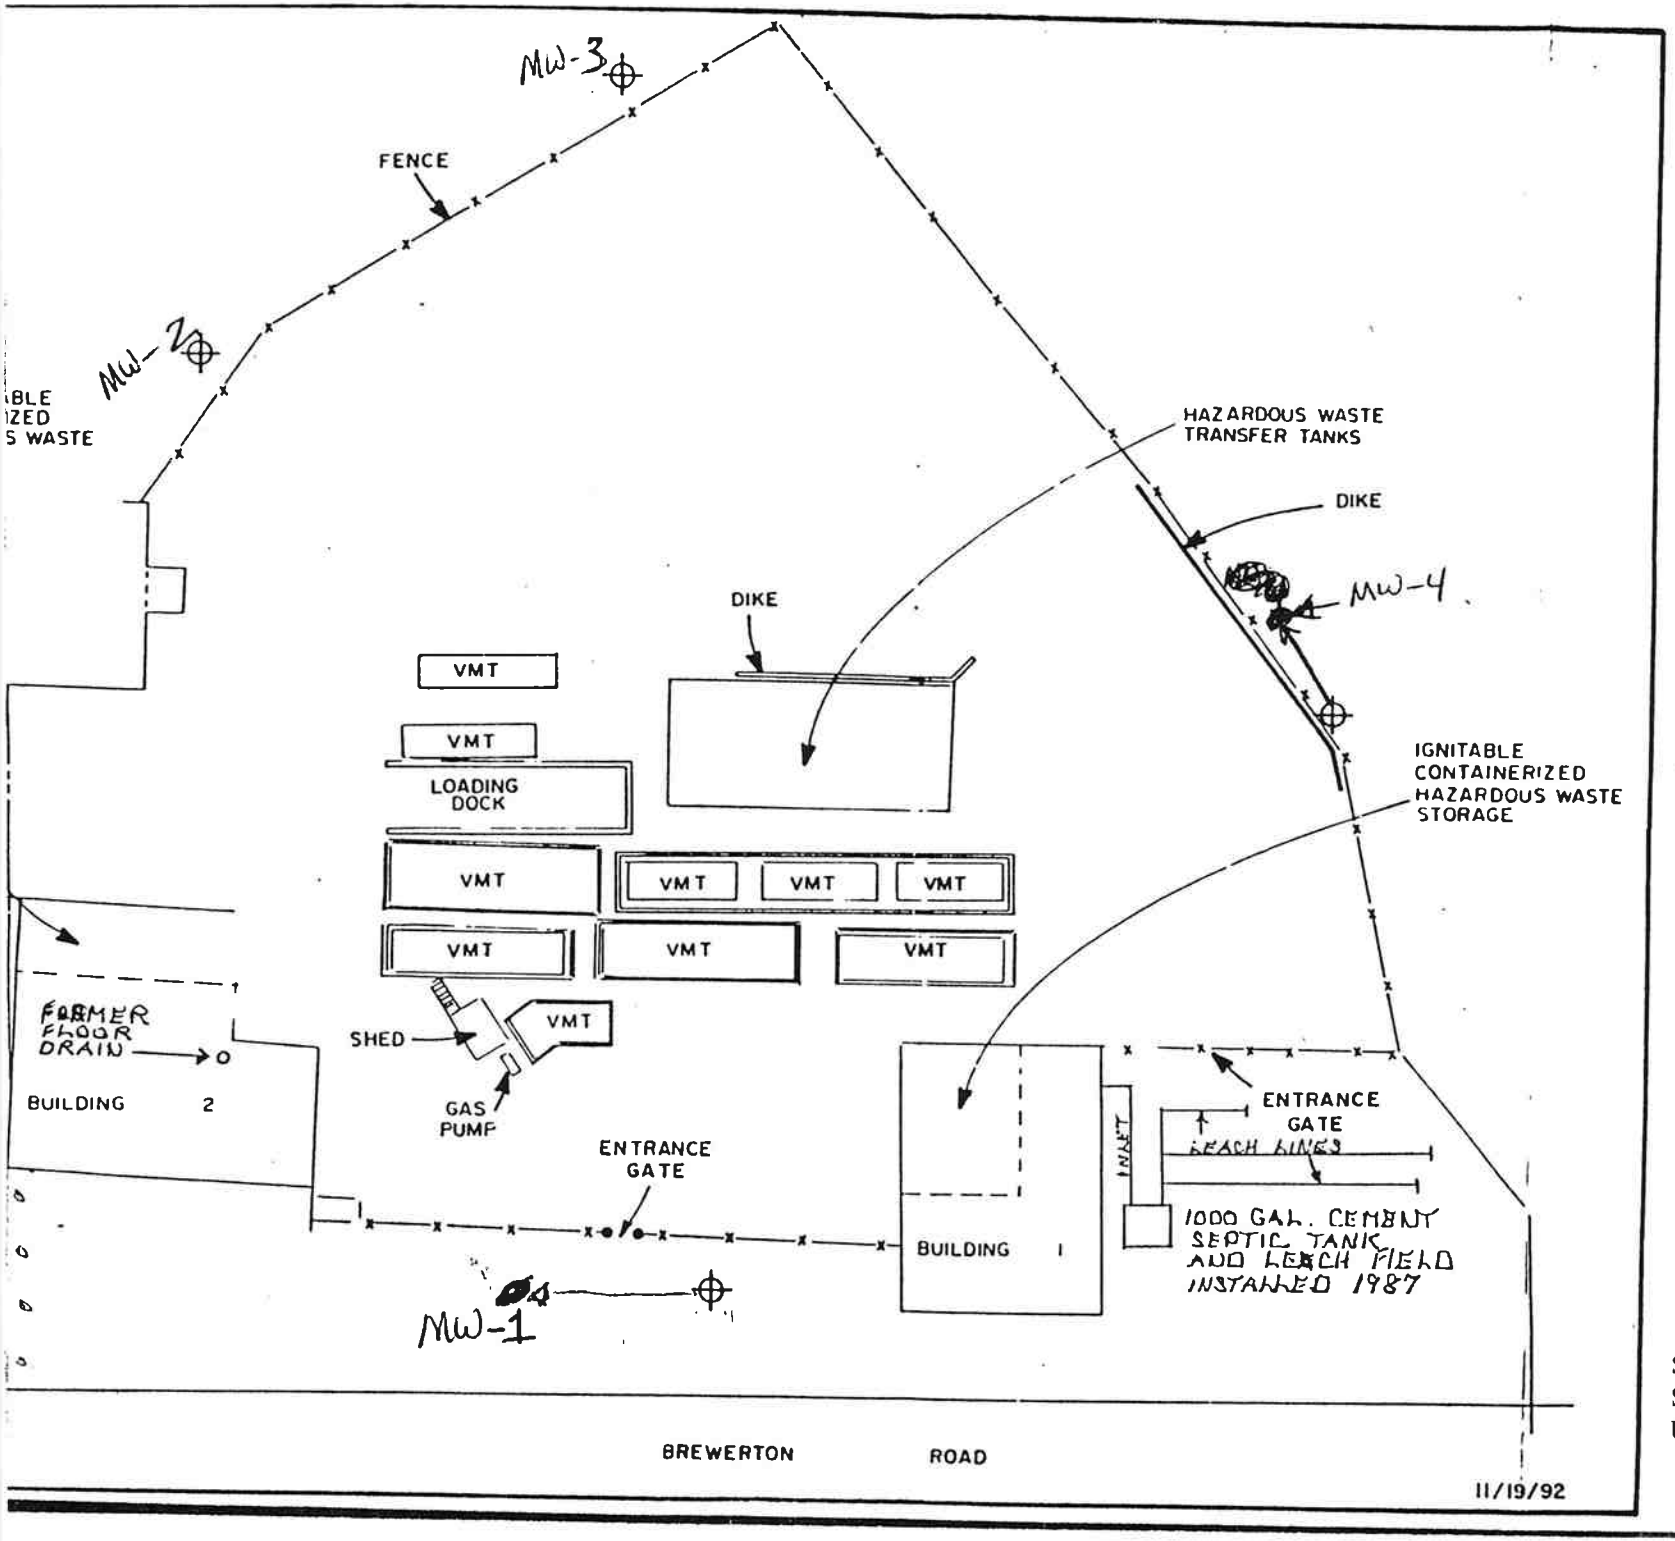
FIGURE 2

The SPS facility is located at 1405 Brewerton Road, in the Town of Salina, Onondaga County, New York. The location of the SPS facility in relation to Onondaga Lake is shown in Figure 1. A detailed site map is included as Figure 2. This map was included as Attachment 2 in the SPS Supplemental Response dated February 2, 1996 (p. 000277) and has been updated by NYSDEC personnel to indicate the final locations and designations of the four monitoring wells.
