Re: RCRA Sampling - Former Foster Wheeler Energy Corporation Plant
North Dansville, Livingston County, New York
EPA Identification No. NYD002205599

Re: RCRA Sampling
Former Foster Wheeler Energy Corporation Plant
9431 Foster Wheeler Road; Dansville, New York 14437
LaBella Project No. 205239.01

SUPPLEMENTAL PHASE II ENVIRONMENTAL STIE ASSESSMENT

SITE MAP AND SAMPLING LOCATIONS

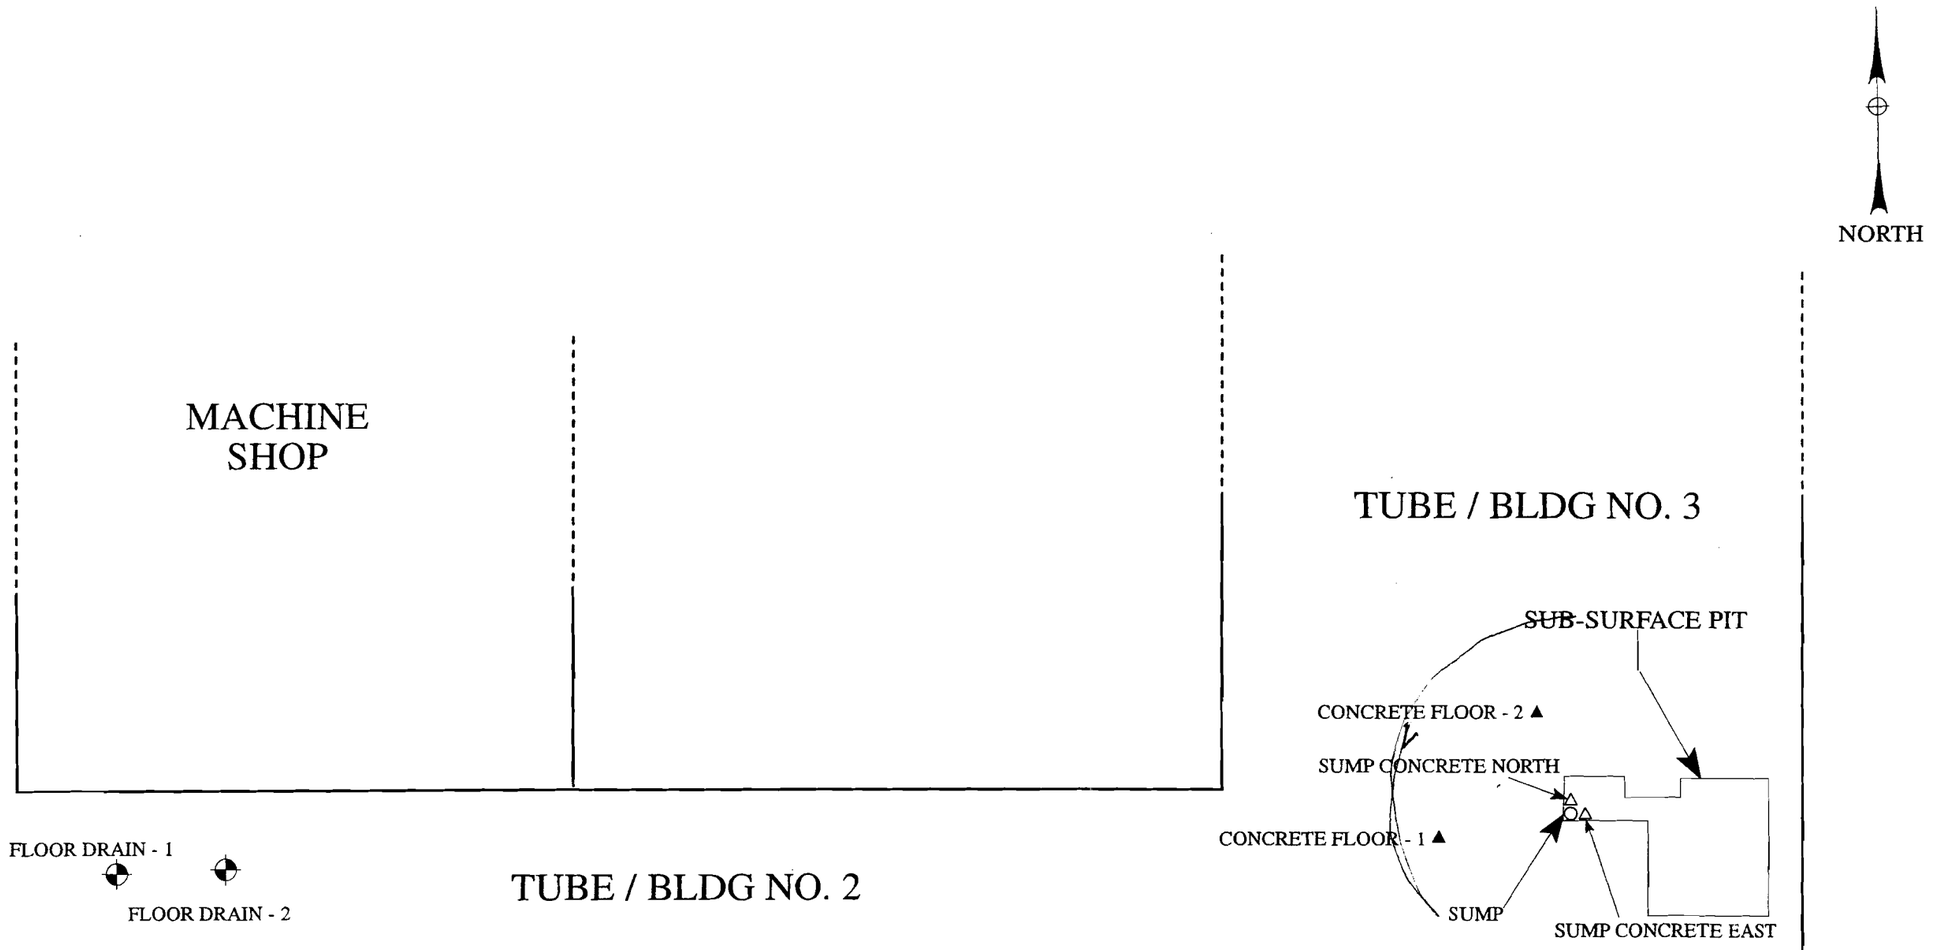
[FIGURE 1]

The approximate sample locations are shown on Figure 1 attached.

One PCB (Aroclor 1248) was detected above the reported laboratory detection limits in the two concrete samples collected from the area of staining within Tube 3 on December 30, 2005. However, the detected concentrations are 0.716 and 0.740 milligrams per kilogram (mg/Kg) or parts per million (ppm), are below the NYSDEC Technical and Administrative Guidance Memorandum (TAGM) 4046 recommended soil cleanup objective (RSCO) of 1 mg/kg for surface soils. In addition, the recently released Brownfield Cleanup Program (BCP) Guide draft Technical Support Document dated November 2005 includes Soil Cleanup Objectives (SCOs) for PCBs. The BCP Guide references an SCO for PCBs of 1 ppm for unrestricted use sites and an SCO for PCBs of 25 ppm for industrial sites. As such, the detected concentrations of PCBs in the concrete samples are below these applicable and relevant cleanup criteria. [*Note: Although these criteria are intended for soils, the 1 mg/kg is a conservative cleanup value for concrete.*]

The two concrete samples collected on March 7, 2006 from within the Tube 3 pit in proximity to the sump did not detect concentrations of PCBs above the reported laboratory detection limits.

Sediment sample Tube 2/Floor Drain-2 detected one VOC (m,p-Xylene) at a concentration slightly above the reported laboratory detection limits; however, the concentration detected is below NYSDEC recommended soil cleanup objectives (RSCOs) referenced in Technical and Administrative Guidance Memorandum (TAGM) 4046 as amended by supplemental tables dated August 22, 2001. Sediment sample Tube 2/Floor Drain-1 detected several petroleum related VOCs, as well as acetone and 2-

butanone at concentrations above the reported laboratory detection limit. The concentrations of xylenes, acetone, 2-butanone, and total VOCs exceed the NYSDEC RSCOs. Since some elevated petroleum VOCs were detected in sediment sample Tube 2/Floor Drain-1, this sample was also tested for ignitablity using USEPA method 1010 in order to confirm that the sediment is not a characteristic hazardous waste due to ignitability. The laboratory report indicated a flashpoint >70°C; therefore, the sediment is not a characteristic hazardous waste.

The two sediment/grit samples collected from Drain 1 and Drain 2 in Tube 2 on March 7, 2006 and tested for PCBs did not detect concentrations of PCBs above the reported laboratory detection limits.

Based on the above, additional sampling in relation to RCRA issues does not appear warranted. Furthermore, it is recommended that this letter be submitted to the NYSDEC and be petitioned to remove the Facility from listings as an active RCRA generator and RCRA TSD facility.
