Interim Remedial Measure
Sampling Report and Excavation Delineation

Dearcop Farm Site
Residential Lot Area
Town of Gates, Monroe County
Site Number 8-28-016

October 1995

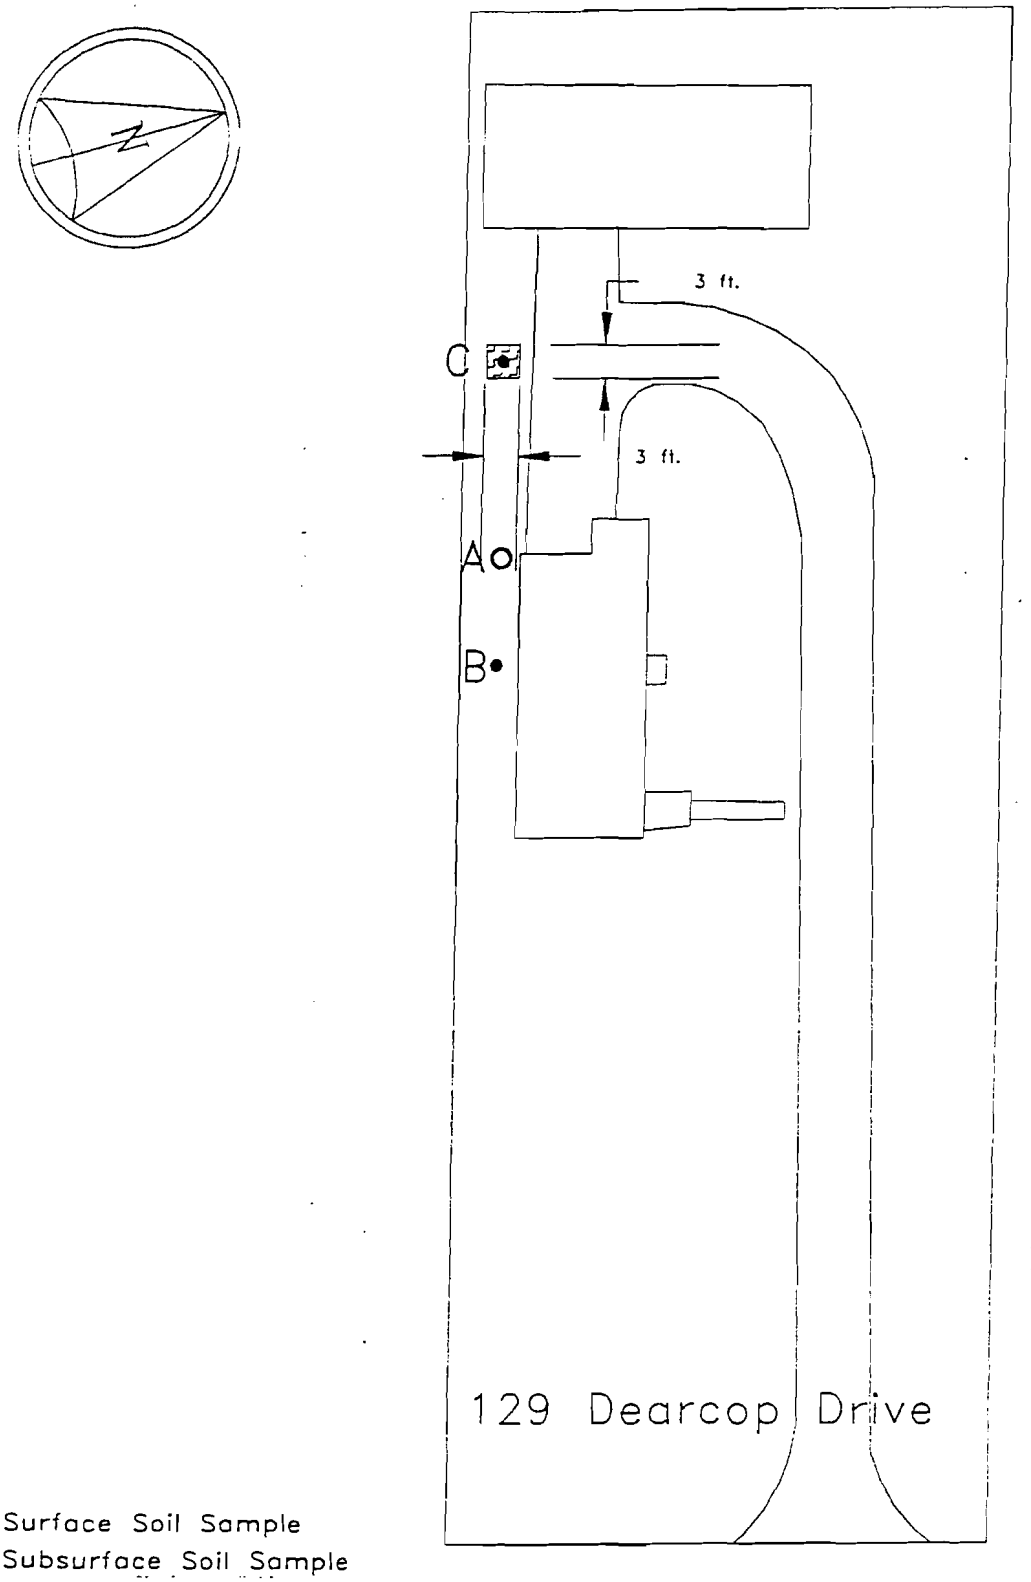
Drawing Not to Scale Figure 1

One sample's analytical result, from 129 Dearcop Drive, (DEAR 129C, 655 ppm lead) was above the site specific cleanup objective for lead. This sample was taken north of the driveway between the house and the garage at approximately 15 inches to 18 inches below ground surface (BGS).

129 Dearcop Drive was sampled at the homeowners request. Only one (1) sample, that was analyzed for lead and cadmium was above site specific cleanup objectives. No other samples, from this lot from any other sampling event, were above site specific cleanup objectives. Since only this sample's concentration was above site specific cleanup objectives, approximately 1 cubic yard of soil/fill material will be removed from 129 Dearcop Drive in the area of sample DEAR 129C (see figure 1). Although the one sample result is only marginally above the cleanup objective (i.e. 655 vs 400 ppm lead (Pb)) and could be the results of variability of sampling techniques or of the material, at this point is believed that a relatively simple removal of this material from the site could resolve the problem. The removal will be approximately 3 ft. long by 3 ft. wide and 3 ft. deep. After the initial removal, confirmatory samples will be taken to ensure that all soil/fill material that is above site specific cleanup objectives is removed from this area.

- Approximately 1 cubic yard of soil/fill material will be removed from 129 Dearcop Drive in the area of sample DEAR 129C (see figure 1). The removal will be approximately 3 ft. long by 3 ft. wide and 3 ft. deep.

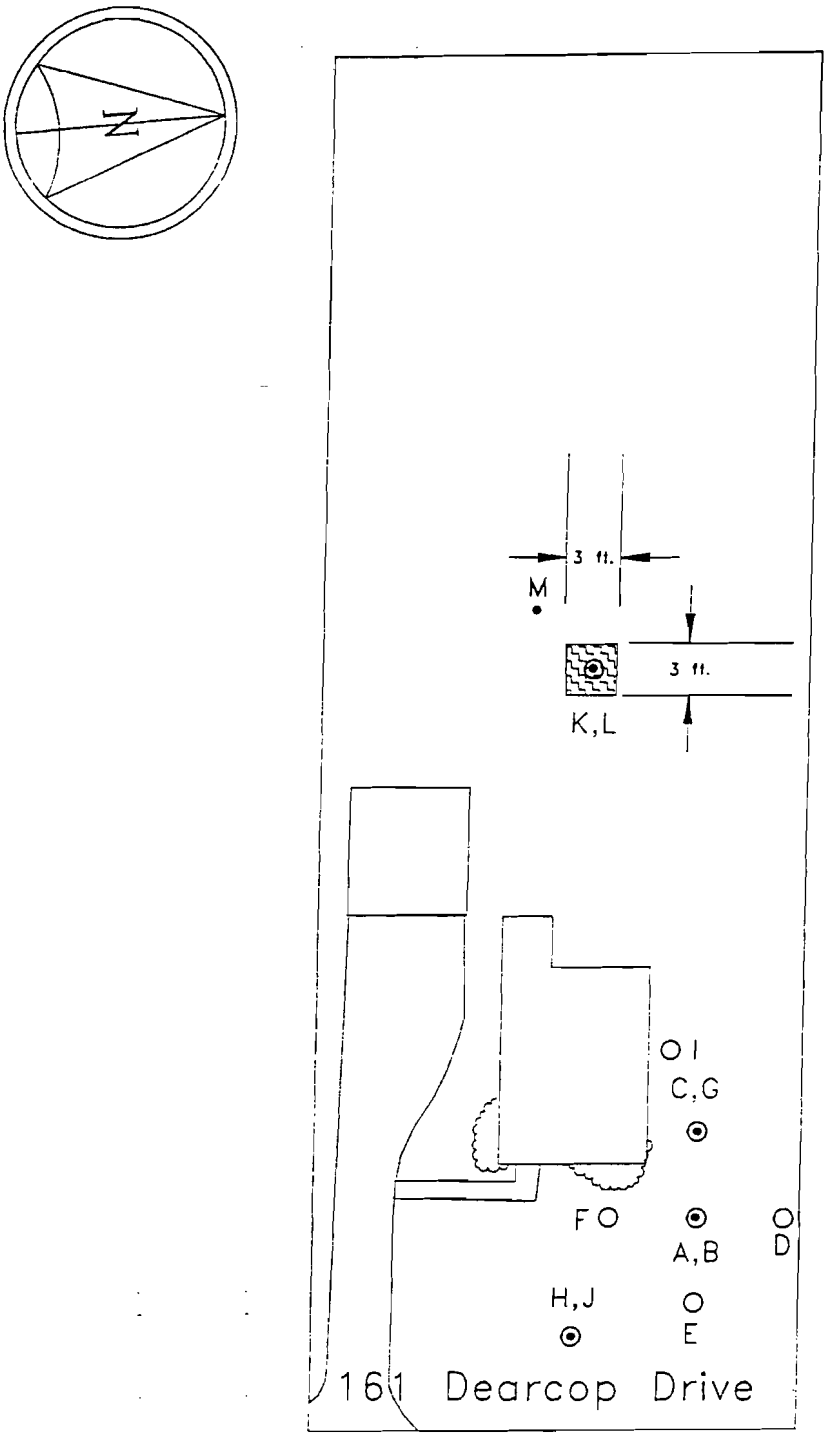
Figure 2

One sample's analytical result, from 161 Dearcop Drive, (DEAR 161K, 604 ppm lead, 15 ppm cadmium) was above site specific cleanup objectives for both lead and cadmium. This sample was a surface soil sample taken from an area of distressed vegetation in the western portion of the lot. This sample location was brought to the Department's attention by the homeowner.

Additional samples were taken in the backyard of this lot at the homeowners request. One of these samples DEAR 161K was above site specific cleanup objectives for both lead and cadmium. Since this samples concentration was above site specific cleanup objectives, approximately 1 cubic yard of soil/fill material will be removed from 161 Dearcop Drive in the area of sample DEAR 161K (see figure 2). Although the sample result is only marginally above the cleanup objectives (i.e. 604 vs 400 ppm Pb and 15 vs 10 ppm Cd) and could be the results of variability of sampling techniques or of the material, at this point is believed that a relatively simple removal of this material from the site could resolve the problem. The removal will be approximately 3 ft. long by 3 ft. wide and 3 ft. deep. After the initial removal, confirmatory samples will be taken to ensure that all soil/fill material that is above site specific cleanup objectives is removed from this area.

- Approximately 1 cubic yard of soil/fill material will be removed from 161 Dearcop Drive in the area of sample DEAR 161K (see figure 2). The removal will be approximately 3 ft. long by 3 ft. wide and 3 ft. deep.

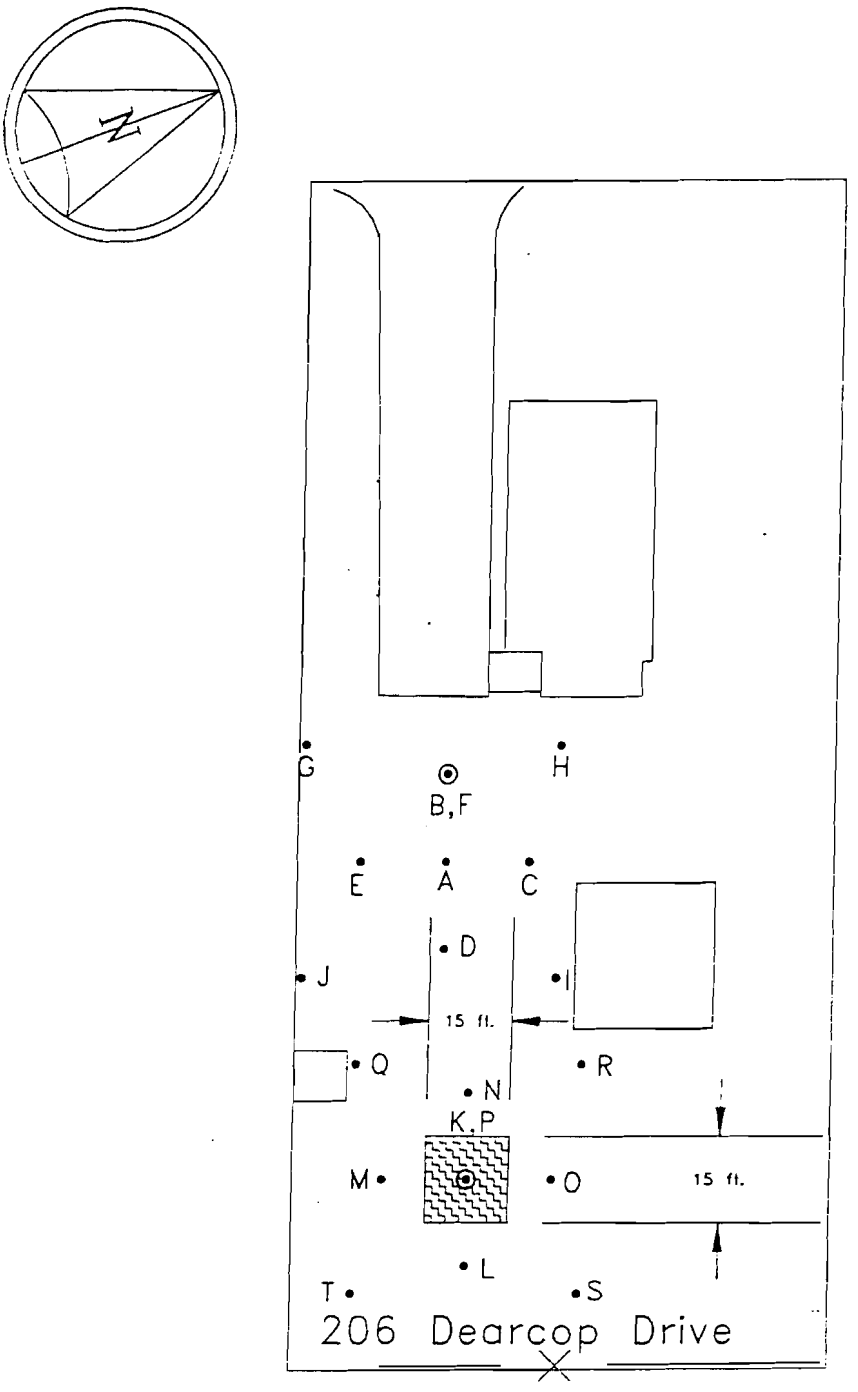
Drawing Not to Scale Figure 3

Two samples' analytical results, from 206 Dearcop Drive, (DEAR 206K, 1350 ppm lead

and DEAR 206P, 444 ppm lead) were above the site specific cleanup objective for lead. Sample DEAR 206K was a subsurface soil sample taken at 2 ft. below ground surface (BGS) from the approximate location of a previous sample whose result was above site specific cleanup objectives. Sample DEAR 206P was a subsurface soil sample taken at approximately 10 inches BGS from same geographic location. These two samples were surrounded by four subsurface samples that were below site specific cleanup objectives.

Samples DEAR 206K and DEAR 206P were taken at the approximate location of the Phase II and Phase III RI samples that were above site specific cleanup objectives for lead. Both DEAR 206K and DEAR 206P were above site specific cleanup objectives for lead. These samples were surrounded by eight (8) samples that were below site specific cleanup objectives. Since DEAR 206K and DEAR 206P confirmed the presence of soil/fill material above site specific cleanup objectives approximately 25 cubic yards of soil/fill material will be excavated

from 206 Dearcop Drive in the area of these samples. The removal should be approximately 15 ft. long by 15 ft. wide and 3 ft. deep. After the initial removal, confirmatory samples will be taken to ensure that all soil/fill material that is above site specific cleanup objectives is removed from this area.

- Approximately 25 cubic yards of soil/fill material will be excavated from 206 Dearcop Drive in the area of samples DEAR 206K and DEAR 206P. The removal should be approximately 15 ft. long by 15 ft. wide and 3 ft. deep. The area of the removal was calculated by; 1. plotting the locations of the samples DEAR 206K and DEAR 206P on a map of lot 206 Dearcop Drive along with the location of the samples, and 2. drawing the limits of the excavation around samples DEAR 206K and DEAR 206P which were half way between these samples and the surrounding samples which were below site specific cleanup objectives.

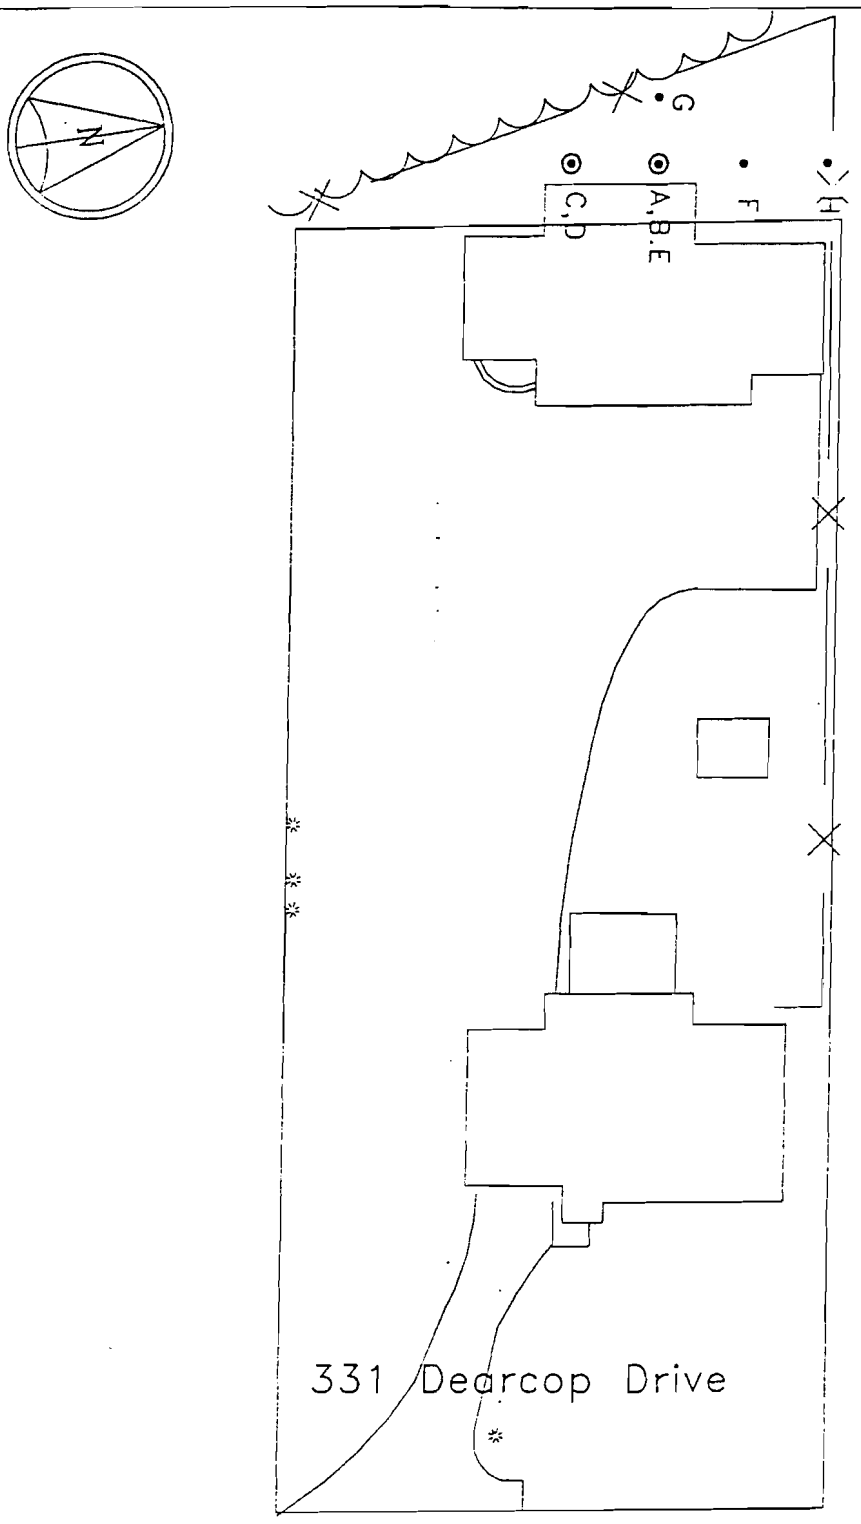
Figure 4

No samples' analytical result from 331 Dearcop Drive were above site specific cleanup objectives for lead or cadmium. Confirmatory sampling in areas that had previously shown concentrations of lead above site specific cleanup objectives showed that the concentrations, present in these locations, are below site specific clean up objectives.

331 Dearcop Drive was sampled during this sampling event because one (1) sample taken during the Phase II RI was above site specific cleanup objectives for lead. Samples DEAR 331A, DEAR 331B and DEAR 331E were taken from the approximate location of the Phase II sample. None of these samples could confirm that the lead concentration was above site specific cleanup objectives. In addition, none of the five samples surrounding this location were above site specific cleanup objectives. This indicates that the elevated concentration was due to the variability in sampling, or of the material, and that lead concentrations, above site specific cleanup objectives, in this area are not widespread or pervasive. Since this sampling event could not confirm the presence of soil/fill material above site specific cleanup objectives, no material will be removed from this lot.

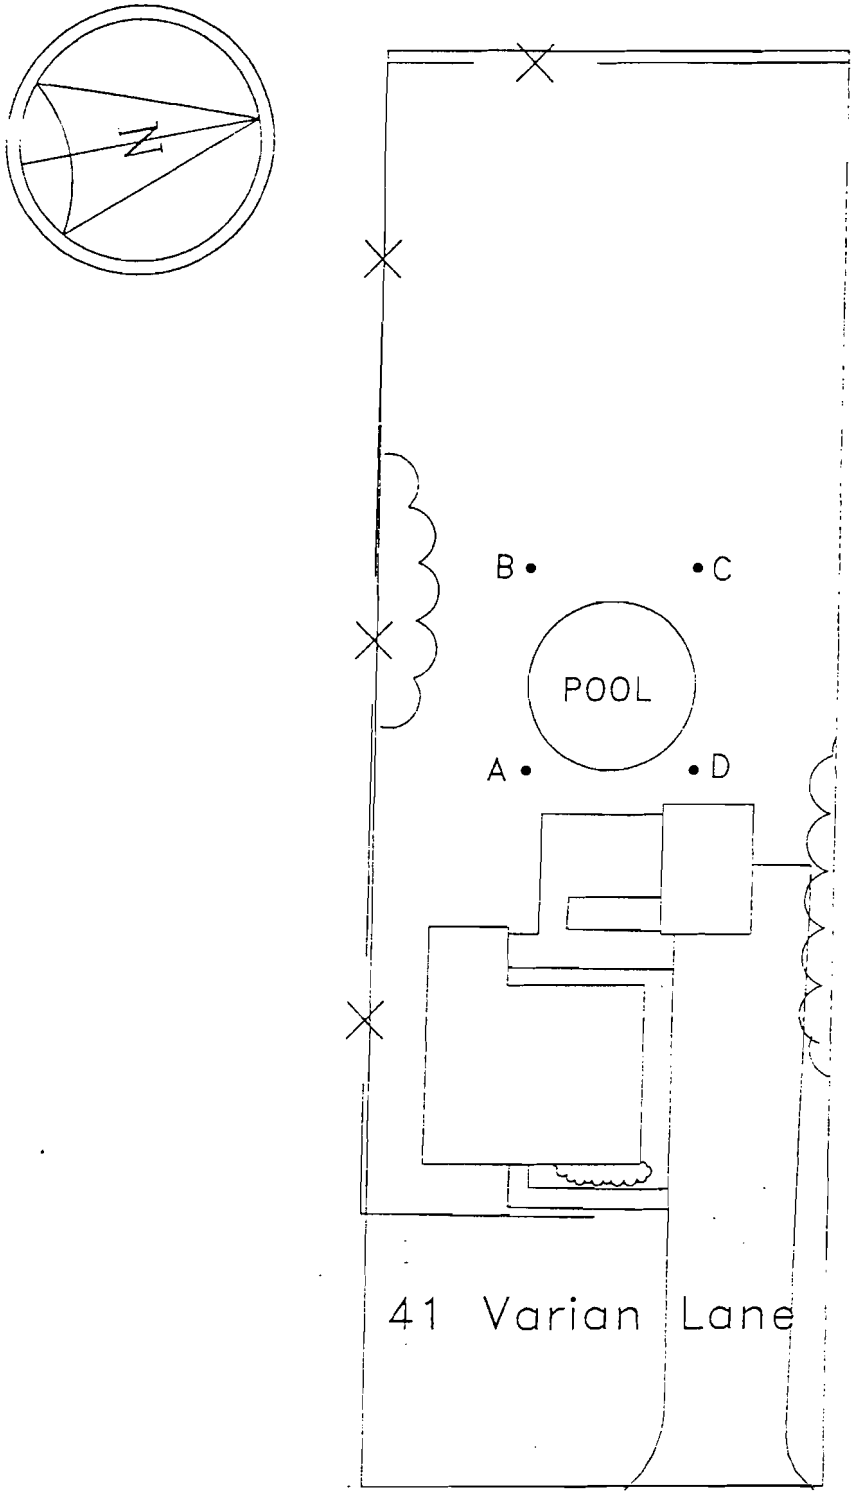
Drawing Not to Scale Figure 5

One sample's analytical result from 41 Varian Lane (VAR 41B, 835 ppm lead) was above the site specific cleanup objective for lead. This sample was a subsurface soil sample taken at 3 ft. BGS south west of the pool on this lot.

41 Varian Lane was sampled during this sampling event at the homeowners request. During the public comment period for the Proposed Remedial Action Plan (PRAP) this homeowner stated that he had encountered a large amount of fill material while installing a pool in his backyard. He also stated that, when he encountered this material he contacted the NYSDEC and asked them to sample this material and that this was never done. Four (4) subsurface soil samples were taken at this lot. Only one sample (VAR 41B) was above site specific cleanup objectives. This indicates that the elevated concentrations are due to the variability in sampling, or of the material, and that lead concentrations, above site specific cleanup objectives, in this area are not widespread or pervasive. Since, this sample was taken from 3 ft. BGS, there is presently no exposure to the contamination, therefore no soil/fill material will be removed from this lot. It is recommended that the NYSDOH recommendations to homeowners that encounter fill material in the Dearcop Drive and Varian Lane neighborhood be followed by this homeowner. Specifically, if any soil/fill material is encountered during any digging or excavation work, direct contact with the material should be avoided and that this soil/fill material should not be left exposed on the surface of the ground.

- No soil/fill material will be excavated from 331 Dearcop Drive and 41 Varian Lane.

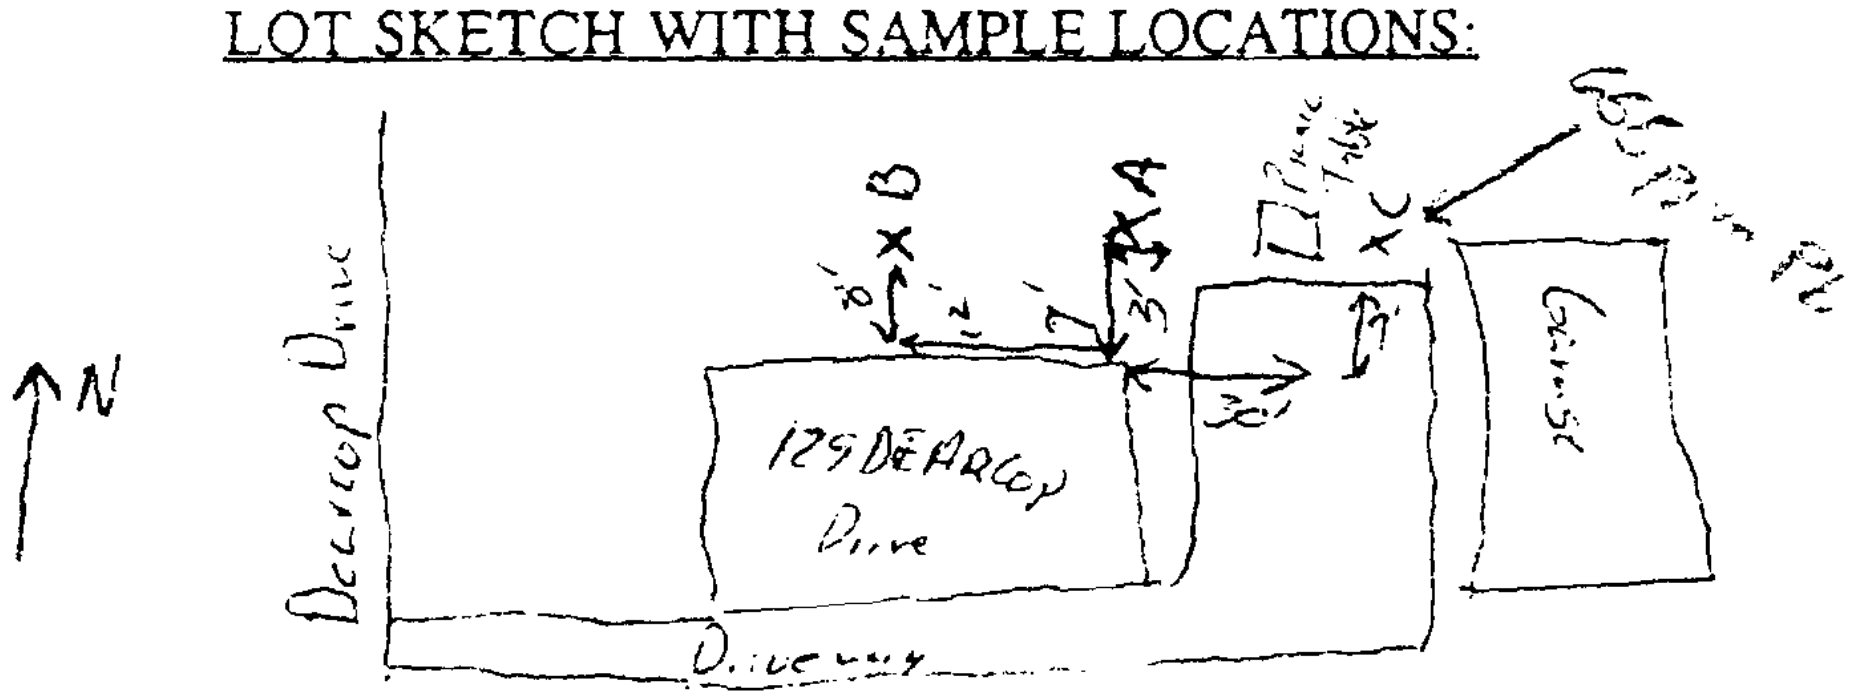
- MOISTURE CONTENT: DRY, DAMP, WET
- ODOR ?: Y or N
- FILL MATERIAL PRESENT ?: Y or N Brick and Cinders approximately 1 Ft below grade at Sample location B
  (If yes, describe the material.)
- COLOR OF SAMPLE: Brown
- SOIL TYPE: Fine to Medium Sand w/ Clay

DEAR 129 A - Surface Soil sample
DEAR 129 B - 8-12"
DEAR 129 C - 15"-18" Mostly light Brown sand
Some fill material Present Brick Rocks
Slag

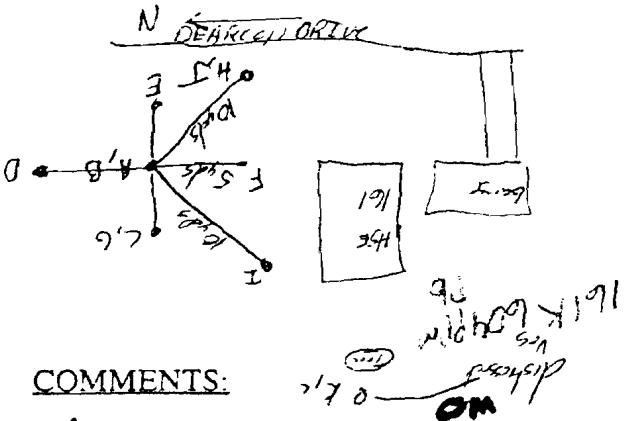
- MOISTURE CONTENT: DRY, DAMP, WET
- ODOR ?: Y or N
- FILL MATERIAL PRESENT ? Y or N – Fill Material Present
  (If yes, describe the material.) Through but the yard chunks of light Green Glass around the yar
- COLOR OF SAMPLE:
- SOIL TYPE:

A Surface Soil Green Red Chips and Soil
B 2' light Brown Sand
C Surface Soil Some Slag
D Surface Soil Sample Brown Silty Sand
E Surface Soil Sample Brown Silty Sand
F Surface Soil Sample Brown Silty Sand
G 2' Some Slag Evident
H. Blue Green Material ~15"
I 2' Some Slag Foundry Sand Right At 2' Approximately ½' of Foundry Sand
J. 2' Orange Pearl Color Some Slag
K Surface Soil Grey Material
L Subsoil 24" deep orange sand slag
M 6" deep Foundry sand orange/ Glass

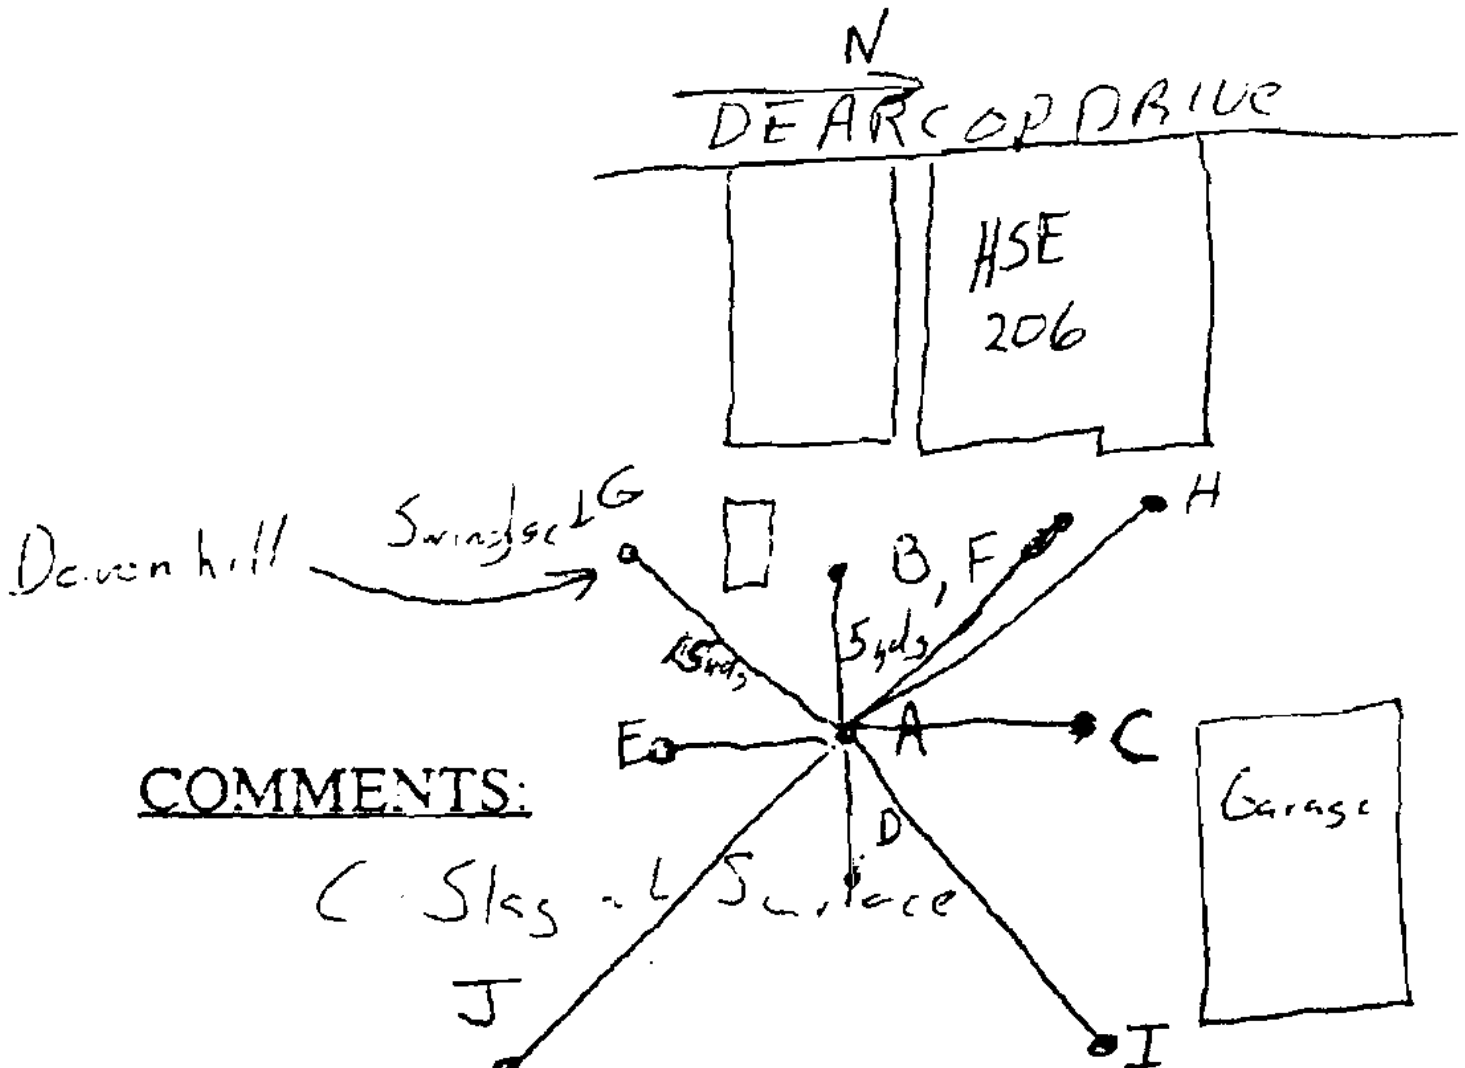
Large Rocks Encountered at each Sample Point Approximately 1 ft in depth. Top 6 inches May Be old Drive way at A, B, C, D, F

C Slag at Surface

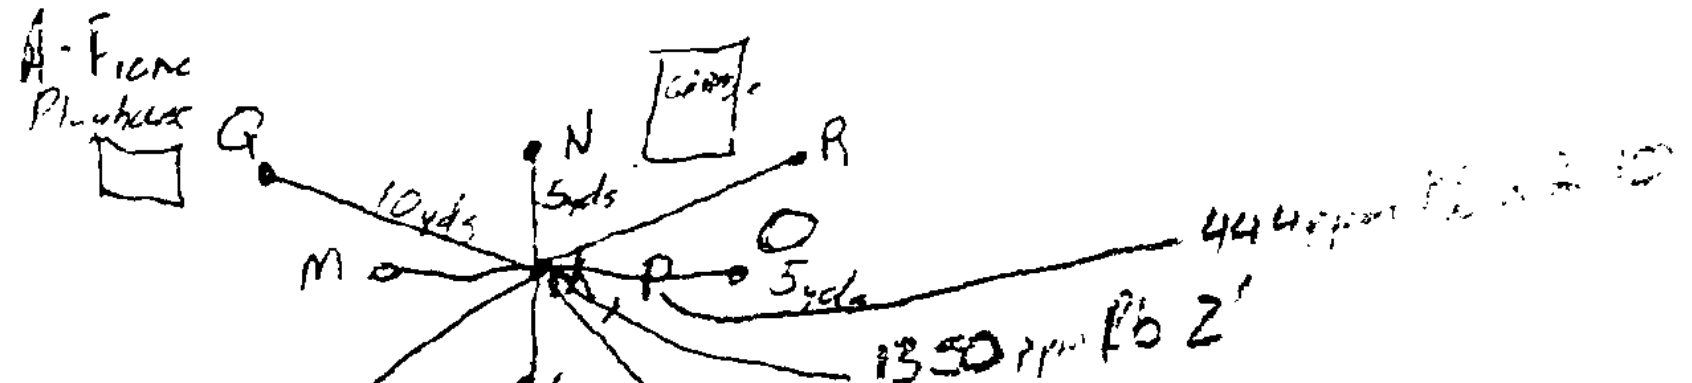
K 2' Orange colored Sand Glass, Slag

L 2' ~~[illegible]~~ White Black Orange and Green Sand Pieces of wire

O 2' Blue Green Material Orange and Black Sand

R 2' Sample had White and Black sand mostly Dirt Went Through Orange and Black Sand layer

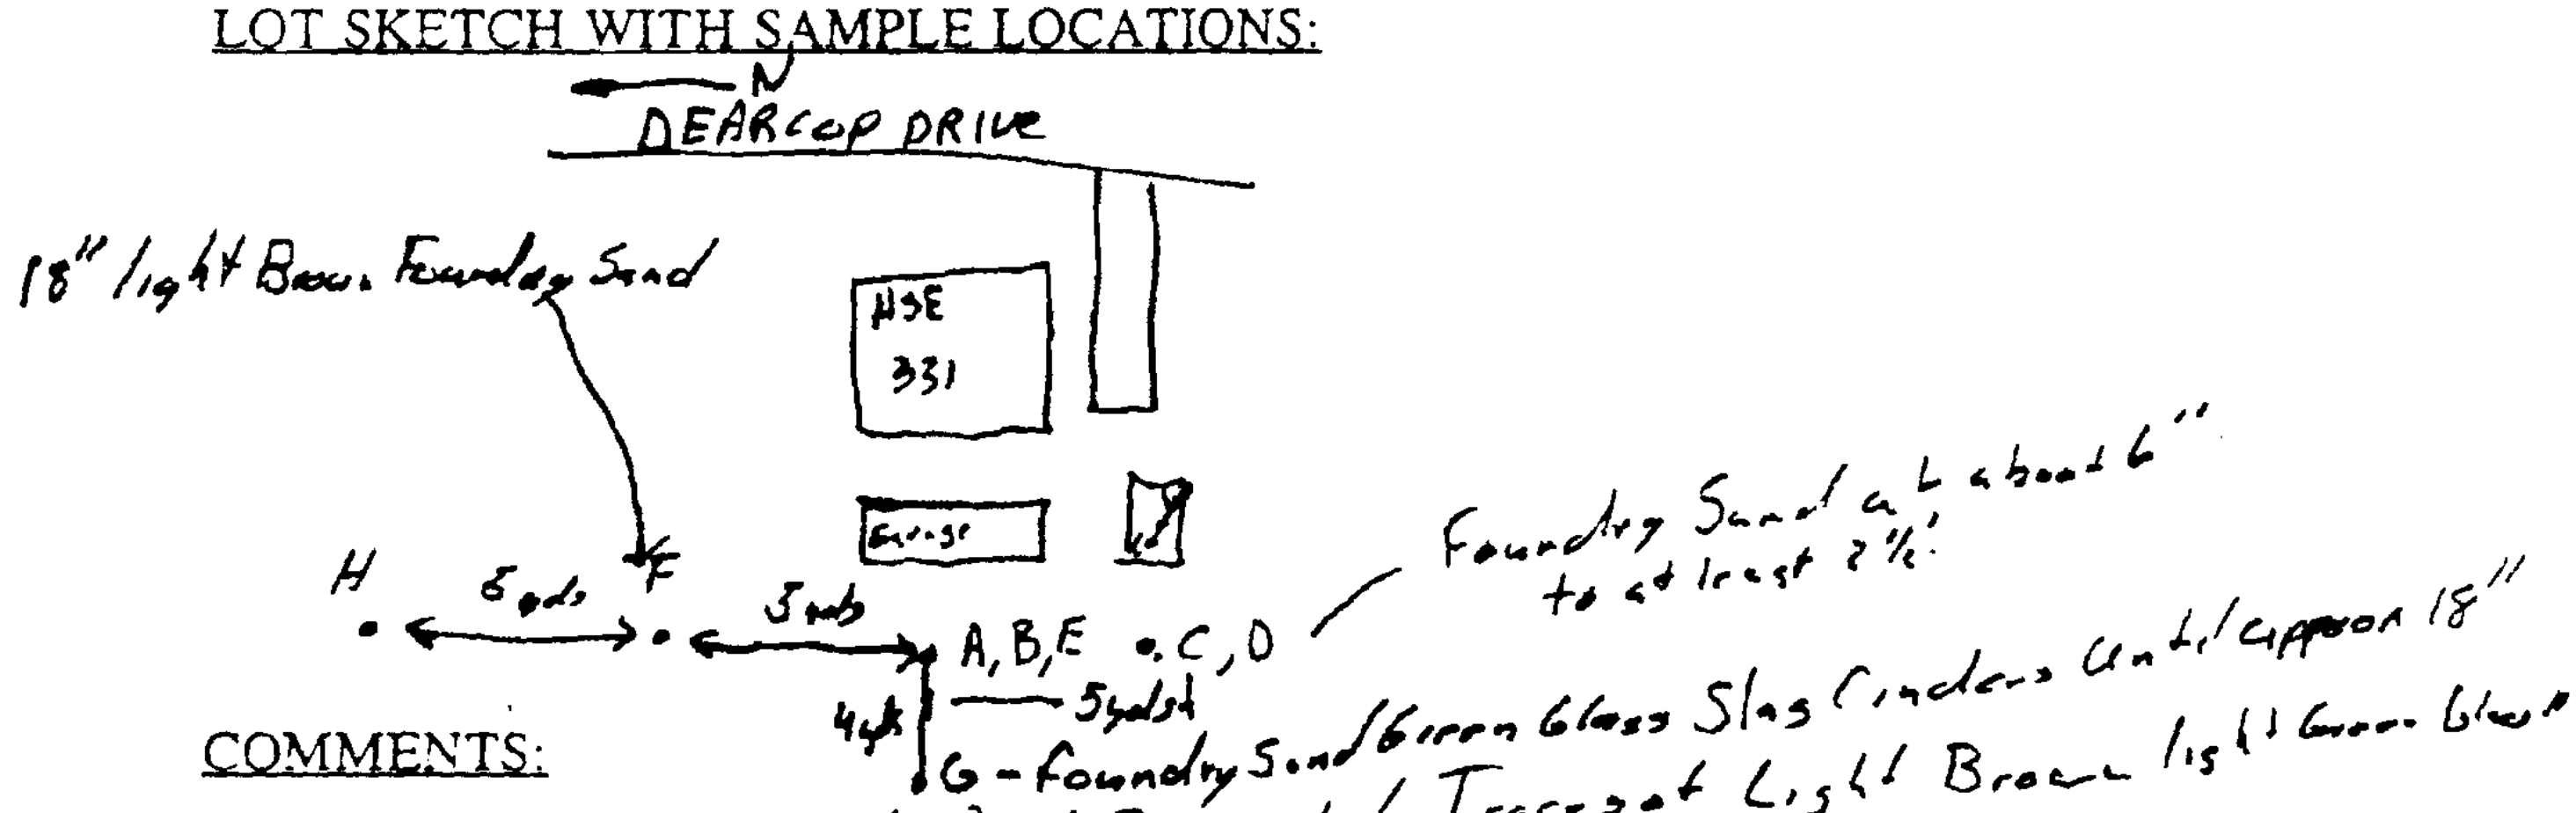
- MOISTURE CONTENT: DRY, (DAMP), WET
- ODOR ?: Y or (N)
- FILL MATERIAL PRESENT ?: Y or N
  (If yes, describe the material.) Slag and Cinders Present Throughout Back lot
- COLOR OF SAMPLE:
- SOIL TYPE:

B 18" Cinders and Slag, 2' looks like regular soil

D 2' Virgin Foundry Sand Cinders Slag

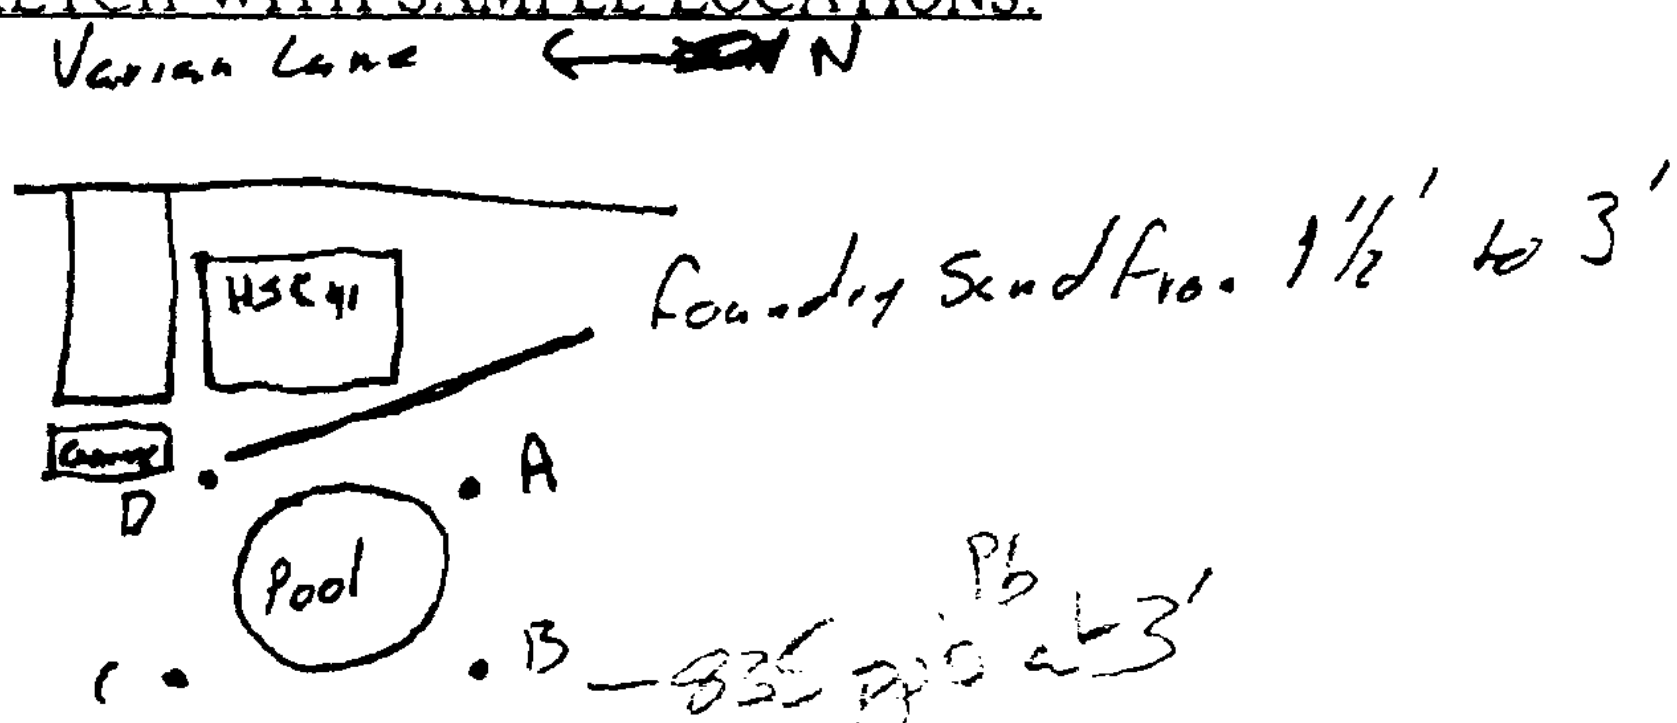
A 2' Mostly Dirt on top Foundry Sand at 2'

B 3' Pieces of Glass Brown and Orange [redacted] Soil Fill (wire) From 2-3'

C 1½' Black foundry Sand w/ some White material out of material By 2'

D 2' Medium Brown Foundry Sand
