Phase II and Phase IA Remediation Results

The Gleason Works Department No. 64

1000 University Avenue
Rochester, New York

Galson Project Nos. GI-113.01, GI-113.02, and GI-113.99

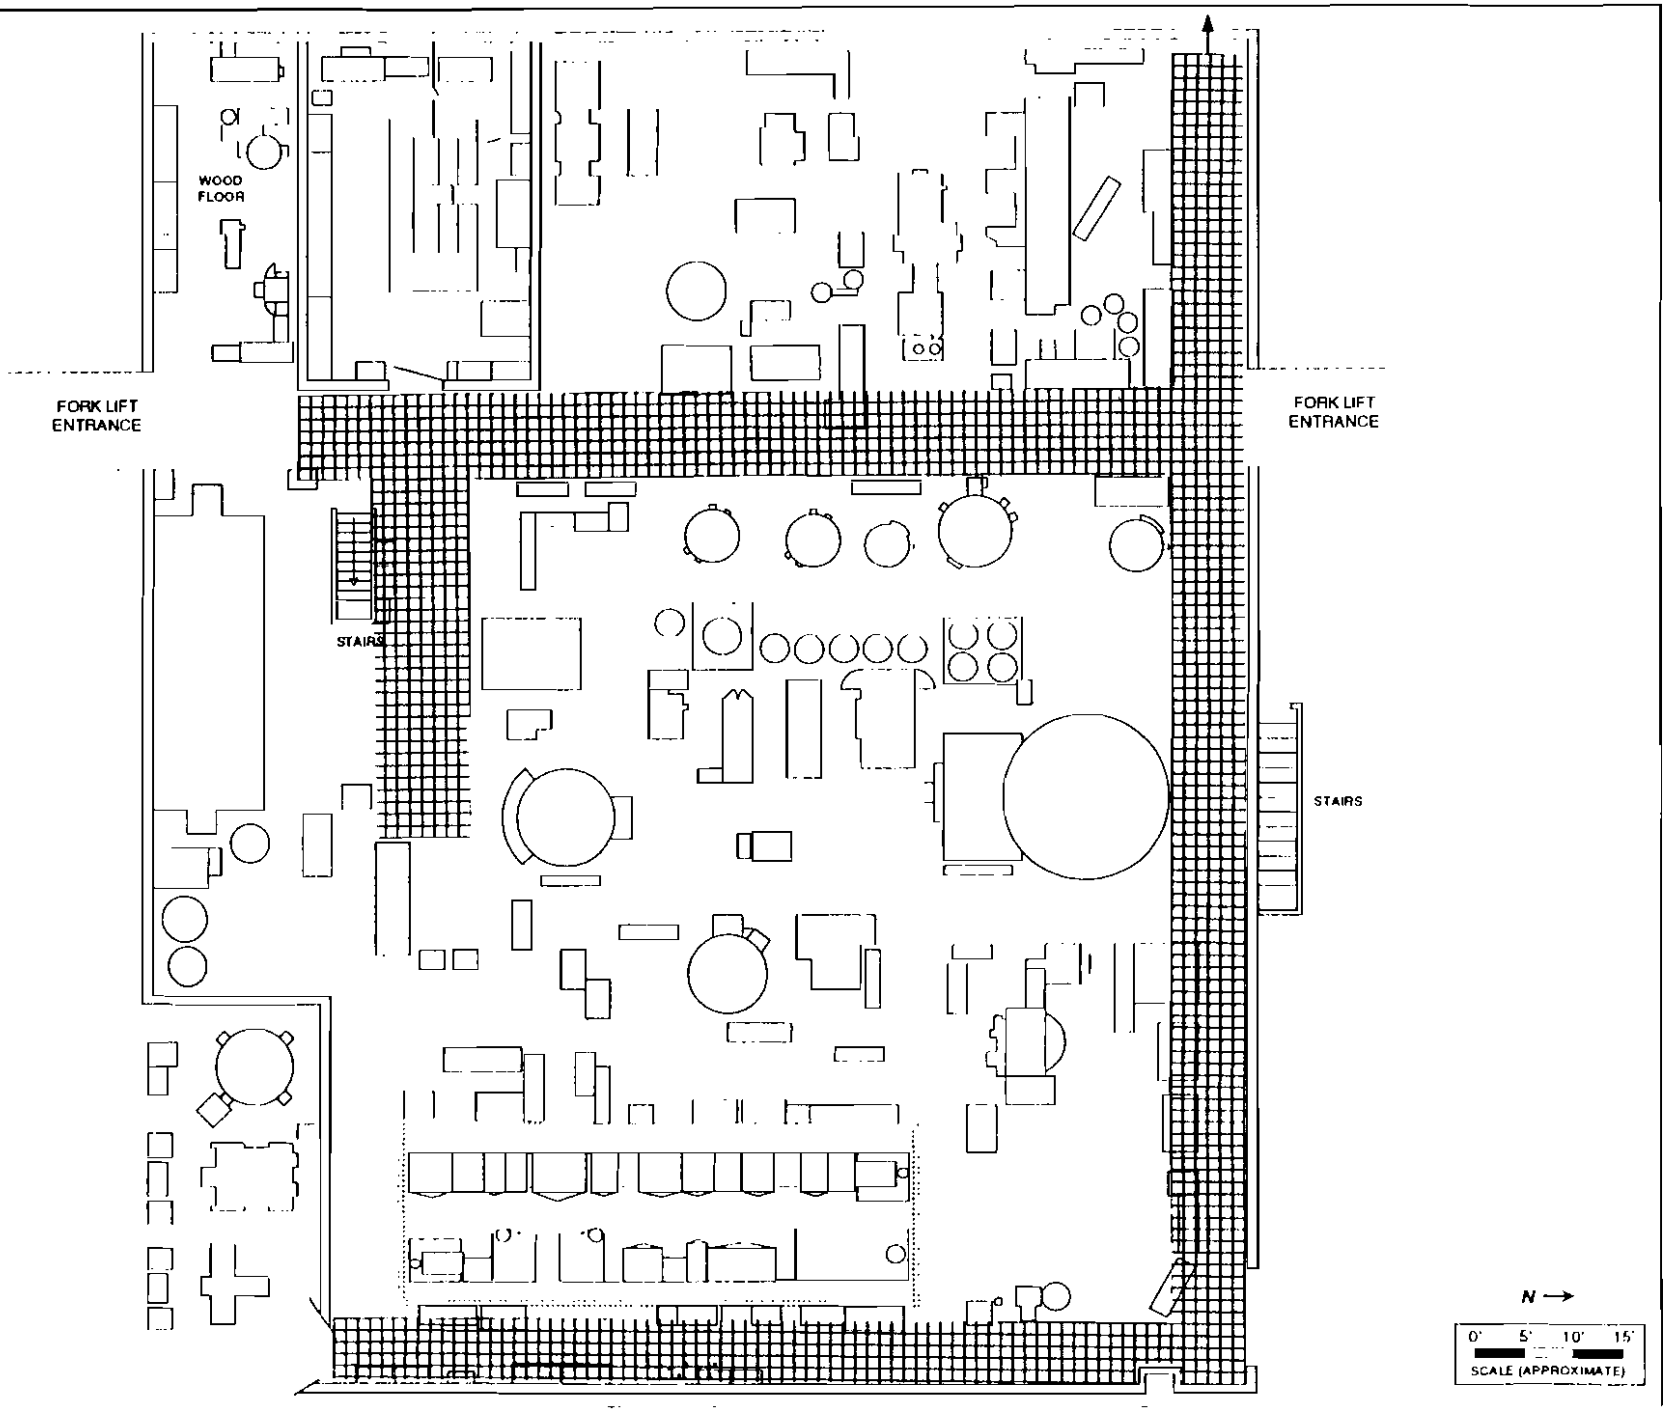
Diagram 1

Two variations of the Silikal R13 acrylic flooring shall be installed; the first incorporating a two-color wear detection system, and the second an acrylic flake wear detection system. Scarification depth requirements shall be 1/4" for the two-color system and 1/8" for the acrylic flake system. High traffic areas shall be encapsulated with the two-color system, which is presented in Diagram 1, and encompass 3,045 square feet. All other exposed concrete flooring shall be encapsulated with the acrylic flake system, which measures 6,095 square feet.

The Gleason Works - Main Floor / Area to Accept Two Color Flooring

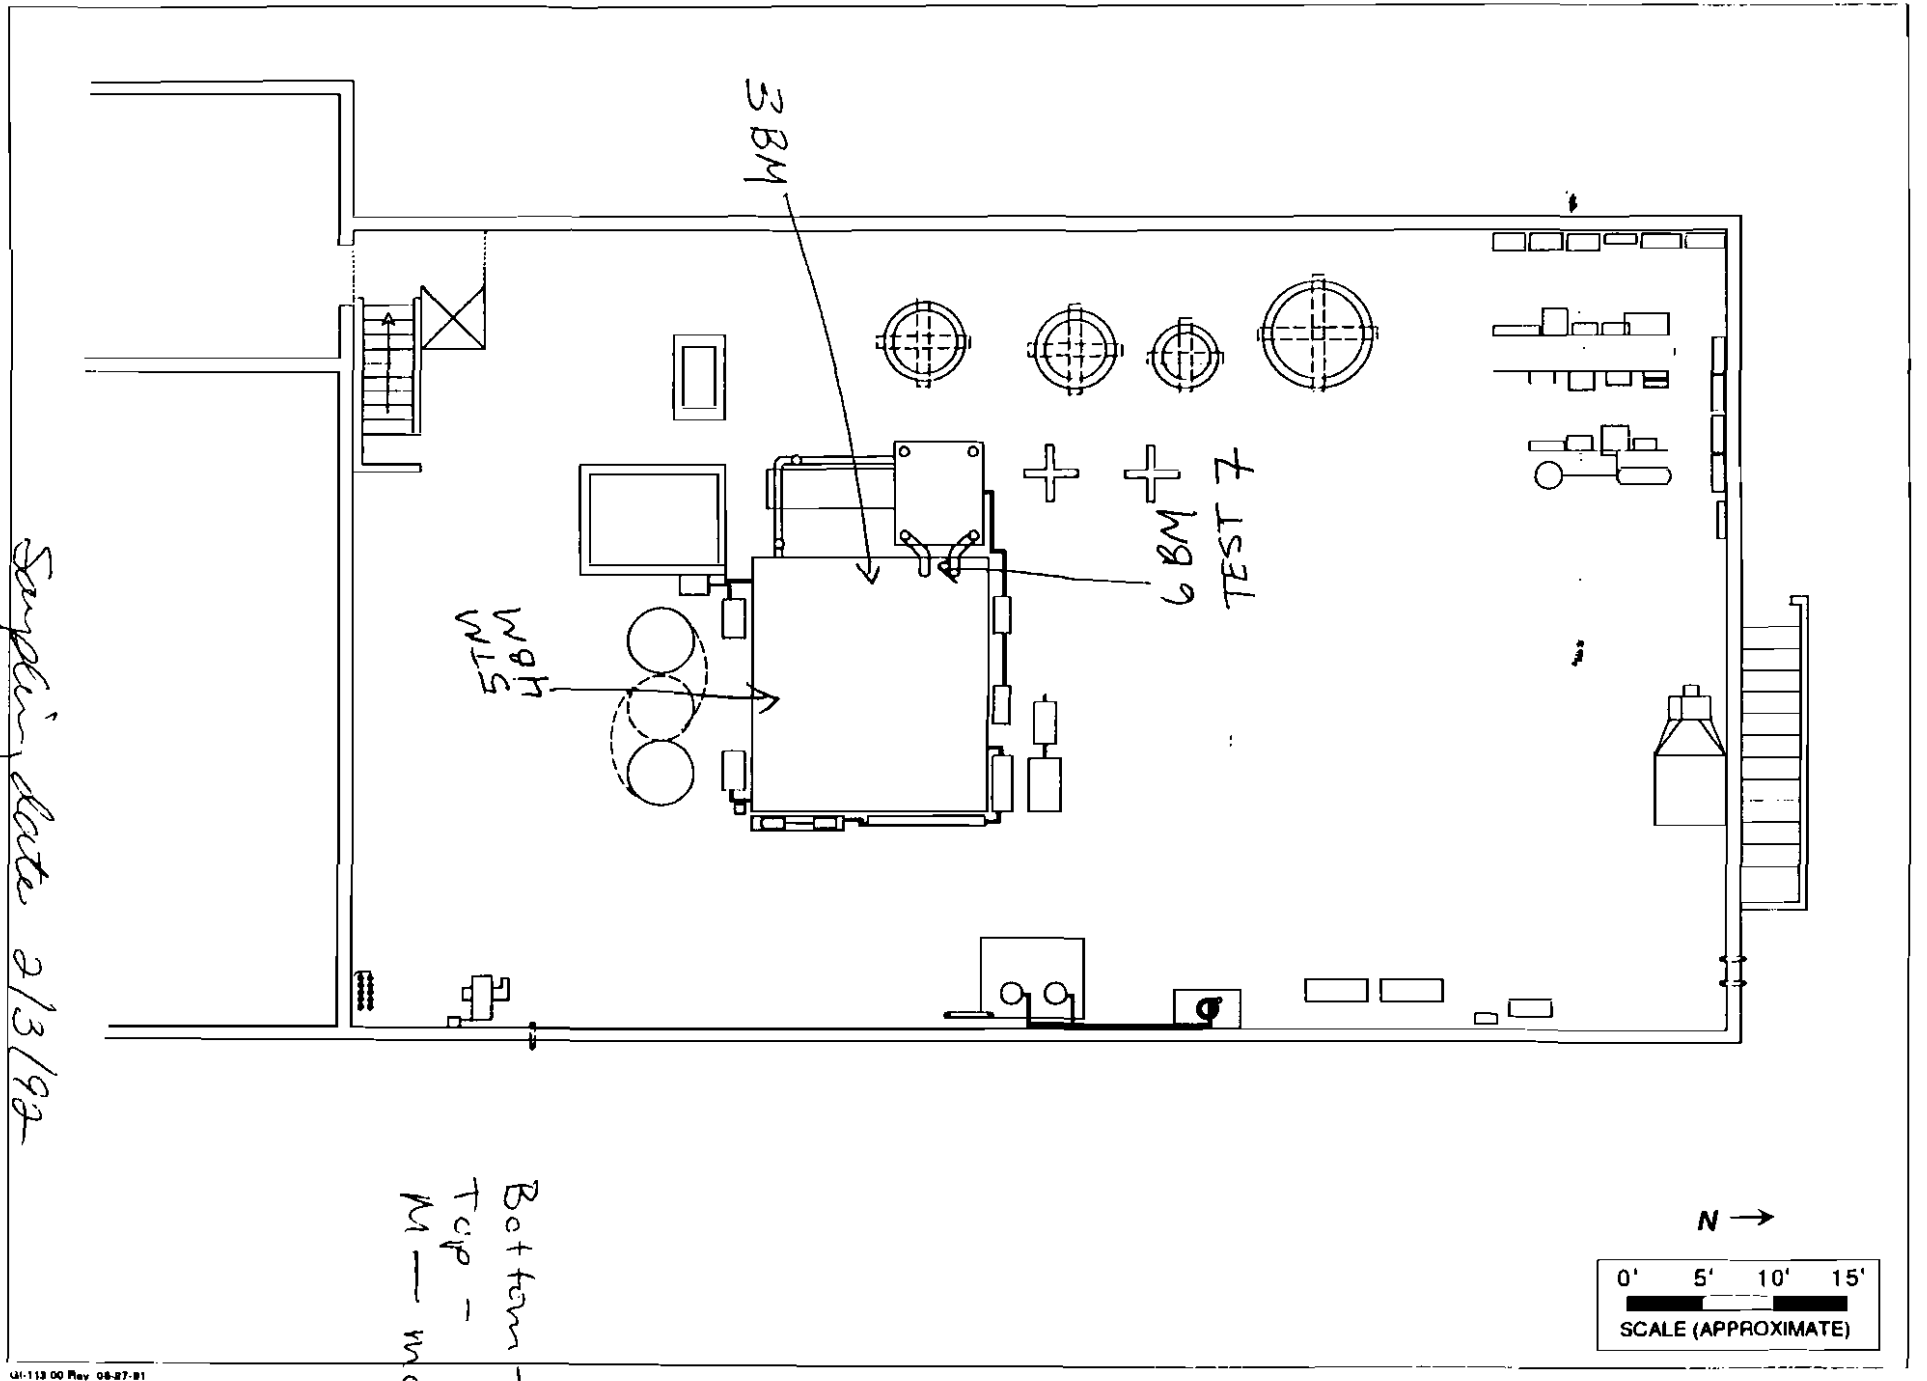
The Gleason Works - Basement Floor

Sampling date 2/3/92

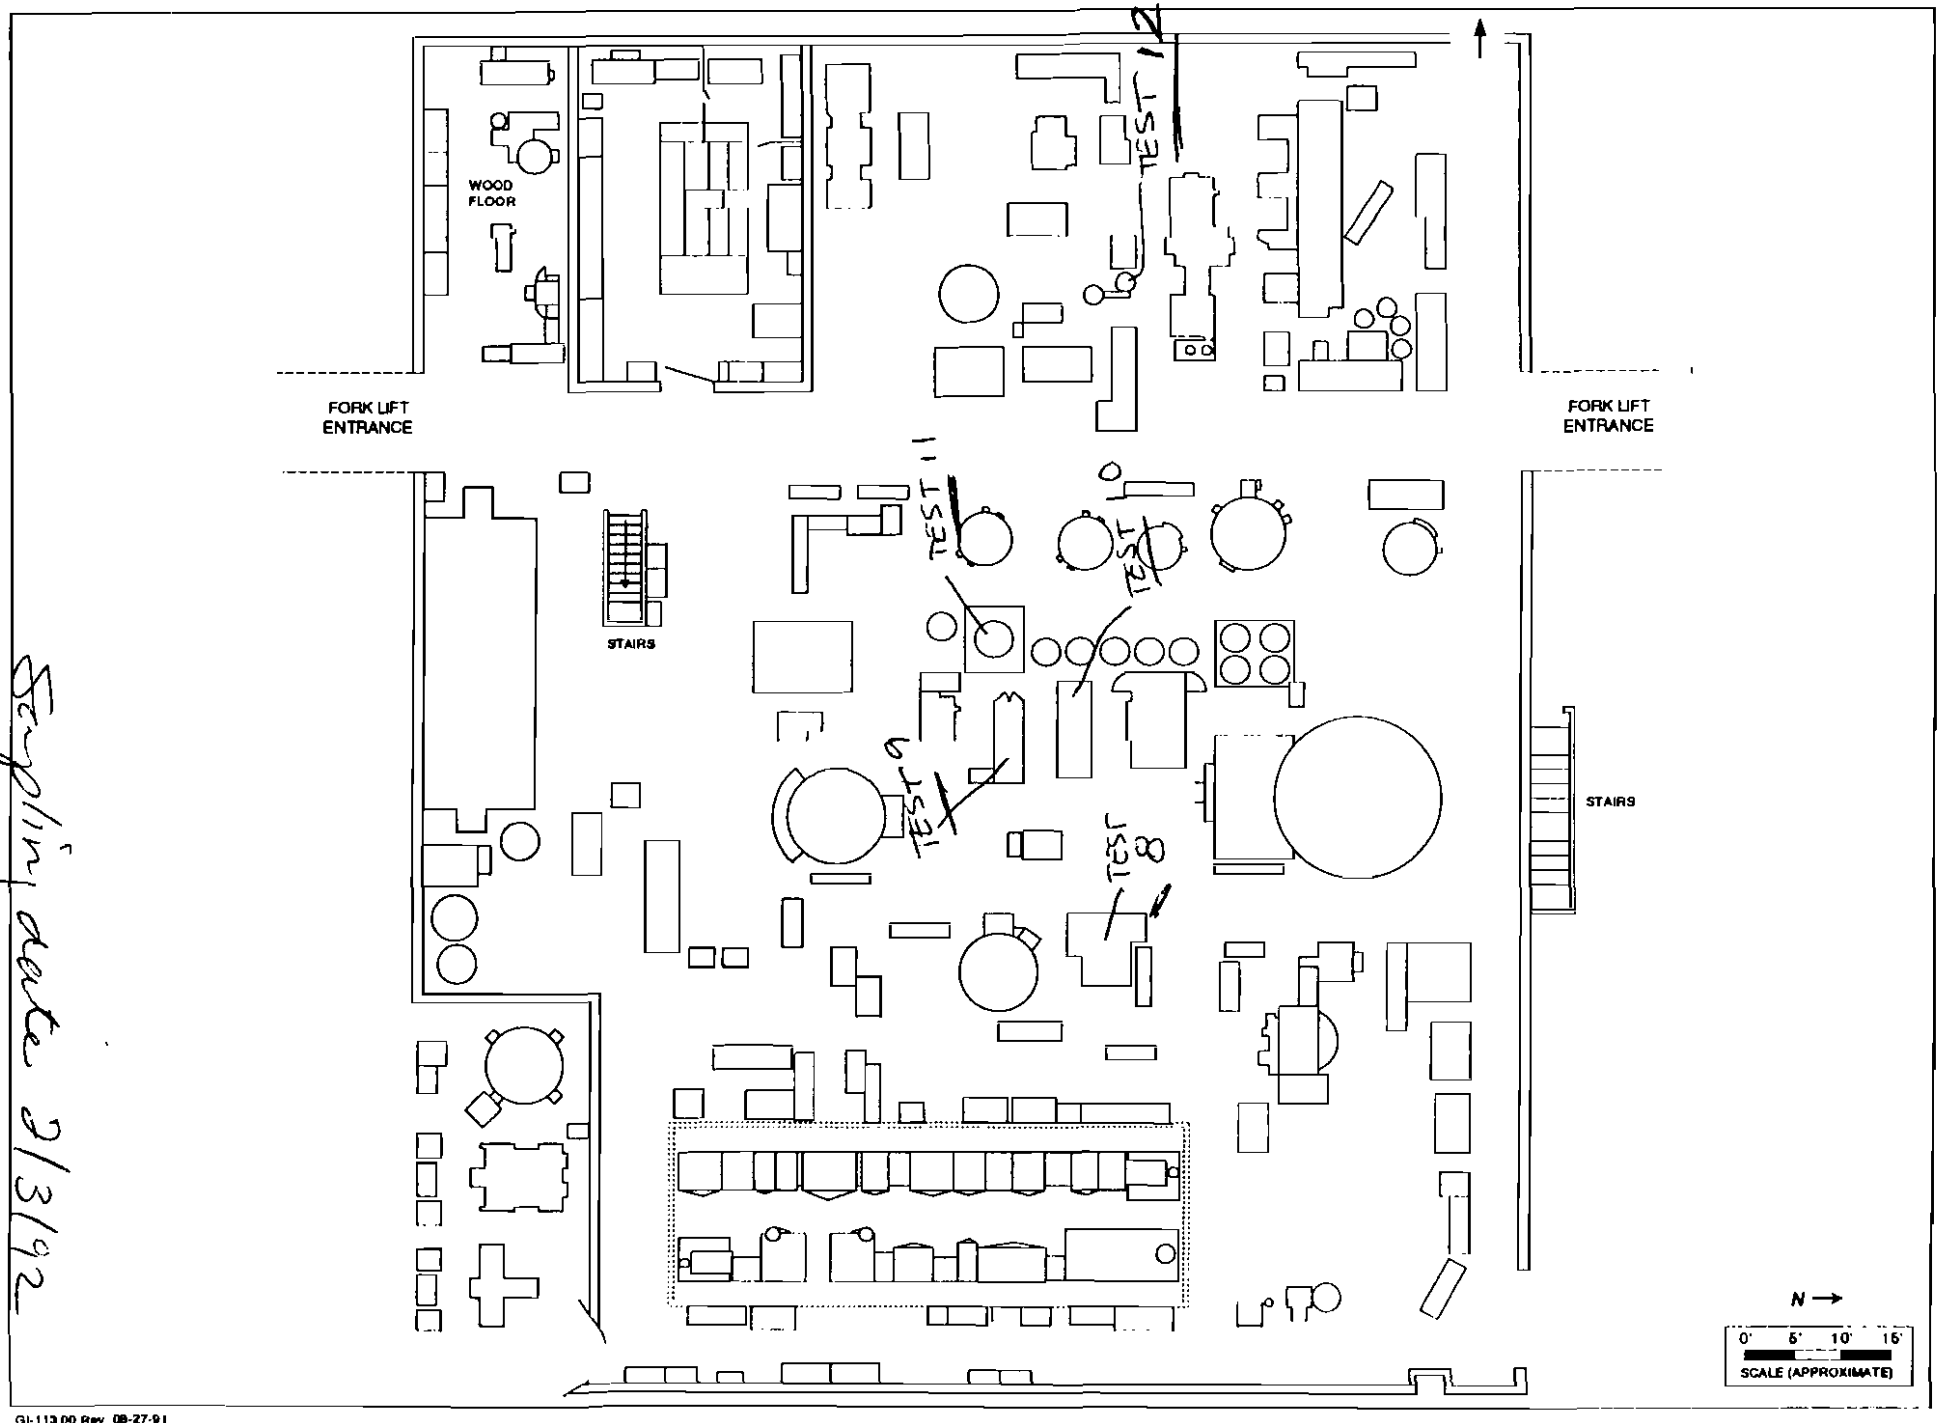
Sampling date 2/3/92

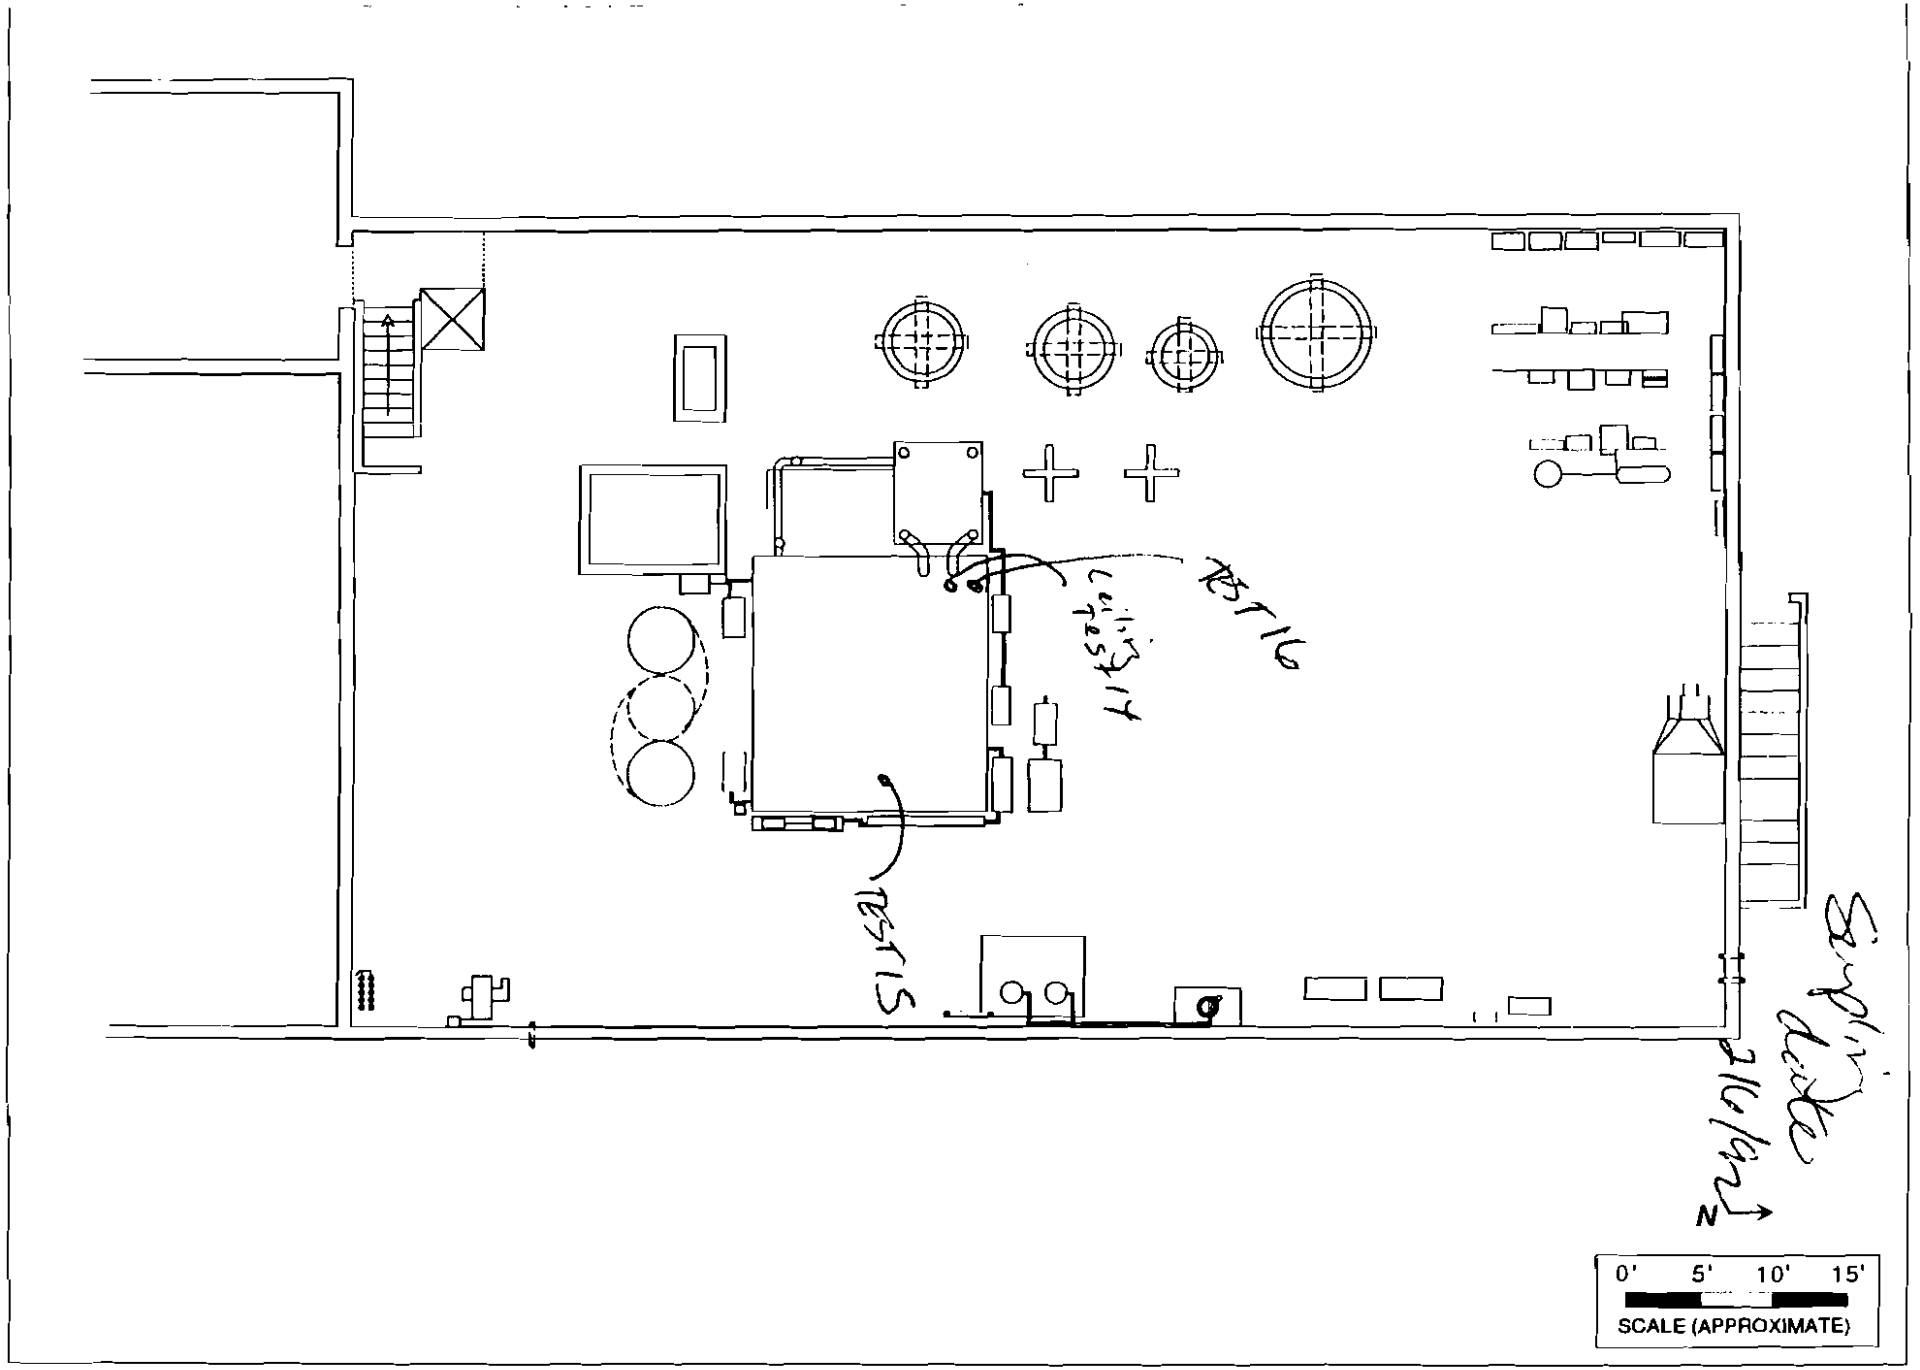
The Gleason Works - Basement Floor

SAMPLING & ANALYTICAL DATA			
SAMPLE NUMBER	TEST 14	TEST 15	TEST 16
SAMPLE MEDIA	Gauze Square	→	→
LOCATION	Ceiling in basement	Top MT.	piping to MT.
AREA SAMPLED (m^2)	12"x12"	12"x12"	Cylinder 5" x 12"
DIMENSIONS	929 cm^2	929 cm^2	18.9 cm DIA 12 length
SPECIAL CONDITIONS	Ceiling base. Near M.T. returns	Top of M.T. South middle	duct into M.T.
CONTAMINANT	RESULT (ug/m^2)	RESULT (ug/m^2)	RESULT (ug/m^2)
PCBs	1,000,000	2200	4300

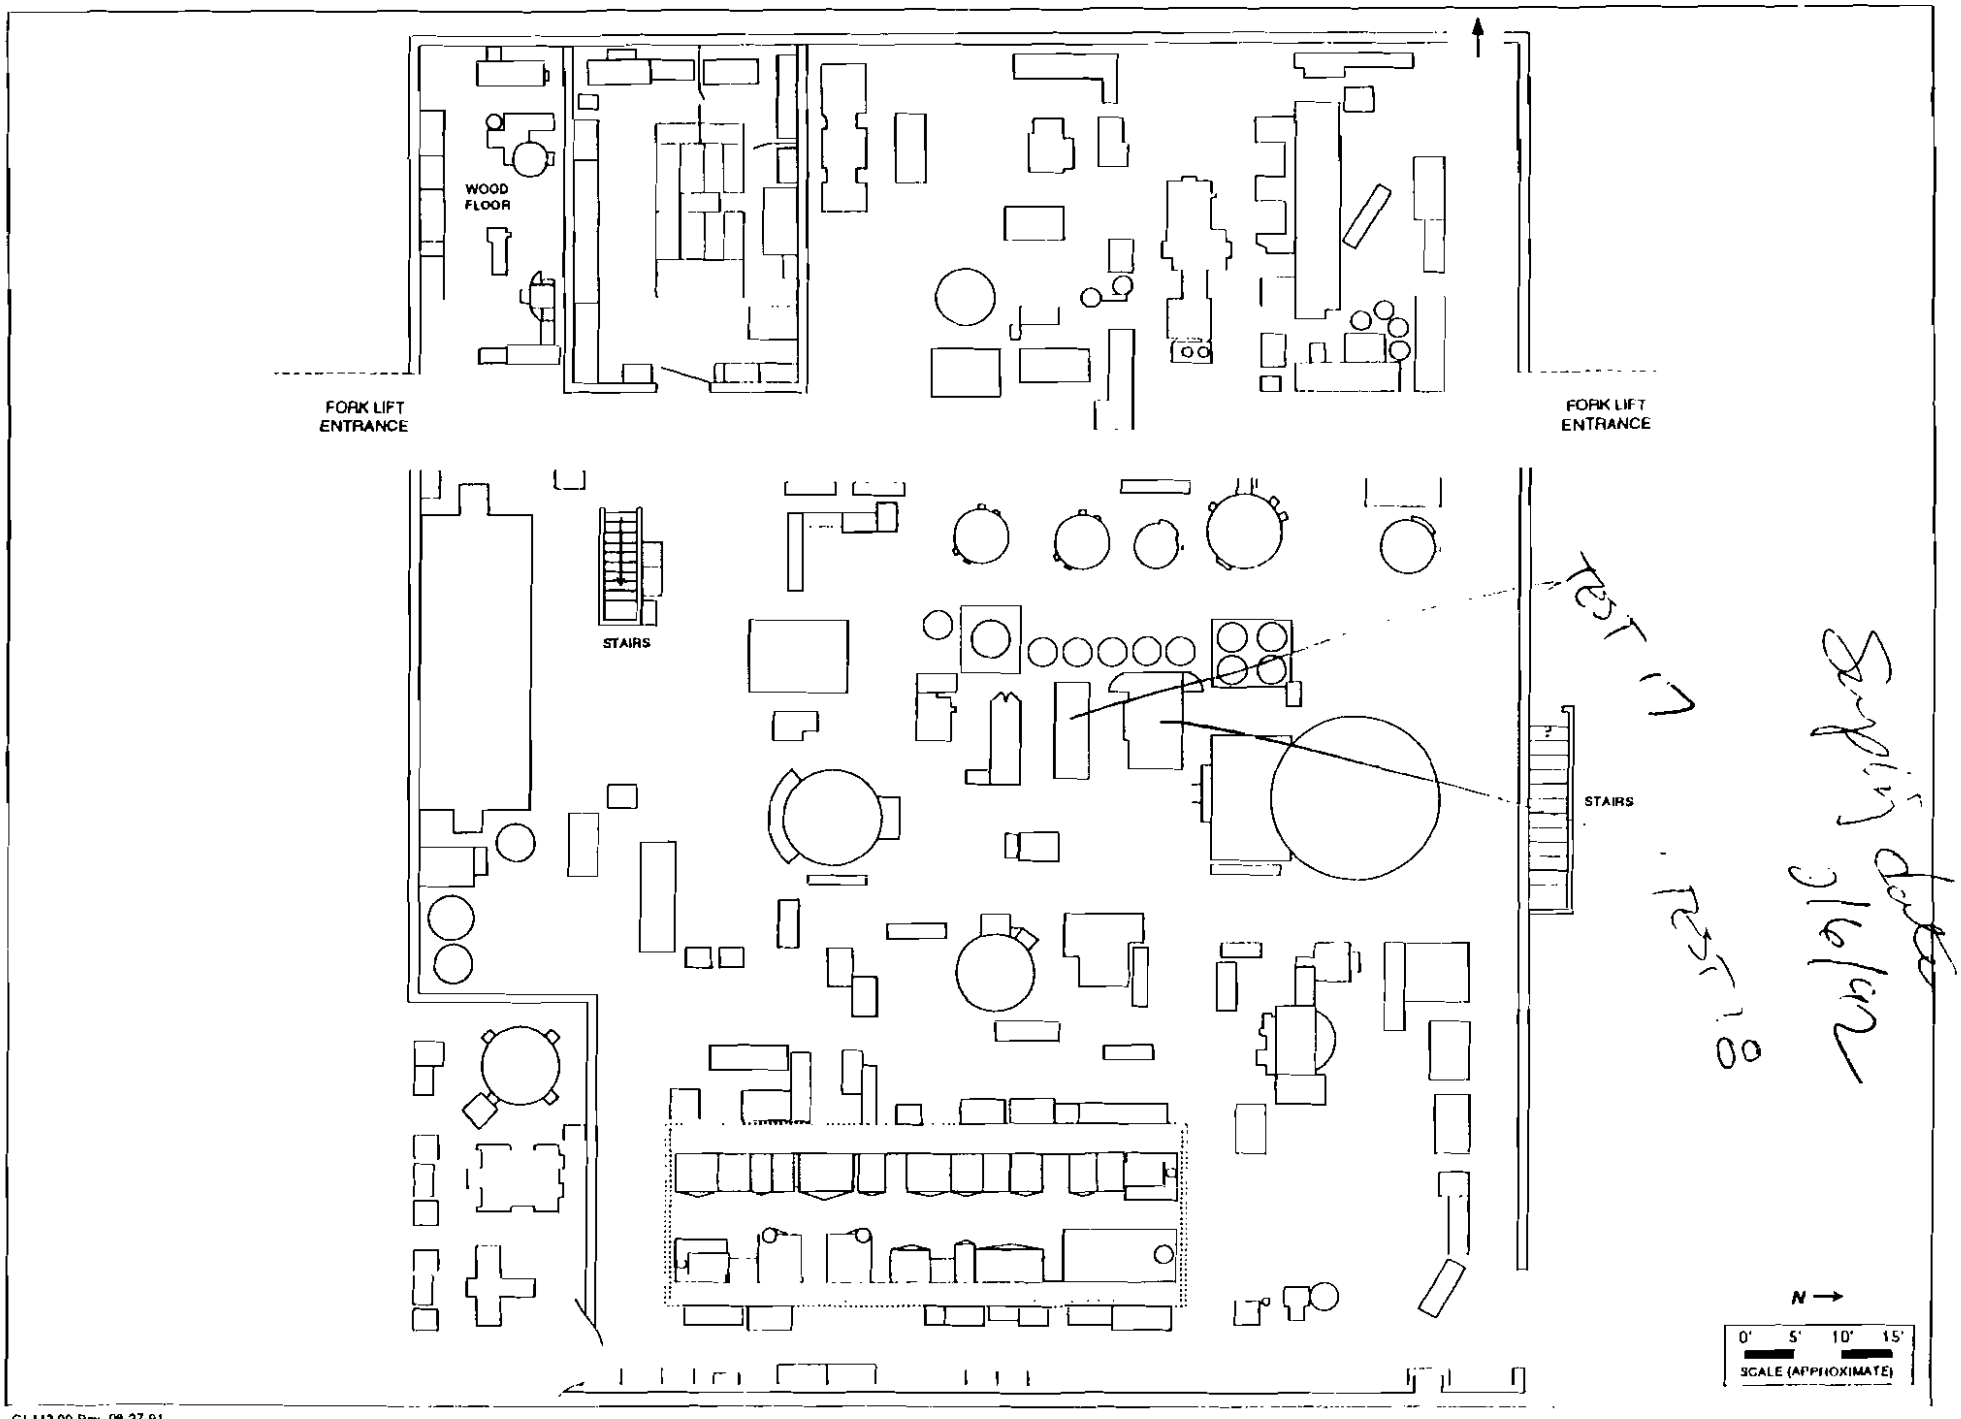
The Gleason Works - Operating Floor

COMMENTS: Oil has pooled in trays below fans at tops of both presses. Duct run below fans generally dirtier than after. Visual evidence of oil & soot flowing back to press.

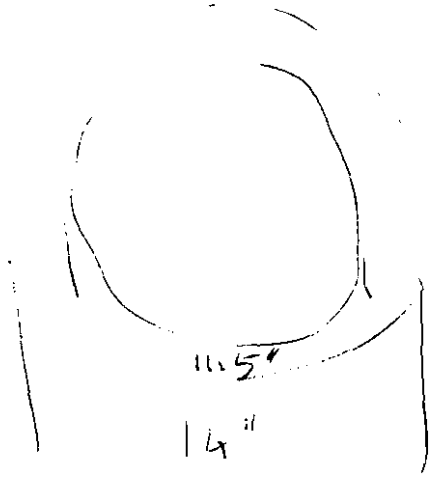
Ser. No. H 4181

Outside Area = 154 in²
Inside Area = 104 in²

Net Area = 50 in²

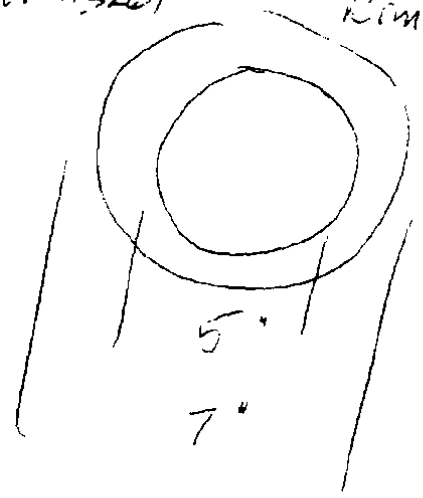
Ser No. H3269

Outside Area = 58.5 in^2

Inside Area = 19.6 in^2

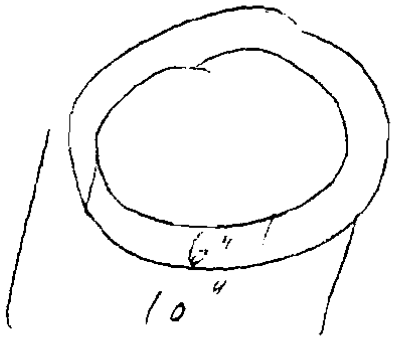
Ser No. Illegible

Outside Area = 78.5

Inside Area = 28.3

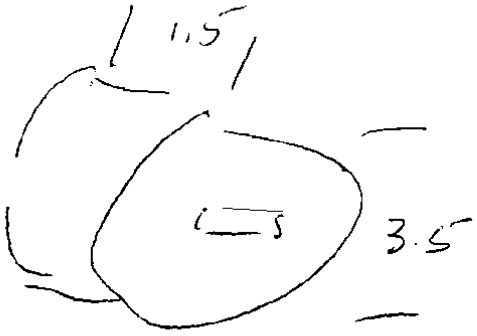
Ser No. H 9239

$A = 9.62 \times 2 = 19.2$

$Rim = \pi D = 16.4$
