SUBJECT: FINAL Sitewide Well Survey Report for the Former Seneca Army Depot in Romulus, NY; EPA Site ID# NY0213820830 and NY Site ID# 8-50-006

SITEWIDE WELL SURVEY REPORT
FINAL

Long-Term Monitoring/Land Use Control Management
Former Seneca Army Depot
Romulus, New York

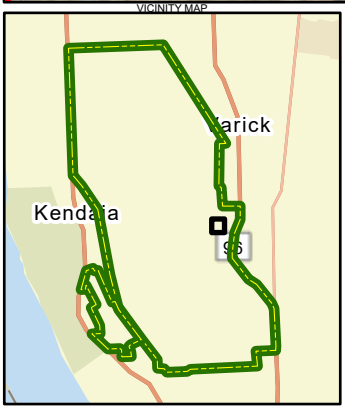
Figure 6
Group 1 - Proposed Well Repair/ Maintenance Locations
Former Seneca Army Depot (SEAD)
Romulus, Seneca County, New York

The flush mount to stick up casing conversion is recommended for MW25-28 and MW26-17 because the flush mount casing cover is unable to be secured on the monitoring wells with a well seal/j-plug, likely due to heaving of the monitoring well. This compromised the integrity of the monitoring well by allowing surface runoff to infiltrate the monitoring wells surface casing. By converting to a stick-up casing and raising the elevation of the well casing the monitoring well will be able to be sealed and locked. This will also allow additional space between the top of the well seal/j-plug and the top of the surface casing if heaving of the monitoring wells were to continue and it would not compromise the wells security or protection from surface runoff. Ballards set is concrete will be installed around the stick-up casing to protect the well from mowing activities at the site. Locations of the Group 1 monitoring wells that require repairs/maintenance are displayed in **Figure 6**. Recommended actions are also detailed in **Table 5**.

The following repairs and maintenance are recommended for Group 1 monitoring wells:

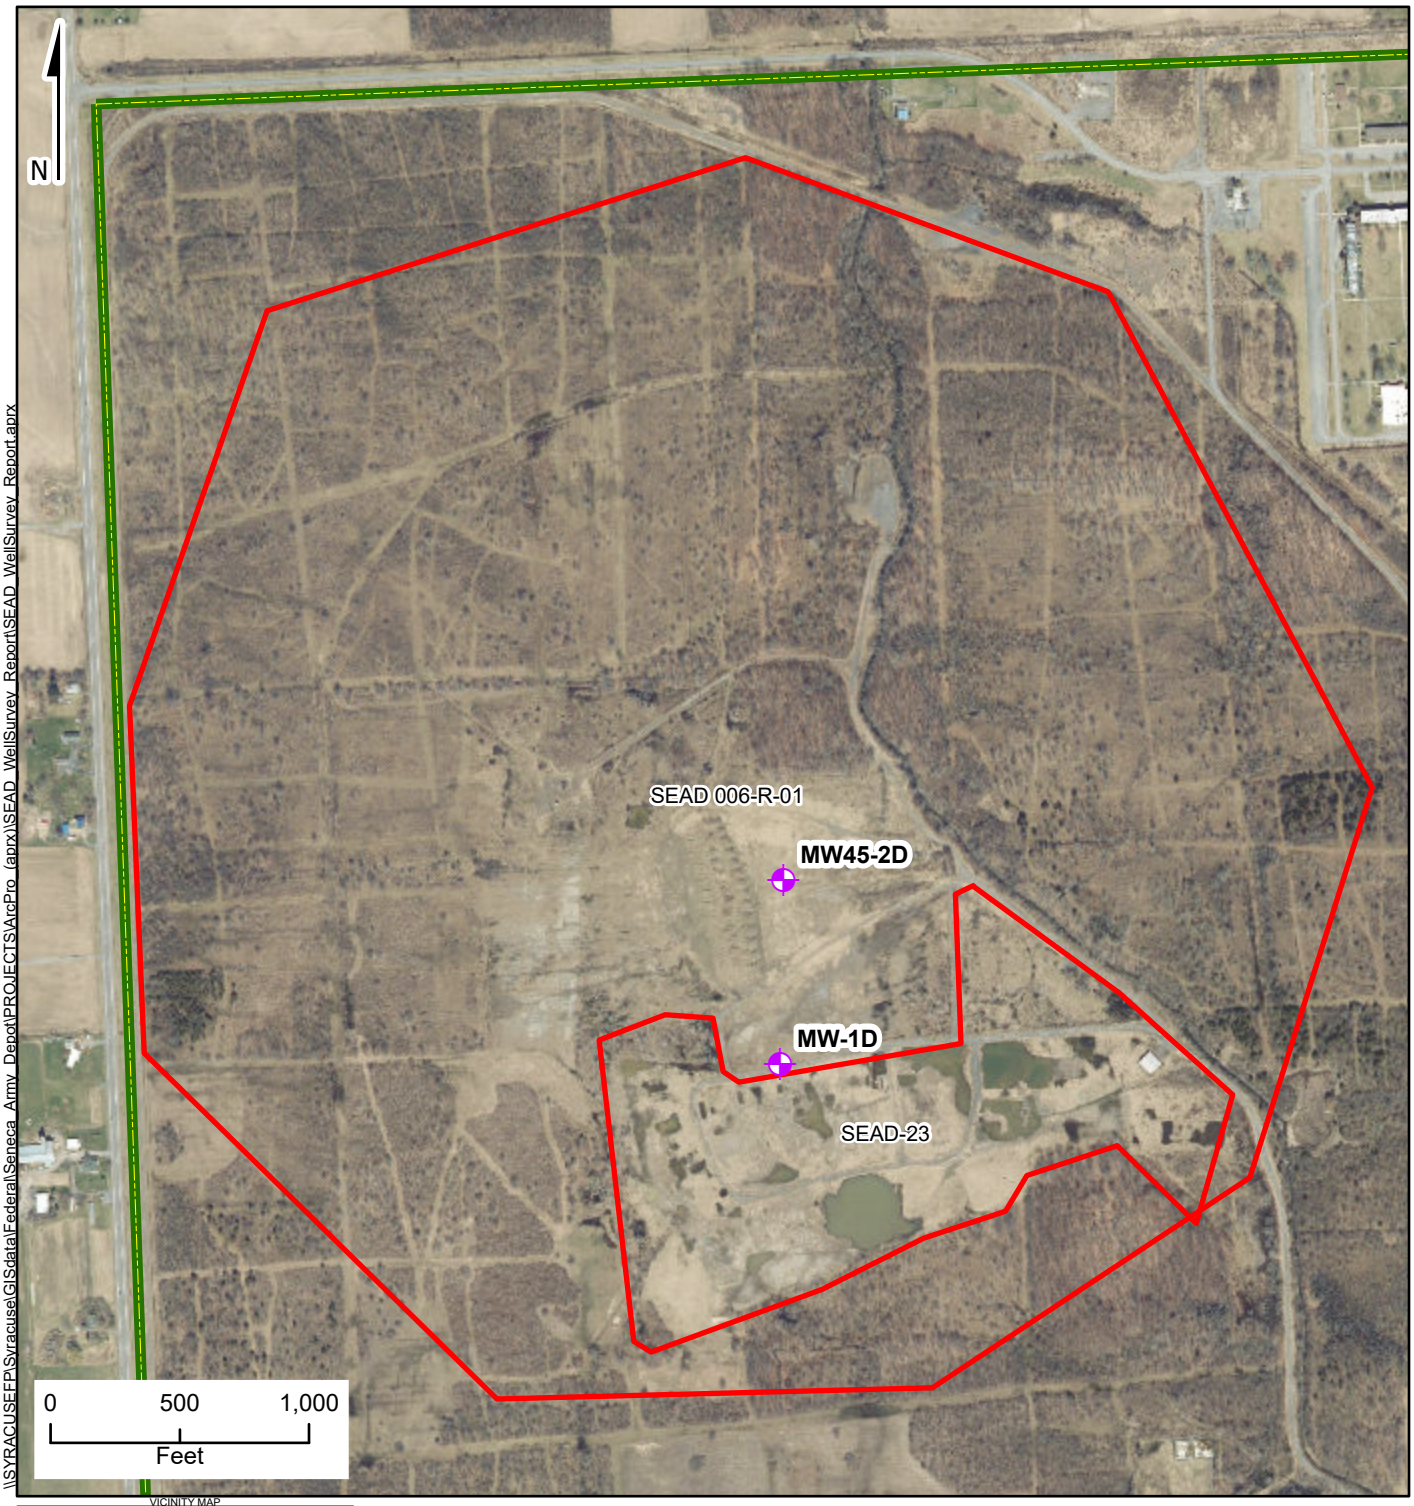
Figure 7
Group 2 - Proposed Well Repair/ Maintenance Locations
Former Seneca Army Depot (SEAD)
Romulus, Seneca County, New York

Following the completion of the well survey inspections, 1 of the 63 monitoring wells in Group 2 was identified for needing repairs/maintenance. Repairs and maintenance required consist of one monitoring well that needs a well seal/j-plug. Well Survey Inspection forms for the Group 2 wells are provided in **Appendix B**.

Locations of the Group 2 monitoring wells that require repairs/maintenance are displayed in **Figure 7**. Recommended actions are also detailed in **Table 5**.

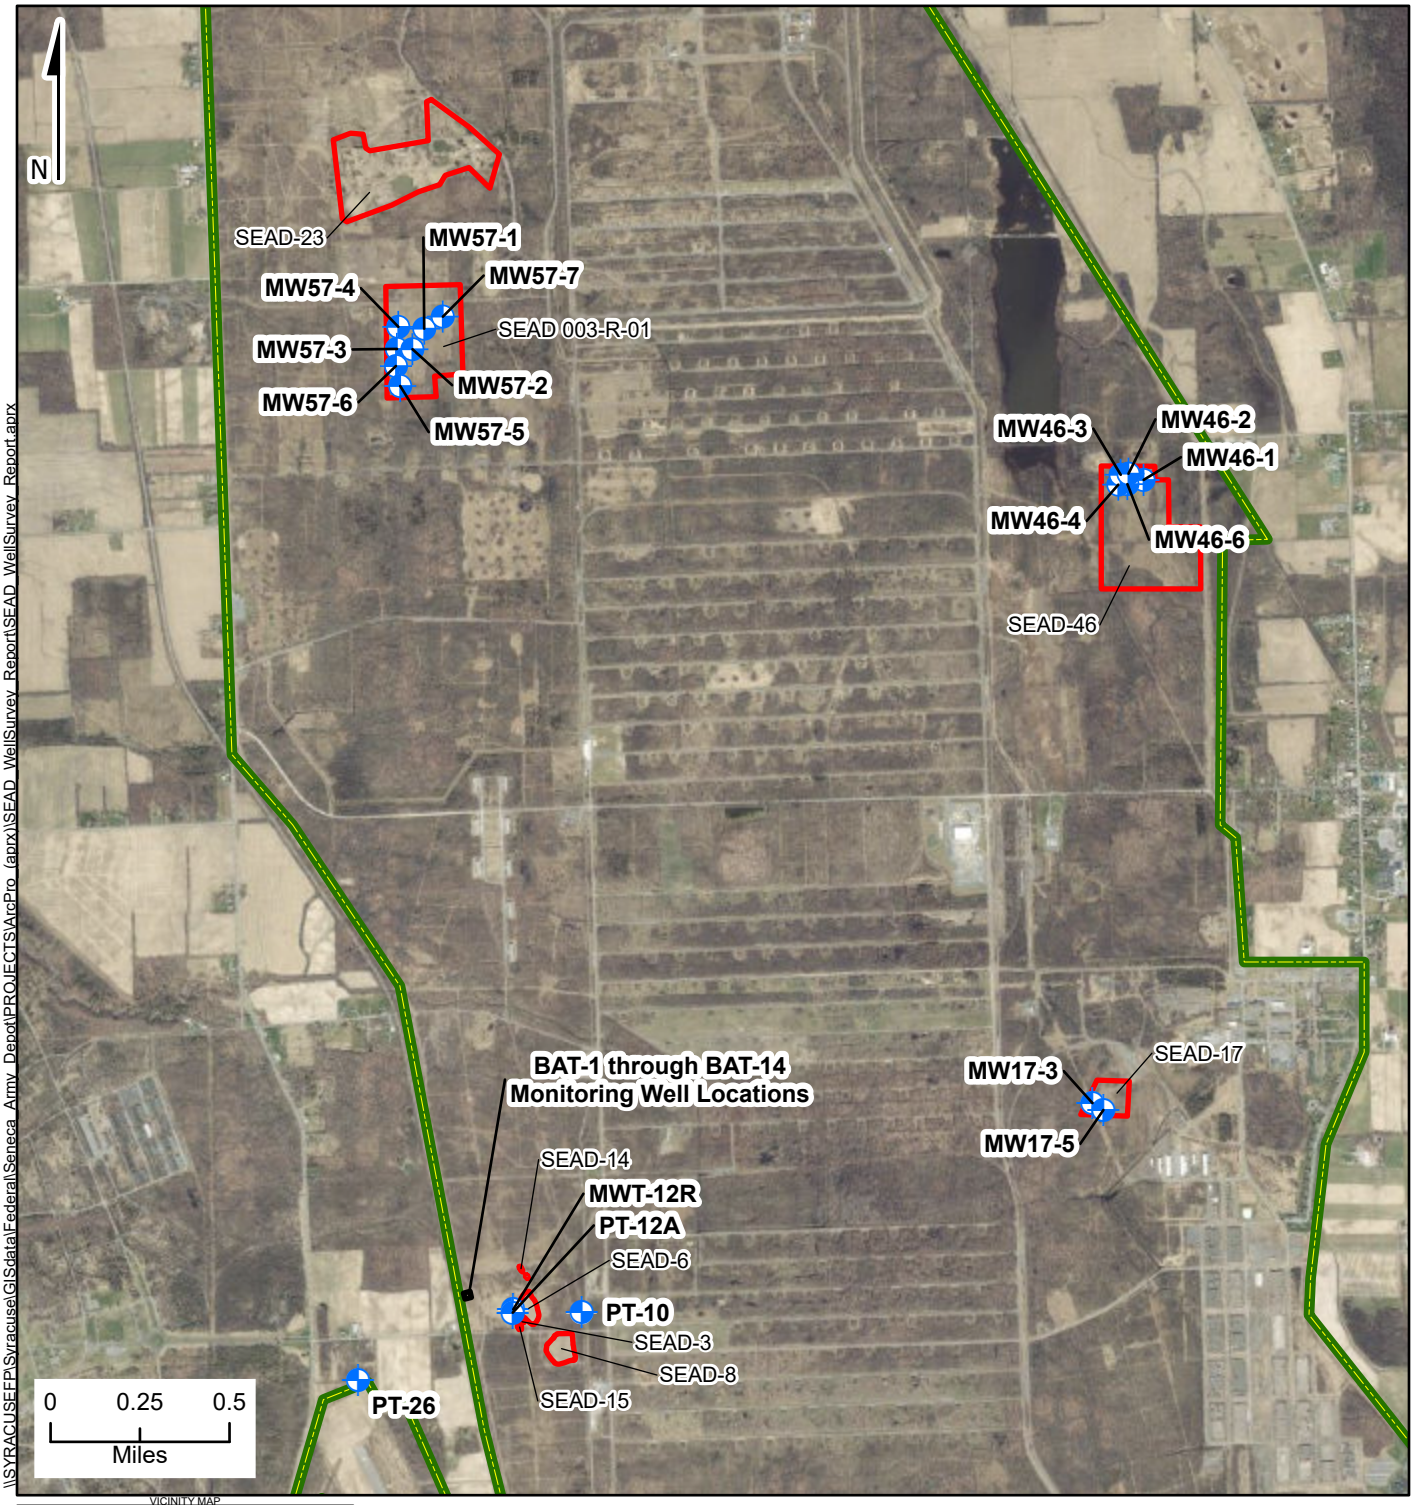
Figure 8
Group 3 - Proposed Well Repair/ Maintenance Locations
Former Seneca Army Depot (SEAD)
Romulus, Seneca County, New York

Following the completion of the well survey inspections, 2 of the 27 monitoring wells in Group 3 were identified for needing repairs/maintenance. Repairs and maintenance required consist of two monitoring wells that need a well seal/j-plug. Well Survey Inspection forms for the Group 3 wells are provided in **Appendix C**.

Locations of the Group 3 monitoring wells that require repairs/maintenance are displayed in **Figure 8**. Recommended actions are also detailed in **Table 5**.

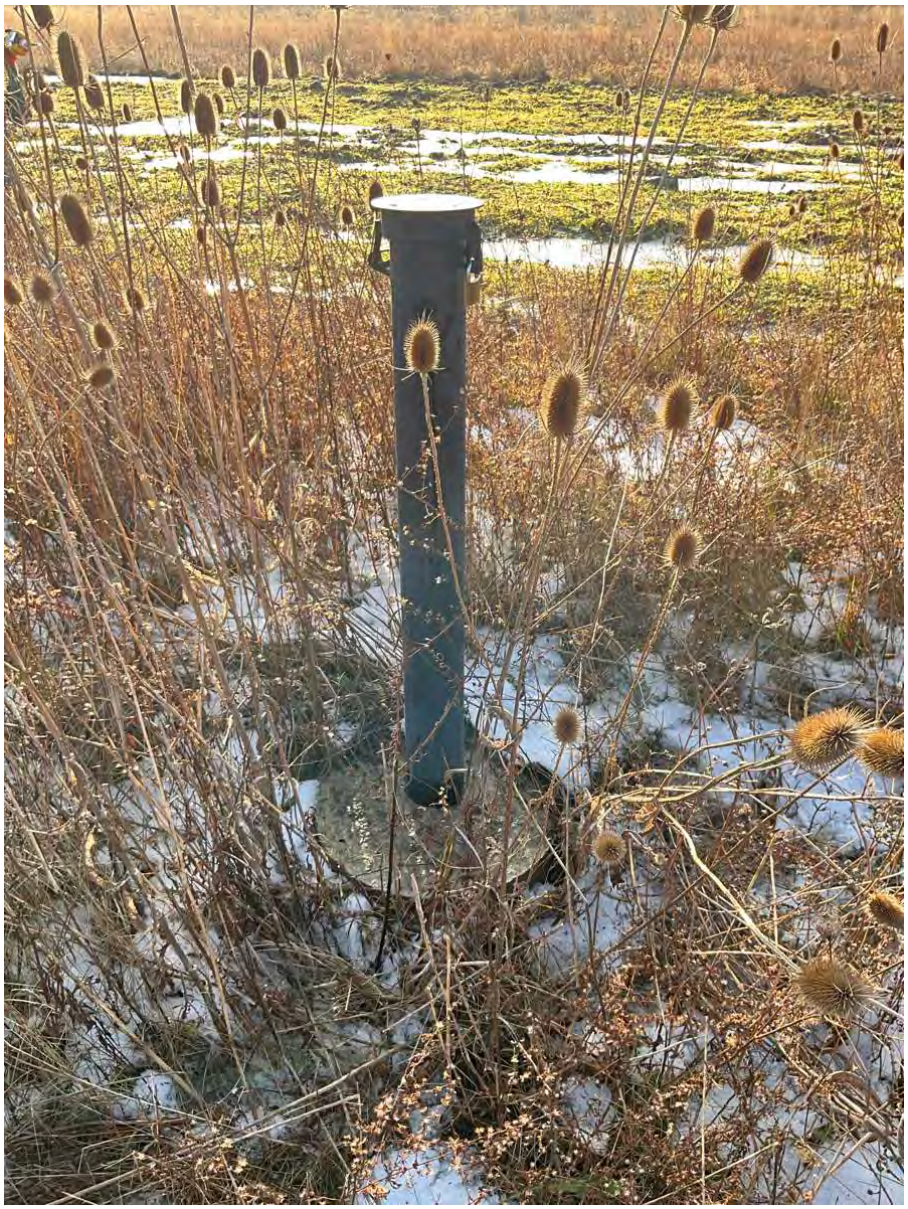
Photos

Is the well clearly labeled?	No
Stick-up or flush mount?	Stick-up
Surface casing diameter (in)	4
Surface casing material	Steel
Surface casing condition	Good
Well casing diameter (inch)	2
Well casing material	PVC
Well casing condition	Good
Concrete pad condition	Heaved
Protective ballards?	No
Well seal?	Yes
Lock/security type?	Lock
Measurement marking?	Yes
Terrian	Flat
Vegetation condition	Field
Evidence of development near location?	No
PID reading	0.0
Depth to water (ft)	2.87
Depth to bottom (ft)	15.05
Additional observations

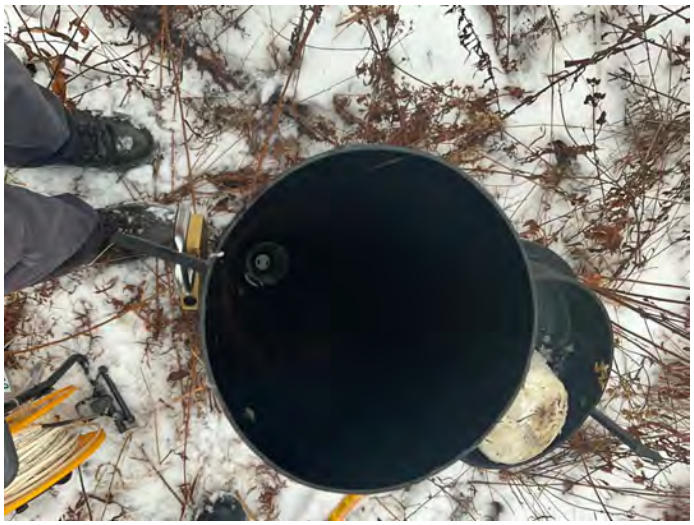
Date: 01-07-2026	Time: 08:46	Inspectors: EB,AR
Well ID: MW58-05		
Is the well clearly labeled?	No	
Stick-up or flush mount?	Stick-up	
Surface casing diameter (in)	4	
Surface casing material	Steel	
Surface casing condition	Good	
Well casing diameter (inch)	2	
Well casing material	PVC	
Well casing condition	Good	
Concrete pad condition	Good	
Protective ballards?	No	
Well seal?	No	
Lock/security type?	Lock	
Measurement marking?	No	
Terrian	Flat	
Vegetation condition	Scrub shrub	
Evidence of development near location?	No	
PID reading	N/A	
Depth to water (ft)	2	
Depth to bottom (ft)	12.9	
Additional observations	Well casing apeears to be 2 ft deep in the steel casing. Unable to get precise measurements.
