March 11, 2010

Re: 124 Victory Highway, Painted Post, NY
Interim Remedial Measure Report

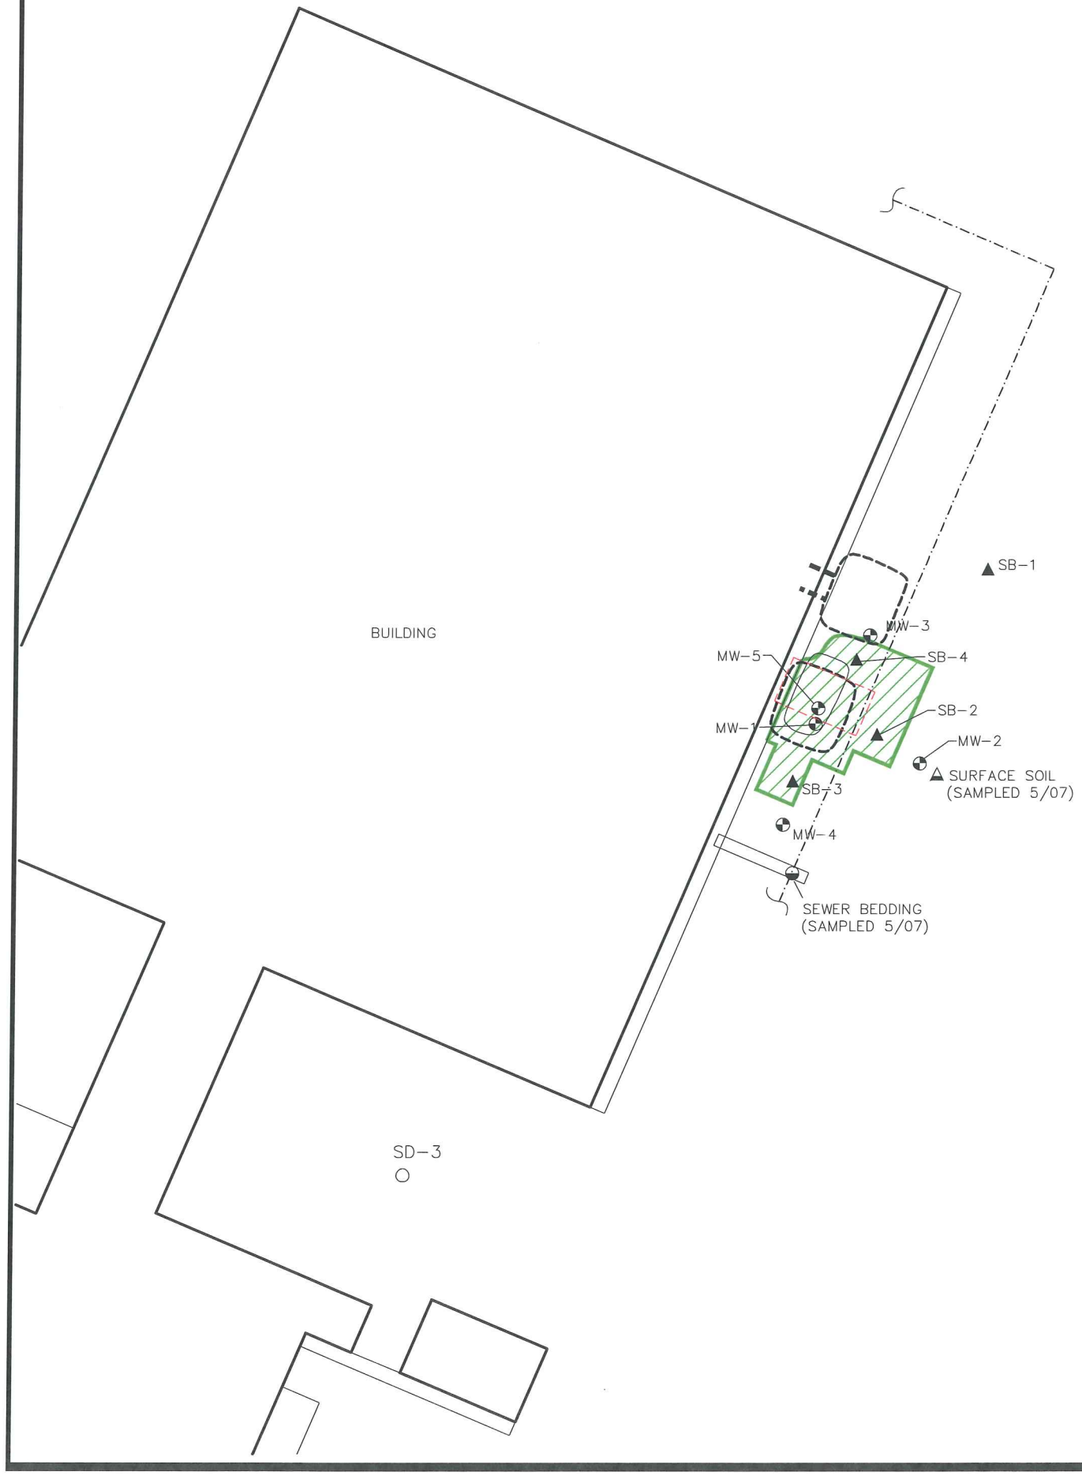
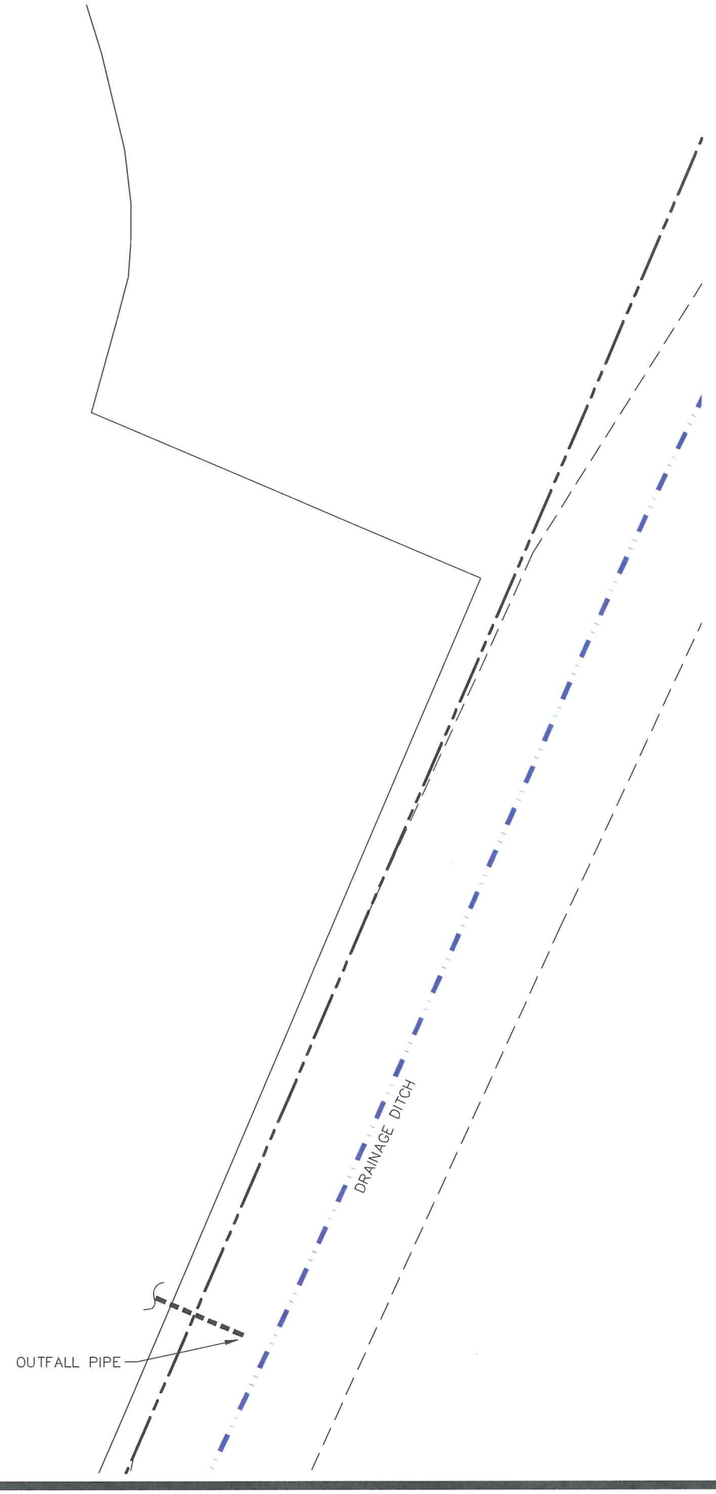
FIGURE 5

In the area of the former UST, it was estimated that 60 cubic yards of material would be removed to address VOC-impacted soil. The anticipated horizontal extent of the excavation was 9 feet by 18 feet as depicted on Figure 5. The deepest part of the excavation was anticipated to extend 10 feet below ground surface (bgs). It was expected that the extent of the excavation could increase based on field observations, photo-ionization detector (PID) readings, and in consultation with NYSDEC field personnel. Excavated soils were to be screened on a per-bucket interval with a PID as they were removed, and segregated into contaminated and uncontaminated piles based on the PID readings. It was anticipated that a sewer force main would be exposed during the excavation. Should the pipe be exposed during the excavation, it was to be supported in accordance with the manufacturer's recommendations.

Figure 5 shows the proposed and final horizontal extent of the excavation. In total, approximately 60 cubic yards of impacted soil was removed from the area of the former UST. Confirmatory samples were taken from each sidewall of the excavation and from the excavation floor. Samples were collected from biased locations that appeared to represent the "worst case" areas of impacted soil and were screened with the PID. PID screening of all samples indicated VOC concentrations below 5.0 ppm. The soil samples were submitted to Test America Laboratories, Inc. in Buffalo, New York for VOC and SVOC analysis following Method 8260 TCL and Method 8270 TCL, respectively. These samples were labeled UST-EW, UST-WW, UST-NW, UST-SW and UST-F. Figure 7 shows the confirmatory sample locations and the associated VOC and SVOC concentrations detected. All confirmatory sample analysis was performed according to Category B standards. An electronic version of all analytical data is available upon request.

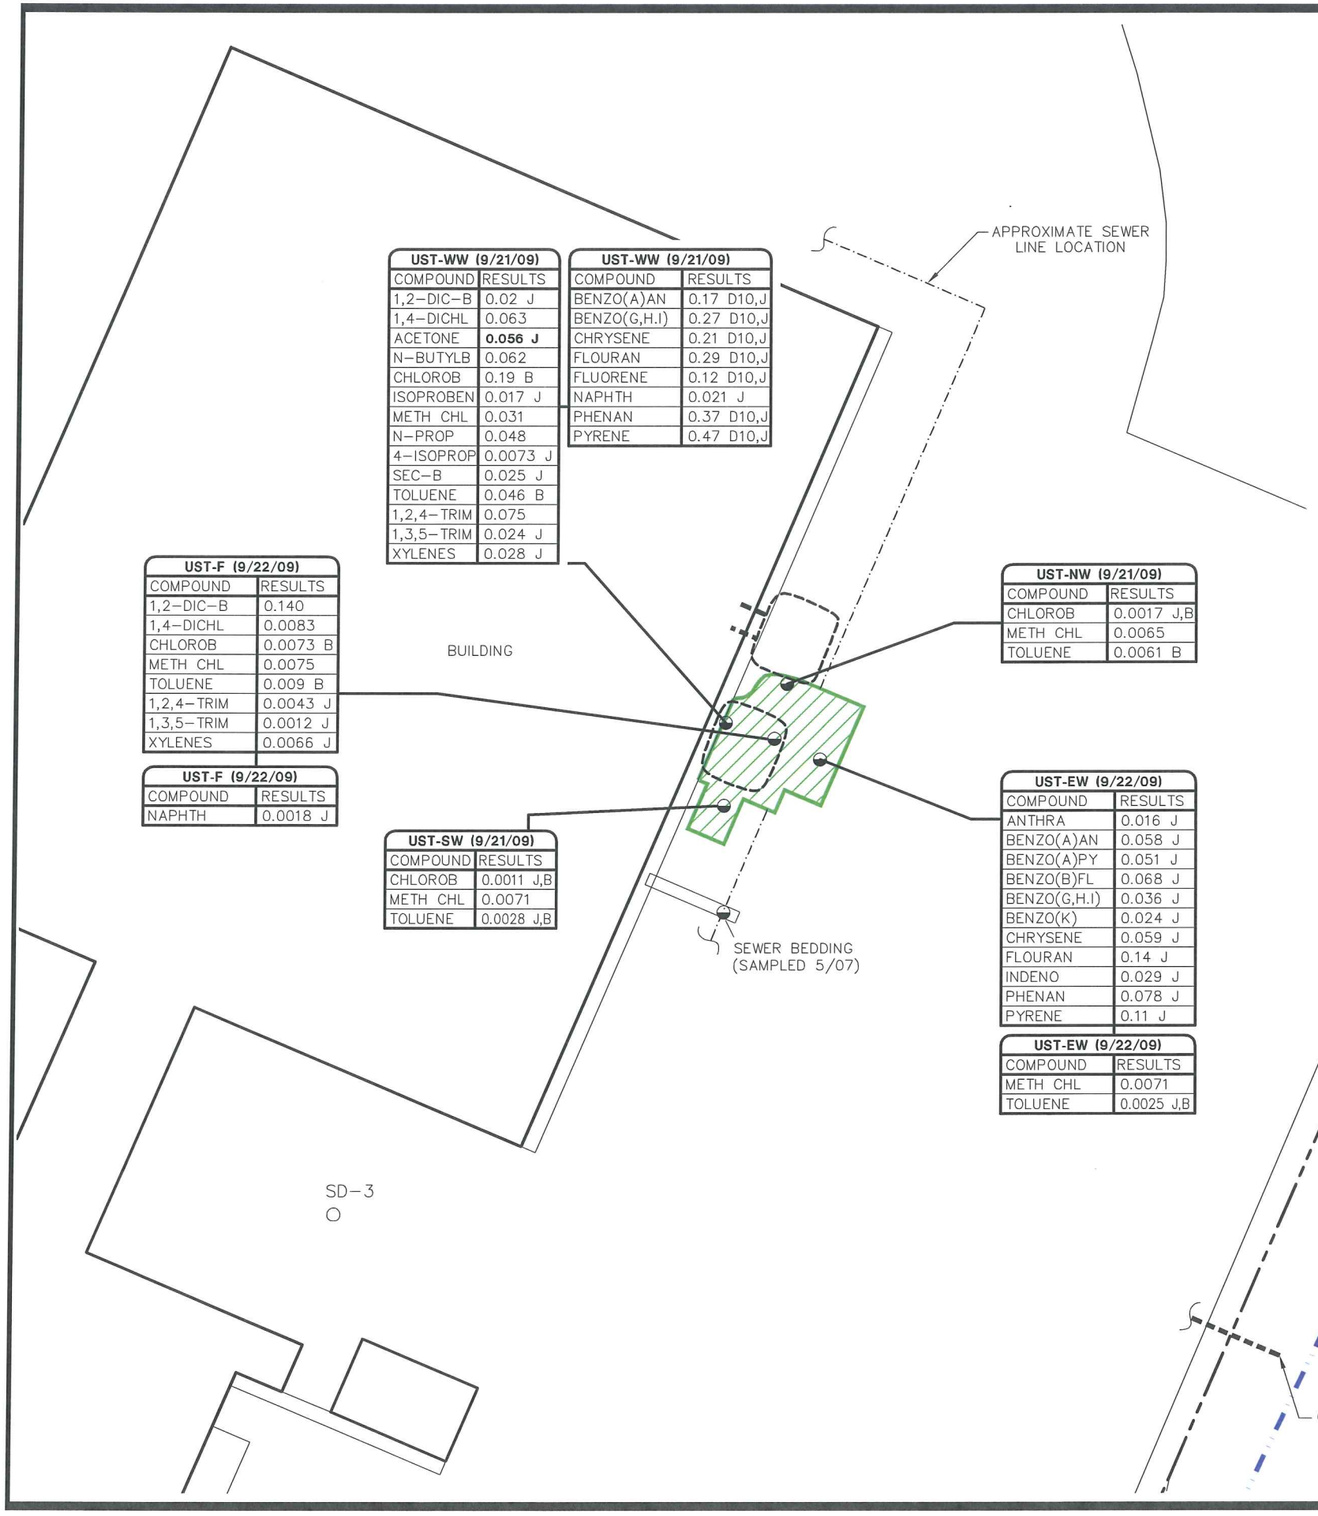
FIGURE 7

The laboratory analysis indicated that VOC and SVOC concentrations detected in the wall samples and the floor sample of the former UST area excavation were below NYSDEC 6 NYCRR Part 375-6 – unrestricted soil use cleanup objectives, with the exception of acetone. Acetone was detected in soil sample UST-WW at an estimated concentration of 0.056 ppm which marginally exceeds the NYSDEC 6 NYCRR Part 375-6 – unrestricted soil use cleanup objective of 0.05 ppm. Upon receipt of the laboratory analytical data, Gary Bonarski of NYSDEC was contacted and approved the backfilling of the UST area excavation. All impacted soil removed from the former UST area excavation was transported offsite by Riccelli for disposal at the Ontario County Landfill on September 23 and 24, 2009.

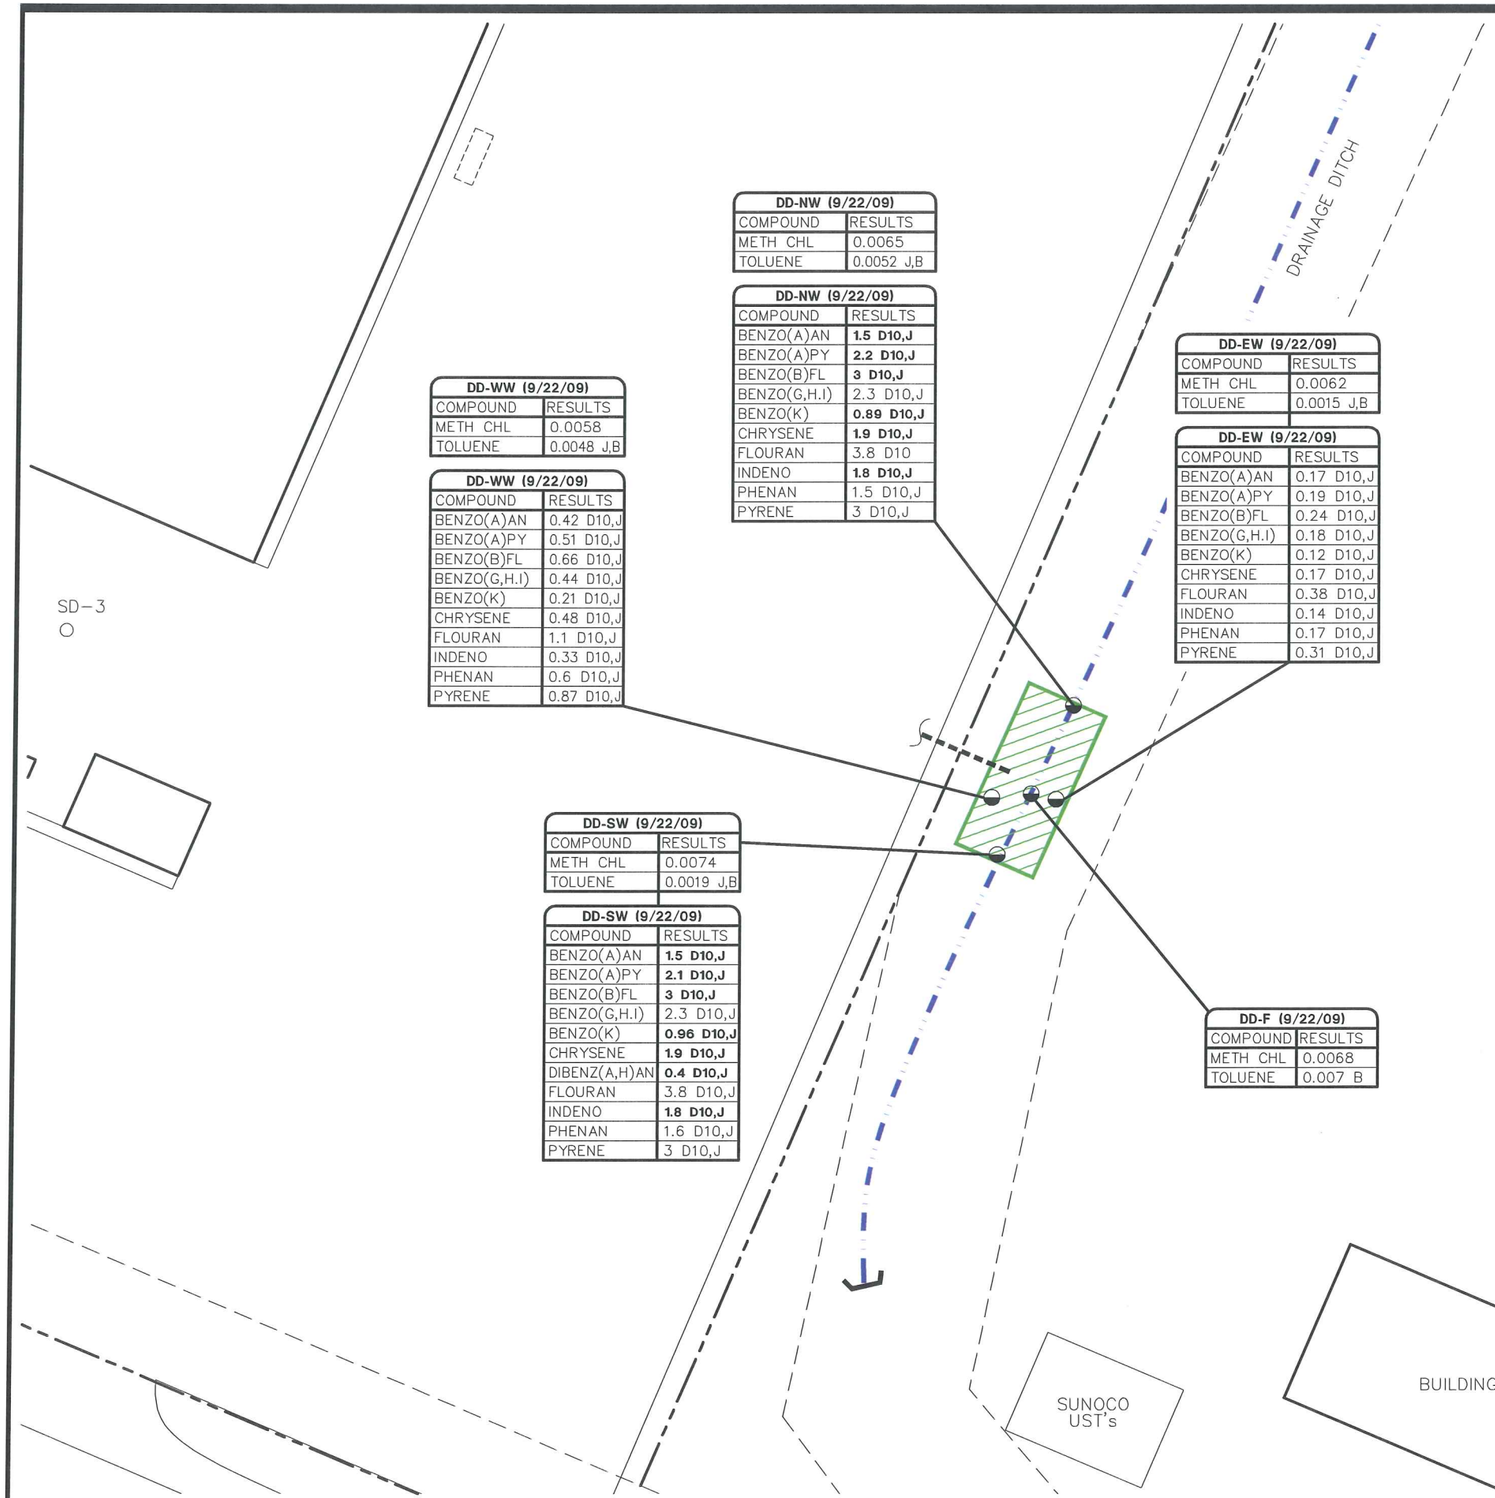
Analytical results are summarized in Table 1 and Table 2, and on Figure 8. Concentrations of VOCs were below NYSDEC 6 NYCRR Part 375-6 – unrestricted soil use cleanup objectives. Concentrations of SVOCs in samples DD-EW, DD-WW and DD-F were also below NYSDEC 6 NYCRR Part 375-6 – unrestricted soil use cleanup objectives. Laboratory analysis of the soil samples collected from the drainage ditch excavation north wall and south wall, DD-NW and DD-SW, respectively, detected concentrations of SVOCs marginally exceeding NYSDEC 6 NYCRR Part 375-6 – unrestricted soil use cleanup objectives. Gary Bonarski noted that SVOCs detected in the drainage ditch were not inconsistent with downstream background concentrations, as shown in Table 2, sample DS-4, and agreed that acceptable soil cleanup levels had been achieved, the degree of soil removal was adequate and the drainage ditch remediation was complete.

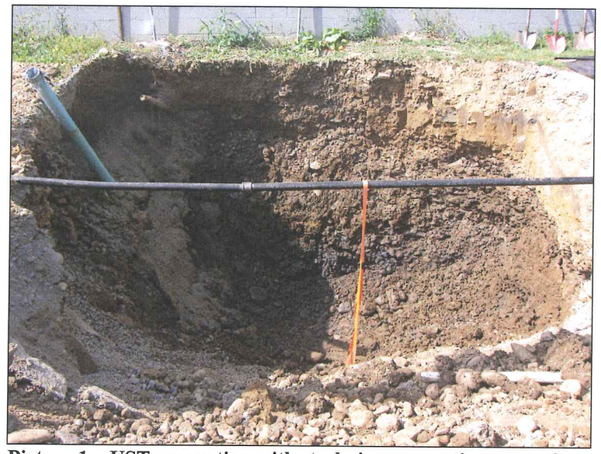
During the course of the excavation, the sewer force main was encountered approximately 6 feet bgs and 16 feet east of the building wall. The line was observed to be constructed with a two-inch diameter polyvinyl chloride (PVC) pipe bedded in pea gravel. The sewer pipe was supported with a steel pipe and mounded clean soil during material excavation.

Picture 1 – UST excavation with steel pipe supporting sewer force main.

Picture 2 – UST excavation in progress
