PERIODIC REVIEW REPORT

FOR
FORMER DOWCRAFT FACILITY
NYSDEC SITE #907020
FALCONER, CHAUTAUQUA COUNTY, NEW YORK

NOVEMBER 2018

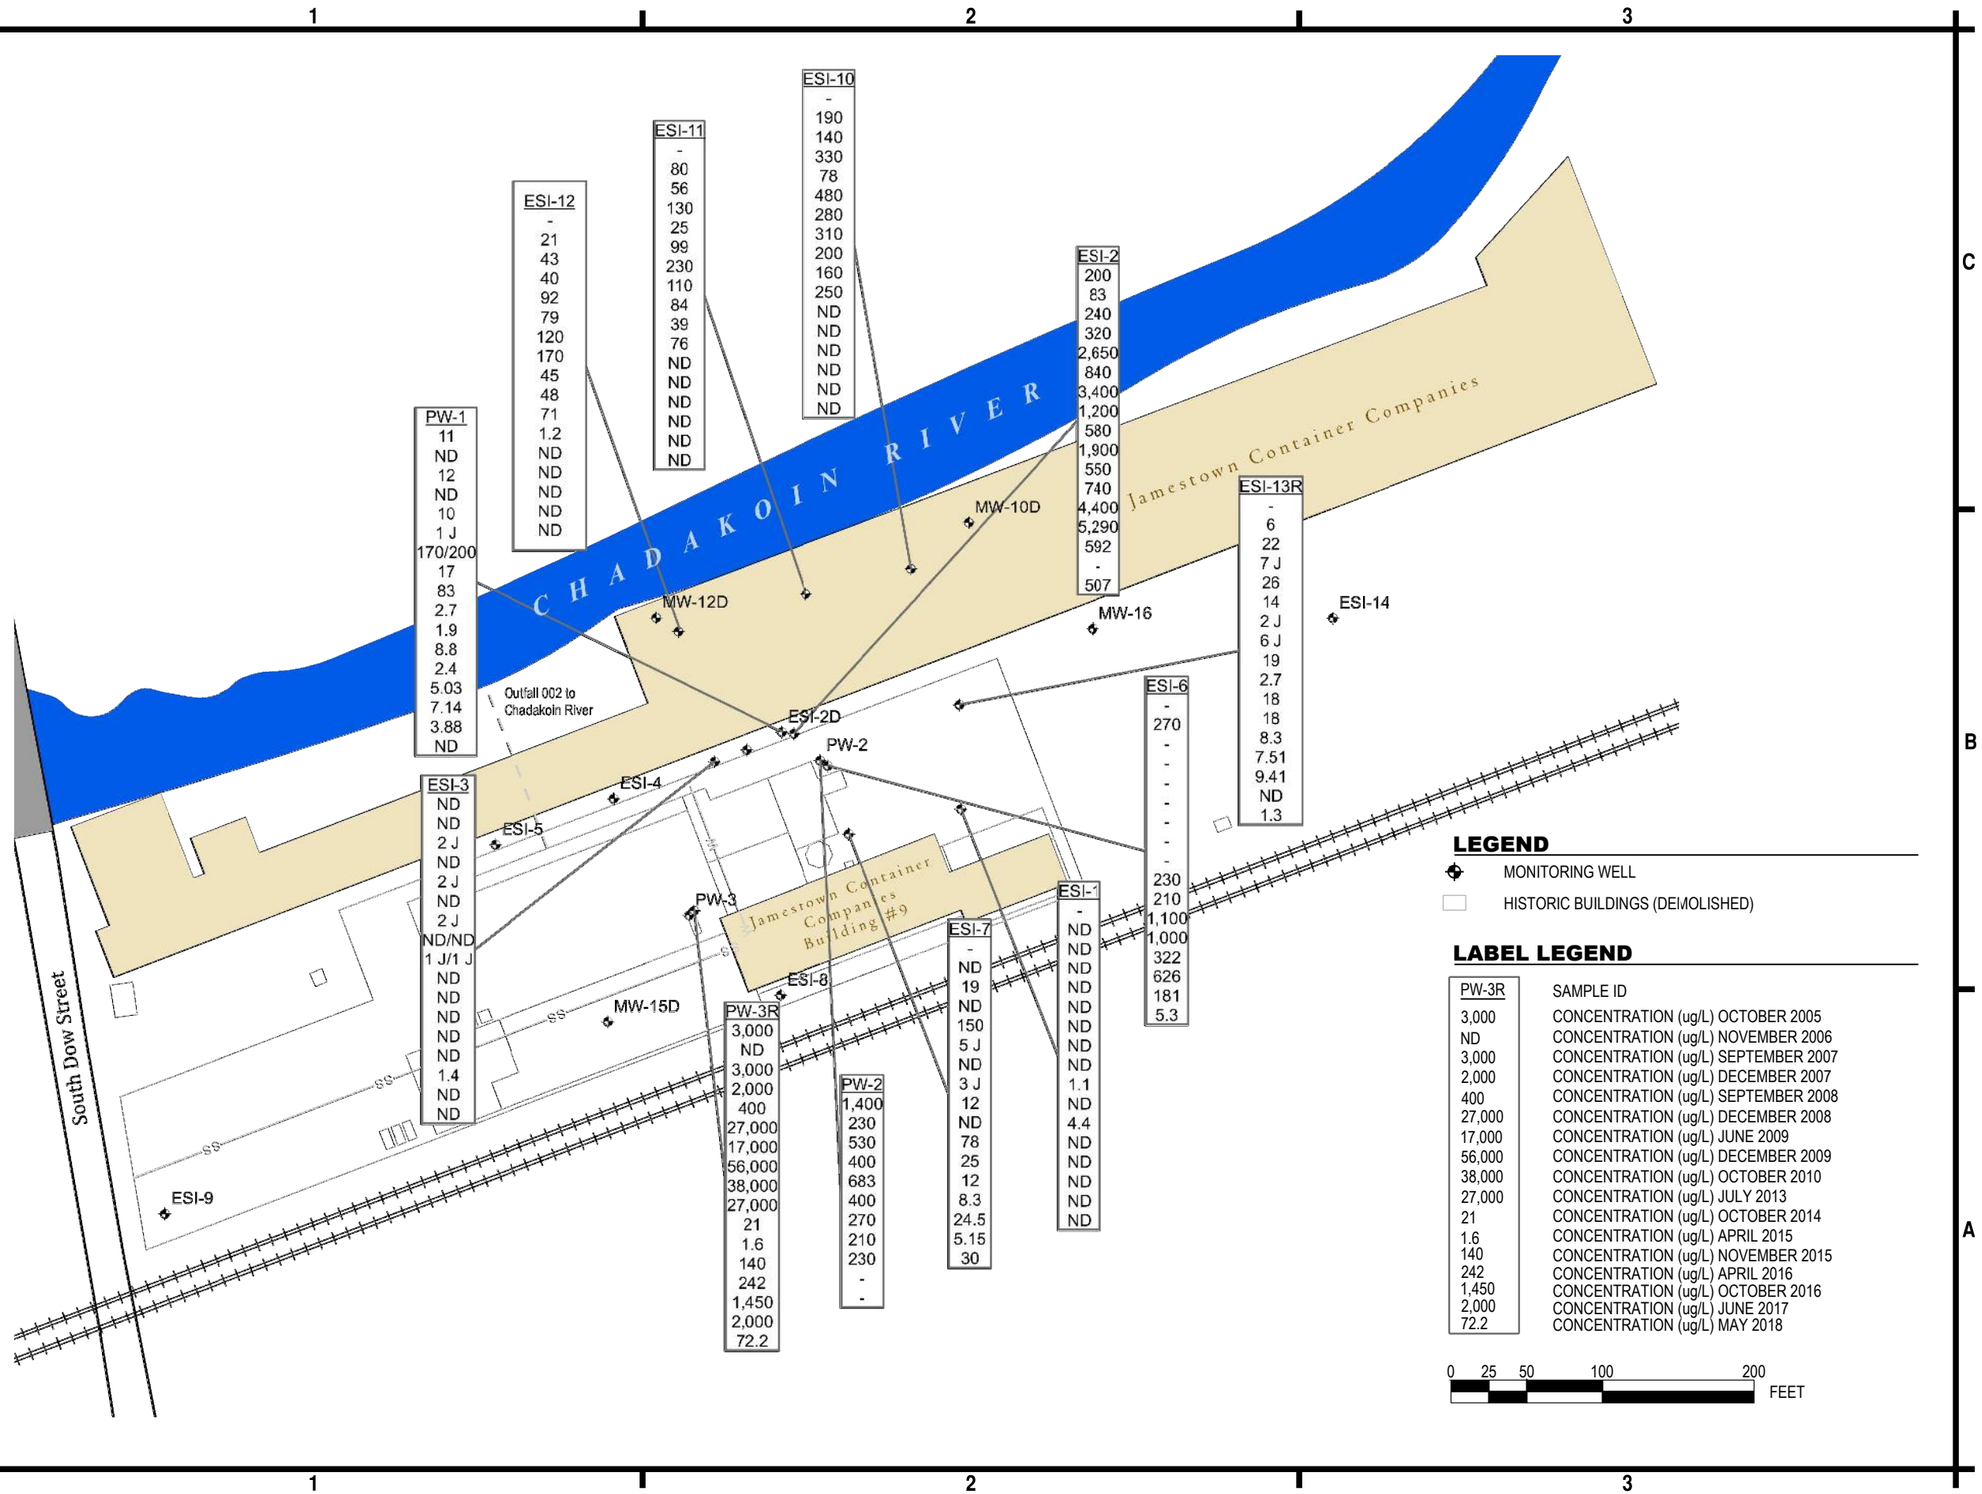
FIGURE 2

Historic concentrations of TCE and its daughter compounds from October 2005 to May 2018 are presented on **Figures 2, 3, and 4**. Laboratory analytical results are provided in **Appendix A**.

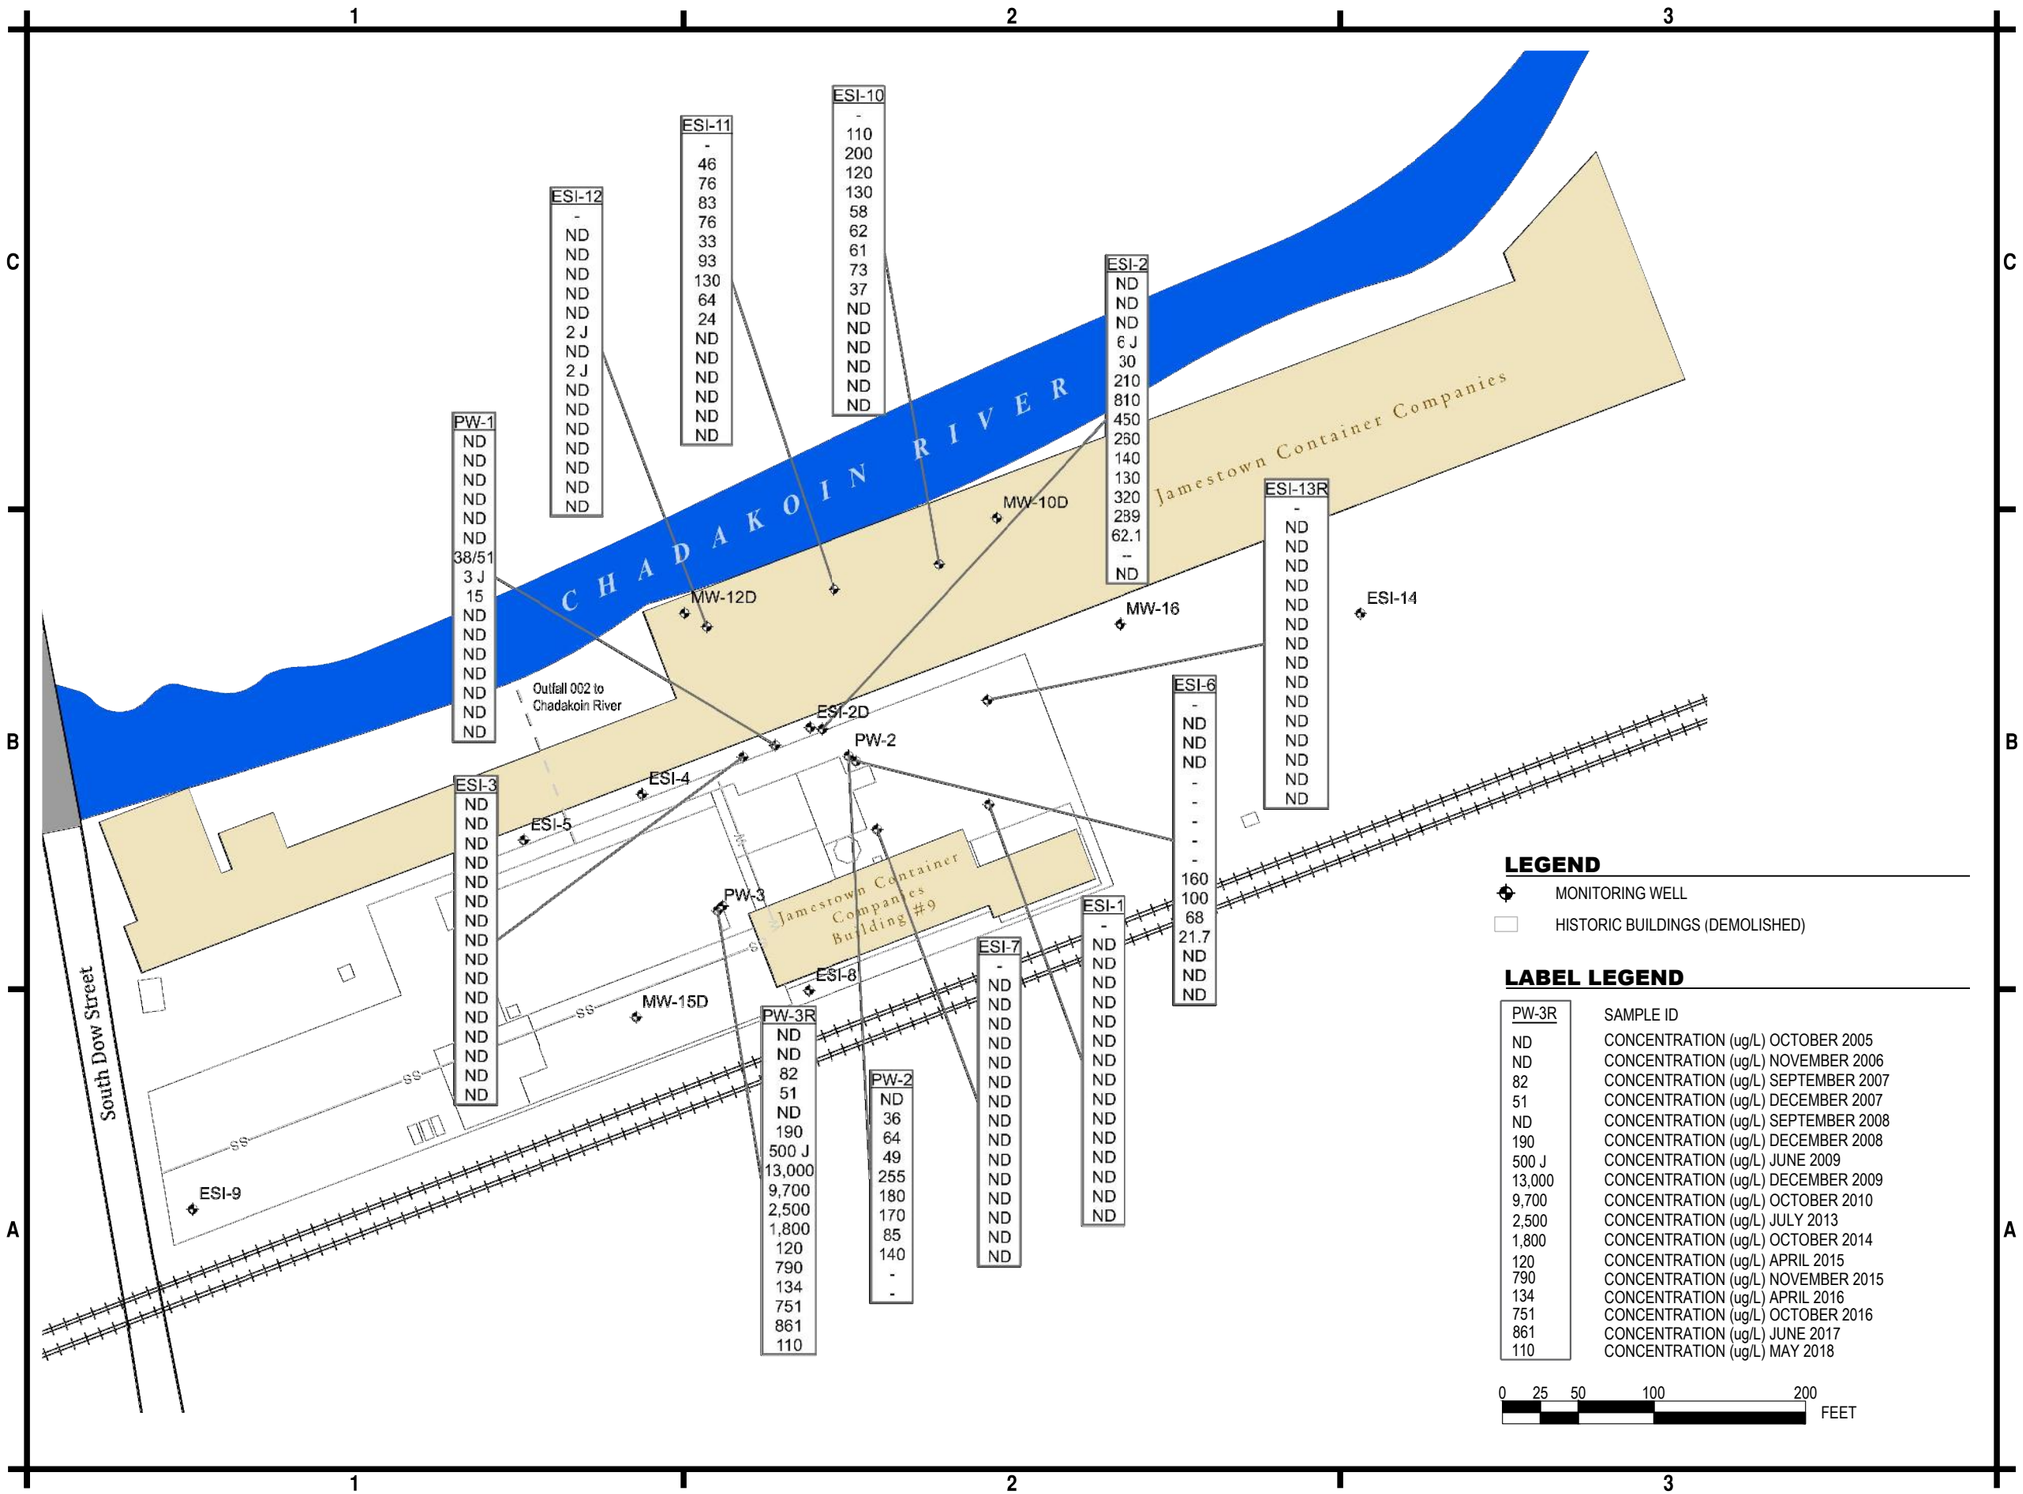
FIGURE 3

WELL CAP DAMAGED. SAMPLE NOT COLLCETED.

On May 7, 2018, Nature's Way Environmental repaired the two these groundwater monitoring wells. Other maintenance items completed by Nature's Way, but not identified by the previous Periodic Review Report include repair of the PVC raiser in ESI-7 and replacement of road boxes for ESI-13R and PW-3R.
