LIMITED SITE DATA REPORT

BENGART AND MEMEL SITE
NYSDEC SITE NO. 9-15-115
BUFFALO (C), ERIE COUNTY

SITE INVESTIGATION REPORT

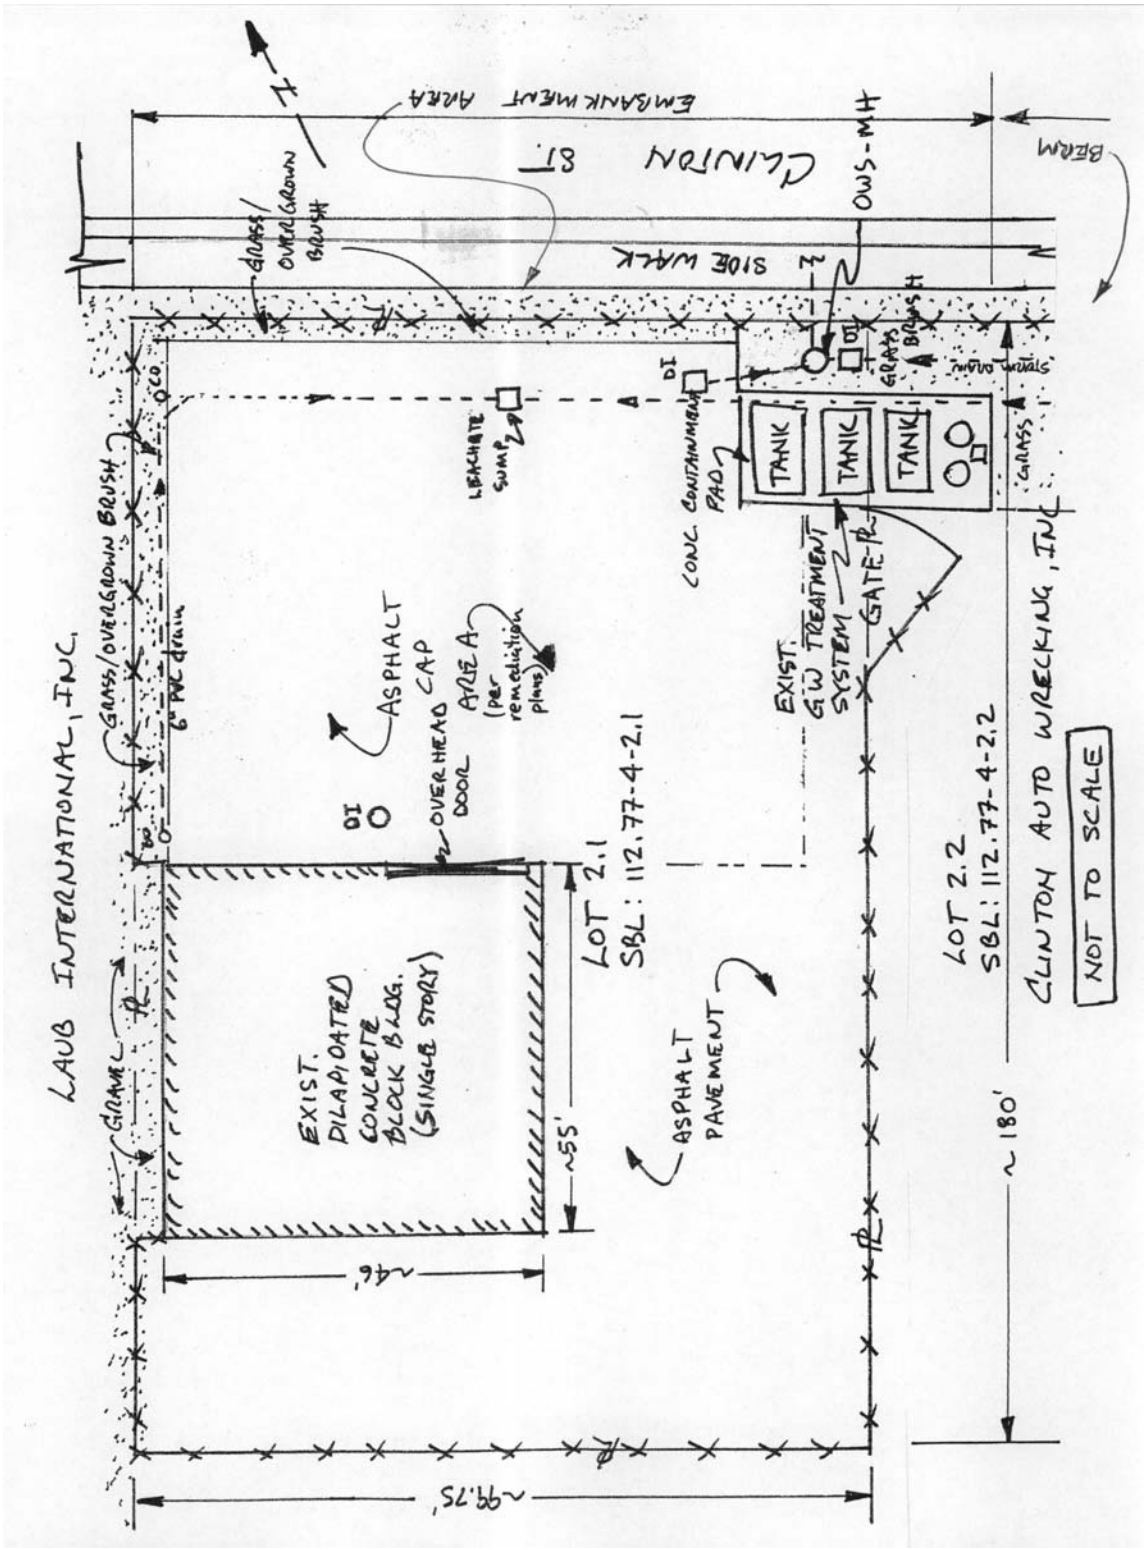
Detailed Site Plan **Figure 3**

collection system was batch treated by carbon adsorption prior to discharge to the City of Buffalo combined sewer system. The PCB contaminated area was paved with an asphalt cover to preclude contact with soil contaminated with residual PCBs (less than 50 ppm) and reduce infiltration of surface water to limit the generation of PCB contaminated groundwater. The asphalt cover was equipped with surface drains to capture and treat surface water via an oil water separator prior to discharge to the sanitary sewer. Refer to Figure 3 for the features described above.

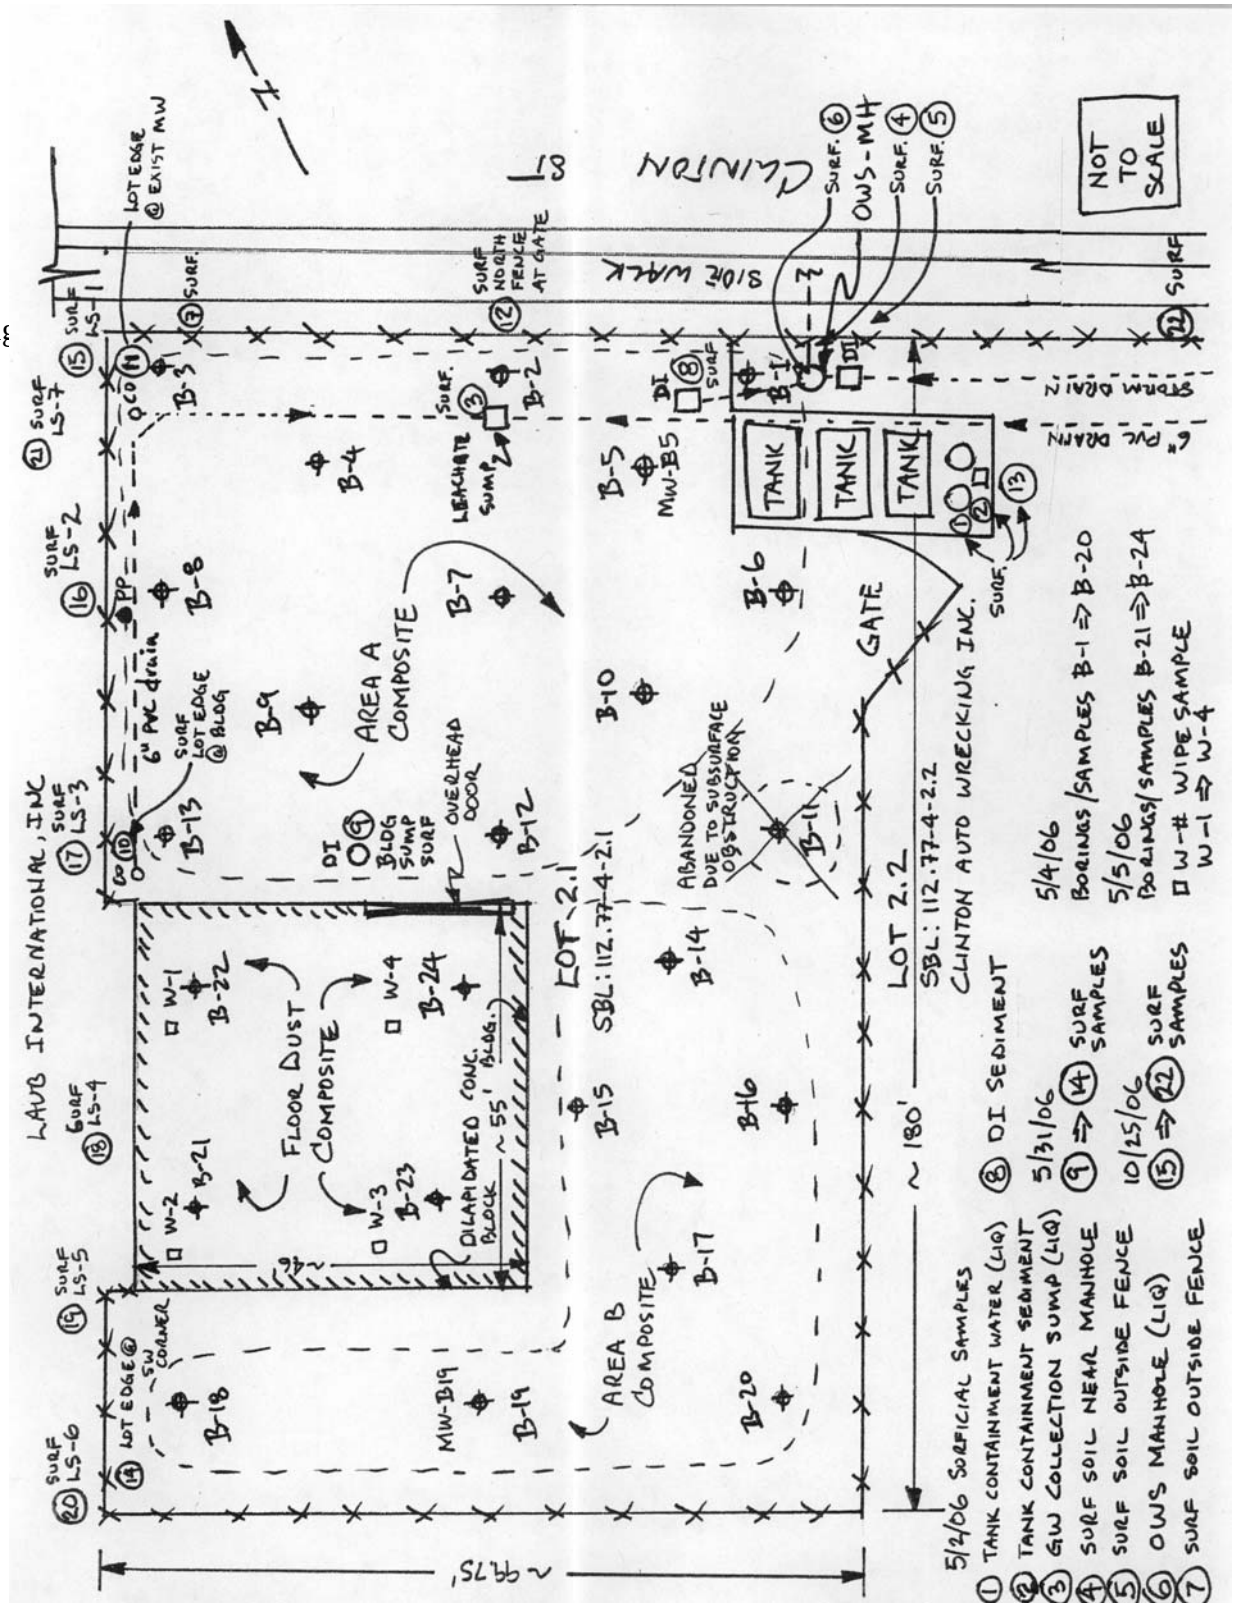
Site Investigation Plan **Figure 4**

Surface soil, sediment and water samples were collected from a total of 22 sampling points. An initial round of eight sampling points were sampled. Because of some elevated PCB levels found in an initial round of surface and sediment sampling, additional surface samples were collected from Lot 2.1. An additional sample consisting of a composite from floor dust inside the building was collected during this effort. Wipe samples were also collected from the concrete floor in the dilapidated building to assess the presence of PCBs in the floor surface. Following the receipt of the additional surface sampling results, eight additional surface sample points were sampled at offsite locations adjacent to Lot 2.1. Refer to Figure 4 for sampling locations.

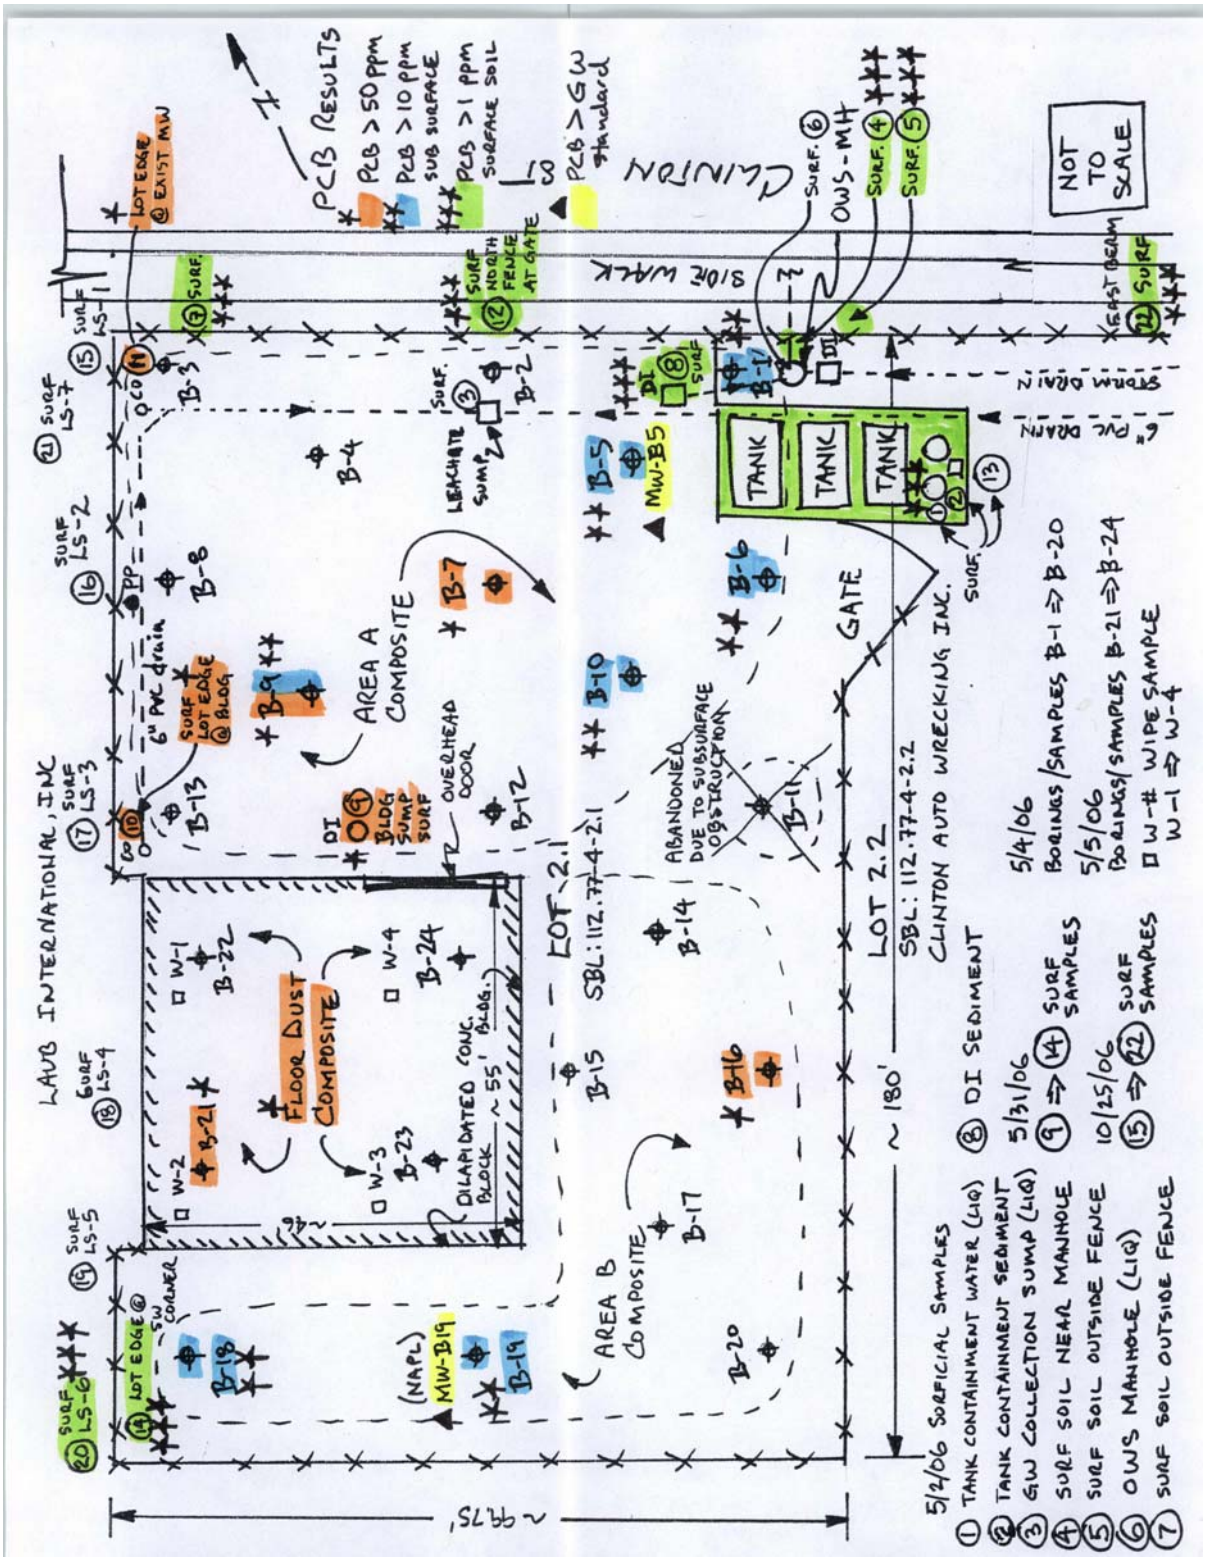
PCB Results Plan **Figure 5**

Fill materials from each boring were sampled for PCB analysis. Fill samples from B-4, B-5, B-6, B-9, and B-10 exceed the TAGM 4046 total PCB subsurface cleanup level of 10,000 ppb (11,000 to 37,200 ppb for total PCB's). Fill samples from B-7, and B-9 exceed the total PCB hazardous waste characteristic level of 50,000 ppb (70,600 and 69,000 ppb respectively). PCB results are presented in Table 1. The sampling locations with the elevated levels of PCBs are indicated on Figure 5.

Fill materials from each boring were sampled for PCB analysis. Fill samples from B-18 and B-19 exceed the total PCB TAGM 4046 subsurface cleanup level of 10,000 ppb (26,900 and 19,000 ppb for total PCB's, respectively). Fill sample from B-16 exceeded the total PCB hazardous waste characteristic level of 50,000 ppb (52,000 ppb). PCB results are presented in Table 1. The sampling locations with the elevated levels of PCBs are indicated on Figure 5.

Surface water samples were collected from three sample location points including the inactive groundwater collection system sump (3), the oil water separator manhole(6) and the treatment system containment pad (1) and analyzed for PCBs. See Figure 4 for sample locations. The results for PCBs reveal the total PCB levels (82 ppb, 18.2 ppb, and 0.38 ppb, respectively) are above all groundwater and surface water standards for total PCBs (0.09 ppb). PCB results for water samples are presented in Table 5. The sampling locations with the elevated levels of PCBs are indicated on Figure 5.

The elevated levels of PCBs at the site is a cause of concern for both groundwater and surface exposure and migration. The existing groundwater collection system at the site that is required to capture PCB contaminated groundwater is not functional. Given the shallow groundwater levels at the site, and elevated grade, contaminated groundwater could potentially seep to the surface during prolonged damp periods and migrate offsite.

The elevated levels of PCBs at site surface areas are another cause for concern exposure and migration. There are either elevated levels above the surface standard and above the hazardous waste threshold in several areas around the lot, near the property boundaries, and areas outside fenced limits that are accessible to the general public. The western perimeter inside the fence limits are both above surface cleanup levels and hazardous waste levels. Sampling of surface soil beyond the Lot 2.1 on adjoining properties including the Laub property, the right-of-way area along the Clinton Street sidewalk, and on the Clinton Auto Wrecking property reveal limited PCBs at the. This represents a significant human health hazard to adjoining property owners due to potential dermal contact and respiratory inhalation of PCB laden dust. Surface samples collected outside the fence lot limits along the Clinton Street pedestrian sidewalk are above surface cleanup levels. This represents a significant human health hazard to the general due to potential dermal contact. Inside the site, there are PCB levels above surface cleanup levels and above hazardous waste levels that represent another human health and environment exposure. The surface material are exposed and uncontrolled and can migrate along the surface from wind and water erosion.

There are elevated levels of PCBs in subsurface horizons that are either above subsurface cleanup levels or above hazardous waste levels in both the remediated and non-remediated areas. Because there are no deed restrictions for the lot, there is no legal mechanism that would preclude disturbance, exposure and safe handling of PCB contaminated material at this site. The proximity of these elevated levels near property boundary formerly owned by B&M (now owned and operated by Clinton Auto Wrecking, a car dismantling operation) suggests that there may potentially be PCB contamination in areas formerly implied as free of PCB contamination. This may have been an assumption that was used by the Consent Order respondent to subdivide the former B&M property and sell off the portion of the site presumed to be absent of PCB contamination.
