2025-2026 Periodic Review Report
(Reporting Period: August 01, 2025 to August 01, 2026)

Bern Metal Corporation
22 Bender Avenue, City of Buffalo, New York
NYSDEC Site No. 915135

LaBella Project No. 2254330

September 2026

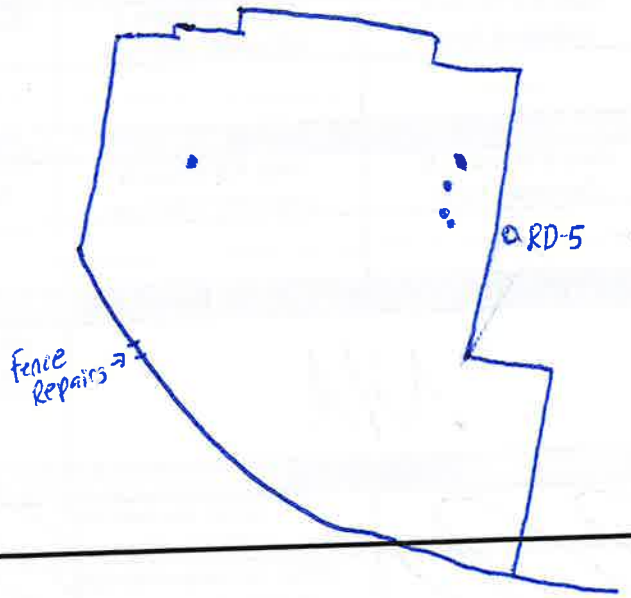
SITE SKETCH

General outline of site
• : holes encountered while conducting survey
