ecology and environment engineering and geology, p.c.
Environmental Specialists
BUFFALO CORPORATE CENTER
368 Pleasant View Drive
Lancaster, New York 14086
Tel: (716) 684-8060, Fax: (716) 684-0844

Re: Mr. C's Dry Cleaners Site, Contract # D007617, Site # 915157
November 2019 Operations, Maintenance, and Monitoring Report

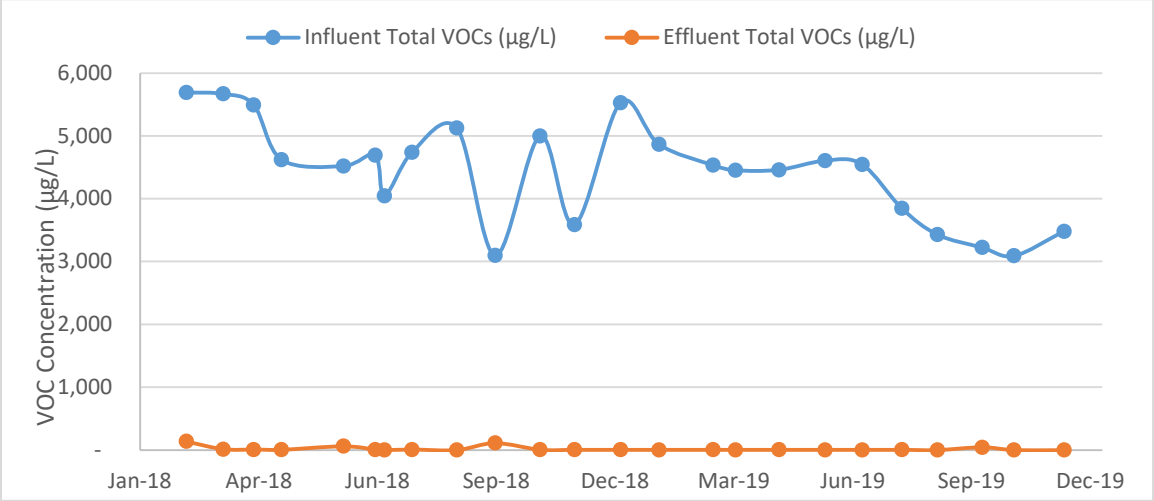
- The analytical summary results of the December 2, 2019 samples revealed the total volatile organic contaminant concentrations of the influent to be 3,603.0 µg/L and the concentration of total volatile organic contaminants in the effluent was 10.1 µg/L. The summary of influent and effluent contaminant concentrations for the November 2019 sampling are presented in Table 3. Figure 1 shows the influent and effluent VOC concentrations during each sampling event in 2018 and 2019.

Figure 1: Monthly Influent and Effluent VOC concentrations - 2018 and 2019.

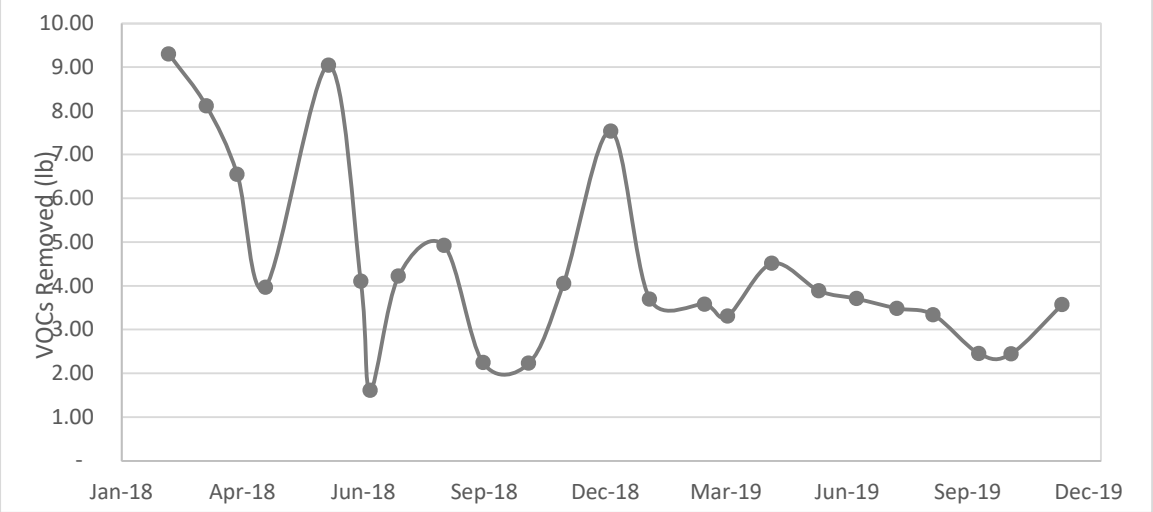
- The Mr. C's treatment system, based on the total flows from the uptime operations, removed 3.68 lbs. of targeted contaminants from the groundwater between November 1 to December 2, 2019. The cleanup effectiveness for November 2019 was approximately 99.7%. The calculations and data for the month are presented in Table 3. The mass of VOCs removed each month throughout 2018 and 2019 is shown in Figure 2.

Figure 2: Mass of VOCs removed each month - 2018 and 2019.
