Re: Mr. C's Dry Cleaners Site, Contract # D009807, Site # 915157
April 2021 Operations, Maintenance, and Monitoring Report

Ecology and Environment Engineering and Geology, P.C. (E&E) is pleased to provide the April 2021 Operations, Maintenance, and Monitoring (OM&M) Report for the Mr. C's Dry Cleaners Site, NYSDEC Site # 915157, located in the Village of East Aurora, New York.

Mr. C's CLEANERS OM&M

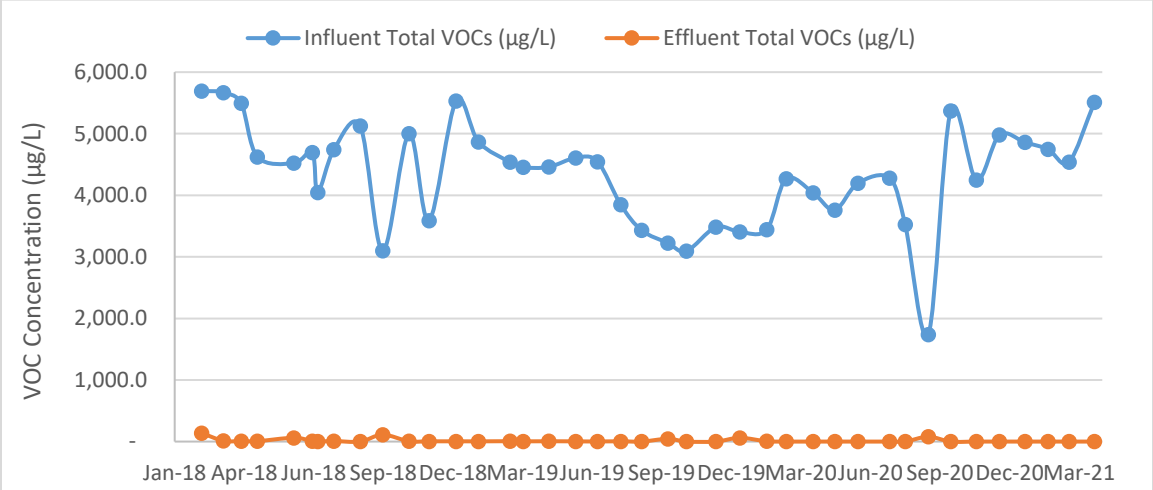
- The analytical summary results of the April 5, 2021 samples revealed the total volatile organic contaminant concentrations of the influent to be 5,514.0 µg/L and the concentration of total volatile organic contaminants in the effluent was 0.0 µg/L. The summary of influent and effluent contaminant concentrations for the April 2021 sampling are presented in Table 3. Figure 1 shows the influent and effluent VOC concentrations during each sampling event in 2018, 2019, 2020, and 2021.

Figure 1: Monthly Influent and Effluent VOC concentrations - 2018 - 2021.

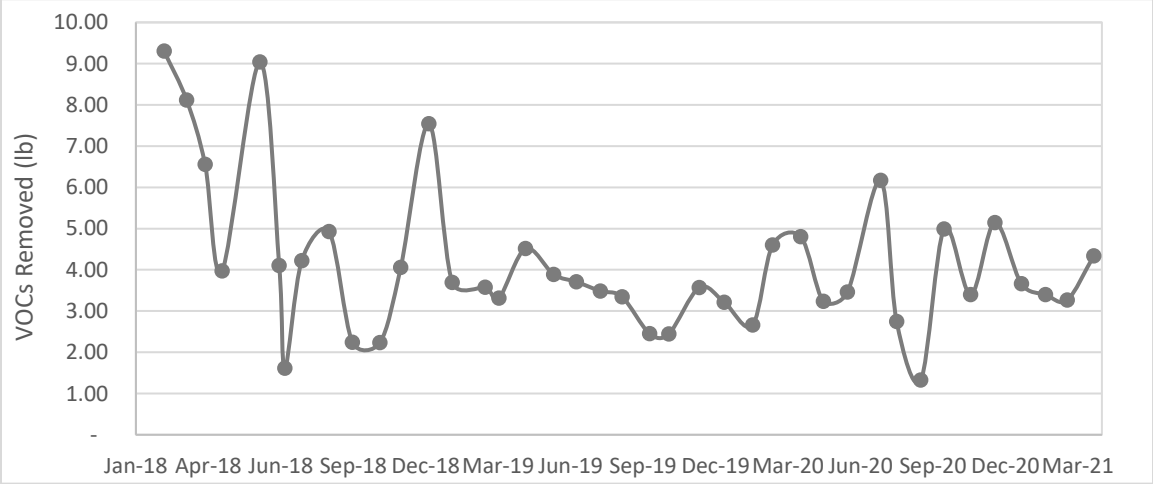
- The Mr. C's treatment system, based on the total flows from the uptime operations, removed 4.34 lbs. of targeted contaminants from the groundwater between March 30, 2021 through May 3, 2021. The cleanup effectiveness for April 2021 was

approximately 100%. The calculations and data for the month are presented in Table 3. The mass of VOCs removed each month throughout 2018, 2019, 2020, and 2021 is shown in Figure 2.

Figure 2: Mass of VOCs removed each month - 2018 - 2021.
