PERIODIC REVIEW REPORT (PRR)

INACTIVE LANDFILL AREA

SAINT GOBAIN ABRASIVES, INC.

FTA Report ET-14-703PRR

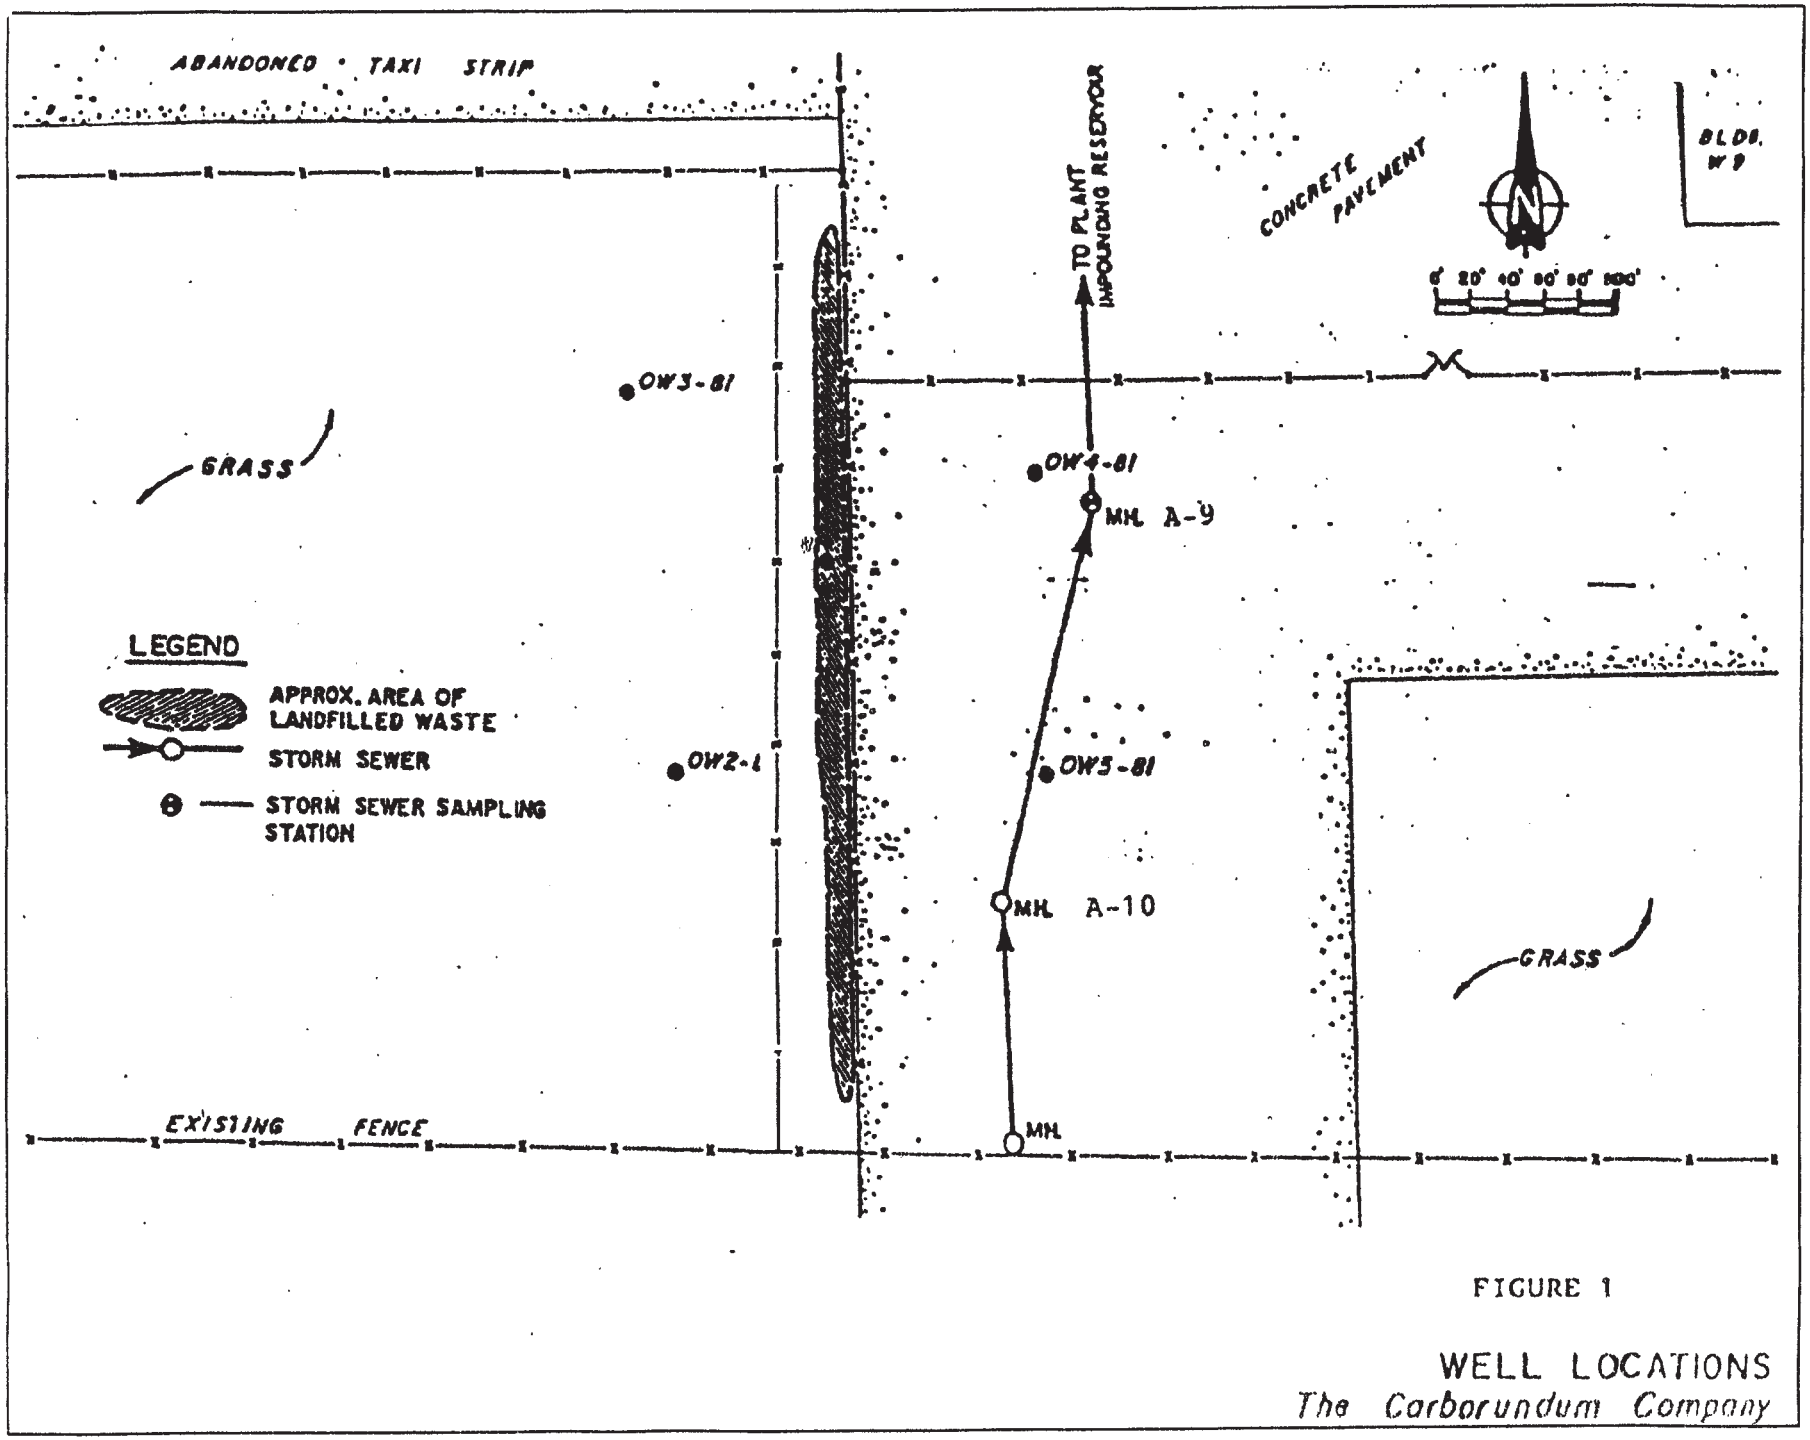
FIGURE 1

WELL LOCATIONS
The Carborundum Company

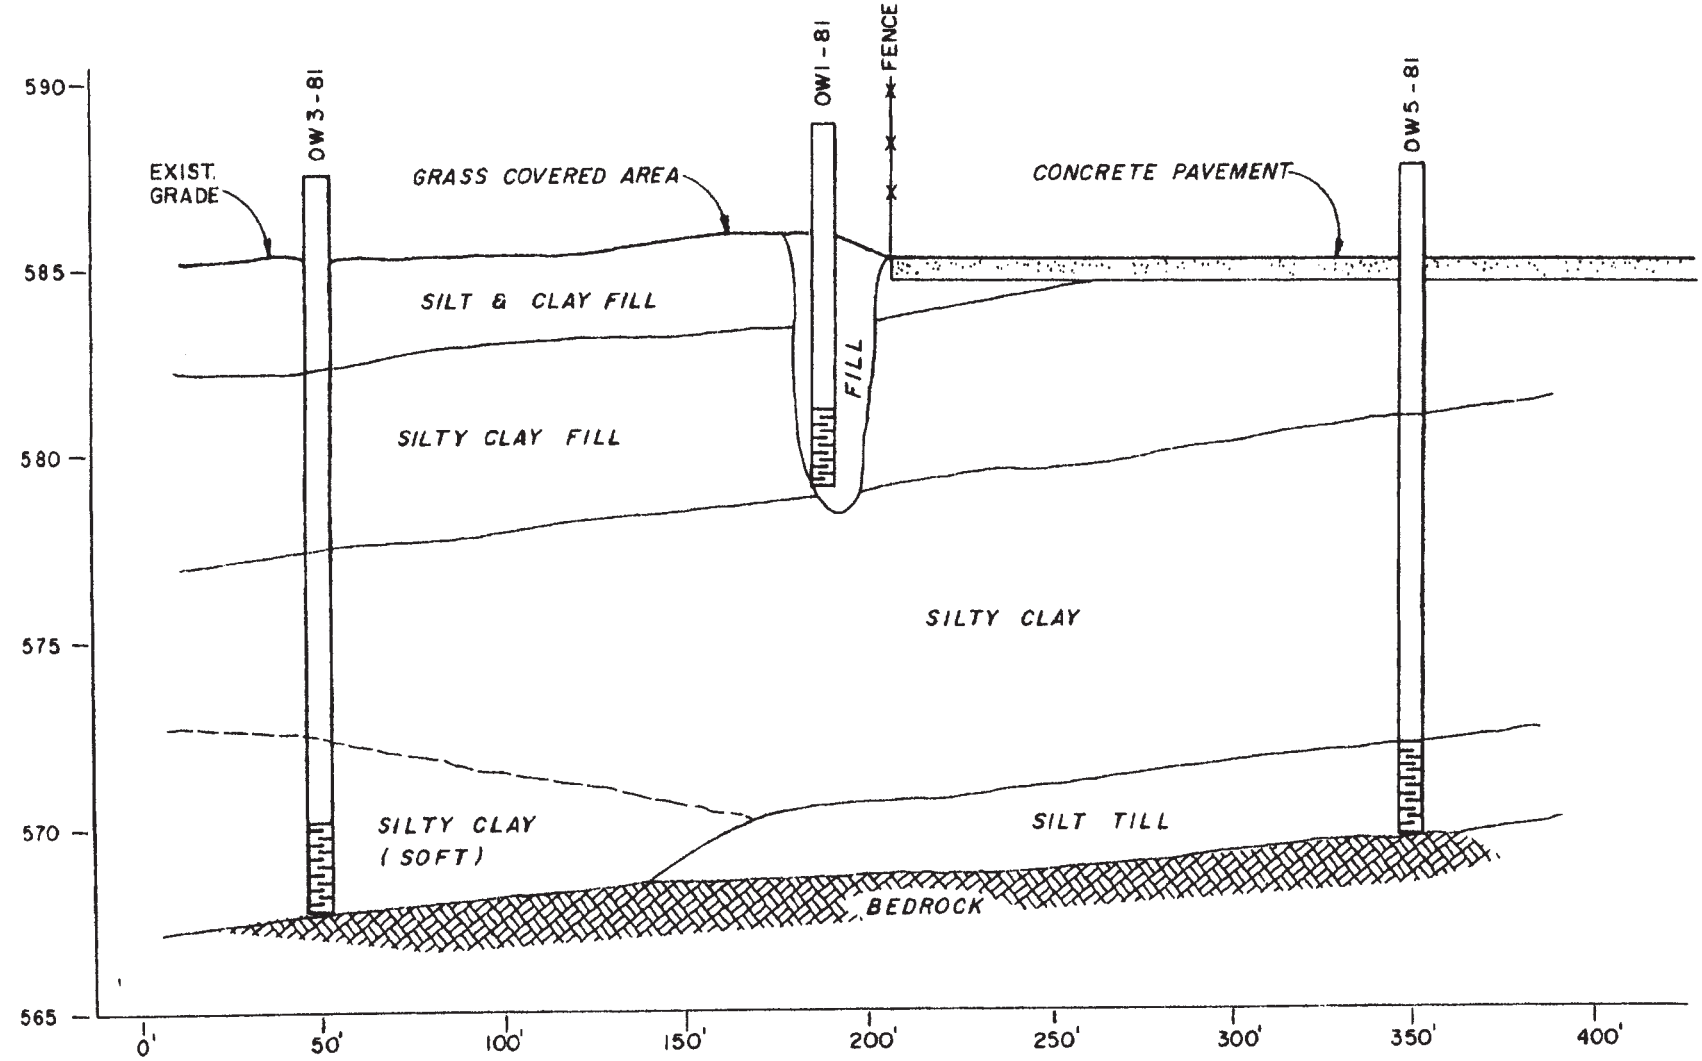
Figure 2

GEOLOGIC CROSS SECTION A - A'

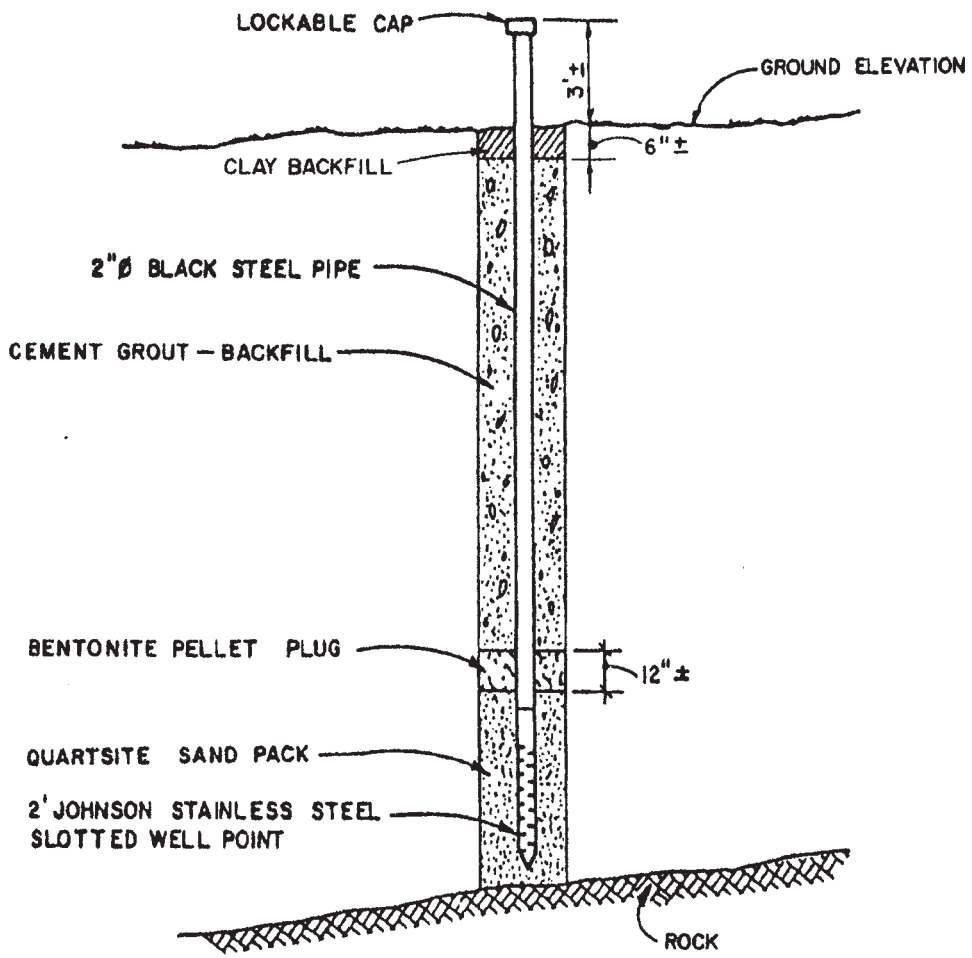
Figure 3

TYPICAL MONITORING
WELL INSTALLATIONS

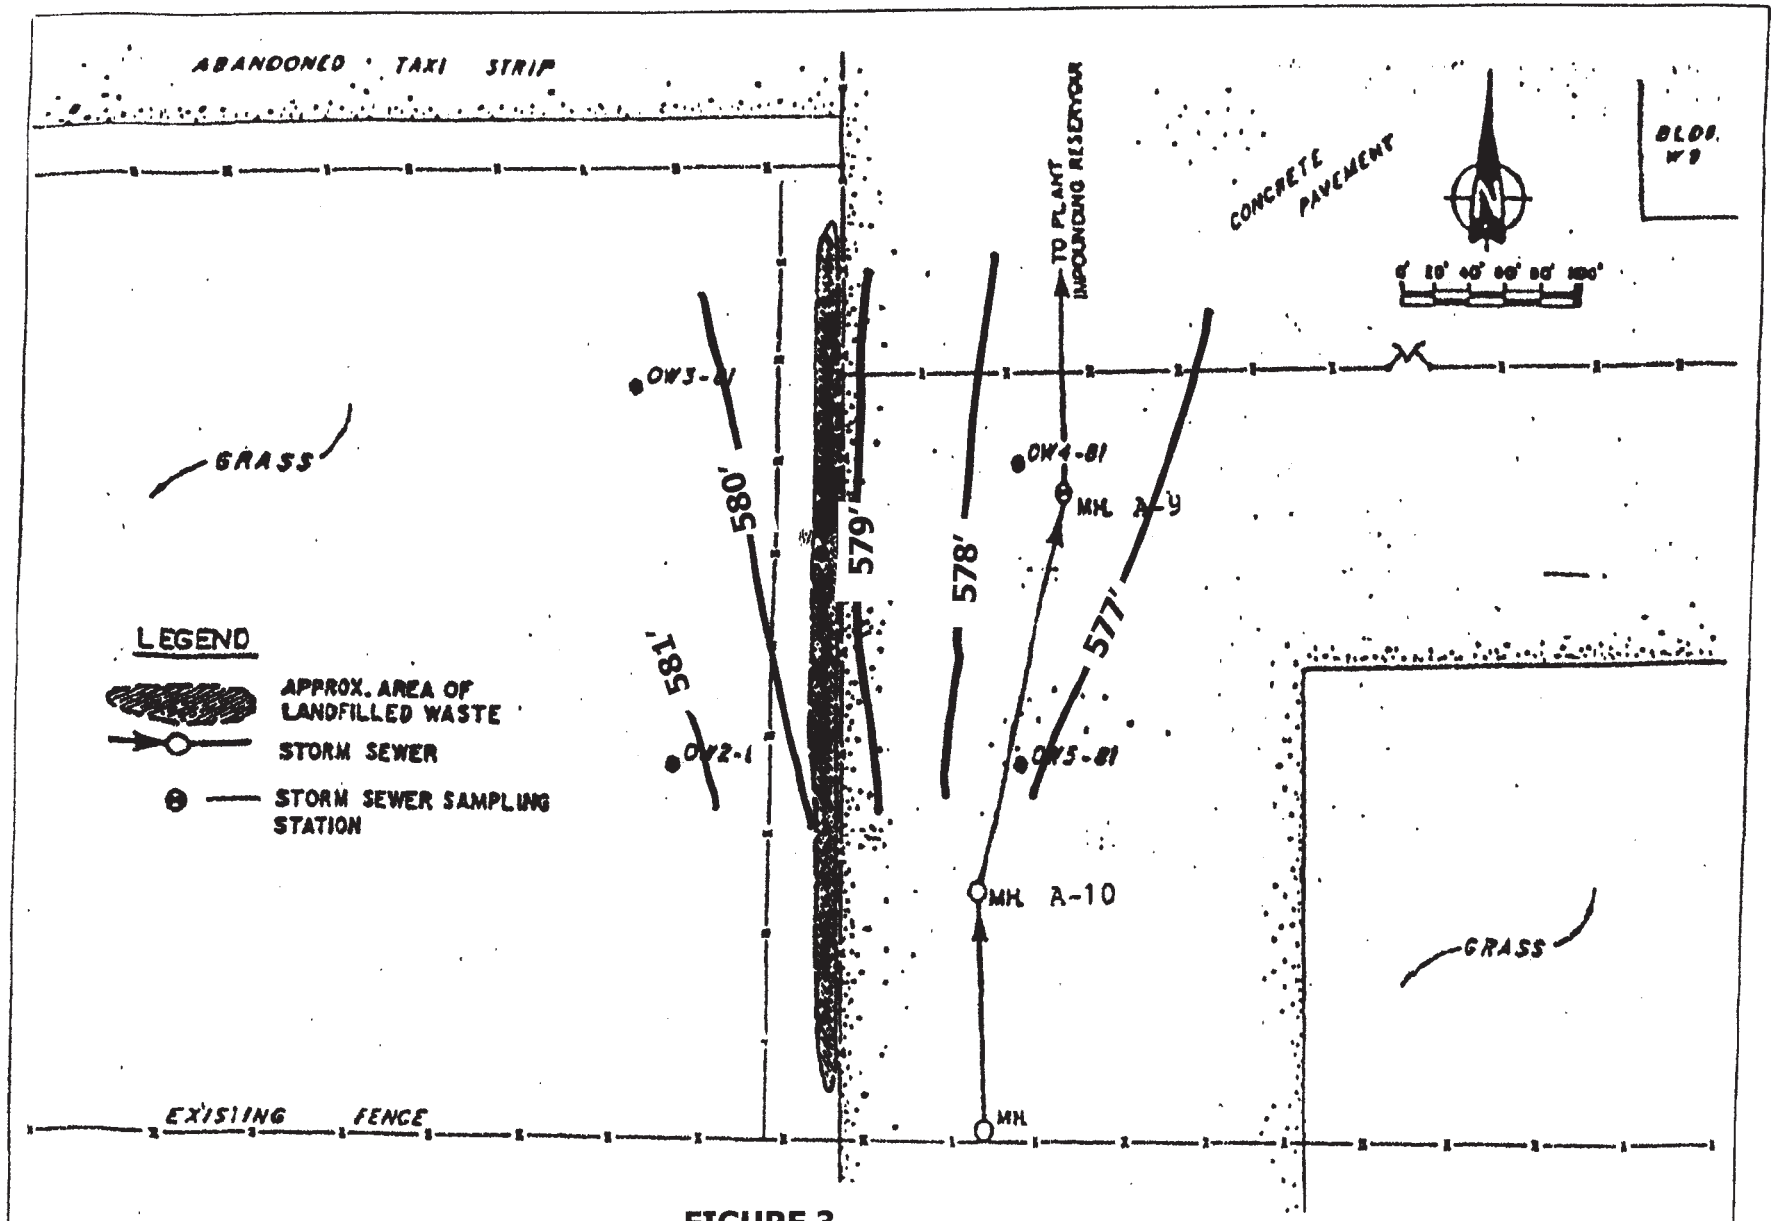
FIGURE 3.
PIEZOMETRIC SURFACE – GROUNDWATER ELEVATION CONTOURS
(August 16, 2013)
