DRAFT REPORT

TASK 1: DATA RECORDS SEARCH AND ASSESSMENT
PRELIMINARY SITE ASSESSMENT

GREAT LAKES CARBON
SITE NO. **932016**
NIAGARA COUNTY

SEPTEMBER 1990

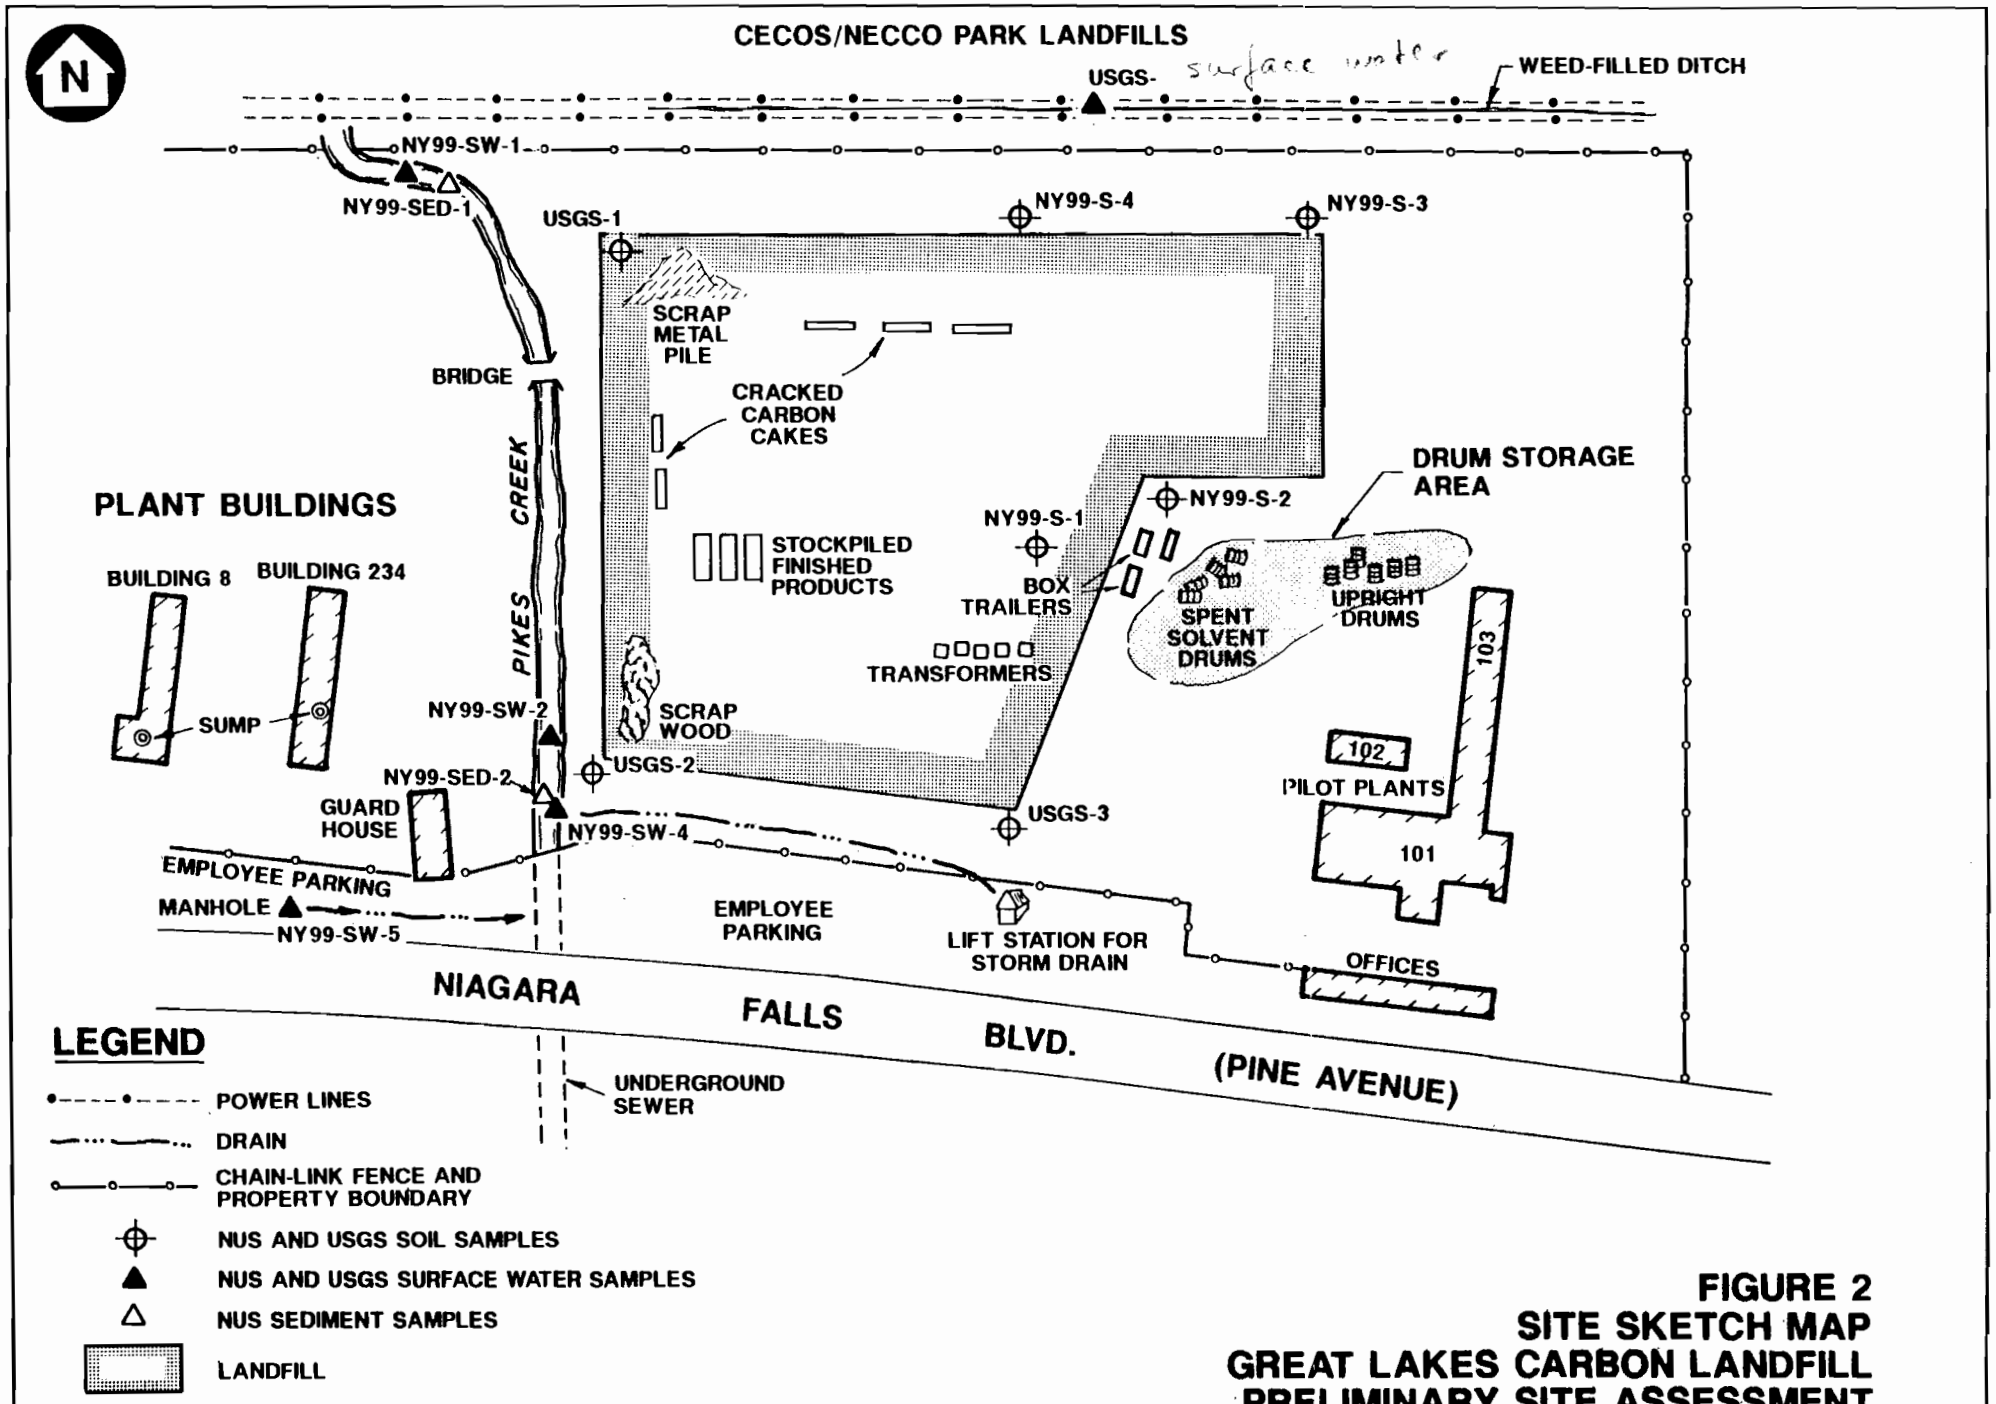
FIGURE 2
SITE SKETCH MAP
GREAT LAKES CARBON LANDFILL
PRELIMINARY SITE ASSESSMENT
NEW YORK STATE DEC

A sketch of the landfill portion of the site is shown as Figure 2. The Jordan team walked along Pikes Creek which abuts the western edge of the landfill area. An oil absorbent boom was observed in the creek in front of a stormwater outfall. This boom reportedly is used to trap oils from surface run-off during storm events and in the event of an oil spill. The water in Pikes Creek was observed as having a milky appearance.

The Jordan team entered the landfill area from the small bridge located on the northwestern edge of the site (Figure 2). A pile of scrap metal containing metal molds, equipment parts, and empty 55-gallon containers was observed. The empty containers, reportedly, contained raw product materials such as carbon fines. East and south of the metal pile were numerous pieces of carbon/graphite material that was cracked or defective. These items are reportedly reused and recycled by GLC. Much of the surface area of the landfill was graded and compacted but uncovered. Residual carbon/graphite fines were evident on the ground surface in many areas of the site. Jordan did not observe leachate outbreaks along the slopes of the landfill.

On the southern portion of the landfill Jordan observed finished graphite products, a scrap wood pile, and five transformers (Figure 2). Three of these transformers are, reportedly, to be removed off-site and the others kept on-site as spares (Reele, 1990).

East of the landfill area Jordan observed a drum storage area (Figure 2). Several containers, located next to parked box trailers, were observed on the ground. Most of the containers appeared to be empty, although some contained rainwater or residual

Jordan also observed several upright 55-gallon containers in the container storage area (Figure 2). These containers were uncovered and were observed to contain dust from dust collectors and lathe turnings from pilot plant operations. These materials are reportedly dumped into trash hoppers and removed by Modern Disposal Services.

The Jordan team toured portions of Buildings 234 and 8 located in the main manufacturing complex to observe sumps that collect and divert water from furnaces (Figure 2). The sumps and connecting drains are used to divert moisture and water away from the furnaces to prevent moisture damage in the carbon manufacturing process. Sump water is reportedly discharged to Pikes Creek. The sump in Building 234 is approximately 20 feet deep and reportedly contains groundwater from bedrock. HNU readings over this sump were less than 1 ppm. The sump in Building 8 is shallow and contains groundwater from the soils. The readings from the sump in this building was 15 ppm.
