2019 Periodic Review Report

Durez North Tonawanda
Interceptor Trench
NYSDEC Site No. 932018

Glenn Springs Holdings, Inc.

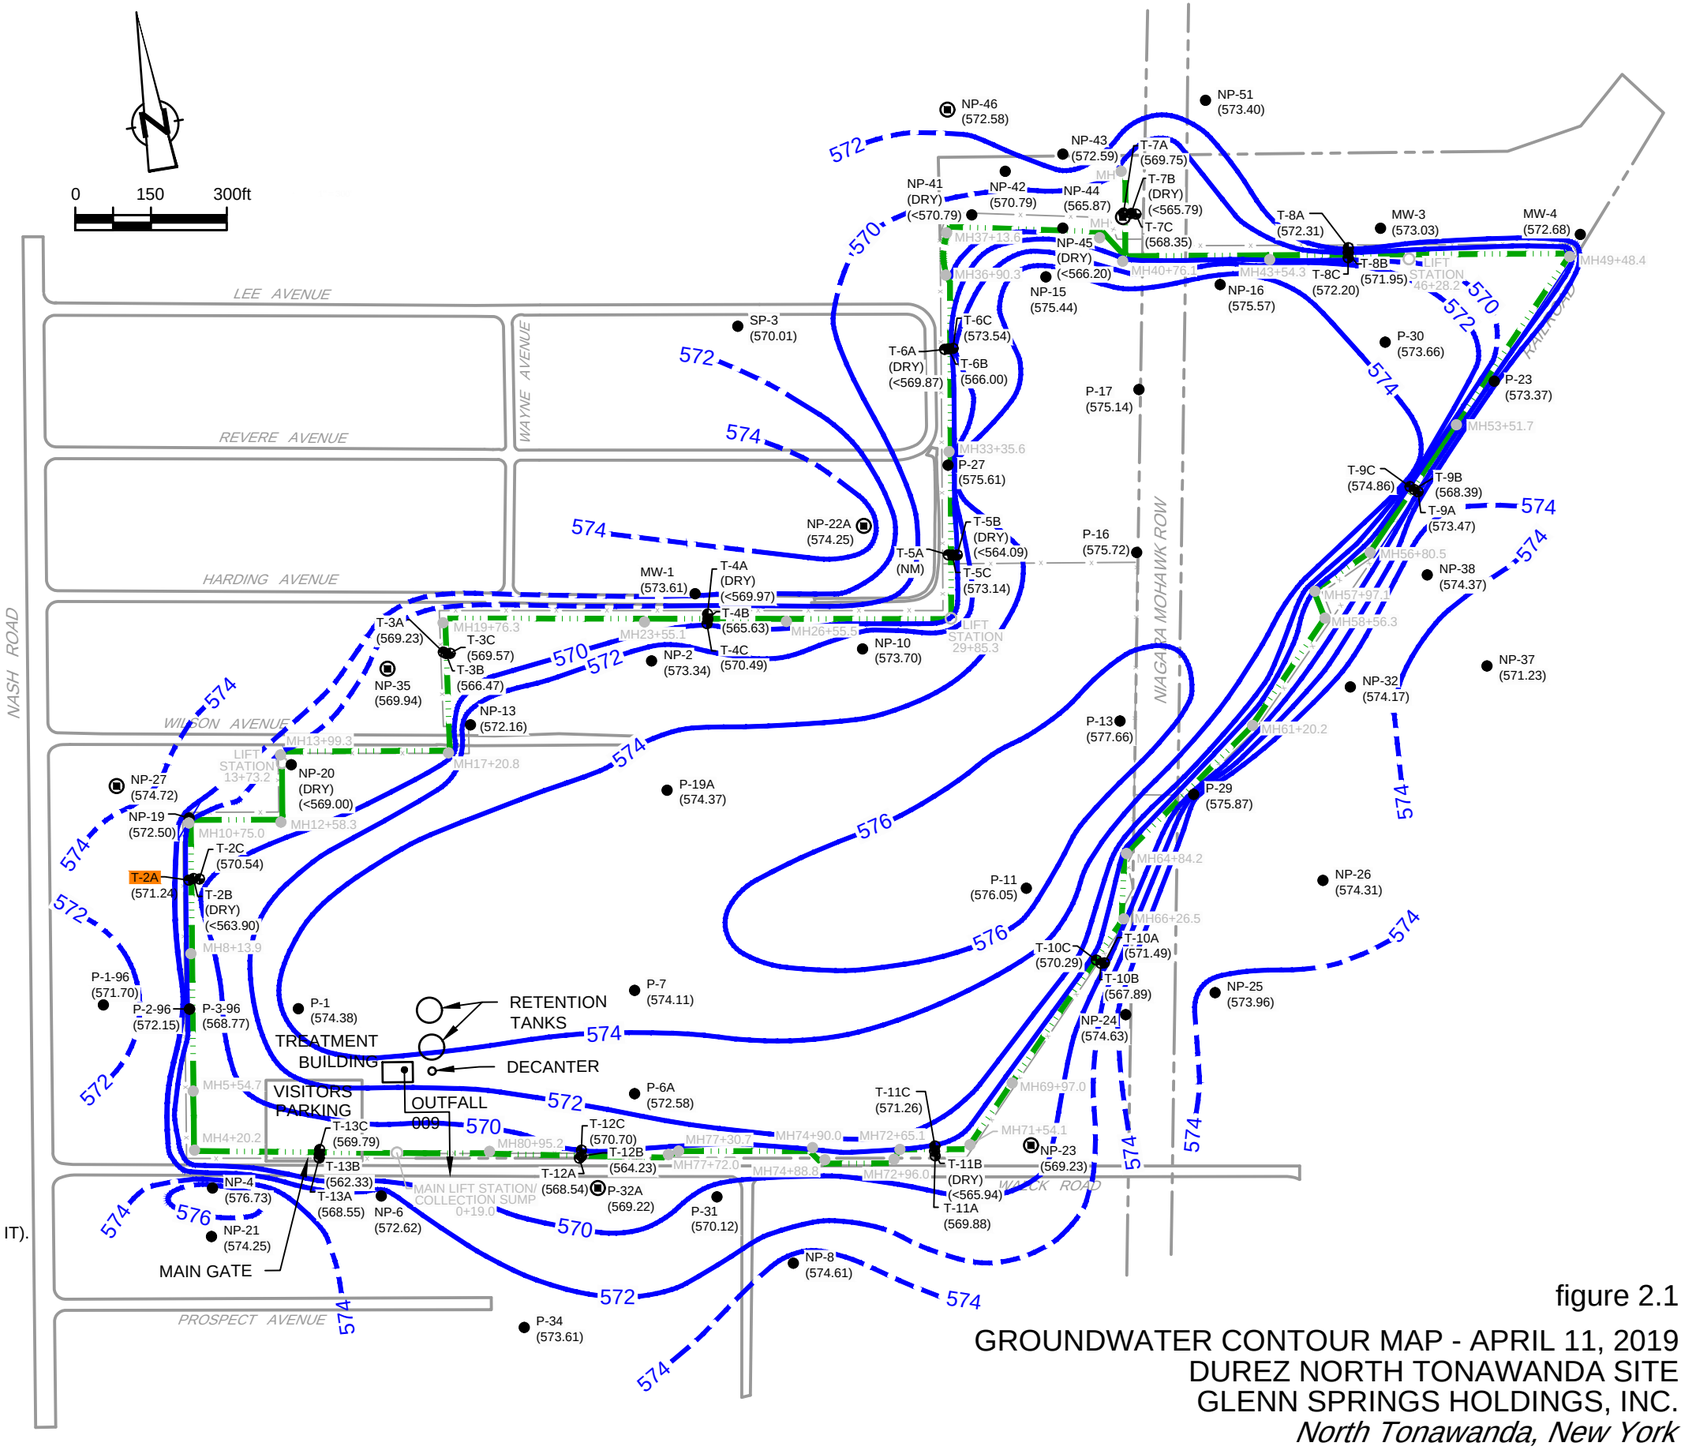
figure 2.1

During the April 11, 2019 hydraulic monitoring event (refer to Figure 2.1), an inward gradient was observed at all trench piezometers. At six piezometer arrays (T-2, T-4, T-5, T-6, T-7, and T-11), at least one of the piezometers in the array was dry. However, an inward gradient was still observed at each of these locations, as follows:

- When the observed depth of piezometer T-2B (563.90 feet above mean sea level [ft. AMSL]) is compared to the water elevation in piezometer T-2A (571.24 ft. AMSL), which is located directly outside of the IT, it is clear that an inward hydraulic gradient into the trench was present at this array.

- When the water elevation in piezometer T-4B (565.63 ft. AMSL) is compared to the water elevation in monitoring well MW-1 (573.61 ft. AMSL), which is located outside of the IT and in close proximity to array T-4, it is clear that an inward hydraulic gradient into the trench was present at this location.

- When the observed depth of piezometer T-5B (564.09 ft. AMSL) is compared to the water elevation in monitoring well NP-22A (574.25 ft. AMSL), which is located outside of the IT and in close proximity to array T-5, it is clear that an inward hydraulic gradient into the trench was present at this location. In addition, the water elevation in piezometer T-5C (573.14 ft. AMSL) located inside the IT is lower than the water elevation in NP-22A located outside of the IT.

- When the water elevation in piezometer T-6B (566.00 ft. AMSL) is compared to the water elevation in monitoring well SP-3 (570.01 ft. AMSL), which is located outside of the IT and in close proximity to array T-6, it is clear that an inward hydraulic gradient into the trench was present at this location.

- When the observed depth of piezometer T-7B (565.79 ft. AMSL) is compared to the water elevation in piezometer T-7A (569.75 ft. AMSL), which is located directly outside of the IT, it is clear that an inward hydraulic gradient into the trench was present at this array.

- When the observed depth of piezometer T-11B (565.94 ft. AMSL) is compared to the water elevation in piezometer T-11A (569.88 ft. AMSL), which is located directly outside of the IT, it is clear that an inward hydraulic gradient into the trench was present at this array.

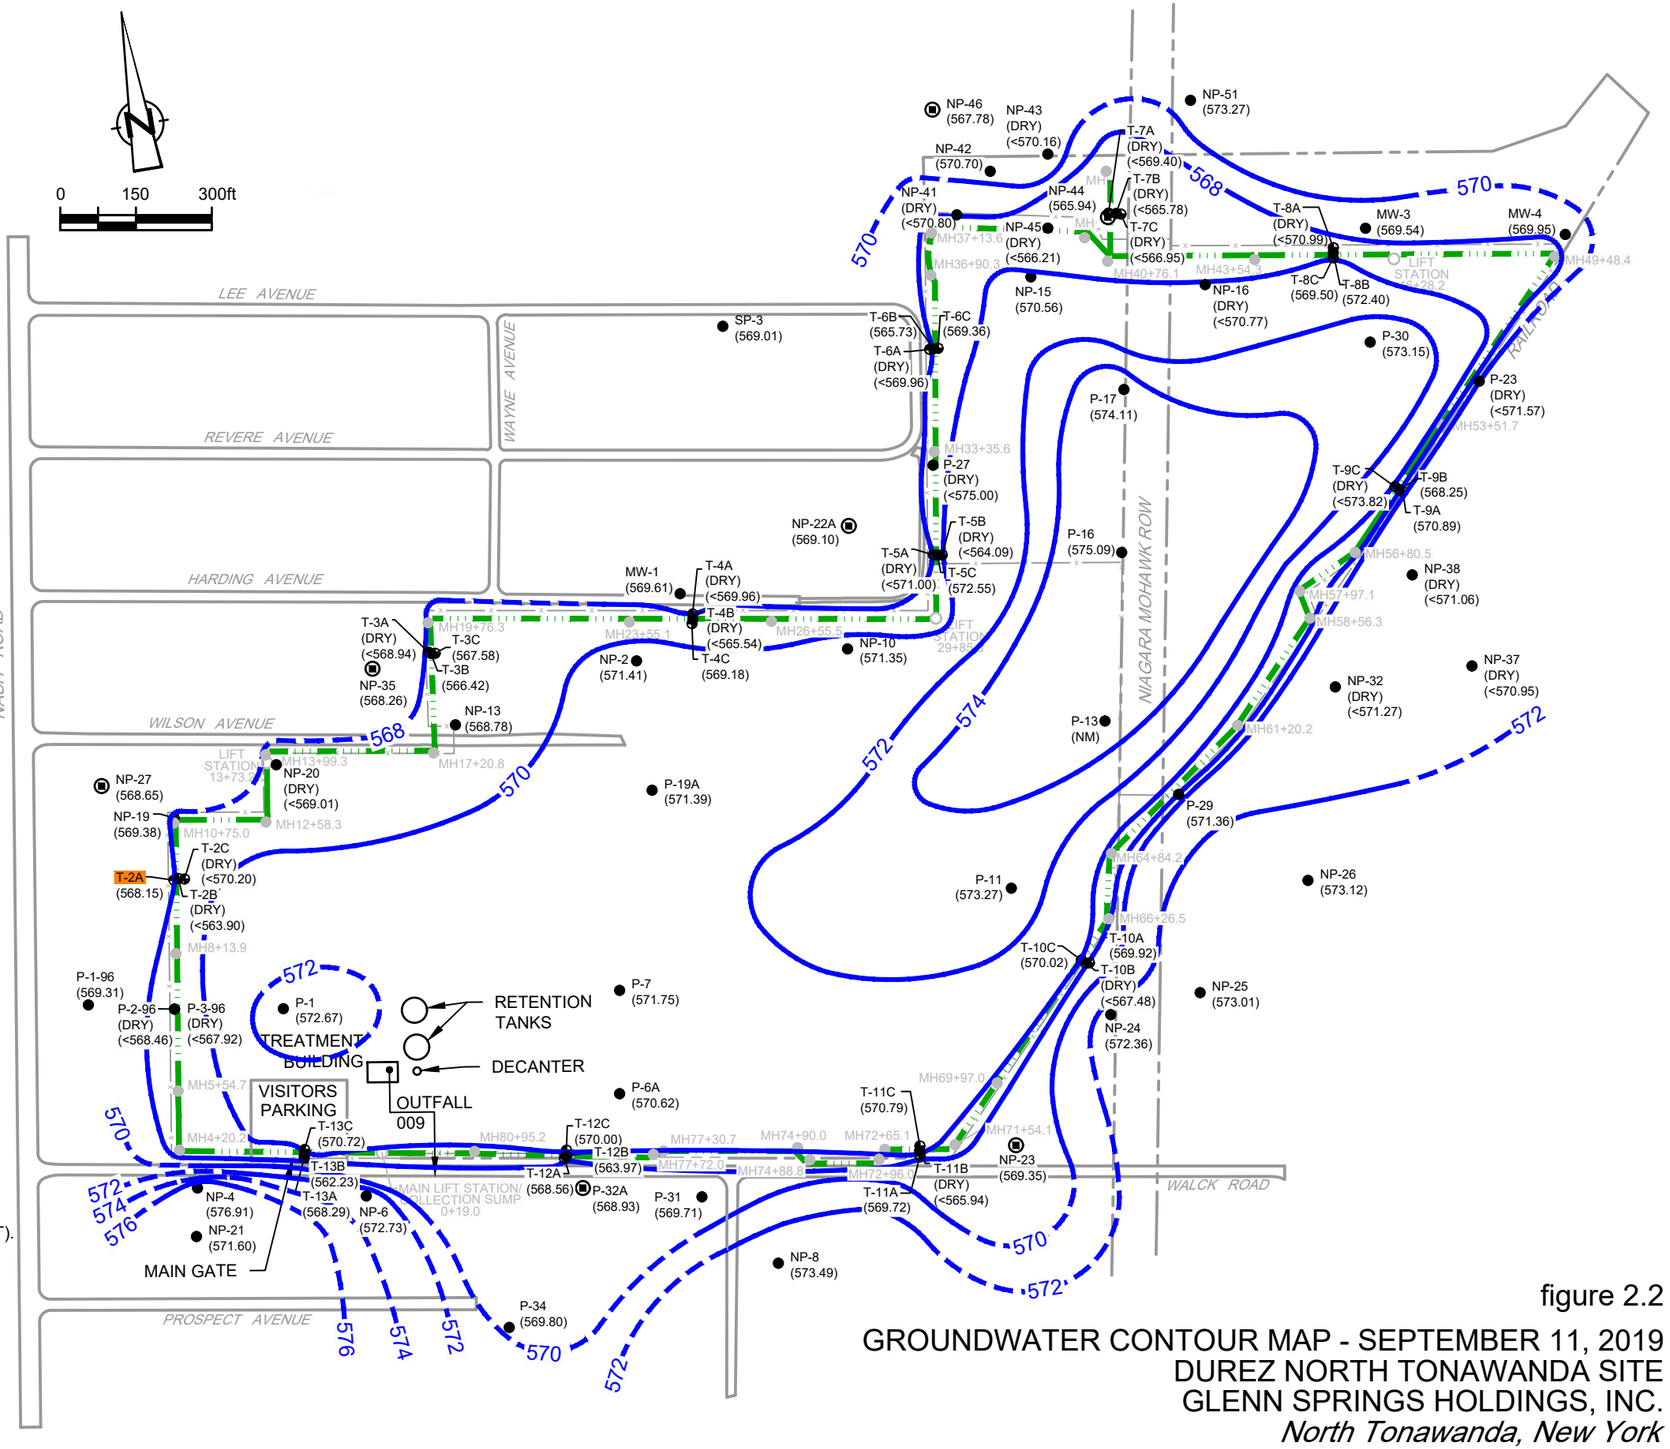
figure 2.2

During the September 11, 2019 hydraulic monitoring event (refer to Figure 2.2), an inward gradient was observed at the locations of all trench piezometer arrays. At 9 of the 13 piezometer arrays (T-2 through T-8, T-10, and T-11), at least one of the piezometers in the array was dry. However, an inward gradient was still observed at each of these locations, as follows:

- When the observed depth of piezometer T-2B (563.90 ft. AMSL) is compared to the water elevation in piezometer T-2A (568.15 ft. AMSL), which is located directly outside of the IT, it is clear that an inward hydraulic gradient into the trench was present at this array.
- When the water level elevation in piezometer T-3B (566.42 ft. AMSL) is compared to the water elevation in piezometer NP-35 (568.26 ft. AMSL), which is located outside of the IT and in close proximity to array T-3, it is clear that an inward hydraulic gradient into the trench was present at this location.

- When the observed depth of piezometer T-4B (565.54 ft. AMSL) is compared to the water elevation in monitoring well MW-1 (569.61 ft. AMSL), which is located outside of the IT and in close proximity to array T-4, it is clear that an inward hydraulic gradient into the trench was present at this location.

- When the observed depth of piezometer T-5B (564.09 ft. AMSL) is compared to the water elevation in piezometer NP-22A (569.10 ft. AMSL), which is located outside of the IT and in close proximity to array T-5, it is clear that an inward hydraulic gradient into the trench was present at this location.

- When the water elevation in piezometer T-6B (565.73 ft. AMSL) is compared to the water elevation in monitoring well SP-3 (569.01 ft. AMSL), which is located outside of the IT and in close proximity to array T-6, it is clear that an inward hydraulic gradient into the trench was present at this location.

- When the observed depth of piezometer T-7B (565.78 ft. AMSL) is compared to the water elevations in monitoring wells NP-51 (573.27 ft. AMSL) and NP-42 (570.70 ft. AMSL), which are located outside of the IT and in close proximity to array T-7, it is clear that an inward hydraulic gradient into the trench was present at this location.

- When the water elevation in piezometer T-8B (572.40 ft. AMSL) is compared to the water level elevation in monitoring well MW-3 (569.54 ft. AMSL), which is located outside of the IT and in close proximity to array T-8, and the observed depth of piezometer T-8A (570.99 ft. AMSL), which is located directly outside of the IT, it appears that an outward gradient away from the trench may have been present at this location. However, when these water elevations are compared to the water elevation in monitoring well NP-51 (573.27 ft. AMSL), which is located even farther outside of the IT and is also in close proximity to array T-8, an overall inward hydraulic gradient into the trench was apparent at this location. Furthermore, no evidence of chemical migration was observed at this location.

- When the observed depth of piezometer T-10B (567.48 ft. AMSL) is compared to the water elevation in piezometer T-10A (569.92 ft. AMSL), which is located directly outside of the IT, it is clear that an inward hydraulic gradient into the trench was present at this location.

- When the observed depth of piezometer T-11B (565.94 ft. AMSL) is compared to the water elevation in piezometer T-11A (569.72 ft. AMSL), which is located directly outside of the IT, it is clear that an inward hydraulic gradient into the trench was present at this array.

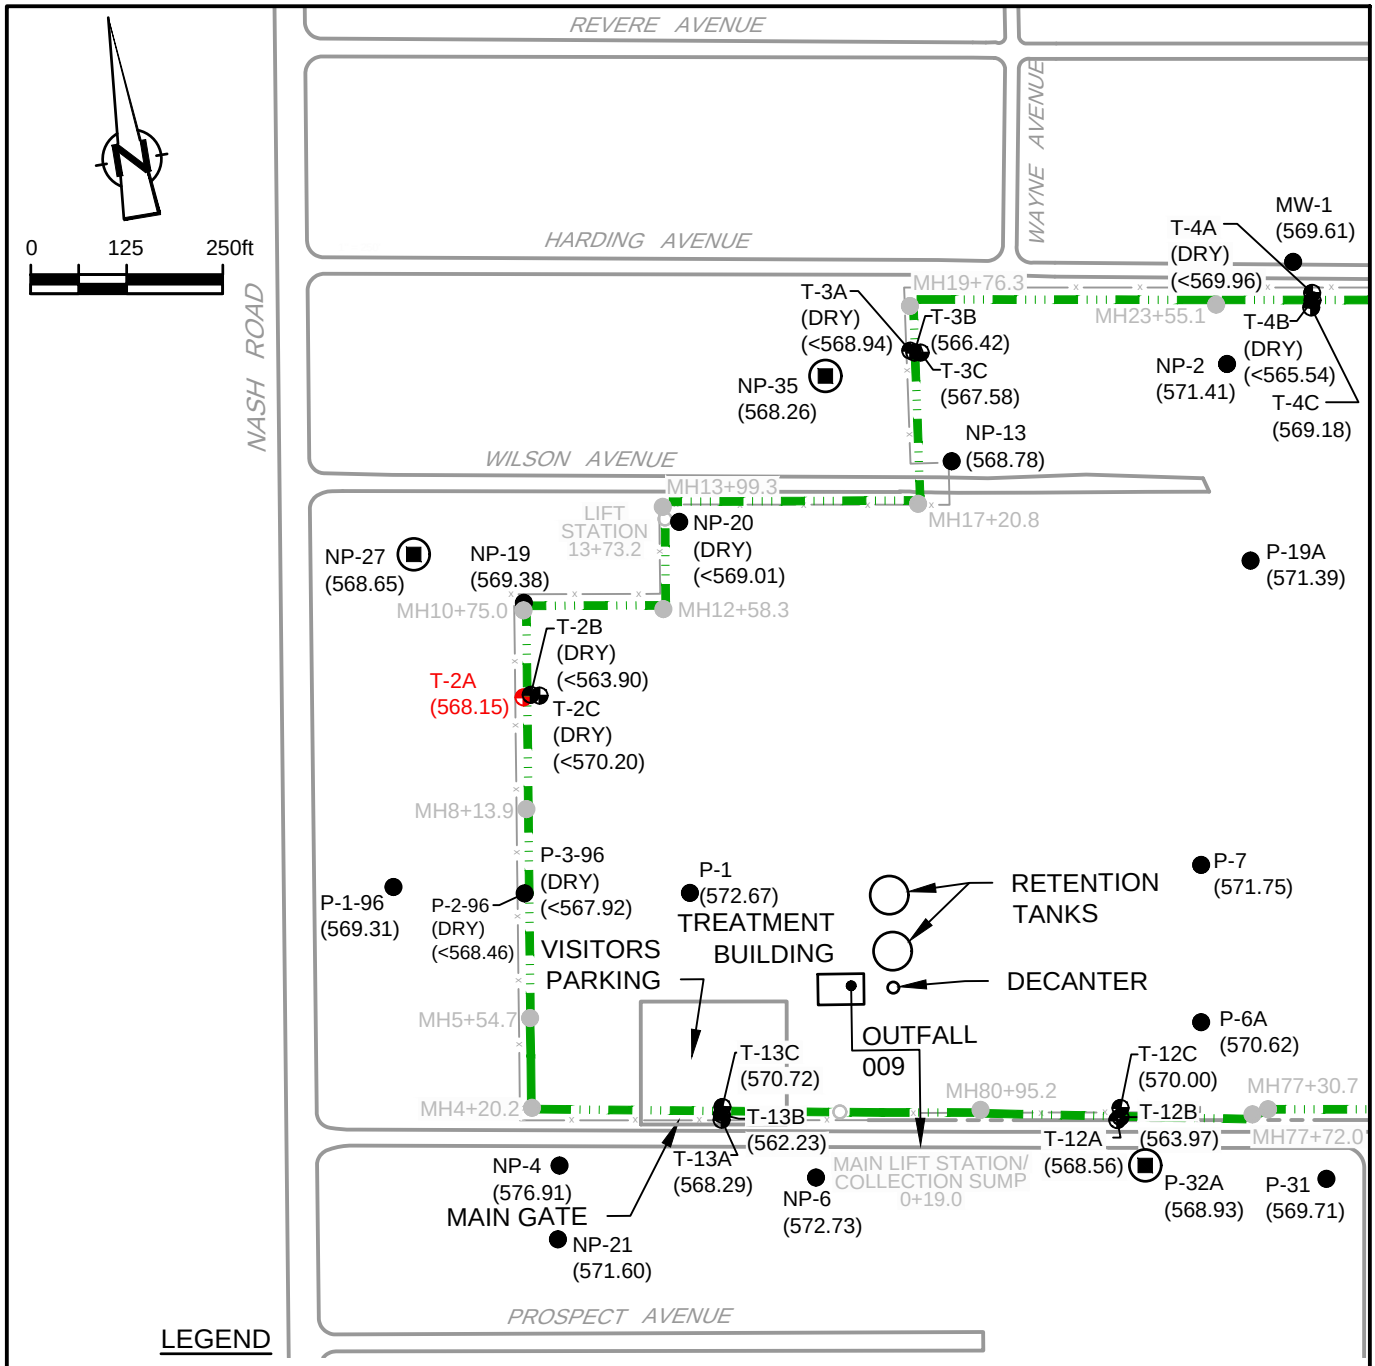
figure 2.3

During 2019, no NAPL was pumped from the T-2A piezometer (see Table 2.3) as the thickness was insufficient to allow for pumping. Table 2.4 presents the semiannual hydraulic monitoring at T-2A and surrounding monitoring wells. Water elevations in these wells and piezometers from the April 11 and September 11, 2019 monitoring events are shown on Figures 2.3 and 2.4, respectively. These elevations demonstrate the presence of an inward gradient in this area as indicated by a lower groundwater elevation in T-2A than monitoring wells farther outside of the IT than T-2A (i.e., P-1-96 and NP-27).
