2020 Periodic Review Report

Durez North Tonawanda
Interceptor Trench
NYSDEC Site No. 932018

Glenn Springs Holdings, Inc.

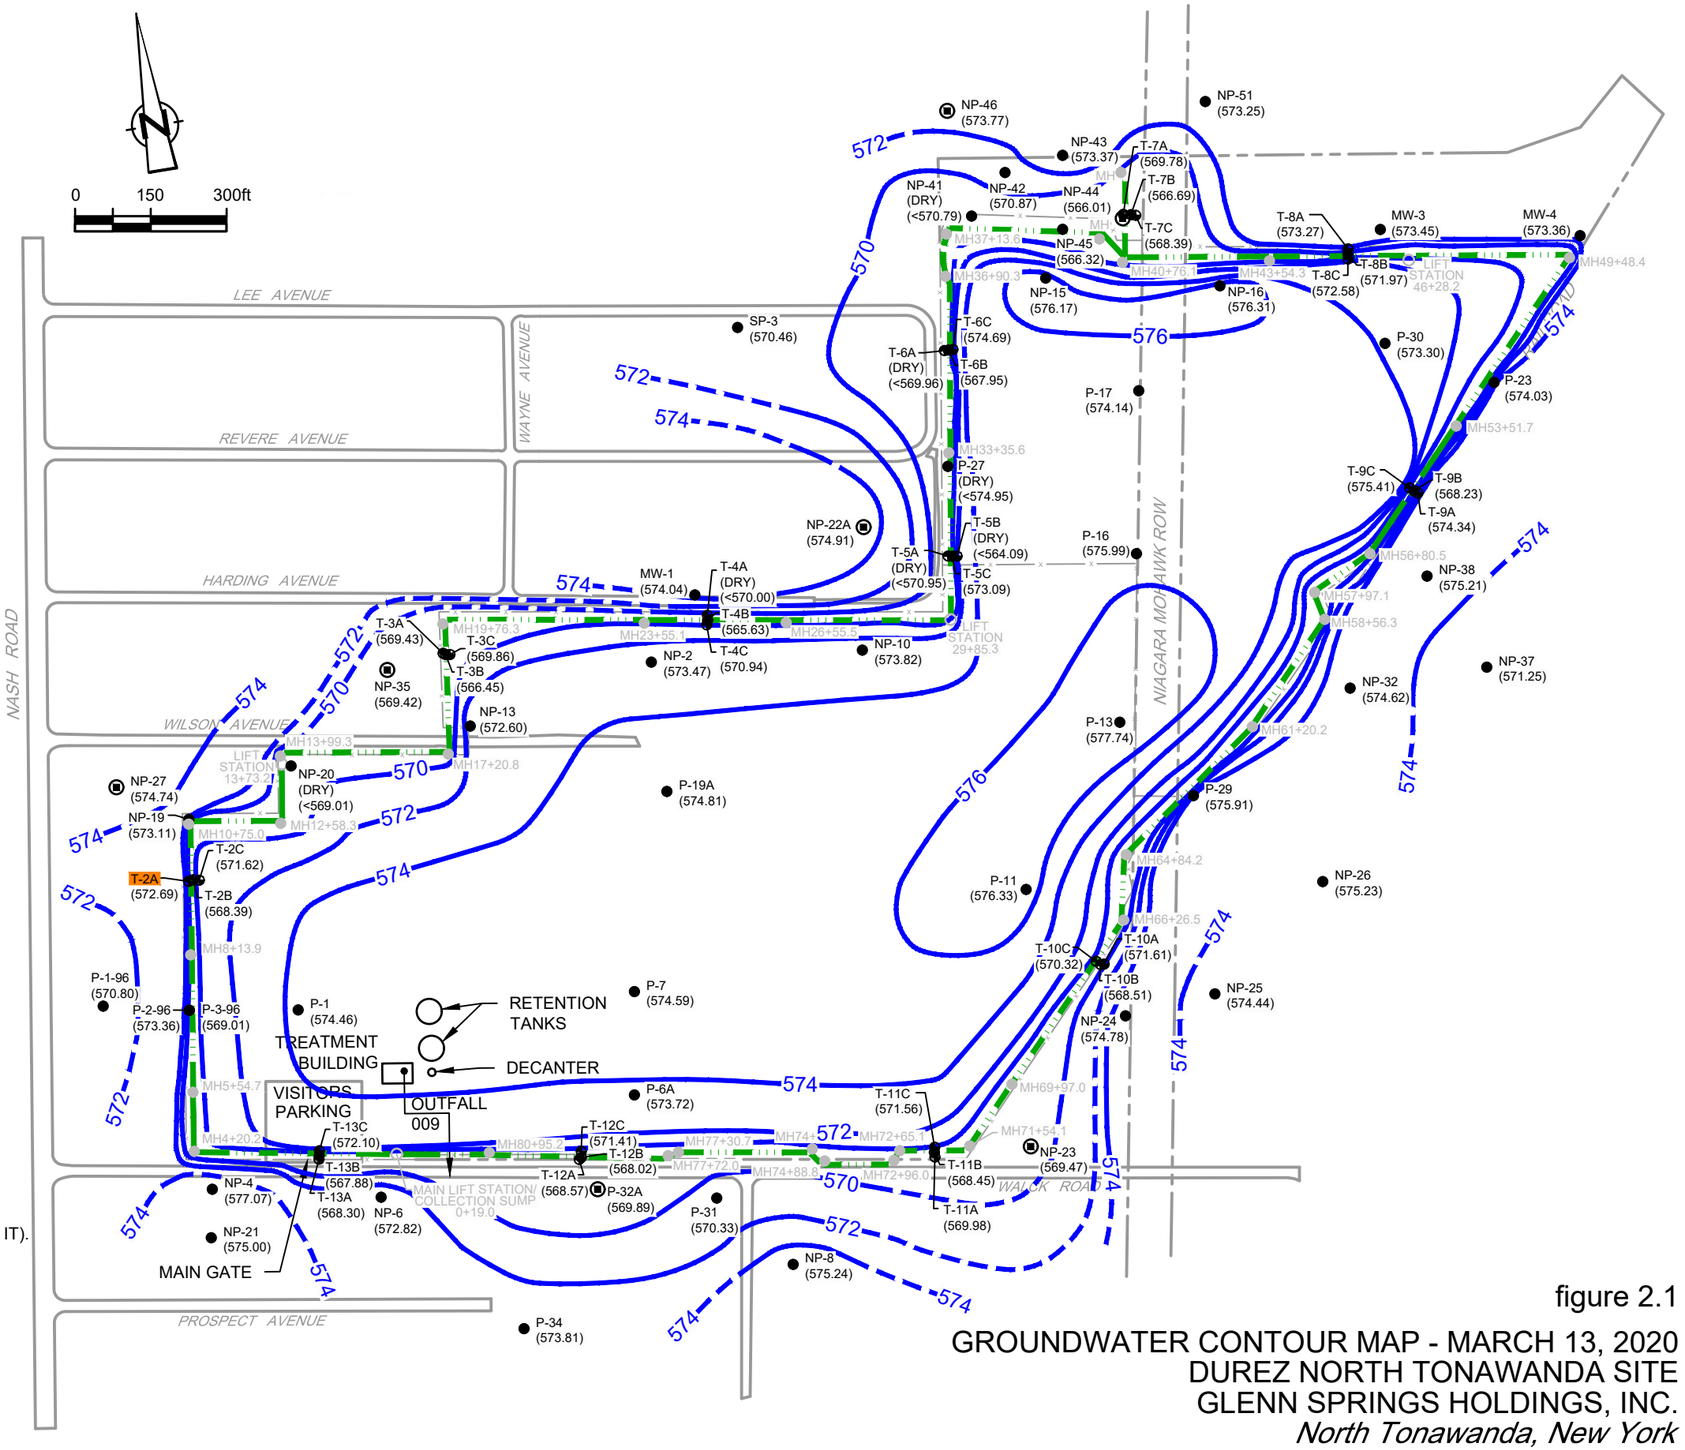
figure 2.1

During the March 13, 2020 hydraulic monitoring event (refer to Figure 2.1), an inward gradient was observed at all trench piezometers. At three piezometer arrays (T-4, T-5, and T-6), at least one of the piezometers in the array was dry. However, an inward gradient was still observed at each of these locations, as follows:

- When the water elevation in piezometer T-4B (565.63 feet above mean sea level [ft. AMSL]) is compared to the water elevation in monitoring well MW-1 (574.04 ft. AMSL), which is located outside of the IT and in close proximity to array T-4, it is clear that an inward hydraulic gradient into the trench was present at this location.

- When the observed depth of piezometer T-5B (564.09 ft. AMSL) is compared to the water elevation in monitoring well NP-22A (574.91 ft. AMSL), which is located outside of the IT and in close proximity to array T-5, it is clear that an inward hydraulic gradient into the trench was present at this location.

- When the water elevation in piezometer T-6B (567.95 ft. AMSL) is compared to the water elevation in monitoring well SP-3 (570.46 ft. AMSL), which is located outside of the IT and in close proximity to array T-6, it is clear that an inward hydraulic gradient into the trench was present at this location.

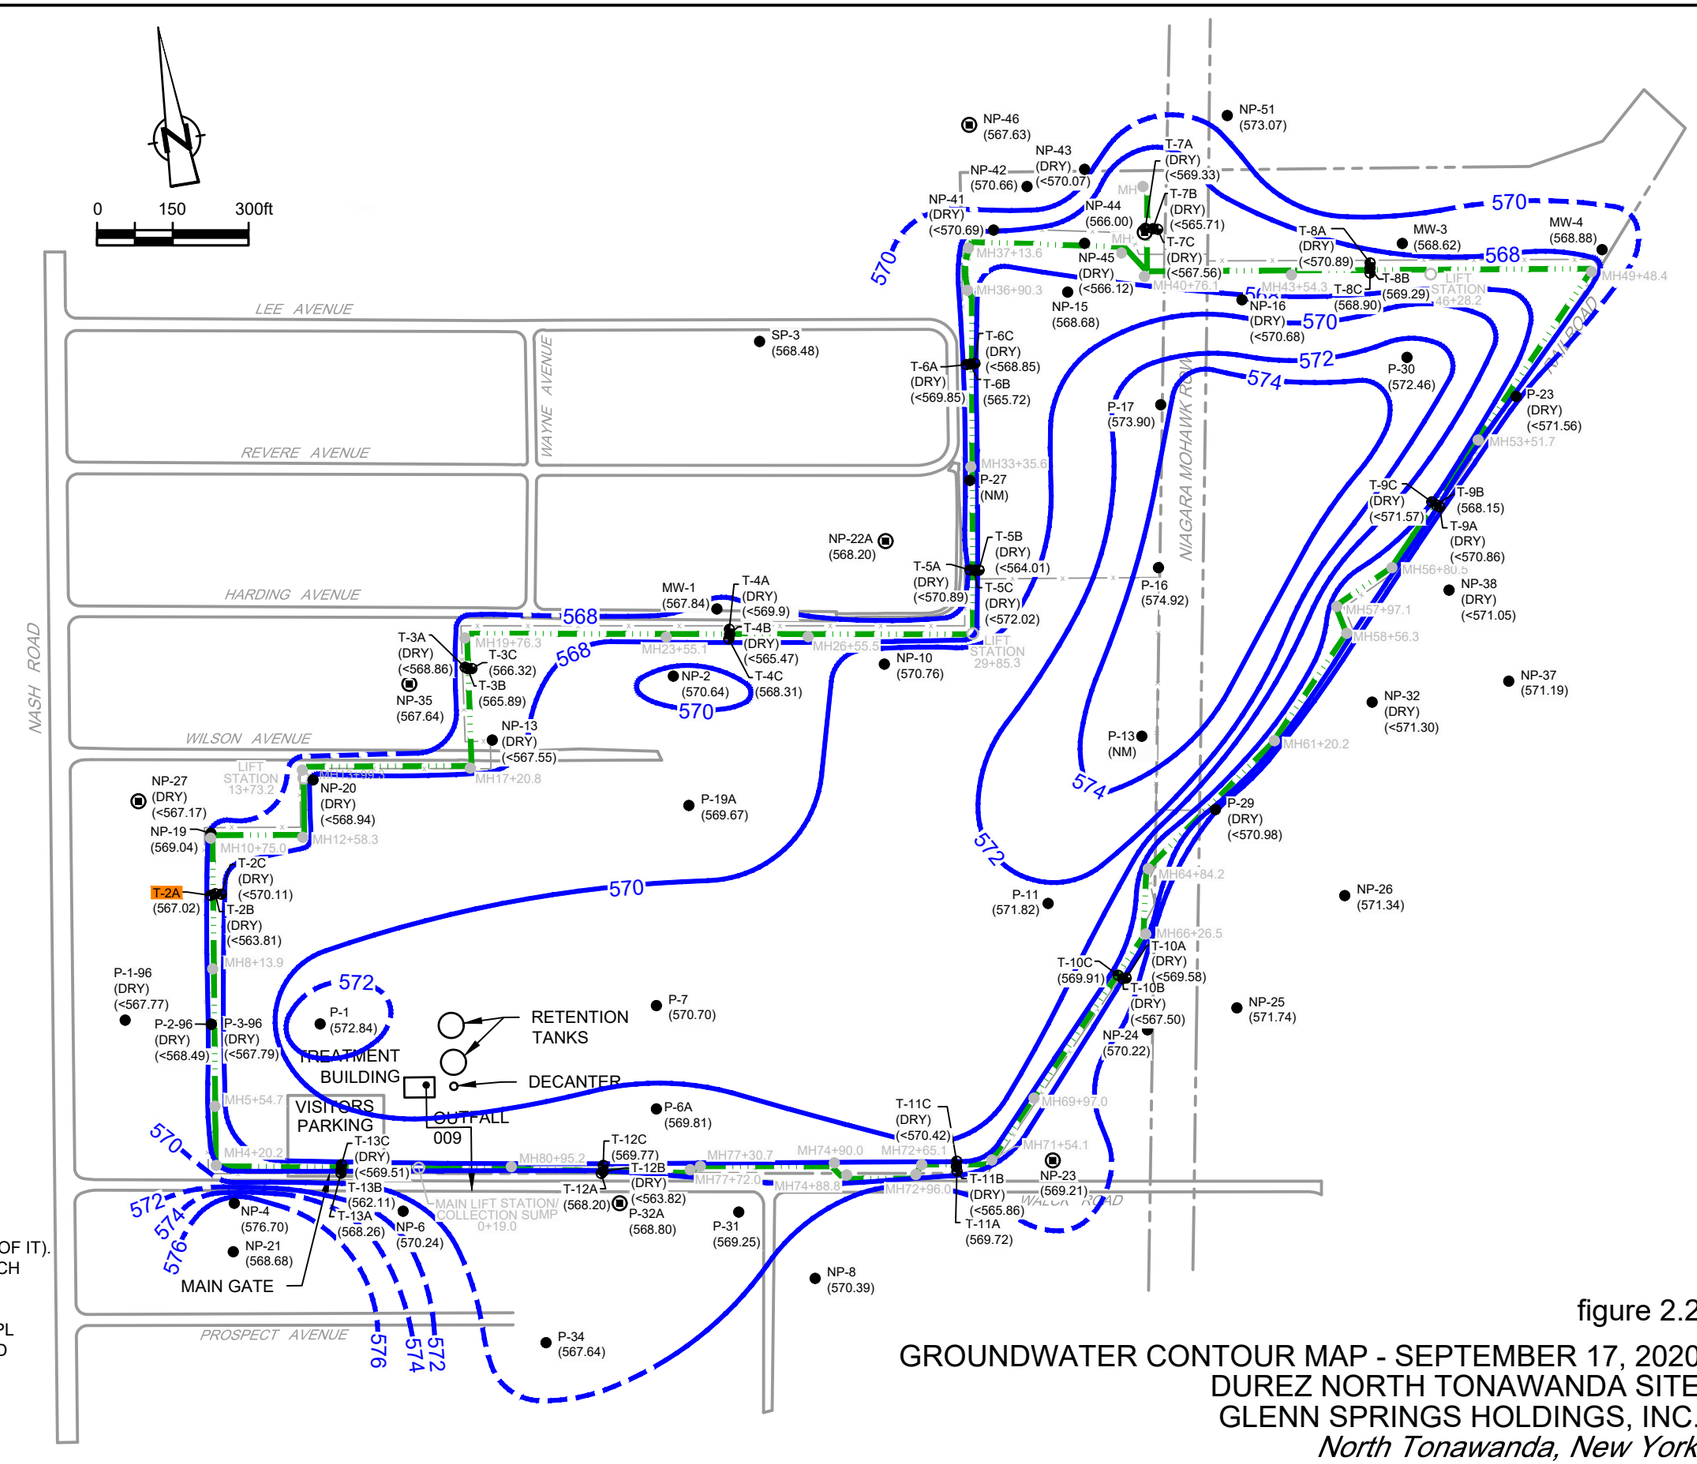
figure 2.2

During the September 13, 2020 hydraulic monitoring event (refer to Figure 2.2), an inward gradient was observed at the locations of all trench piezometer arrays. At 11 of the 12 piezometer arrays (T-2 through T-12), at least one of the A or B piezometers in the array was dry. However, an inward gradient was still observed at each of these locations, as follows:

- When the observed depth of piezometer T-2B (563.81 ft. AMSL) is compared to the water elevation in piezometer T-2A (567.02 ft. AMSL), which is located directly outside of the IT, it is clear that an inward hydraulic gradient into the trench was present at this array.

- When the water level elevation in piezometer T-3B (565.89 ft. AMSL) is compared to the water elevation in monitoring well NP-35 (567.64 ft. AMSL), which is located outside of the IT and in close proximity to array T-3, it is clear that an inward hydraulic gradient into the trench was present at this location.

- When the observed depth of piezometer T-4B (565.47 ft. AMSL) is compared to the water elevation in monitoring well MW-1 (567.84 ft. AMSL), which is located outside of the IT and in close proximity to array T-4, it is clear that an inward hydraulic gradient into the trench was present at this location.

- When the observed depth of piezometer T-5B (564.01 ft. AMSL) is compared to the water elevation in monitoring well NP-22A (568.20 ft. AMSL), which is located outside of the IT and in close proximity to array T-5, it is clear that an inward hydraulic gradient into the trench was present at this location.

- When the water elevation in piezometer T-6B (565.72 ft. AMSL) is compared to the water elevation in monitoring well SP-3 (568.48 ft. AMSL), which is located outside of the IT and in close proximity to array T-6, it is clear that an inward hydraulic gradient into the trench was present at this location.

- When the observed depth of piezometer T-7B (565.71 ft. AMSL) is compared to the water elevations in monitoring wells NP-44 (566.00 ft. AMSL), NP-51 (573.07 ft. AMSL), and NP-42 (570.66 ft. AMSL), which are located outside of the IT and in close proximity to array T-7, it is clear that an inward hydraulic gradient into the trench was present at this location.

- When the water elevation in piezometer T-8B (569.29 ft. AMSL) is compared to the water level elevation in monitoring well MW-3 (568.62 ft. AMSL), which is located outside of the IT and in close proximity to array T-8, it appears that an outward gradient away from the trench may have been present at this location. However, when these water elevations are compared to the water elevation in monitoring well NP-51 (573.07 ft. AMSL), which is located even farther outside of the IT and is also in close proximity to array T-8, an overall inward hydraulic gradient into the trench was apparent at this location. Furthermore, no evidence of chemical migration was observed at this location.

- When the water elevation in piezometer T-9B (568.15 ft. AMSL) is compared to the water elevation in monitoring well NP-37 (571.19 ft. AMSL), which is located outside of the IT and in close proximity to array T-9, it is clear that an inward hydraulic gradient into the trench was present at this location.

- When the observed depth of piezometer T-10B (567.50 ft. AMSL) is compared to the water elevations in monitoring wells NP-24 (570.22 ft. AMSL) and NP-25 (571.74 ft. AMSL), which are located outside of the IT and in close proximity to array T-10, it is clear that an inward hydraulic gradient into the trench was present at this location.

- When the observed depth of piezometer T-11B (565.86 ft. AMSL) is compared to the water elevation in piezometer T-11A (569.72 ft. AMSL), which is located directly outside of the IT, it is clear that an inward hydraulic gradient into the trench was present at this array.

- When the observed depth of piezometer T-12B (563.82 ft. AMSL) is compared to the water elevation in piezometer T-12A (568.20 ft. AMSL), which is located directly outside of the IT, it is clear that an inward hydraulic gradient into the trench was present at this array.

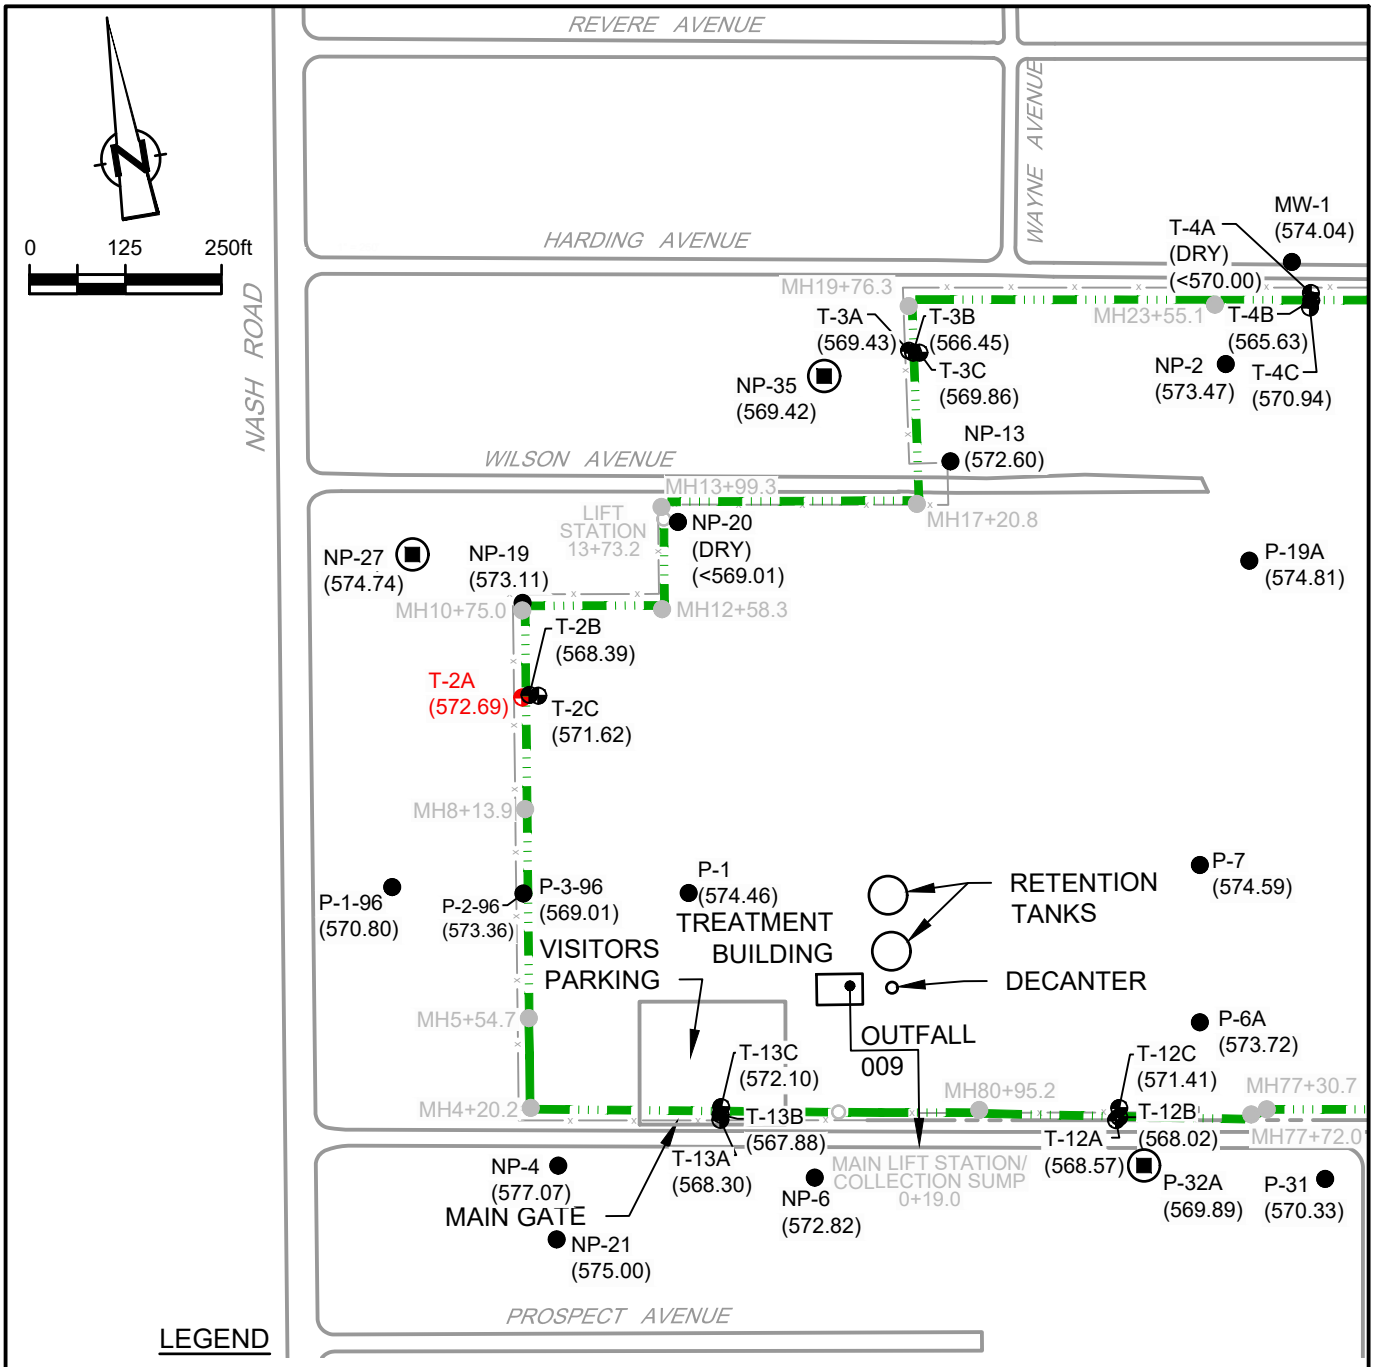
figure 2.3

During 2020, no NAPL was pumped from the T-2A piezometer (see Table 2.3) as the thickness was insufficient to allow for pumping. Table 2.4 presents the semiannual hydraulic monitoring at T-2A and surrounding monitoring wells. Water elevations in these wells and piezometers from the March 13 and September 17, 2020 monitoring events are shown on Figures 2.3 and 2.4, respectively. As indicated in Section 2.2, a strong inward gradient into the trench was present at piezometer array T-2 during both semiannual monitoring events.
