Revised 2023 Site Management Periodic Review Report – Durez North Tonawanda

NYSDEC Site No. 932018
Durez North Tonawanda Interceptor Trench
700 Walck Road
North Tonawanda, New York

Project Number TR1045

January 30, 2024
Revised May 6, 2024

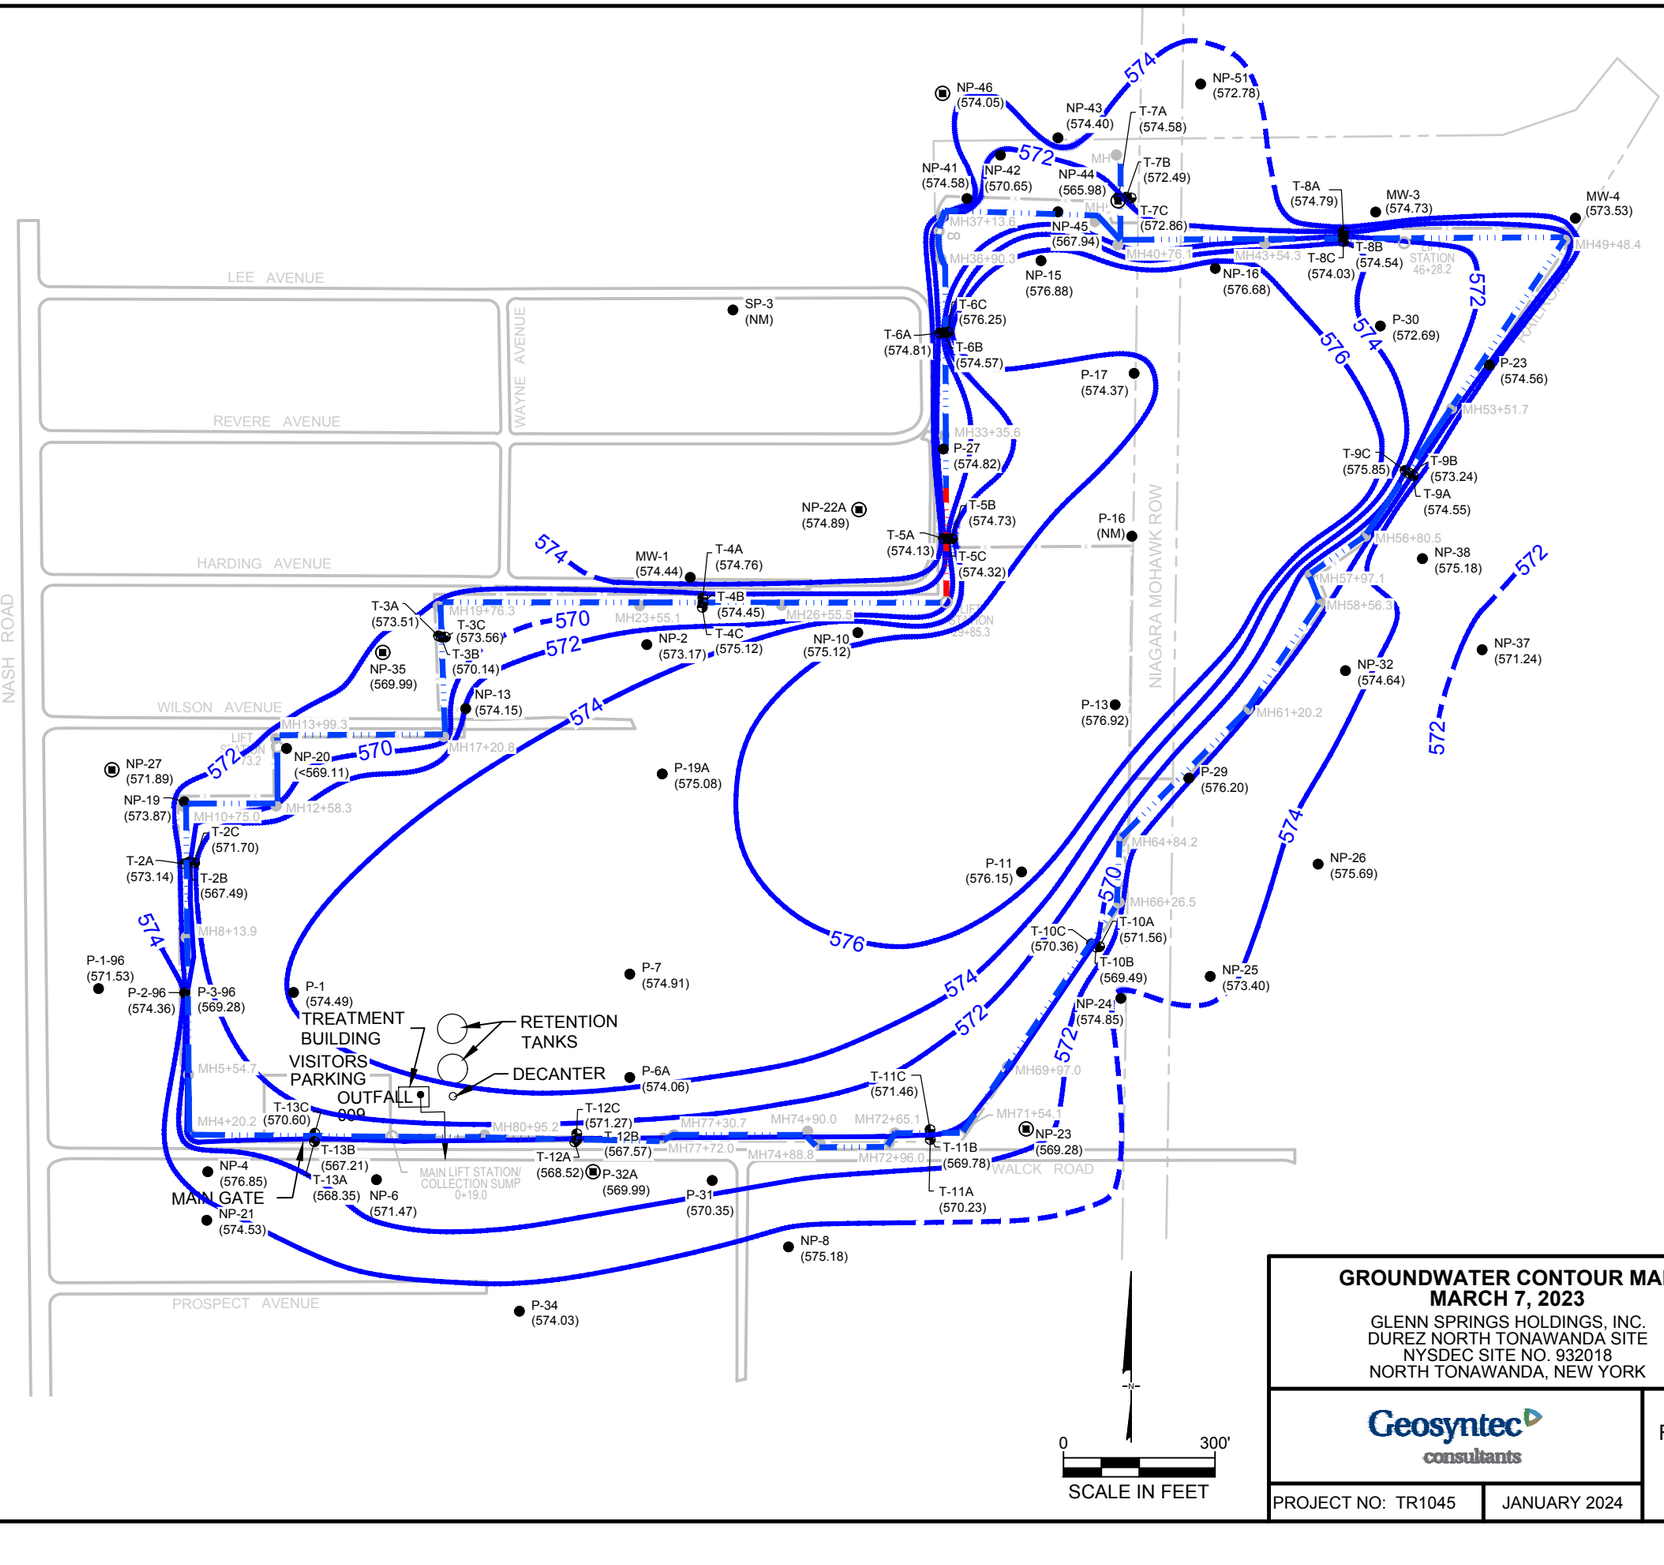
GROUNDWATER CONTOUR MAP
MARCH 7, 2023
GLENN SPRINGS HOLDINGS, INC.
DUREZ NORTH TONAWANDA SITE
NYSDEC SITE NO. 932018
NORTH TONAWANDA, NEW YORK

During the March 7, 2023 hydraulic monitoring event (refer to Figure 2.1), an inward gradient was observed at all trench piezometer arrays with the exception of piezometer array T-5. A review of the elevation data for piezometer array T-5 indicates that the elevation of the IT (T-5B-574.73

feet [ft]) was 0.60 ft (7.2 inches) higher than the exterior T-5A (571.13 ft) piezometer elevation. T-5 is located on the northern portion of the IT. The nearest monitoring well to T-5 is NP-22A, which had a groundwater elevation of 574.89 ft which is 0.76 ft higher than the T-5A elevation and 0.16 feet higher than theT-5B (trench) elevation and therefore would indicate that the groundwater gradient for that area is towards the IT. None of the 12 piezometer arrays were dry during monitoring.

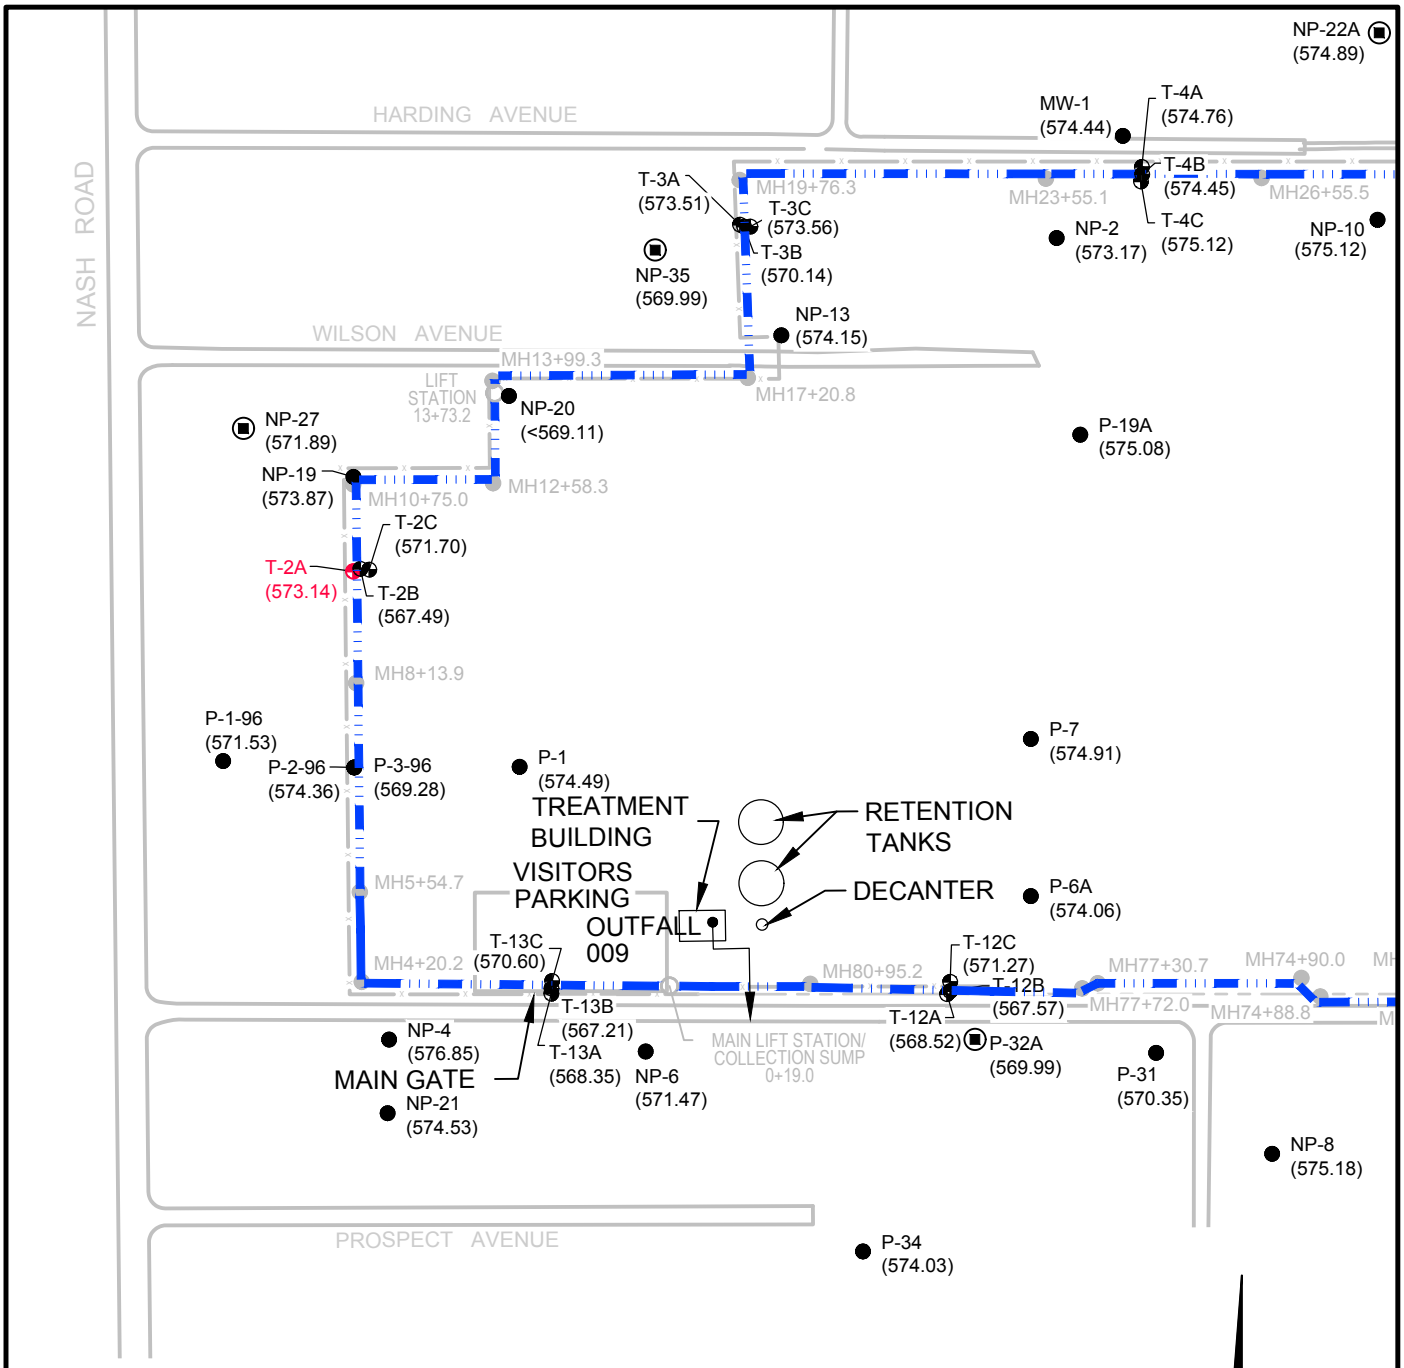
FIGURE 2.2

During the September 14, 2023 hydraulic monitoring event (refer to Figure 2.2), an inward gradient was observed at all trench piezometer arrays except at piezometers T-4, and T-8. A review of the elevation data for piezometer array T-4 shows that the elevation of the IT (T-4B-572.02 ft) was 0.13 feet (1.56 inches) higher than the exterior T-4A elevation of 571.89 ft. Nearby groundwater elevations for wells MW-1 (571.84 ft.) and NP-35 (568.67 ft.) indicate that groundwater is relatively flat in this area with a shallow gradient towards the IT in a west-southwesterly direction. A review of the elevation data for piezometer array T-8 shows that the elevation of the IT (T-8B-574.70 ft) was higher than exterior (T-8A-571.05 ft) piezometer elevations. The T-8 piezometer array is located on the northwestern portion of the IT at the highest point of the IT. The nearest monitoring well to T-8A is MW-3 to the east-northeast and NP-51 to the north-northwest. MW-3 had a groundwater elevation of 569.94 ft which would indicate that a slight outward gradient may be present at this location during the monitoring event, however NP-51 had an elevation of 572.74 which indicates an overall groundwater gradient towards the IT. At 6 of the 12 piezometer arrays (T-2, T-4, T-5, T-6, T-7, and T-11), at least one of the A, B or C piezometers in the array was dry. However, an inward gradient was still observed at each of these locations except T-4 which was previously discussed. The following discussions provide additional information for each dry piezometer sets to support an inward gradient towards the IT.

- When the bottom depth of piezometer T-2B (563.95 ft) is compared to the groundwater elevation in piezometer T-2A (569.23 ft), which is located directly outside of the IT, an inward hydraulic gradient towards the trench was present at this array.

- When the bottom depth of piezometer T-5B (564.13 ft) is compared to the groundwater elevation in piezometer T-5 A (571.48 ft), which is located directly outside of the IT, an inward hydraulic gradient towards the trench was present at this array.

- When the groundwater elevation in piezometer T-6B (567.07 ft) is compared to the bottom depth of piezometer T-6A (569.94 ft), which is located directly outside of the IT, and the groundwater elevation in the nearby monitoring well NP-22A (570.34 ft), which is located outside of the IT and in close proximity to array T-6, an inward hydraulic gradient towards the trench can be assumed to be present at this location.

- Piezometer array T-7 is located on a lateral of the IT that is perpendicular to the IT. As such T-7A and T-7C would both be considered exterior piezometers. Piezometers T-7B and T-7A were both dry during the monitoring event with bottom elevations of 570.13 ft and 571.52 ft, respectively. However, piezometer T-7C had water present and a groundwater elevation of 567.62 ft. which would indicate an inward gradient. In addition, the nearest wells in the direction of the T-7A piezometer with groundwater present are

wells NP-42 (570.71 ft) and NP-46 (568.08 ft). The nearest dry well is NP-43 with a bottom elevation of 570.11 ft). These three nearby wells would indicate an inward gradient towards T-7A and the IT.

- When the bottom depth of piezometer T-11B (566.25 ft) is compared to the groundwater elevations in piezometer T-11A (569.93 ft) an inward hydraulic gradient towards the trench was present at this location.

Piezometer array T-8 and T-5 continued to exhibit the potential for an outward gradient from the IT during both semiannual hydraulic monitoring events. As such GSH recommends continuing to monitor the T-8 and T-5 piezometer array semiannually as required. In addition, GSH plans to clean the IT and remove all trees growing above the IT in the vicinity of T-8 and T-5 in the summer of 2024. As a component of that cleaning, GSH will be video inspecting the IT to verify the condition of the IT and that all root obstructions are adequately removed. It is anticipated that removing the obstructions in the IT will improve the functionality of the IT and results in the groundwater gradients at T-8 and T-5 piezometer arrays being restored.
