Corrective Measures Implementation Annual Performance Evaluation January through December 2019

Occidental Chemical Corporation
Buffalo Avenue Plant
Niagara Falls, New York

Glenn Springs Holdings, Inc.

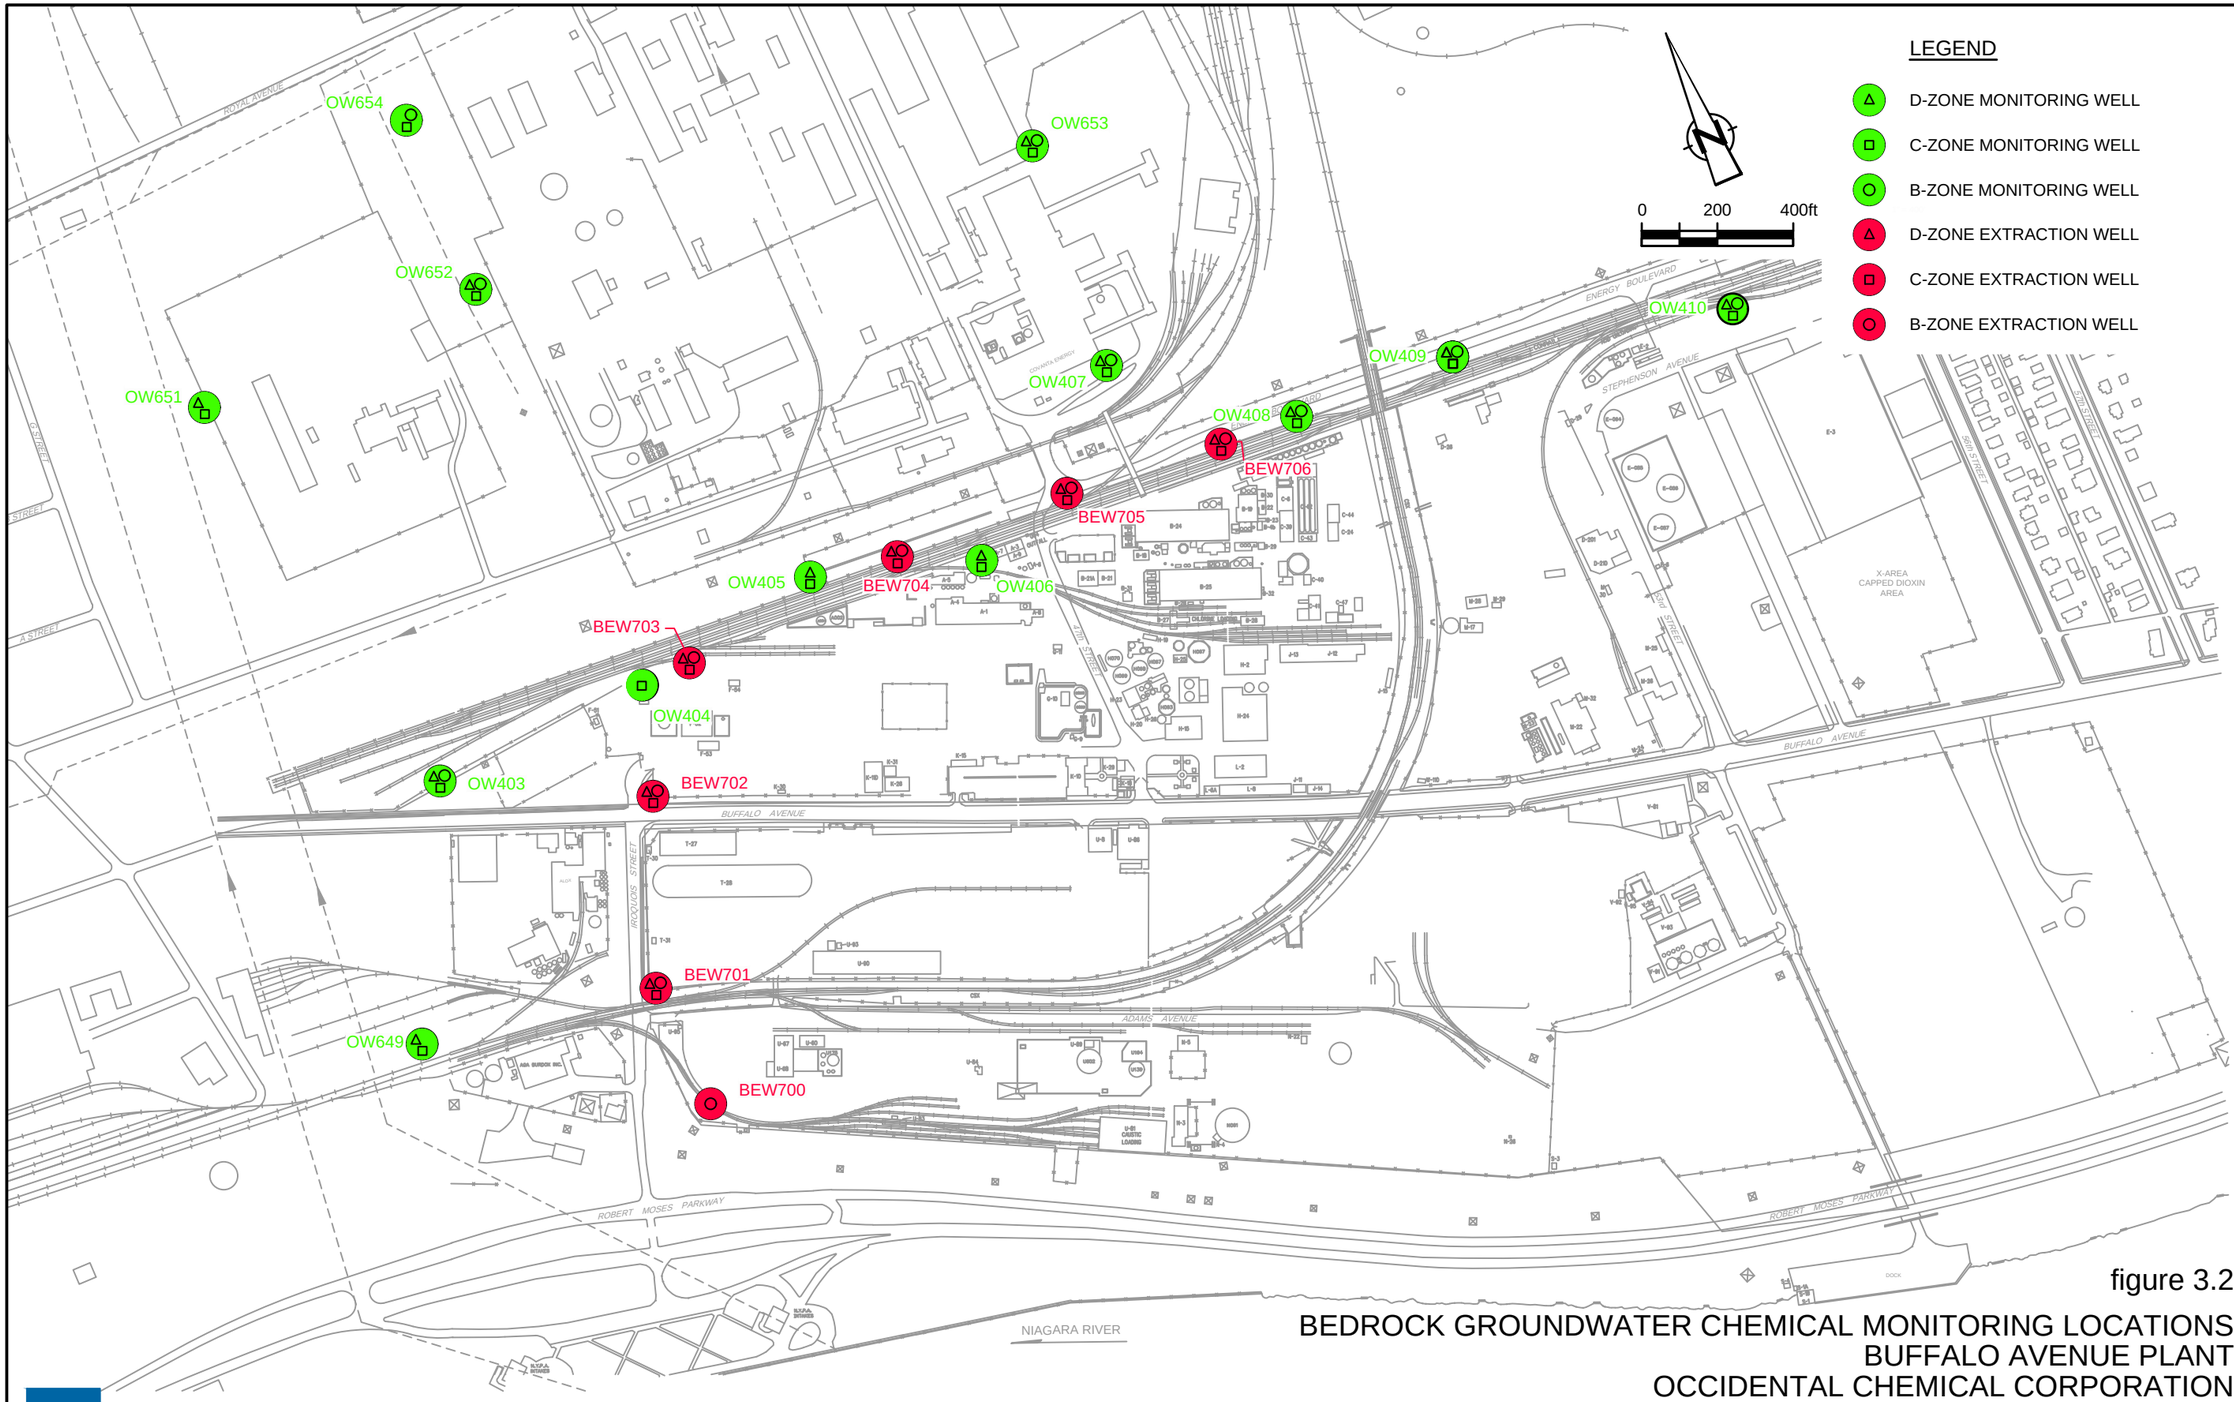
figure 3.2

The annual bedrock chemical monitoring event was performed between March 15, 2019 and May 10, 2019. The chemical monitoring was conducted using the protocols presented in the document entitled "Supplemental Data Collection Program, Appendix A, Site Operations Plan", dated April 1988. The locations of the monitored wells are shown on Figure 3.2.

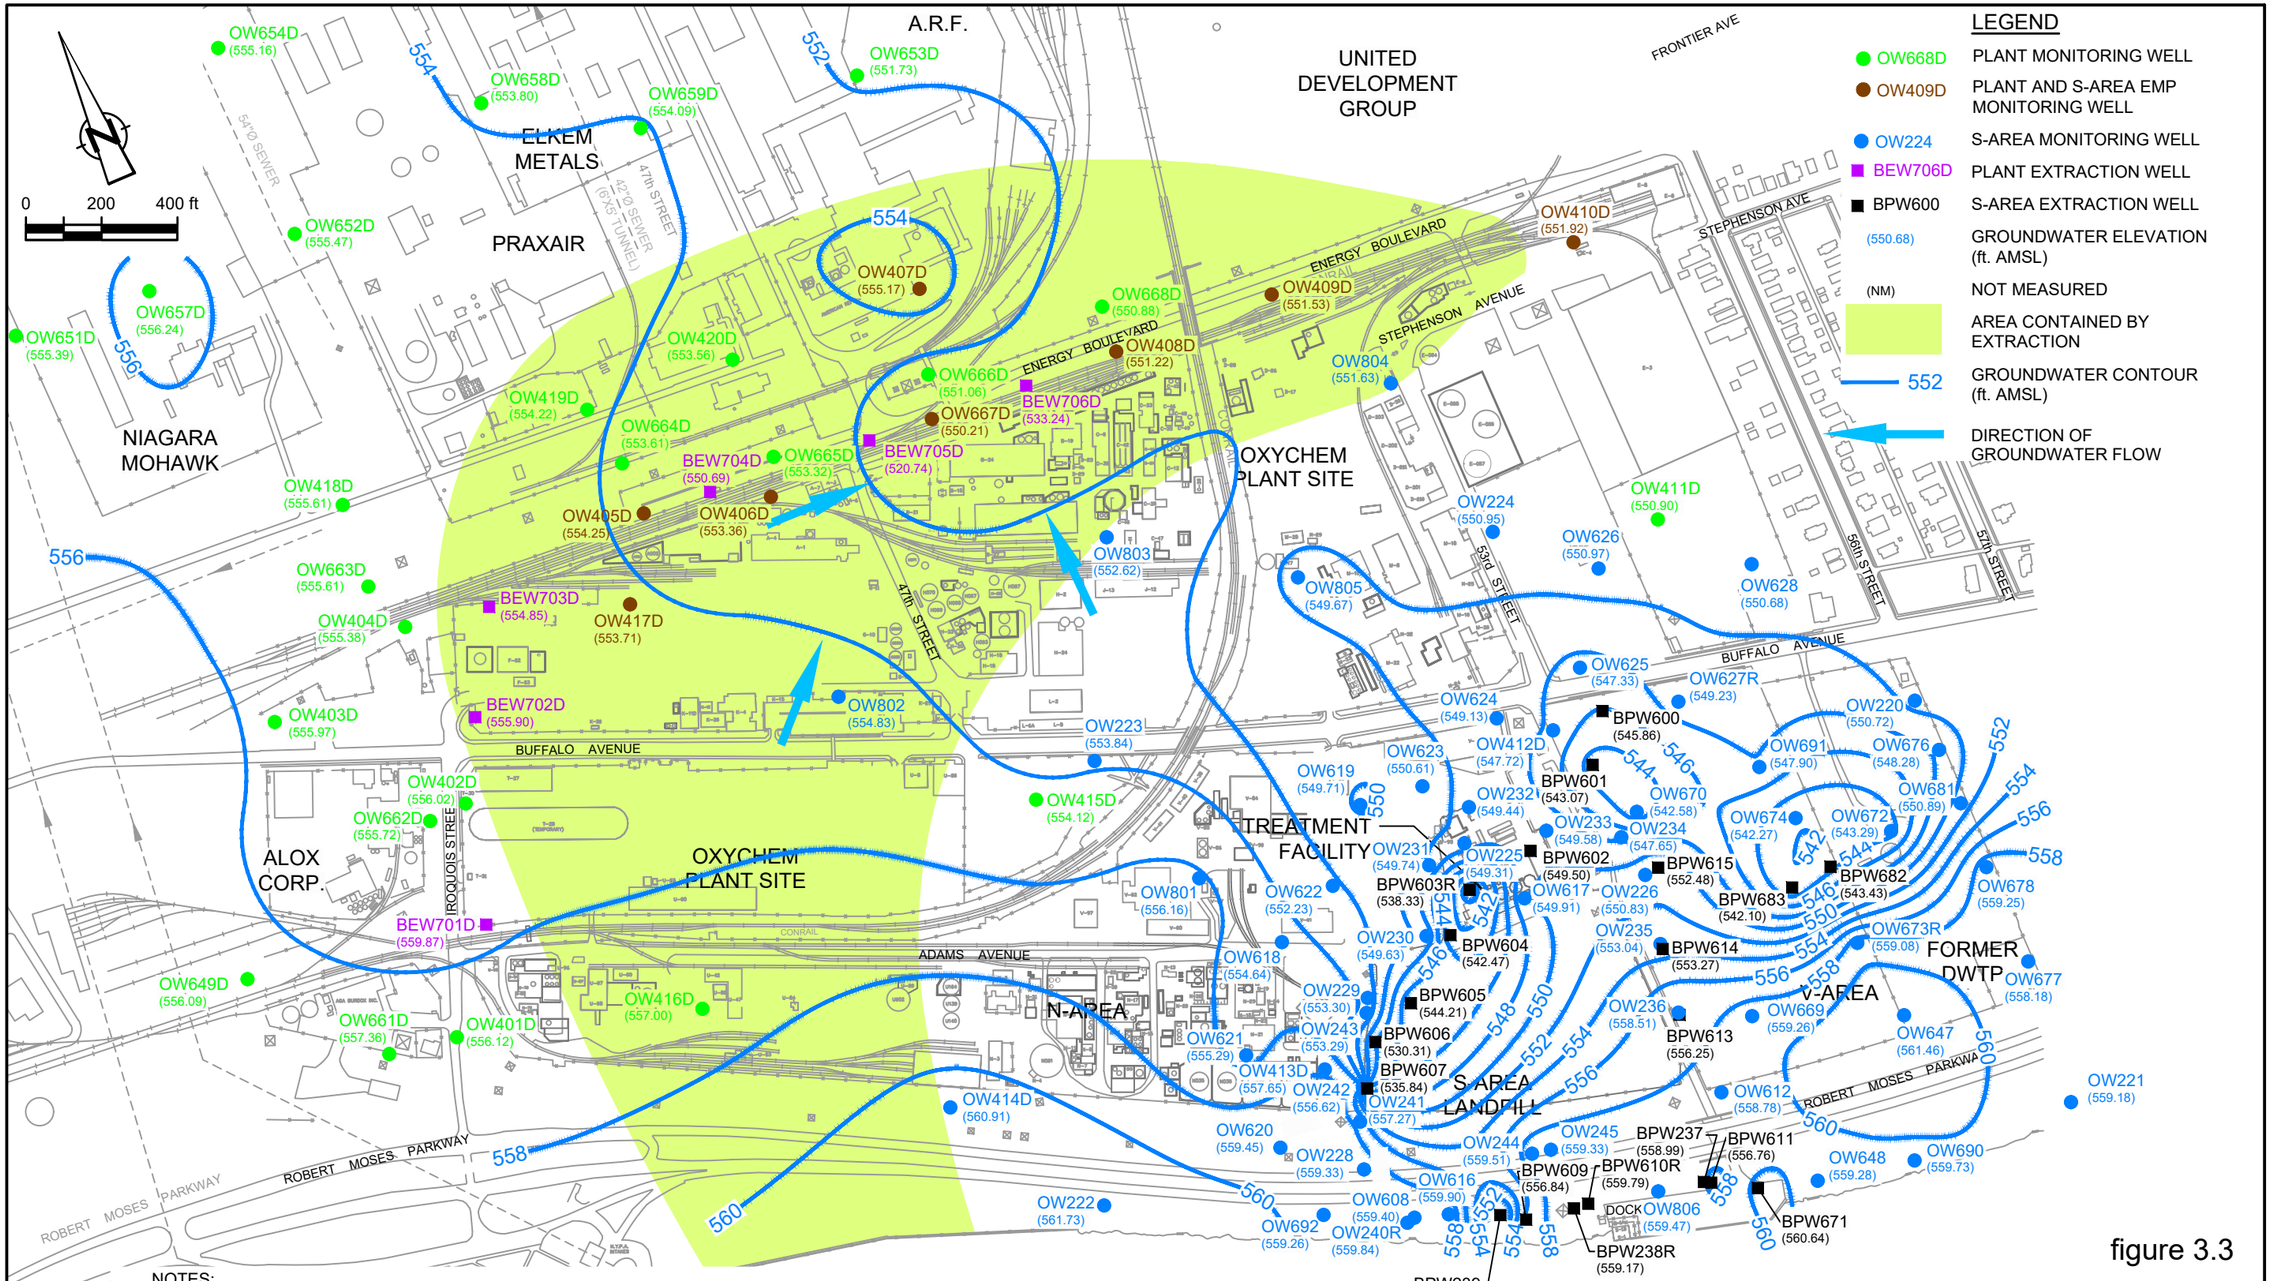
D-ZONE BEDROCK GROUNDWATER CONTOURS NOVEMBER 25, 2019 BUFFALO AVENUE PLANT OCCIDENTAL CHEMICAL CORPORATION GLENN SPRINGS HOLDINGS, INC.

The average monthly flow rate of the D-Zone while the system was operating ranged between 89 gpm (December) and 98 gpm (February). Even though these flows are below the target flow rate of 120 gpm (40 gpm each), the groundwater elevations in the three extraction wells were consistent with those observed while pumping at the target rate and hydraulic containment was observed for all hydraulic monitoring events. The potentiometric contours presented on Figure 3.3 are representative of this period. The area contained by extraction extended beyond the Plant boundary. The groundwater flow patterns did not change significantly between the first and fourth quarters, demonstrating that hydraulic stabilization was maintained in the D-Zone.

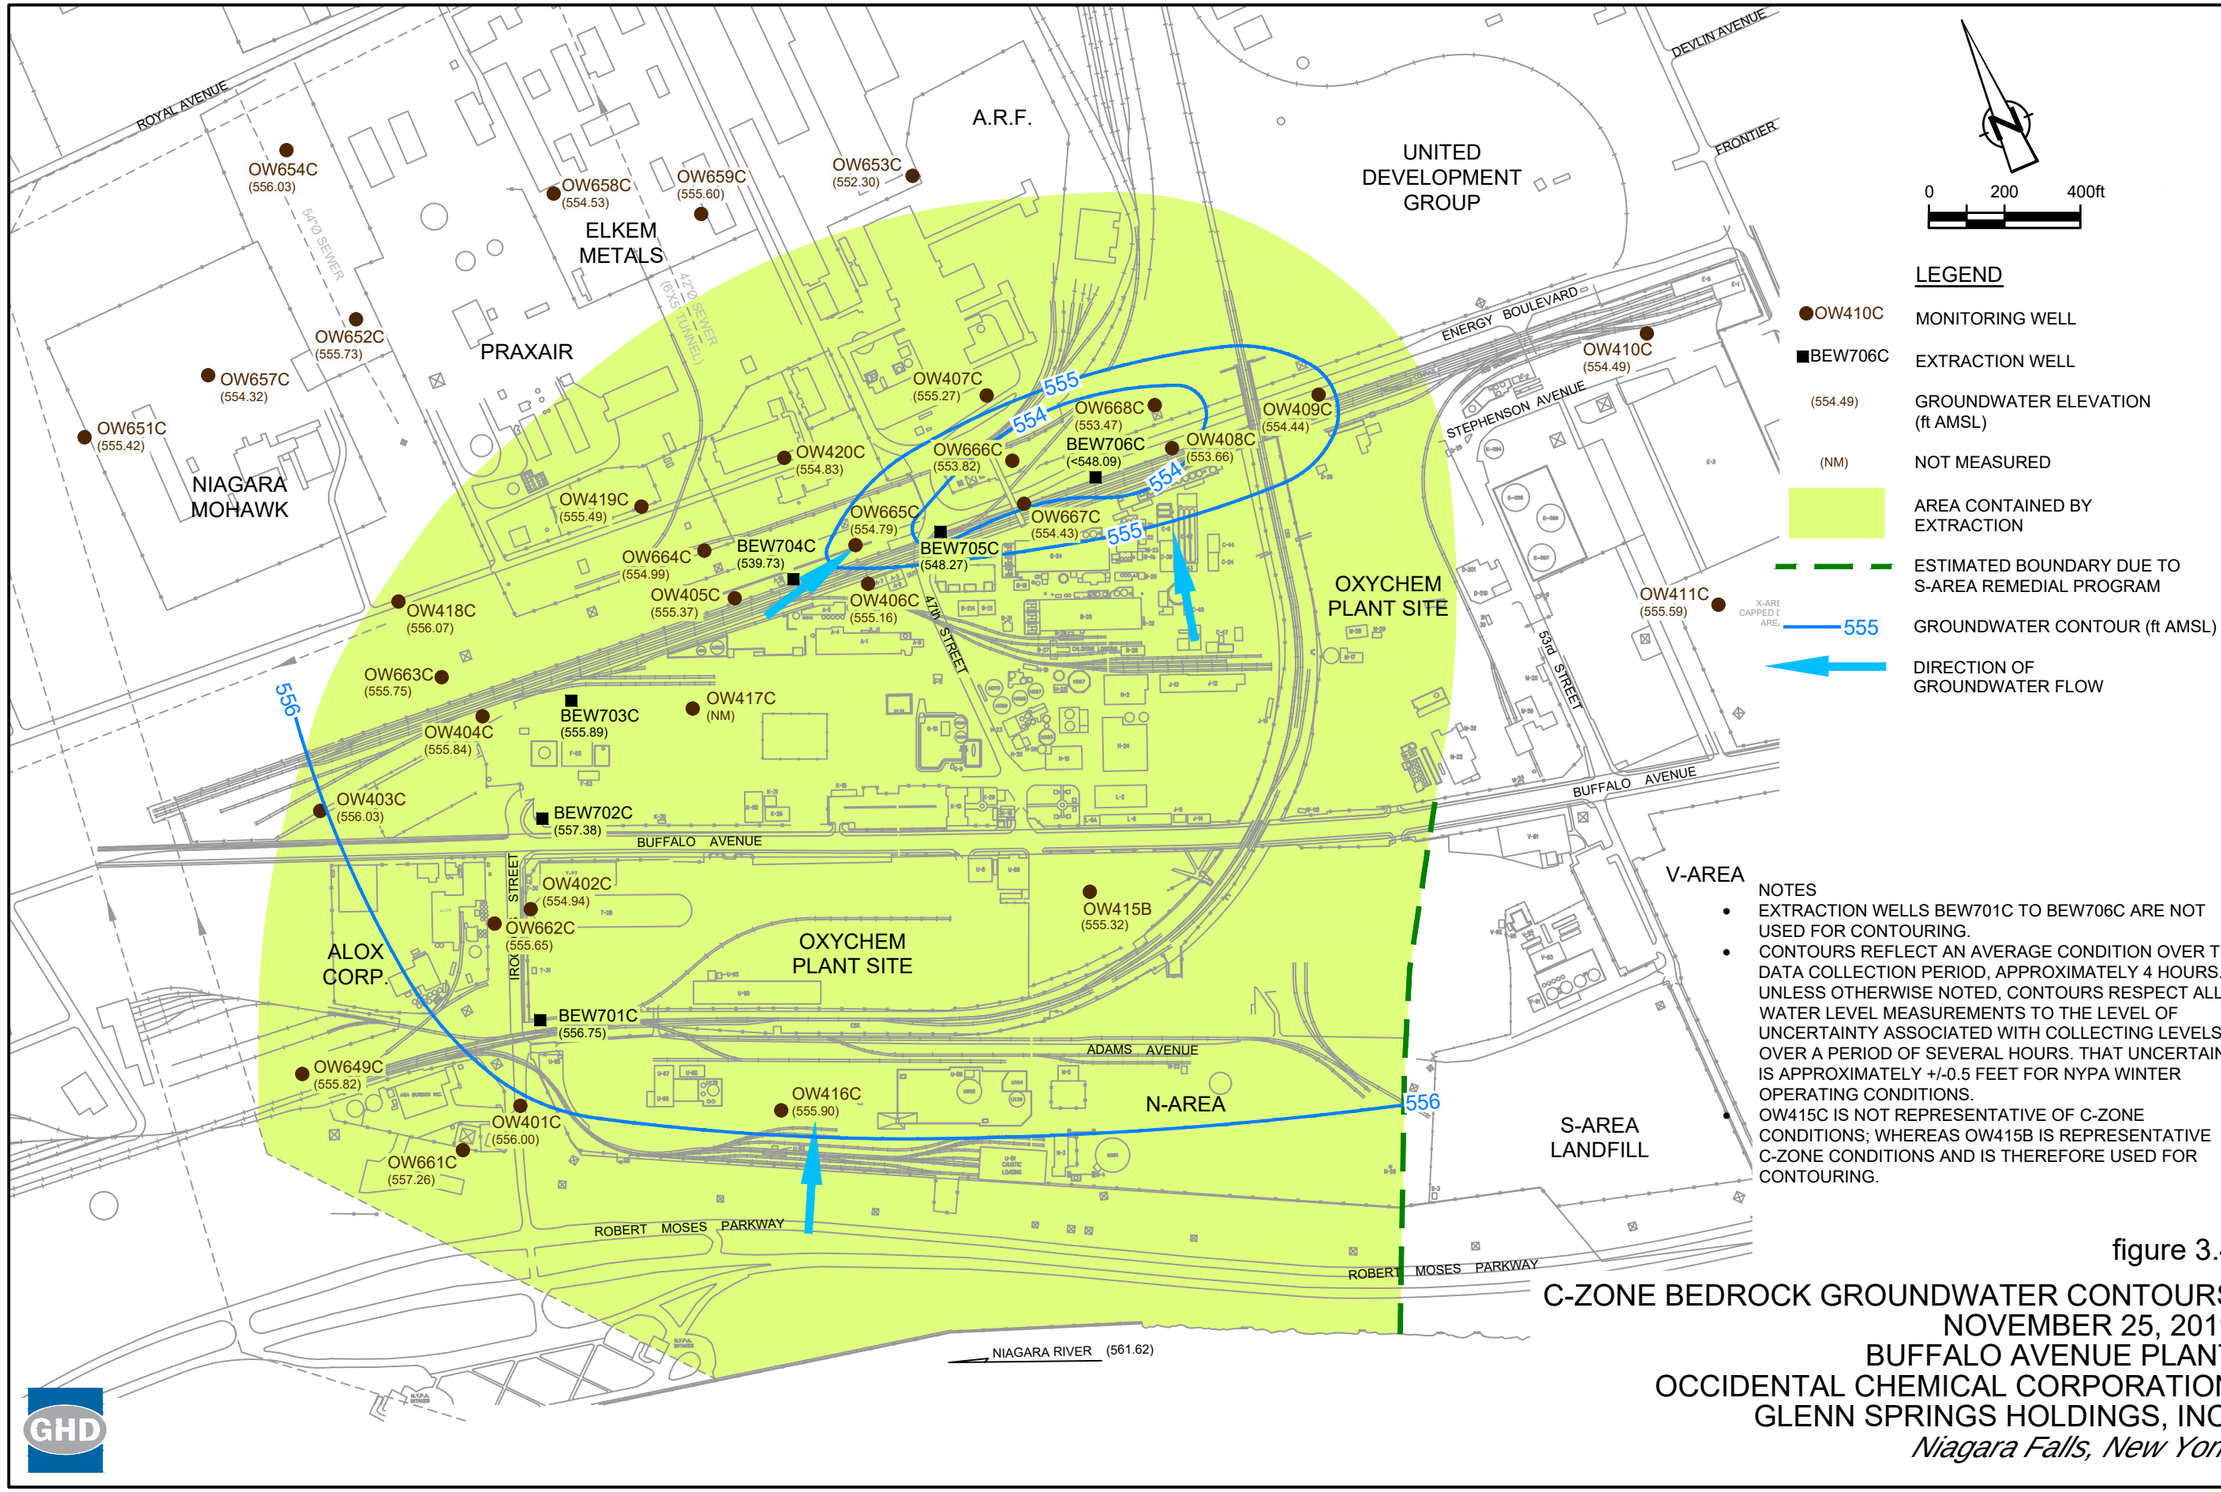
The average monthly flow rate of the C-Zone ranged between 290 gpm (March) and 308 gpm (December). Hydraulic containment was observed for all hydraulic monitoring events. The Potentiometric contours presented on Figure 3.4 were representative of this period. The area contained by extraction extended beyond the Plant boundary. The groundwater flow patterns did not change significantly between the first and fourth quarters demonstrating that hydraulic stabilization was maintained in the C-Zone.

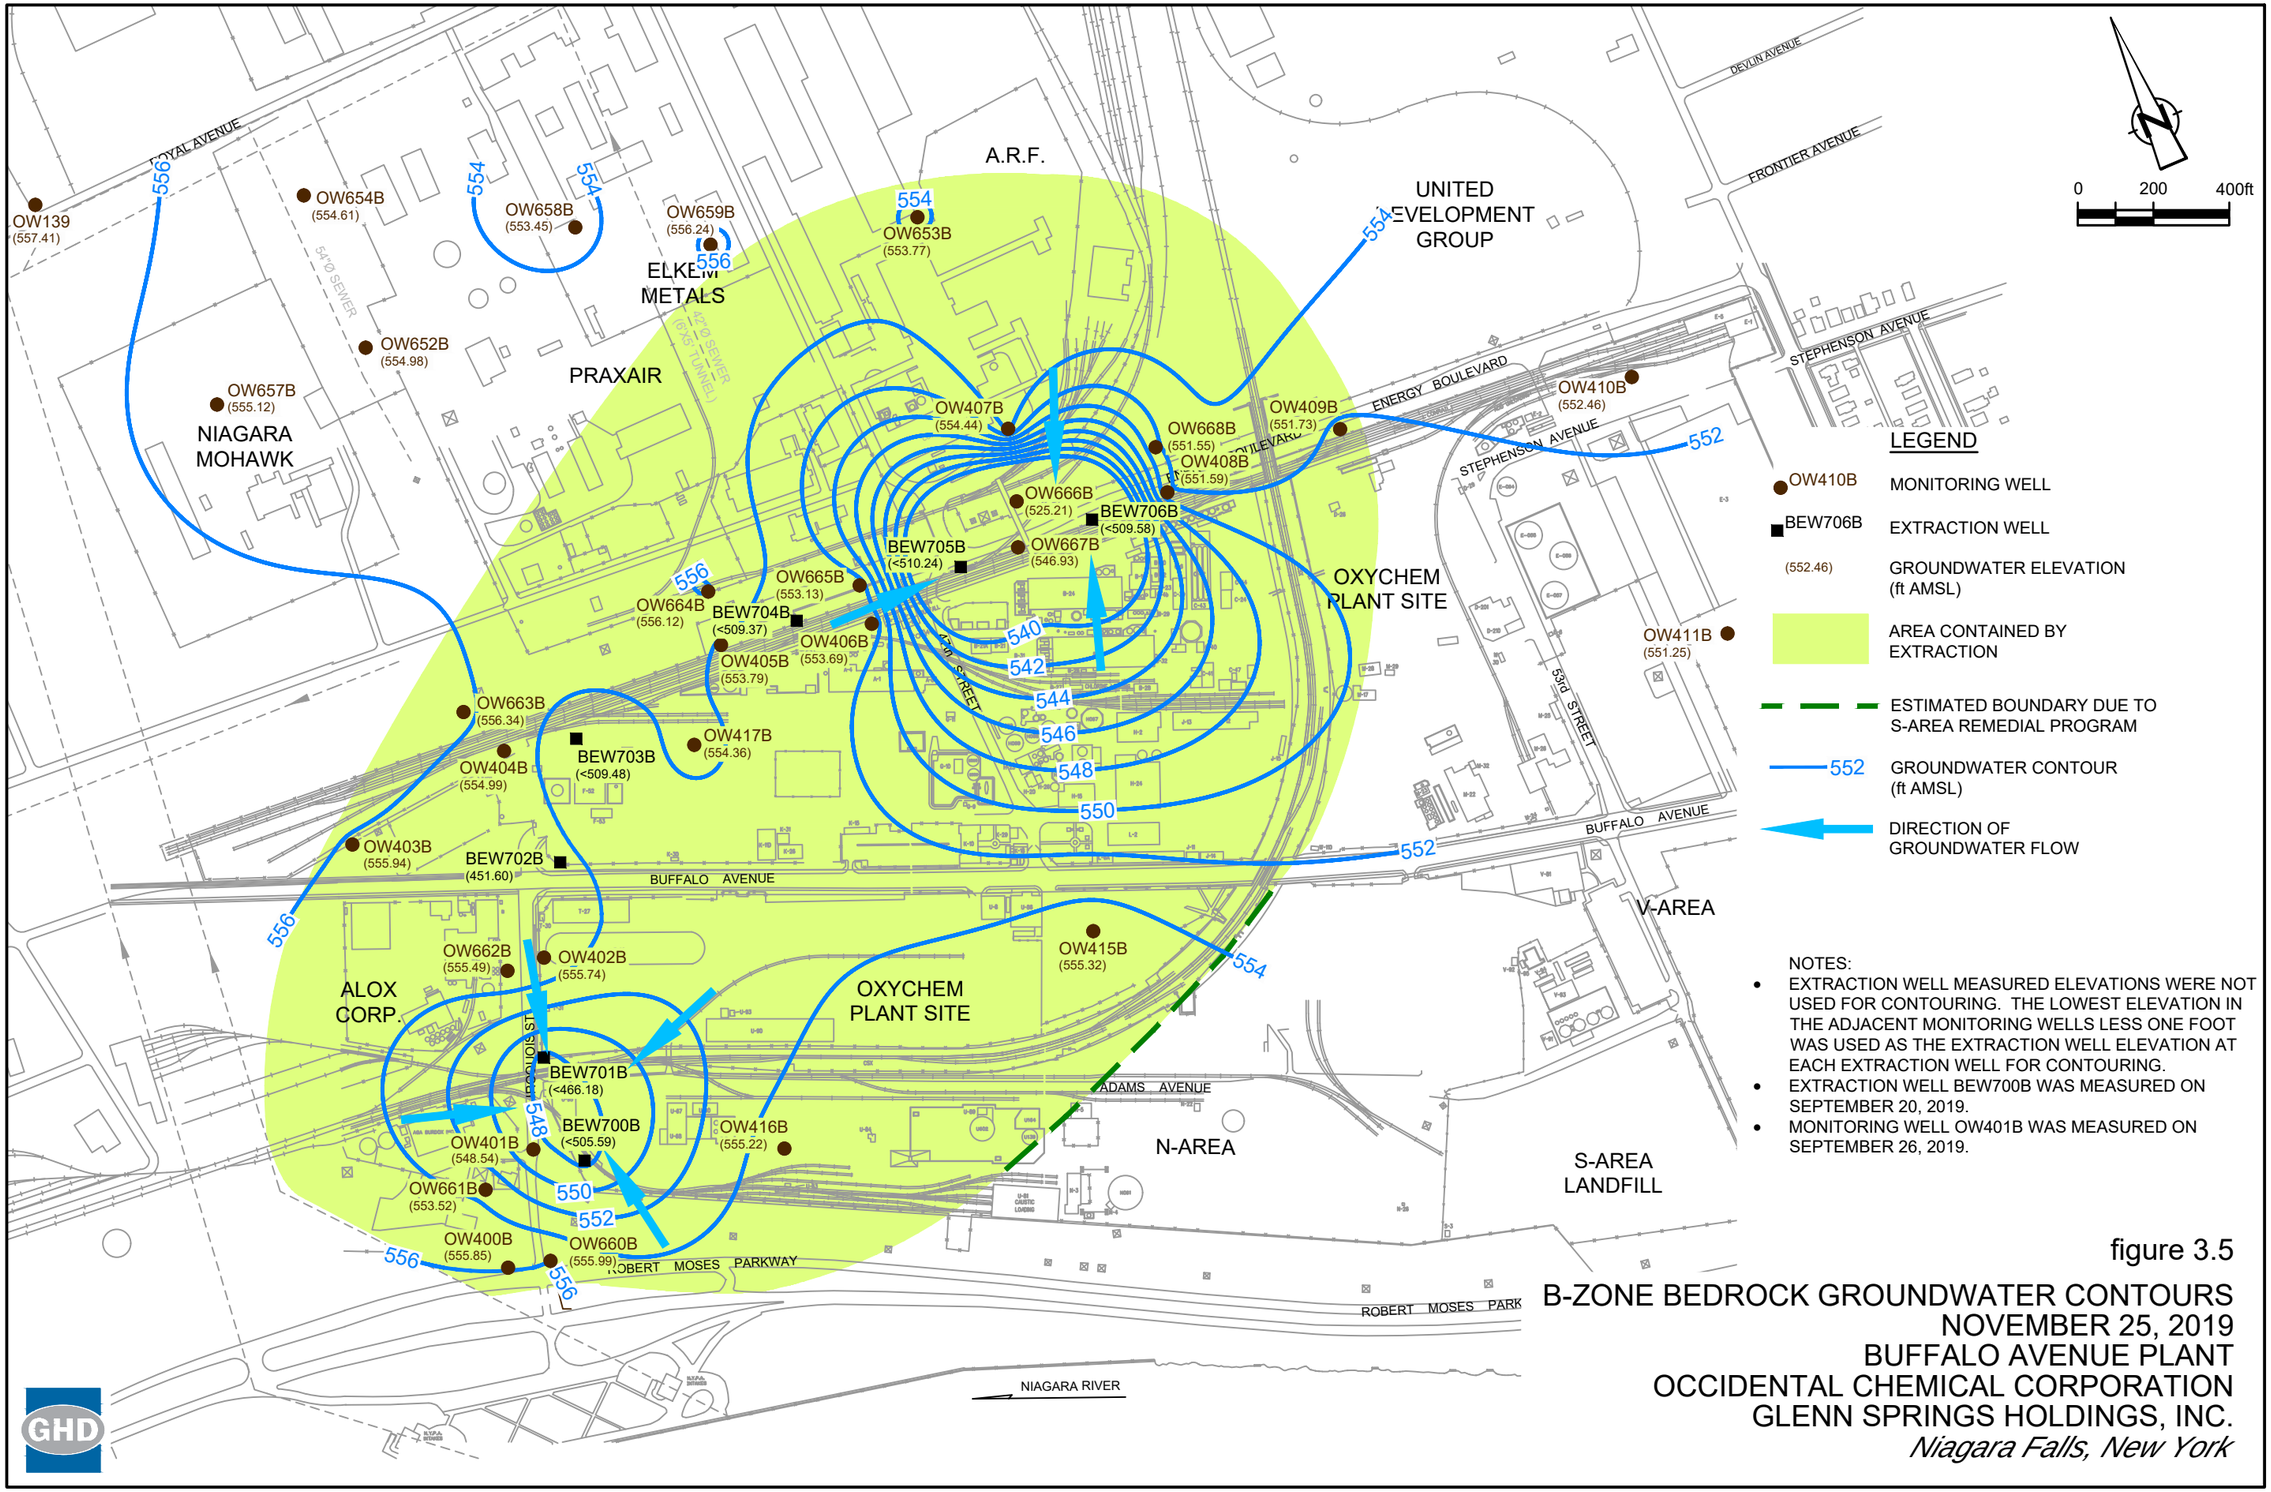
B-ZONE BEDROCK GROUNDWATER CONTOURS NOVEMBER 25, 2019 BUFFALO AVENUE PLANT OCCIDENTAL CHEMICAL CORPORATION GLENN SPRINGS HOLDINGS, INC.

The average monthly flow rate of the B-Zone while the system was operating ranged between 18 gpm (December) and 30 gpm (June). Hydraulic containment was observed in the B-Zone for all monitoring events. The groundwater flow patterns presented on Figure 3.5 were representative of this period. The area contained by extraction extended beyond the Plant boundary. The groundwater flow patterns did not change significantly between the first and fourth quarters demonstrating that hydraulic stabilization was maintained in the B-Zone.

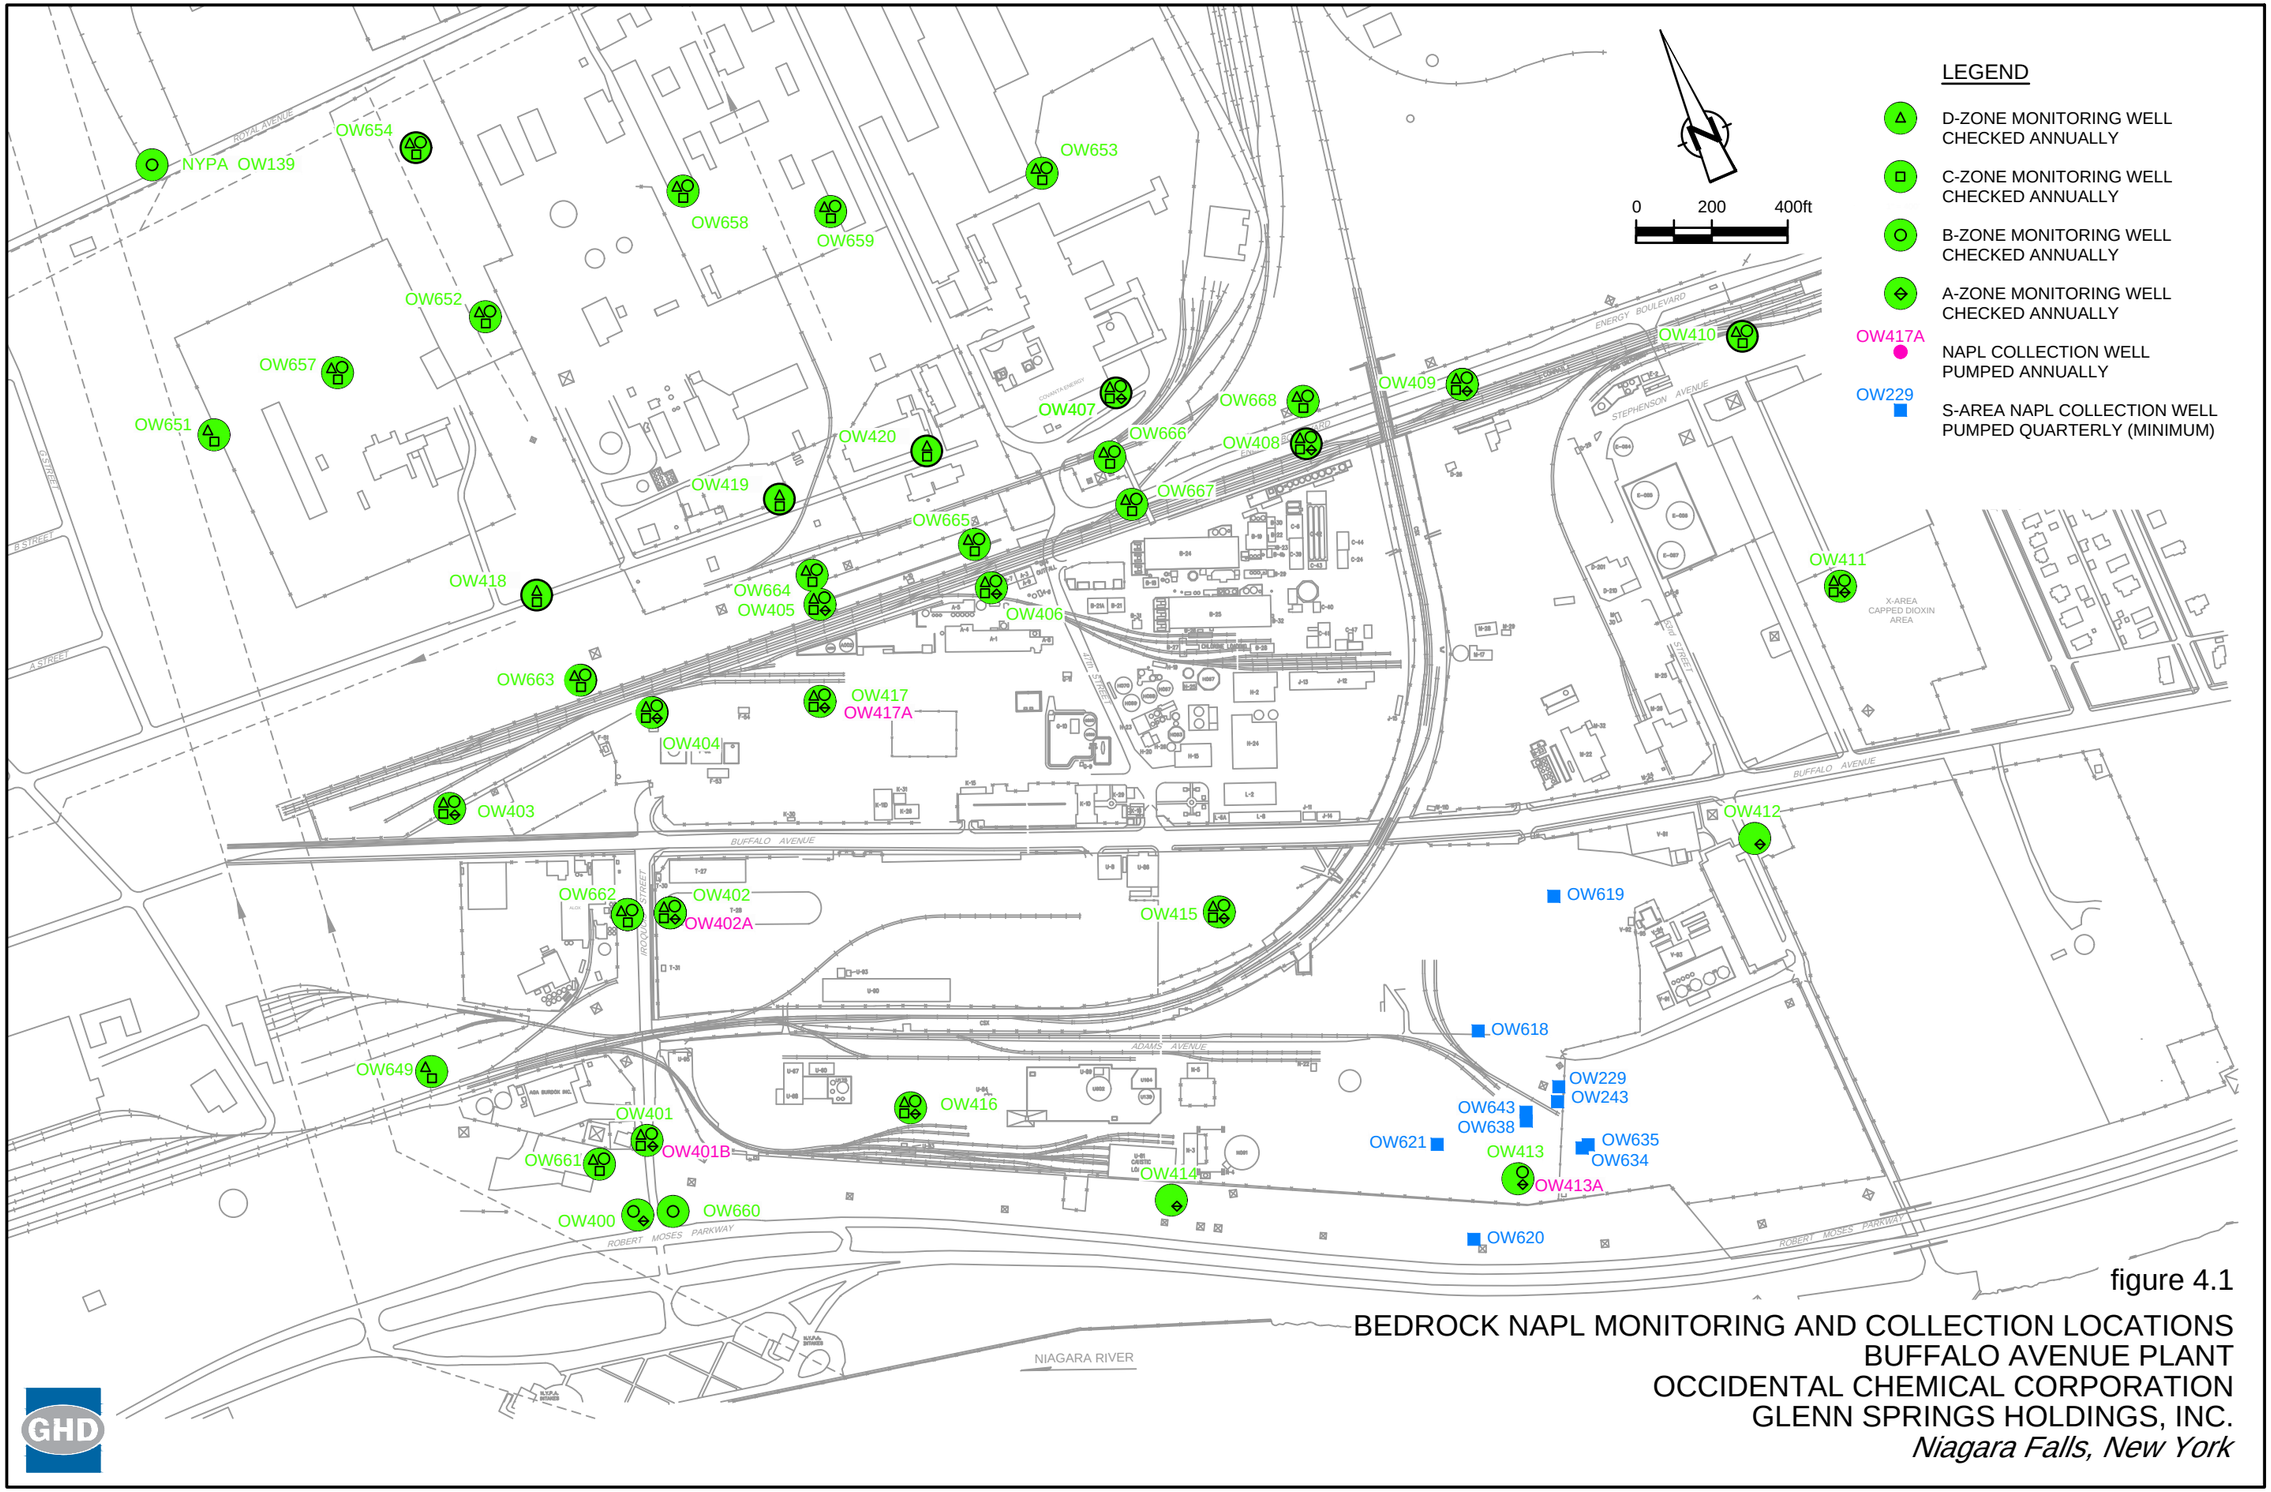
figure 4.1

Quarterly NAPL monitoring and collection from the S-Area bedrock wells (OW229, OW243, OW618, OW619, OW620, OW621, OW634, OW638, OW635, and OW643) that exhibit N-Area NAPL was performed quarterly in 2019. A total of 12.30 gallons of NAPL was recovered from six of the ten S-Area bedrock wells in the N-Area (Table 4.1). Unrecoverable amounts were identified in wells OW619, OW620, OW634, and OW635. The locations of these wells are shown on Figure 4.1.

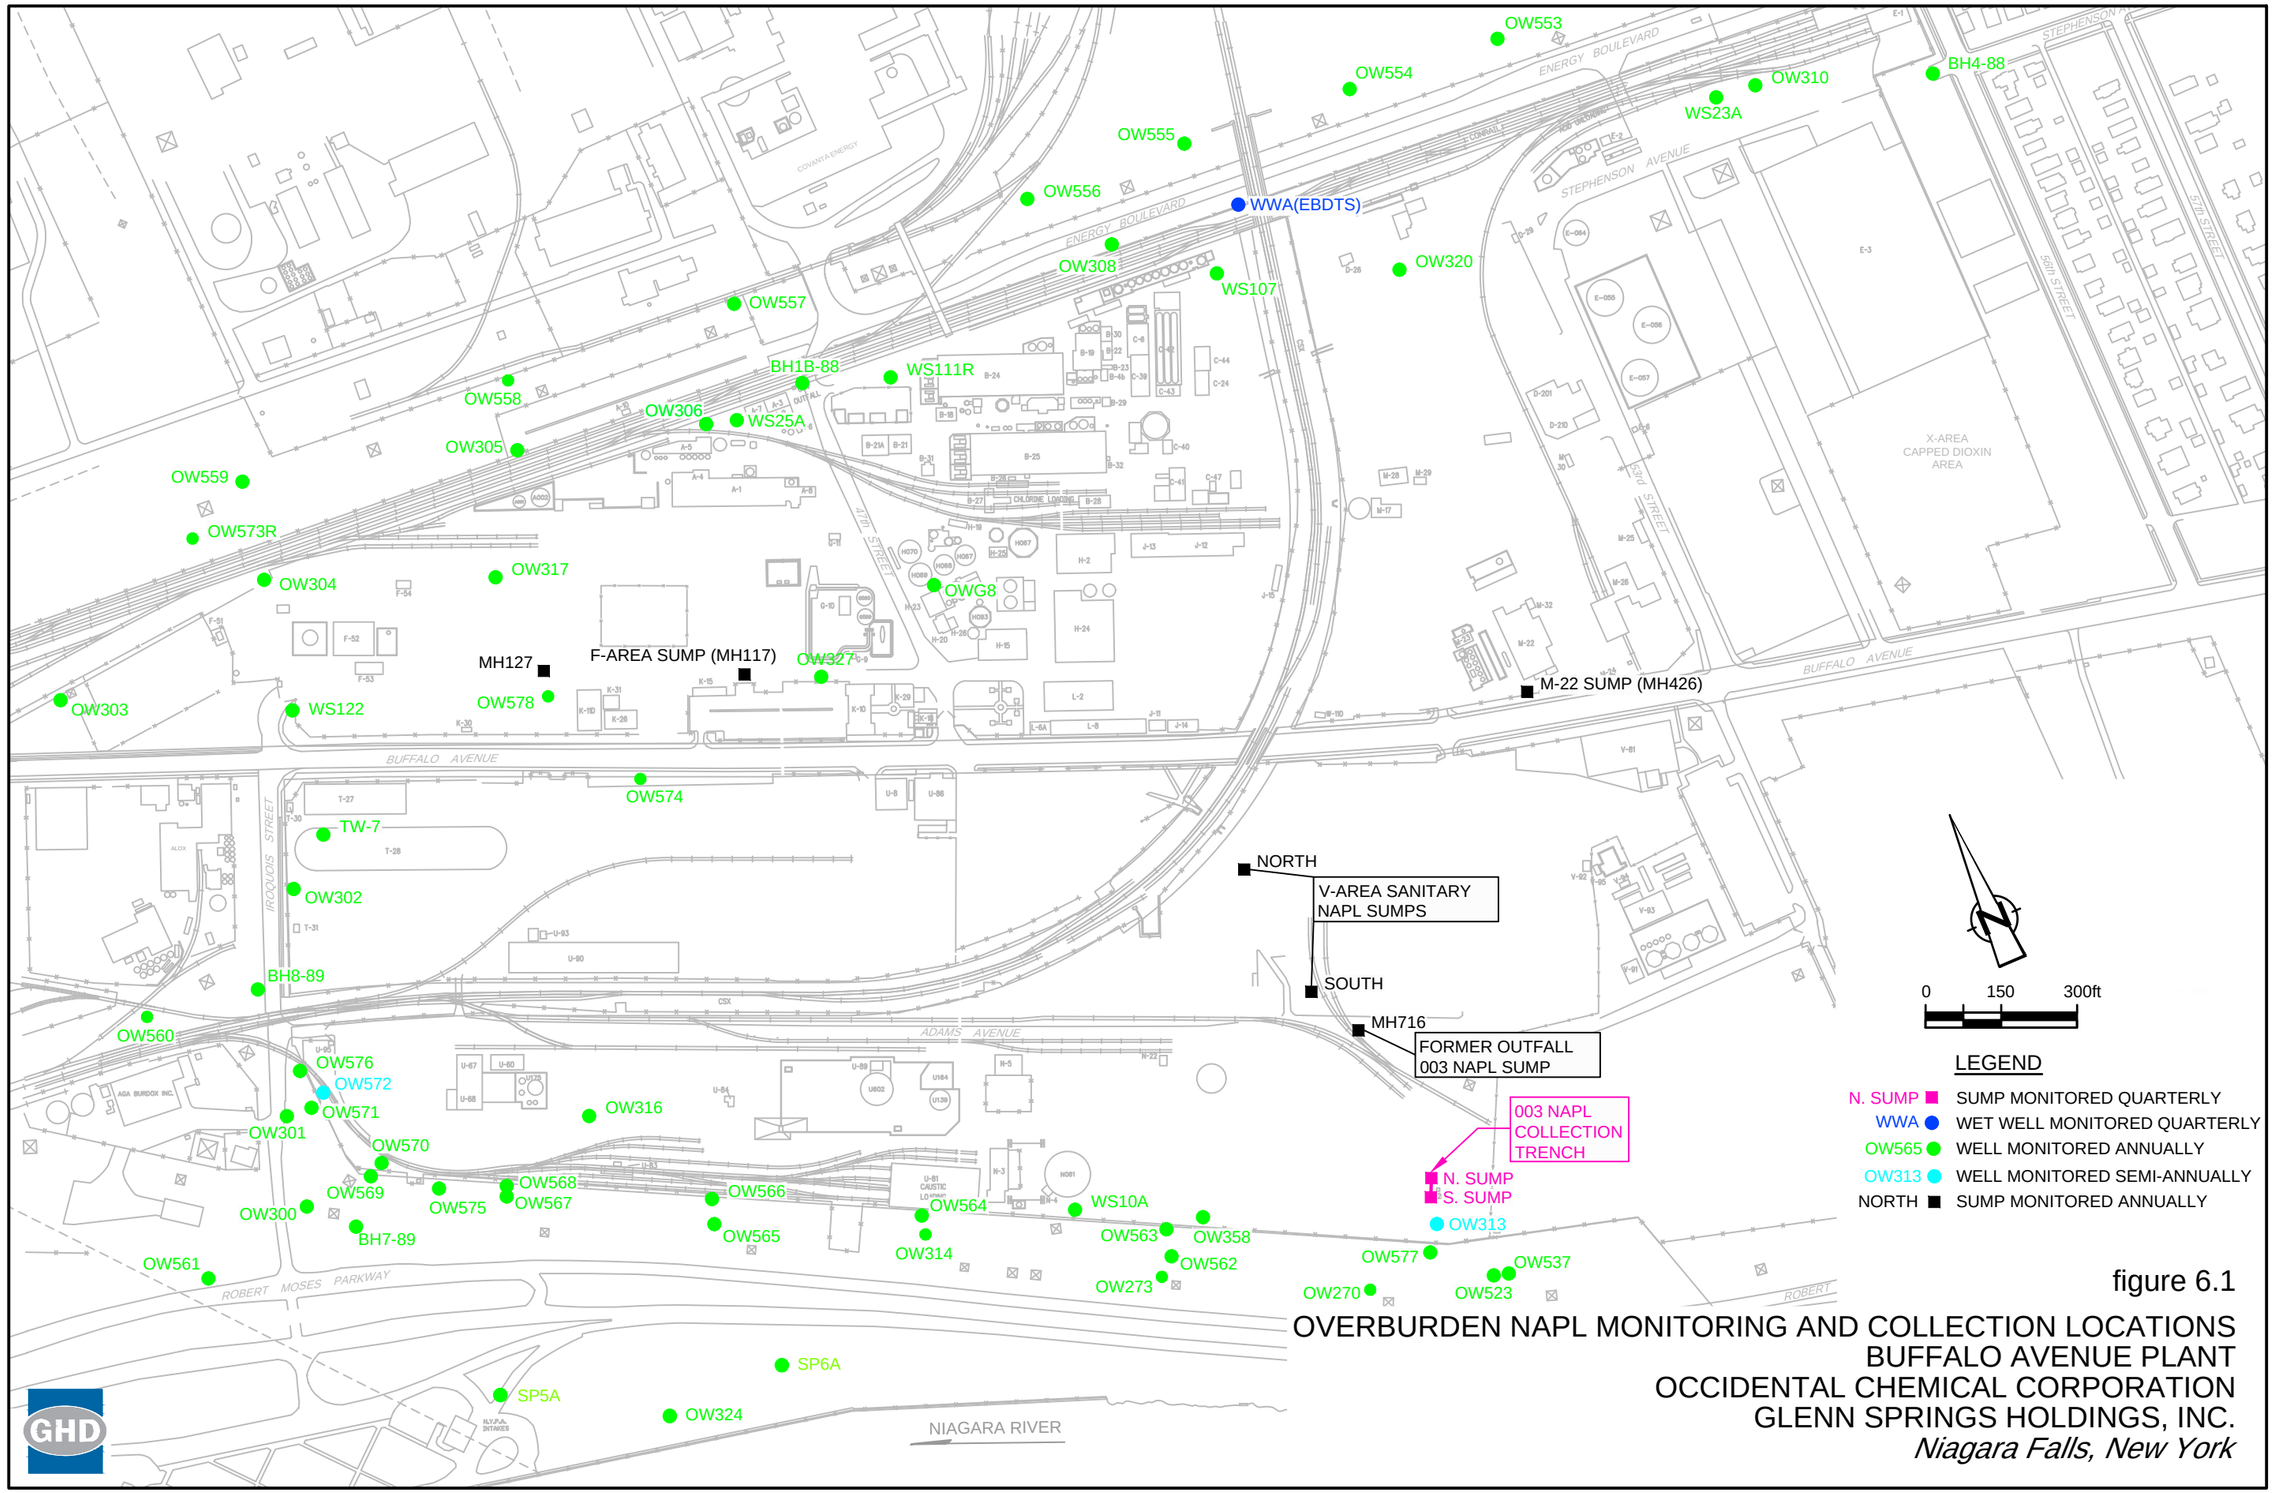
figure 6.1

The overburden NAPL monitoring and collection locations discussed above are shown on Figure 6.1. The volumes of NAPL collected at each overburden location are presented in Table 6.1.

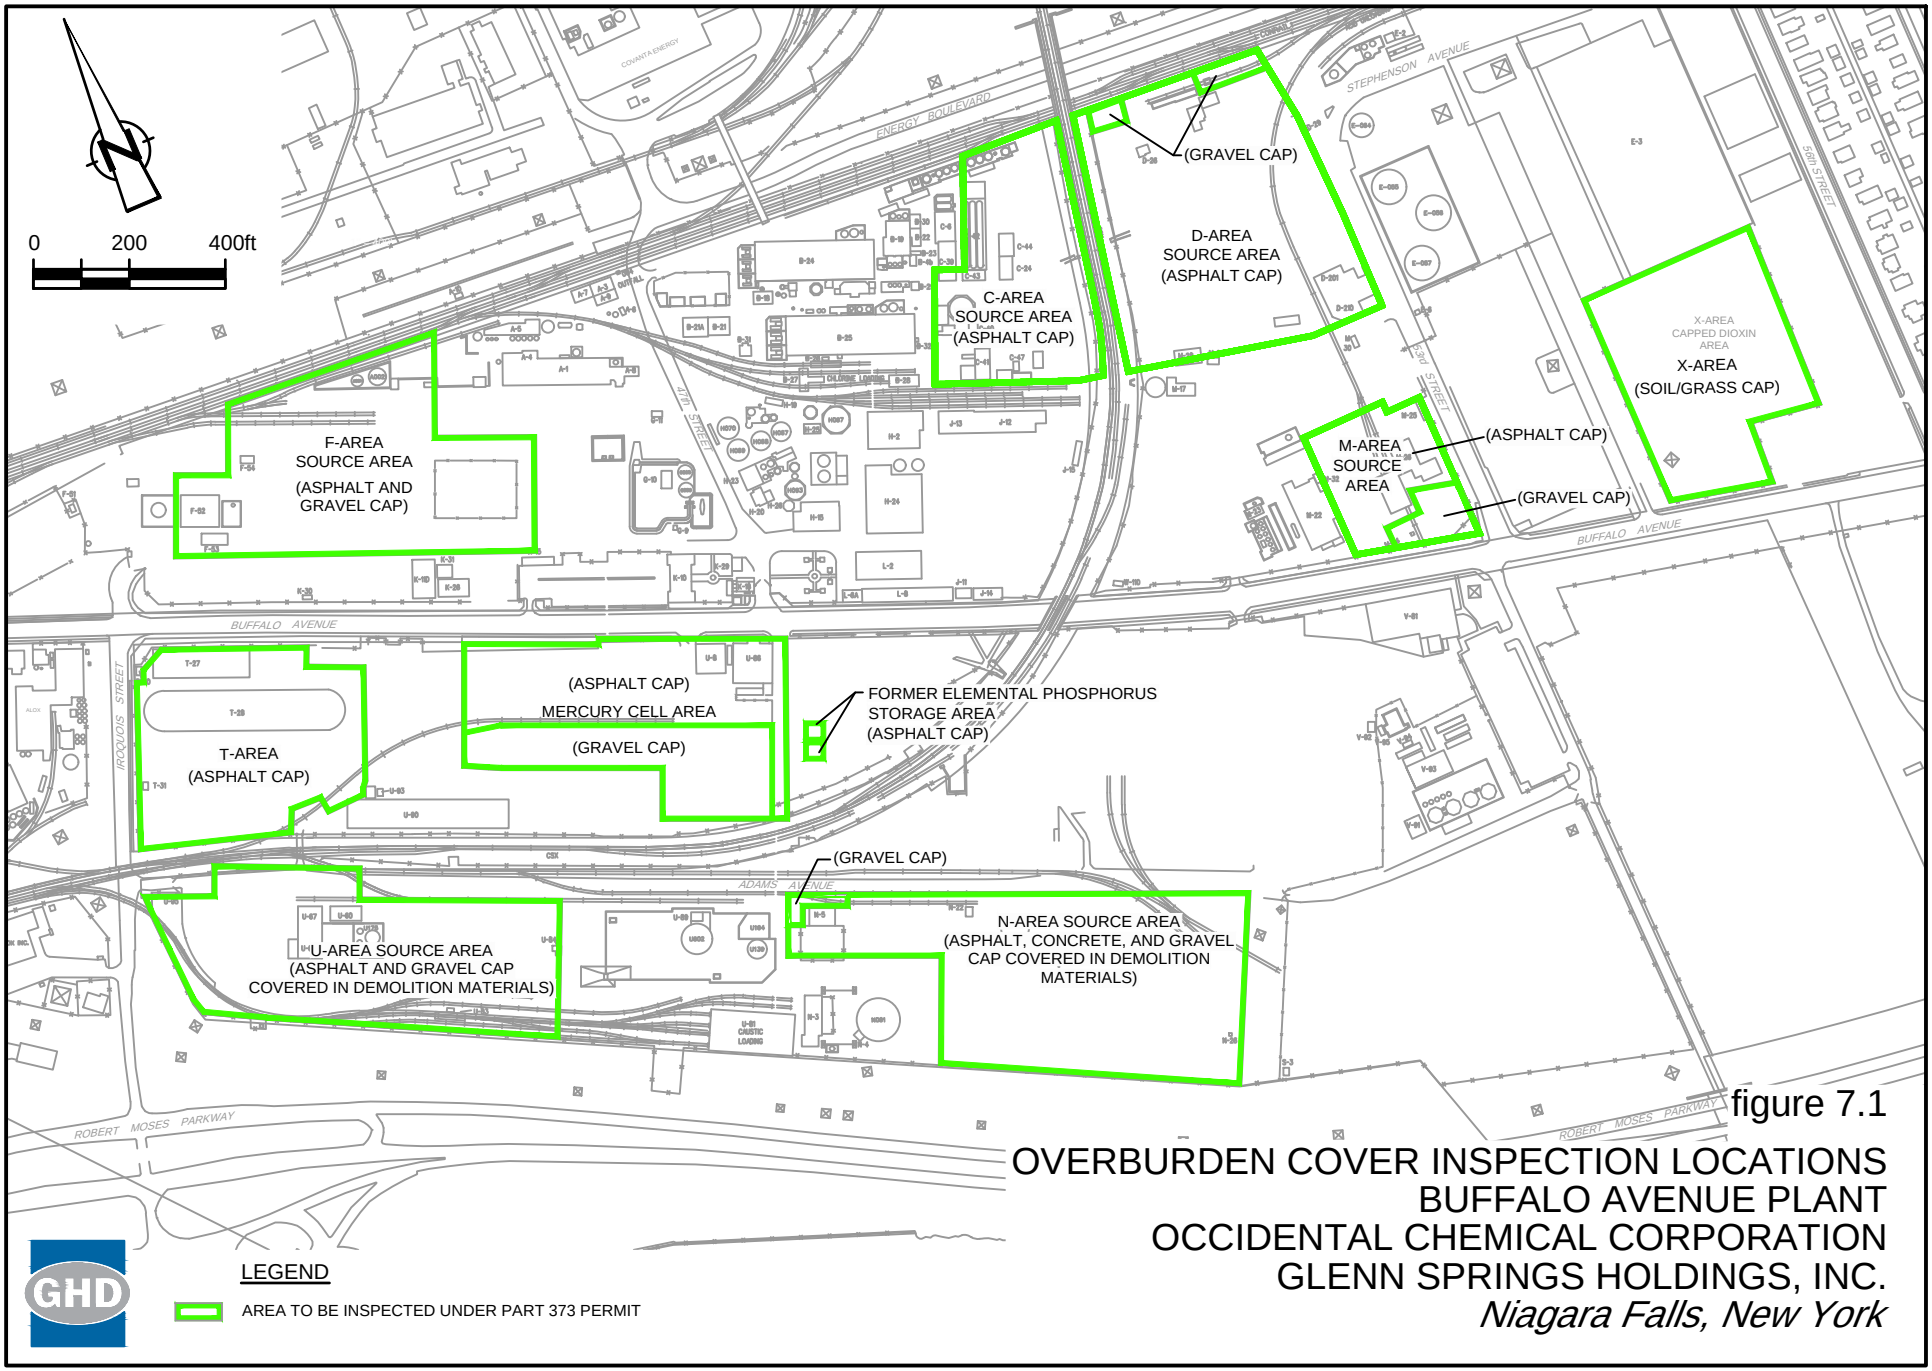
figure 7.1

Pursuant to the RCRA/Part 373 Permit, surface cover materials in various areas of the Plant are inspected on an annual basis to determine the condition of surface cover materials. The locations of these areas are presented on Figure 7.1. The annual inspection of these areas was performed on April 25, 2019. No repairs were required and the surfaces were in good condition.

1. Monitoring of surface cover materials should continue without modification.
2. The Mercury Cell Area Monitoring Program should continue without modification.
