Corrective Measures Implementation Annual Performance Evaluation January through December 2019

Occidental Chemical Corporation
Buffalo Avenue Plant
Niagara Falls, New York

Glenn Springs Holdings, Inc.

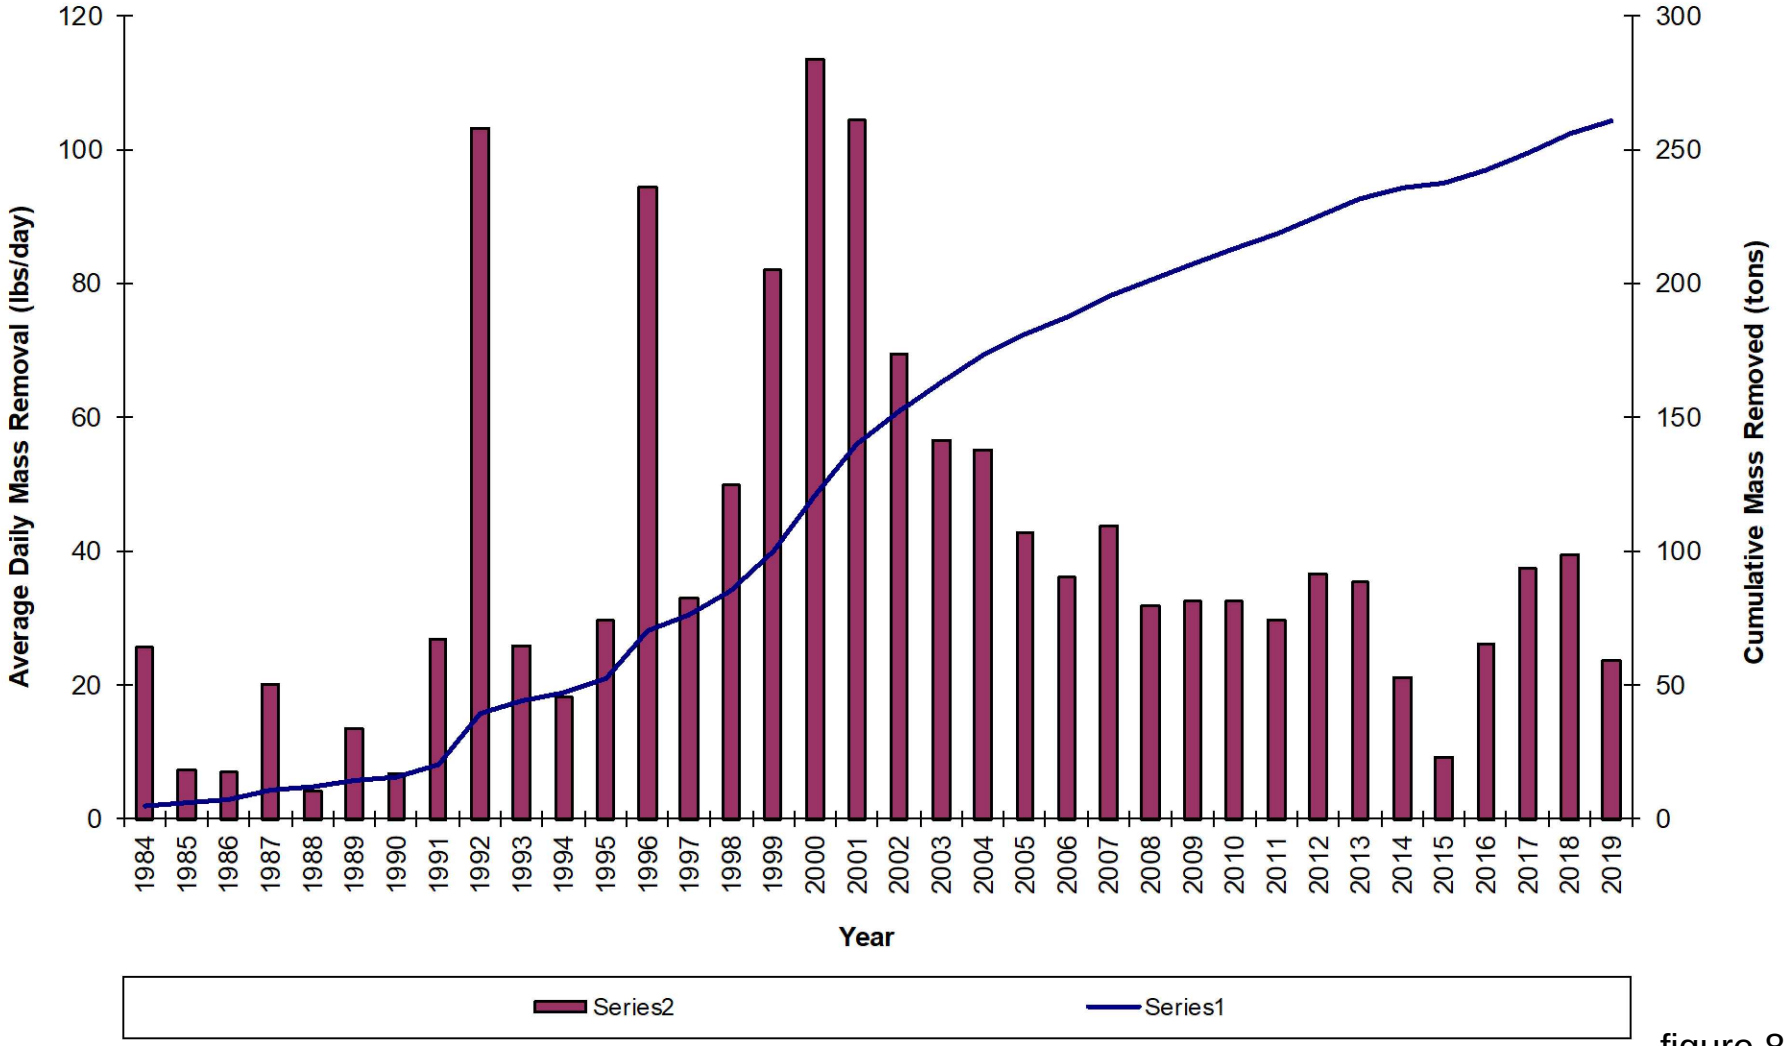
figure 8.1

The Corrective Measures have been effective in removing chemicals and non-aqueous phase liquid (NAPL) from the bedrock and overburden units with an average of 23.8 pounds per day recovered in 2019. The following table summarizes the estimated annual and cumulative removal of chemicals and NAPL since the beginning of the programs based on amount of NAPL collected, average flow rates, and analytical data.

A graph showing the average daily removal rate and cumulative chemical mass removed per year is presented on Figure 8.1.
