Re: 2019 Annual Periodic Review Report
102nd Street Landfill Site, Niagara Falls, New York

2019 Annual Periodic Review Report

102nd Street Landfill Site
Niagara Falls, New York
NYSDEC Site No. 932022

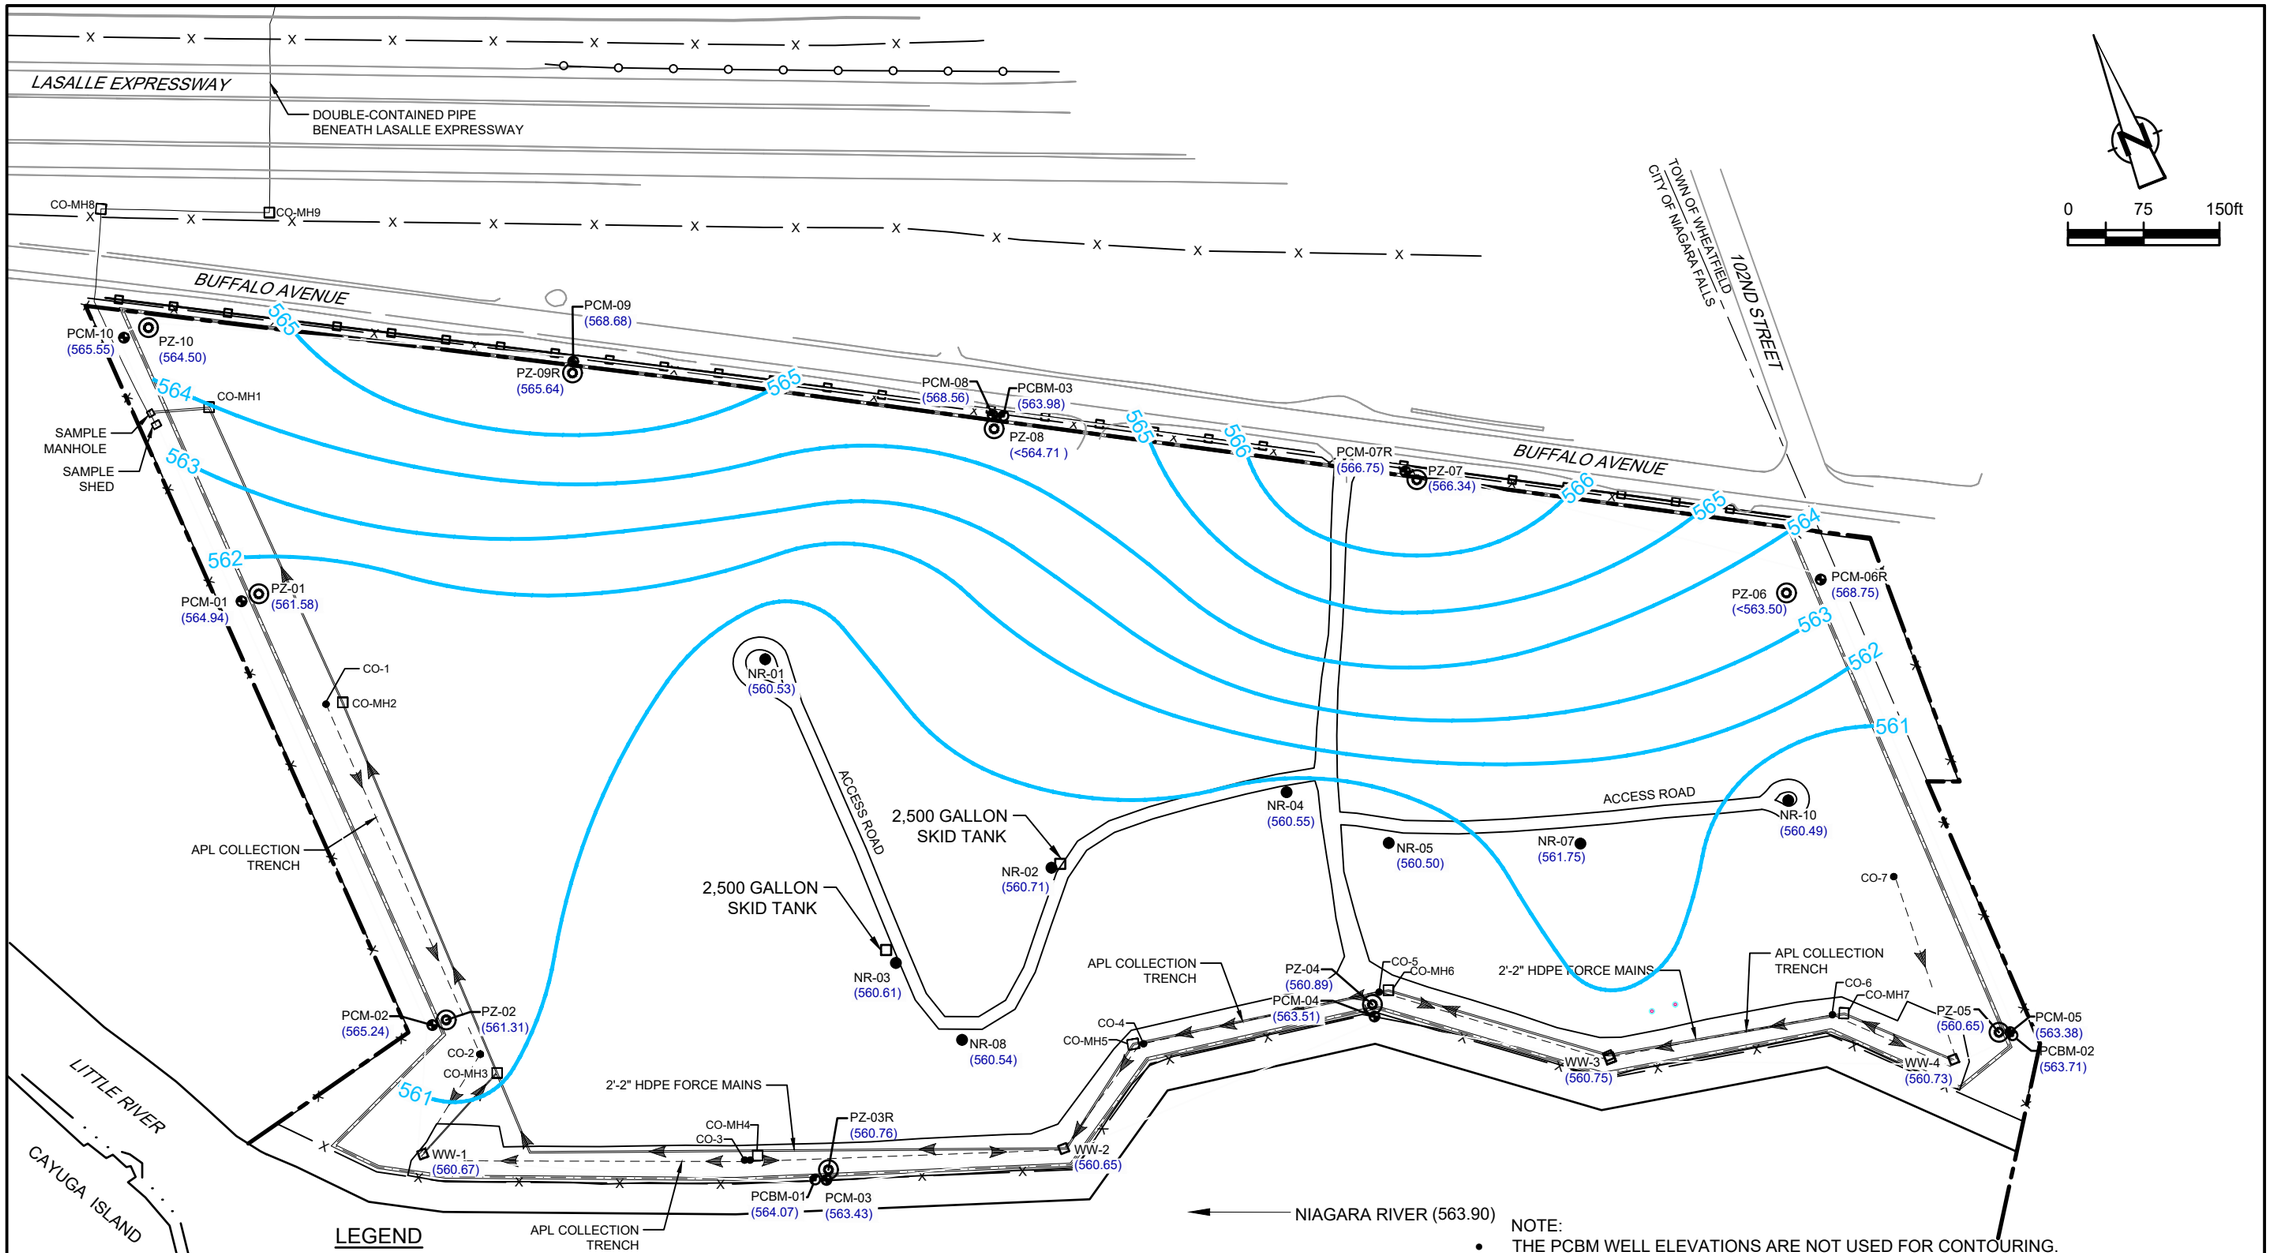
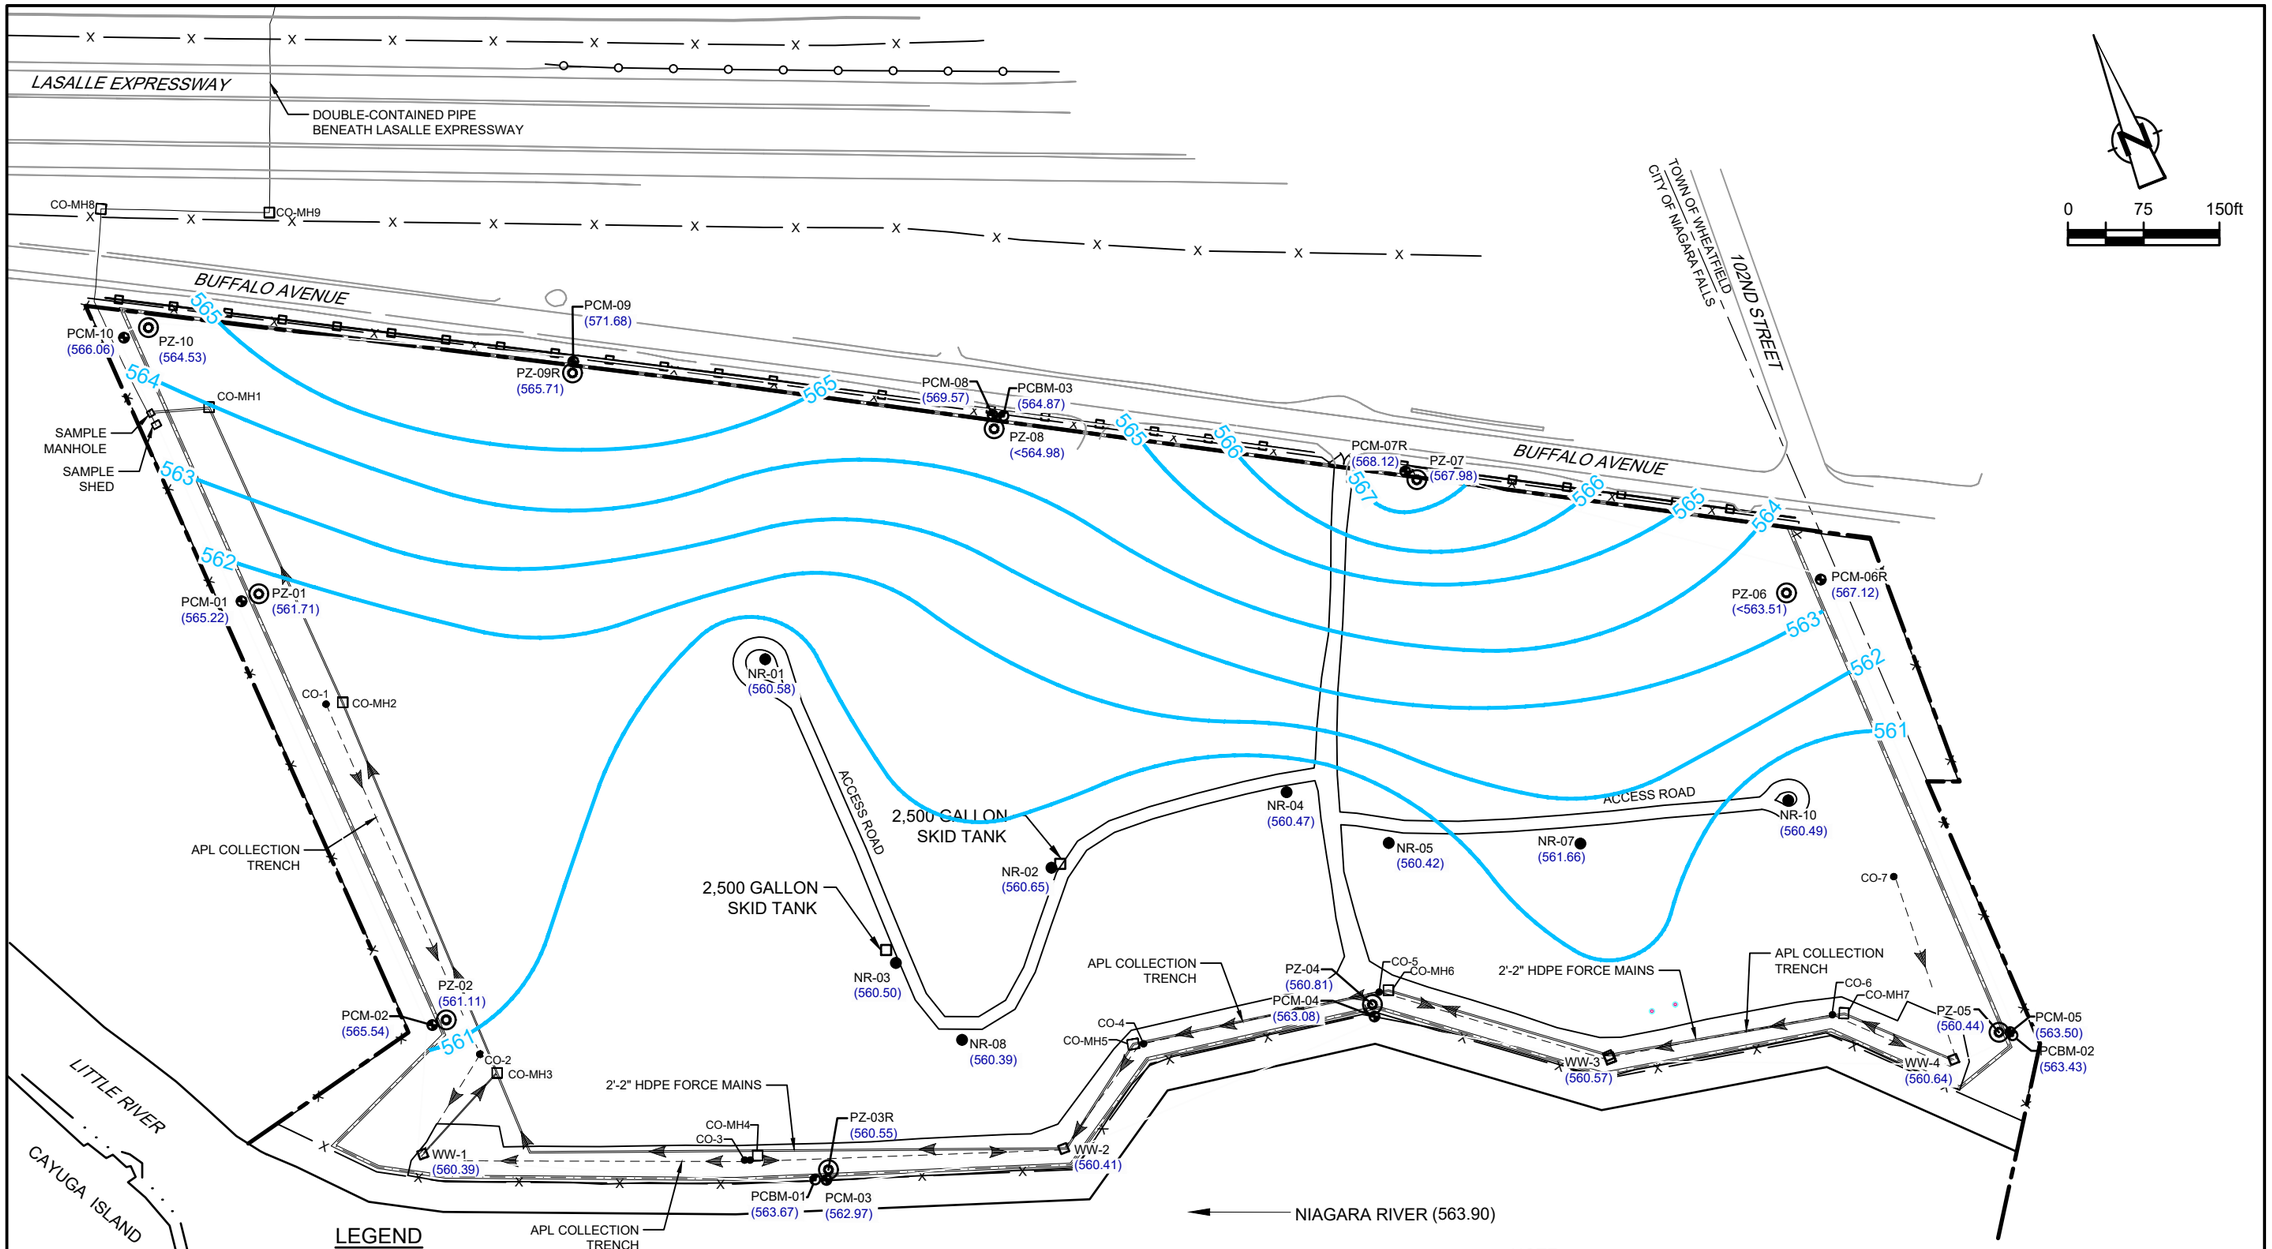
The 2019 quarterly groundwater elevations and potentiometric groundwater contours are shown on Figures 2.1 through 2.4. Where groundwater was present, inward gradients across the slurry wall towards the landfill (as indicated by a lower water elevation inside the slurry wall than outside the slurry wall) were demonstrated at all monitoring wells pairs for each event (see Table 2.3).

Piezometers PZ-06, PZ-07, PZ-08, PZ-09R, and PZ-10 are located along the northern side of the Site, and as shown on Figures 2.1 through 2.4, exhibit groundwater elevations ranging from 564.50 feet above mean sea level (AMSL) to 567.98 feet AMSL. The remaining wells inside the slurry wall at the Site (piezometers PZ-01, PZ-02, PZ-03R, PZ-04, PZ-05), NAPL recovery wells (NR-01, NR-02, NR-03, NR-04, NR-05, NR-07, NR-08, NR-10), and Wet Wells (1 through 4) to the south of piezometers PZ-06, PZ-07, PZ-08, PZ-09R, and PZ-10 exhibit groundwater elevations ranging from 560.20 feet AMSL to 561.75 feet AMSL. Groundwater potentiometric contours presented on Figures 2.1 through 2.4 demonstrate that within the landfill, groundwater flows in a north-to-south direction towards the APL collection trench (located on the south side of the Site along the Niagara River and portions of the east and west sides of the Site). Therefore, the water table is depressed inside the slurry wall and any groundwater impacts would migrate to the APL collection trench.

Based on the long-term stability of the groundwater elevations measured in the monitoring well pairs and demonstrated hydraulic containment (Appendix C), the frequency of the hydraulic monitoring events is recommended to be reduced from quarterly to semiannually, conducted in the fall and spring beginning in the spring of 2020.

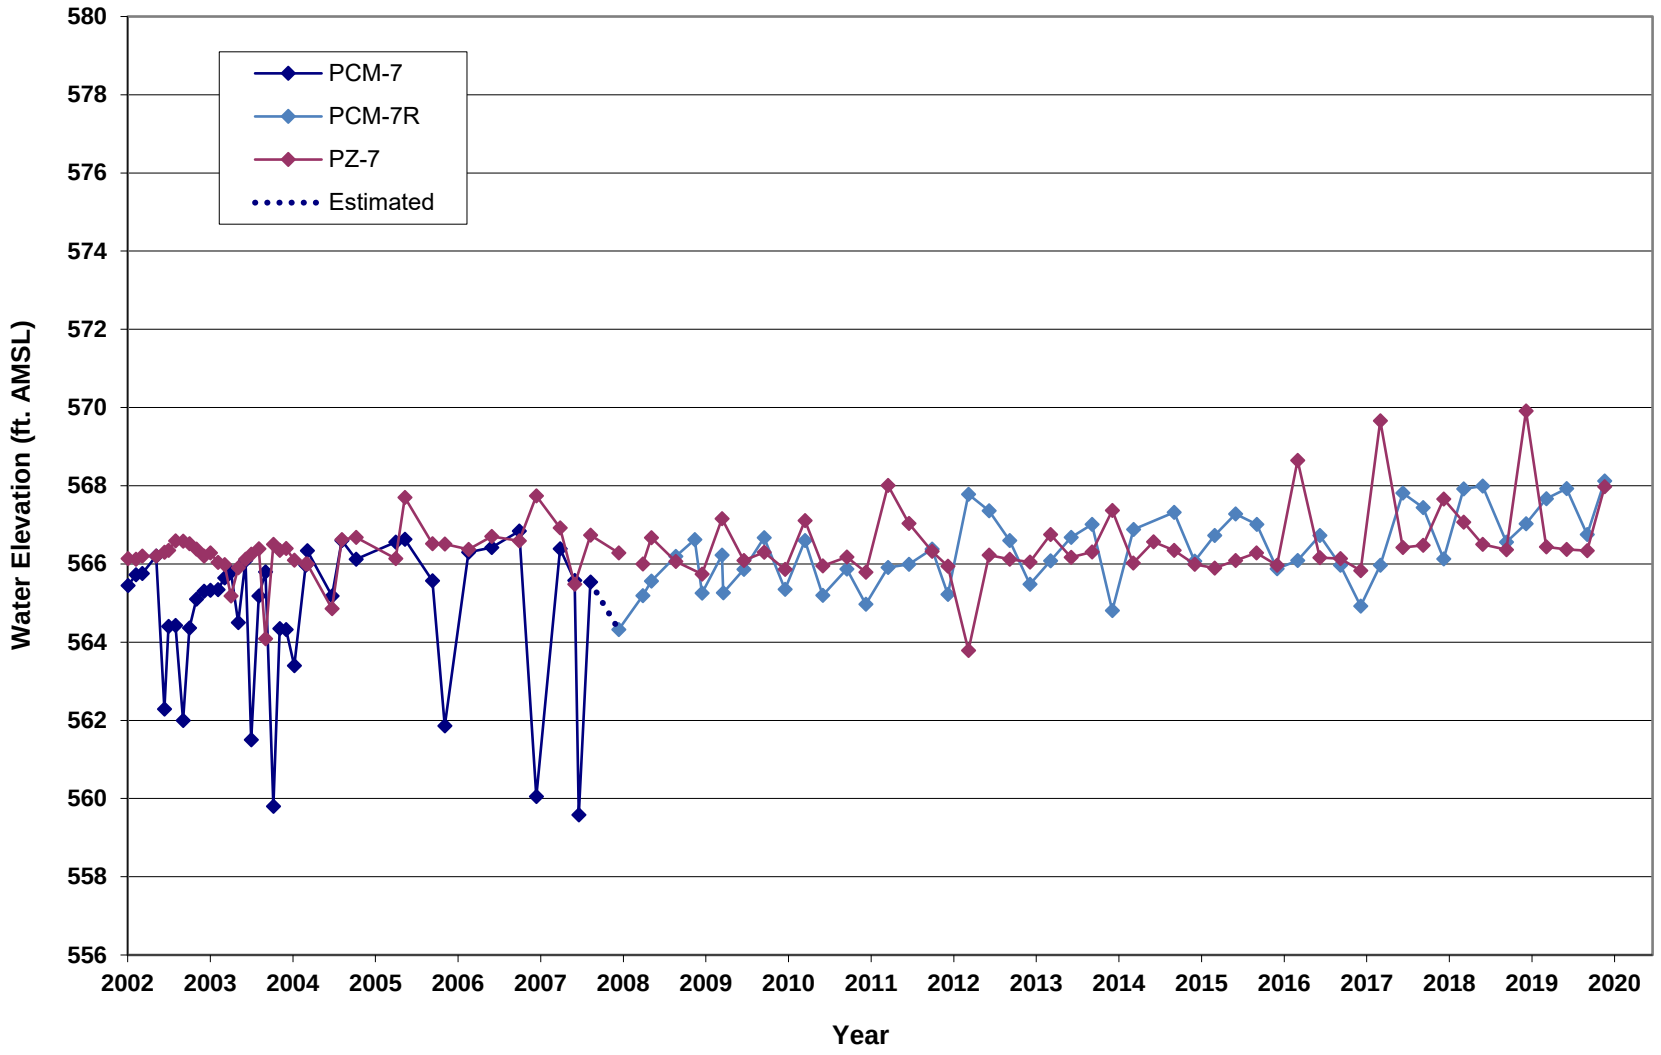
figure C.7
GROUNDWATER LEVELS WELL PAIR 7
102ND STREET LANDFILL SITE
GLENN SPRINGS HOLDINGS, INC
Niagara Falls, New York

Higher water levels have historically been observed in PZ-07 (inside the slurry wall) relative to PCM-07R (outside the slurry wall) during certain quarters (refer to Figure C.7 in Appendix C). The reason for this is unknown. As a result, PZ-07 was redeveloped on June 5, 2018. Following redevelopment the groundwater elevation in PZ-07 was lower than the groundwater elevation in PCM-07R during the September 2018 monitoring event, indicating an inward gradient, but was still higher than the groundwater elevation in PCM-07R during the December 2018 monitoring event, indicating an outward gradient. However, given the thickness and the low permeability of the slurry wall that separates the two wells, and that the natural and current groundwater flow direction along the northern portion of the Site (where PCM-07R and PZ-07 are located) is from the north (off-Site) to the south (on-Site), the potential for chemical migration to occur through the wall is negligible. This is confirmed by the fact that there has not been any chemical evidence to suggest that contaminants have migrated from the landfill at this location. Based on this, the 2018 PRR recommended that the water levels in these wells continue to be monitored on a quarterly basis for one additional year, with recommendations for further evaluation (if needed) to be provided in the 2019 PRR. The NYSDEC agreed with this recommendation in its April 9, 2019 letter accepting the 2018 PRR. As indicated in Table 2.3, groundwater elevations in PZ-07 were lower than those in PCM-07R during all four quarterly monitoring events in 2019, indicating an inward gradient.

Therefore, no further evaluation is warranted at this time. Water levels will continue to be monitored at these locations in accordance with the hydraulic monitoring requirements.

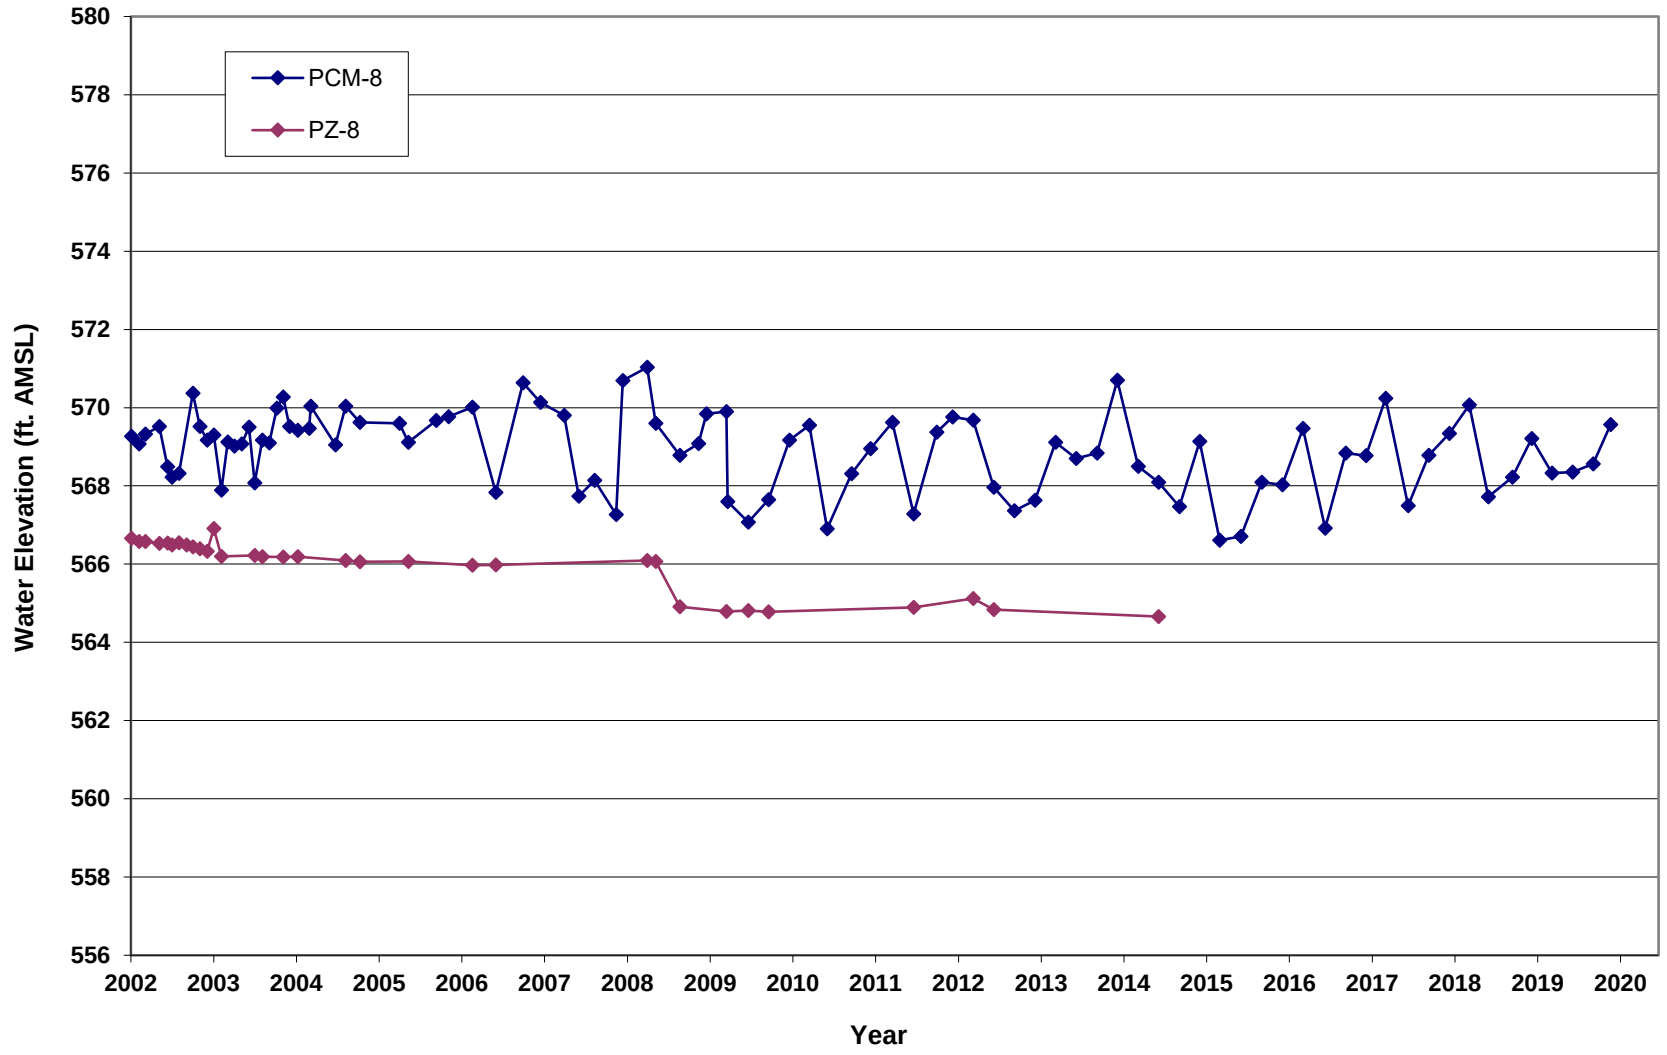
figure C.8
GROUNDWATER LEVELS WELL PAIR 8
102ND STREET LANDFILL SITE
GLENN SPRINGS HOLDINGS, INC
Niagara Falls, New York

Note: PZ-8 dry during all four quarters of the 2016 quarterly monitoring.

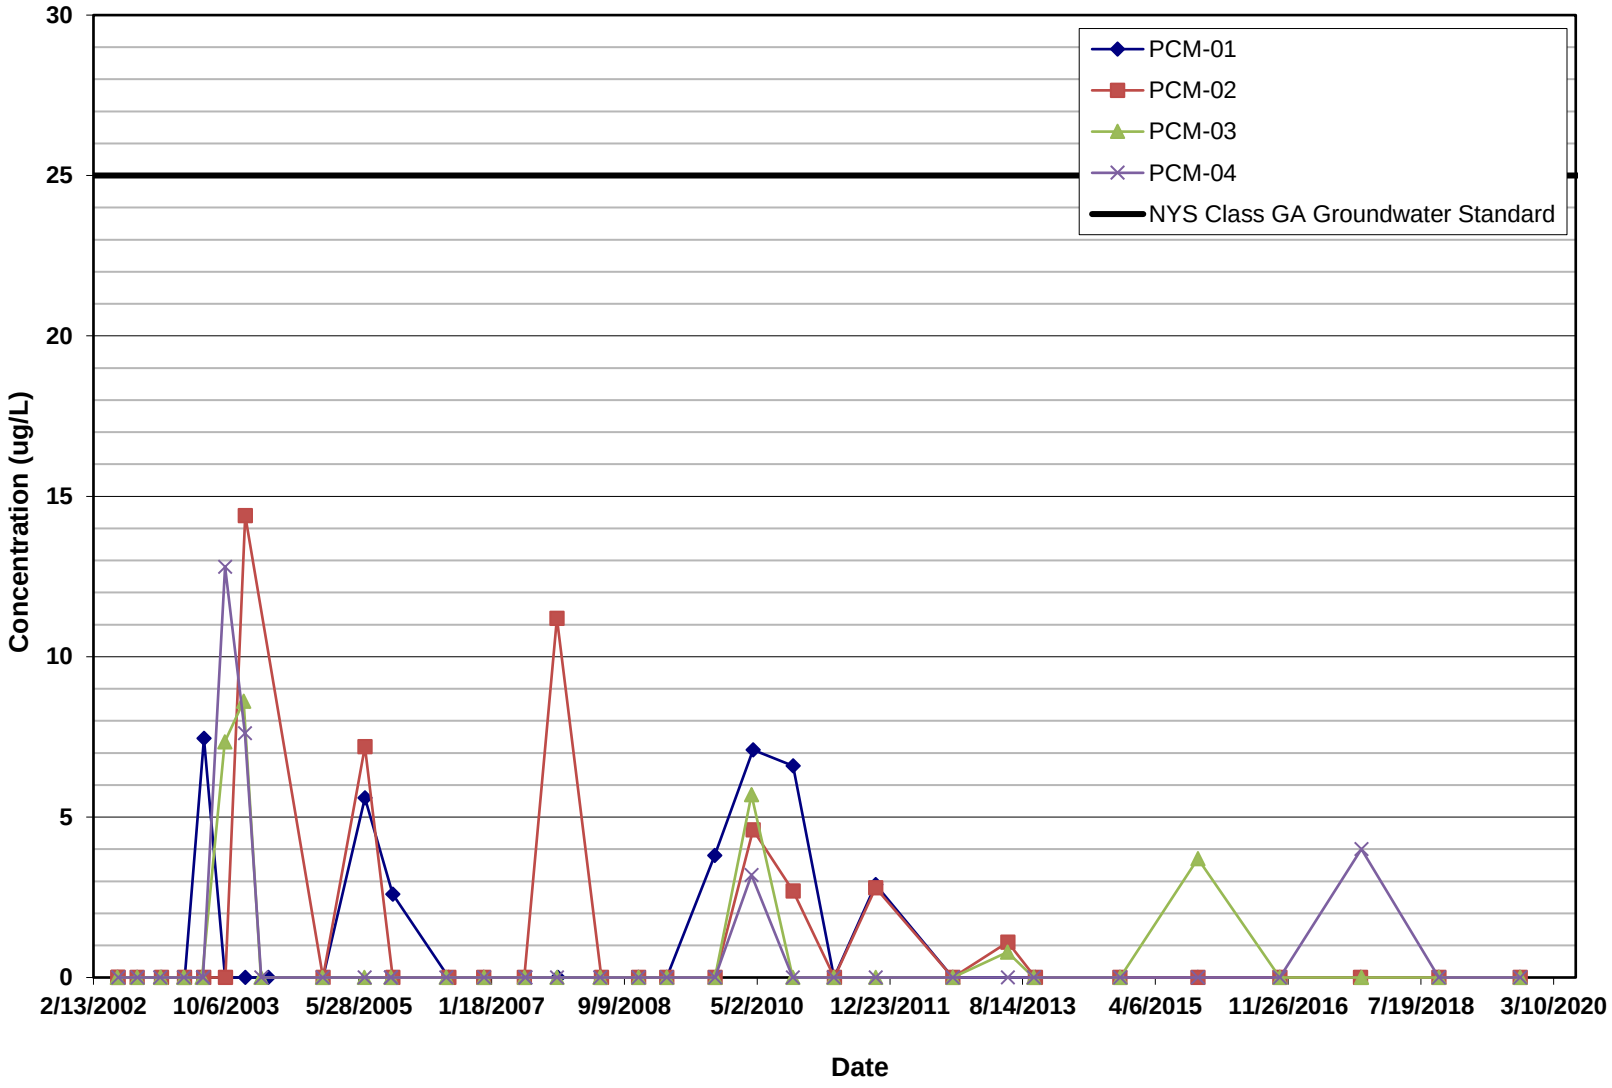
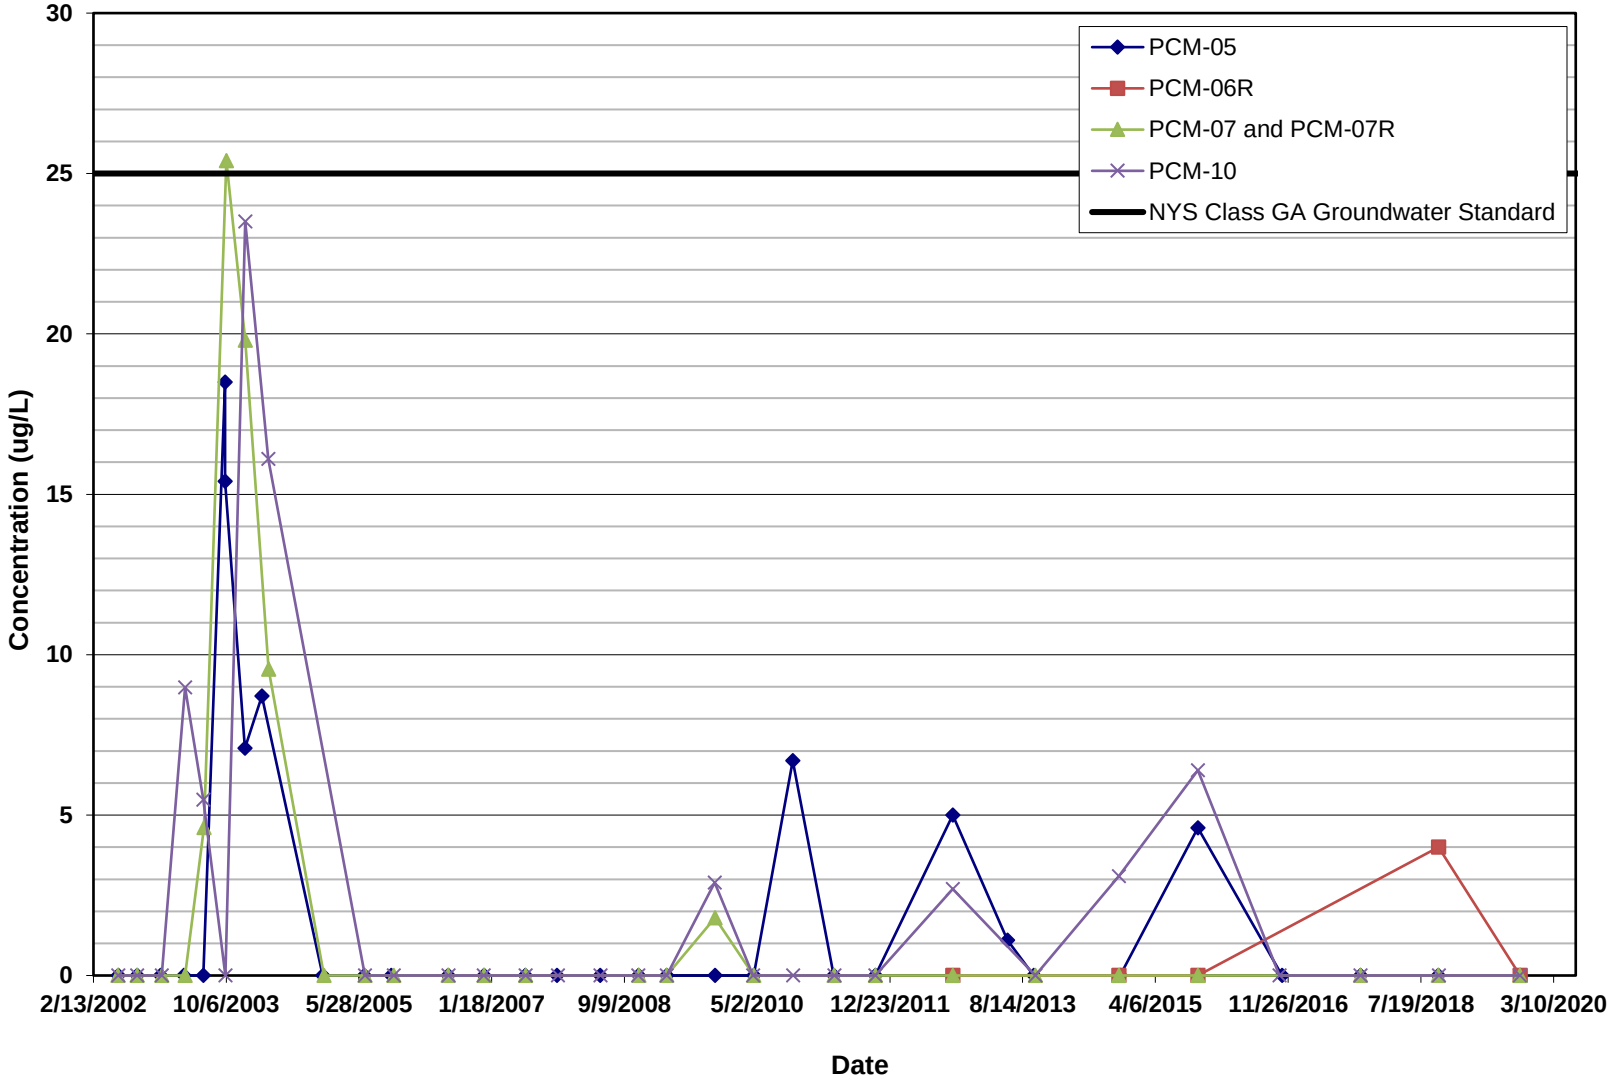
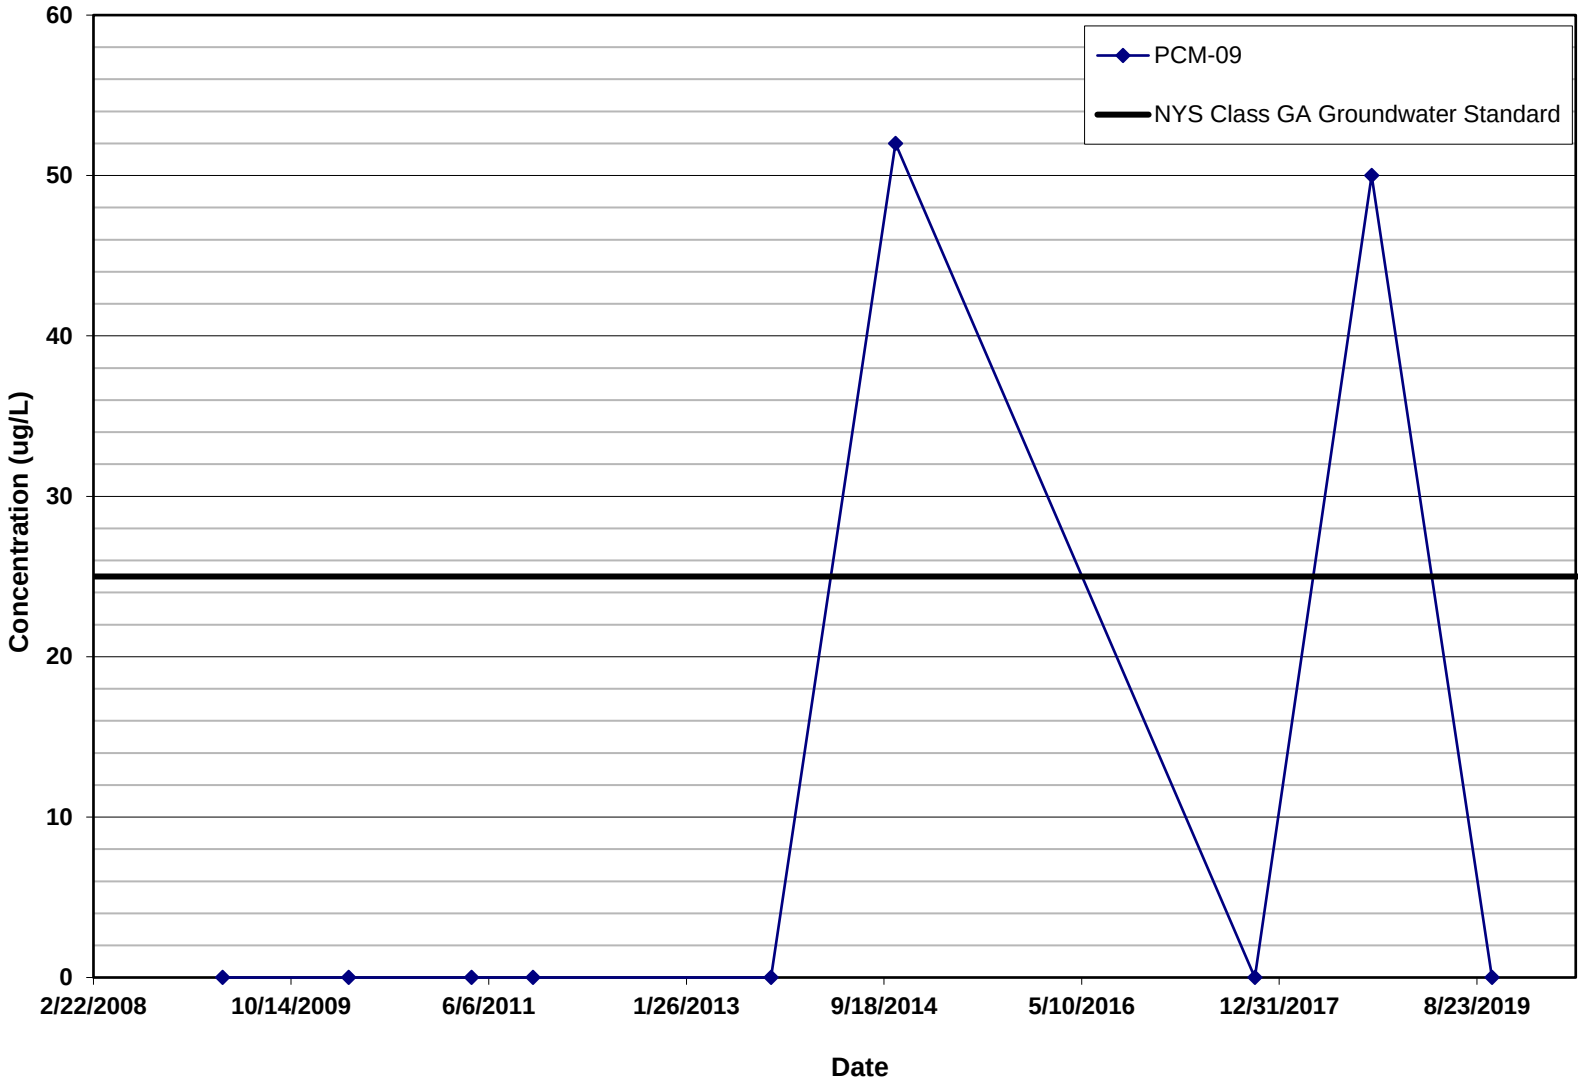
The 2018 PRR stated that arsenic and mercury have only been detected sporadically at concentrations above NYS Groundwater Standards in the overburden groundwater since groundwater monitoring commenced. As recommended by NYSDEC in its letter dated April 9, 2019, arsenic and mercury concentration trend plots have been developed to further evaluate arsenic and mercury concentration trends in overburden groundwater over time. The concentration trend plots, as well as a summary of arsenic and mercury concentrations, are presented in Appendix G.

Based on the sporadic, low concentrations of arsenic and mercury detected in overburden wells during historical sampling events, it is recommended to remove arsenic and mercury from the list of analytes for future overburden annual monitoring events, starting with the 2020 annual monitoring event.

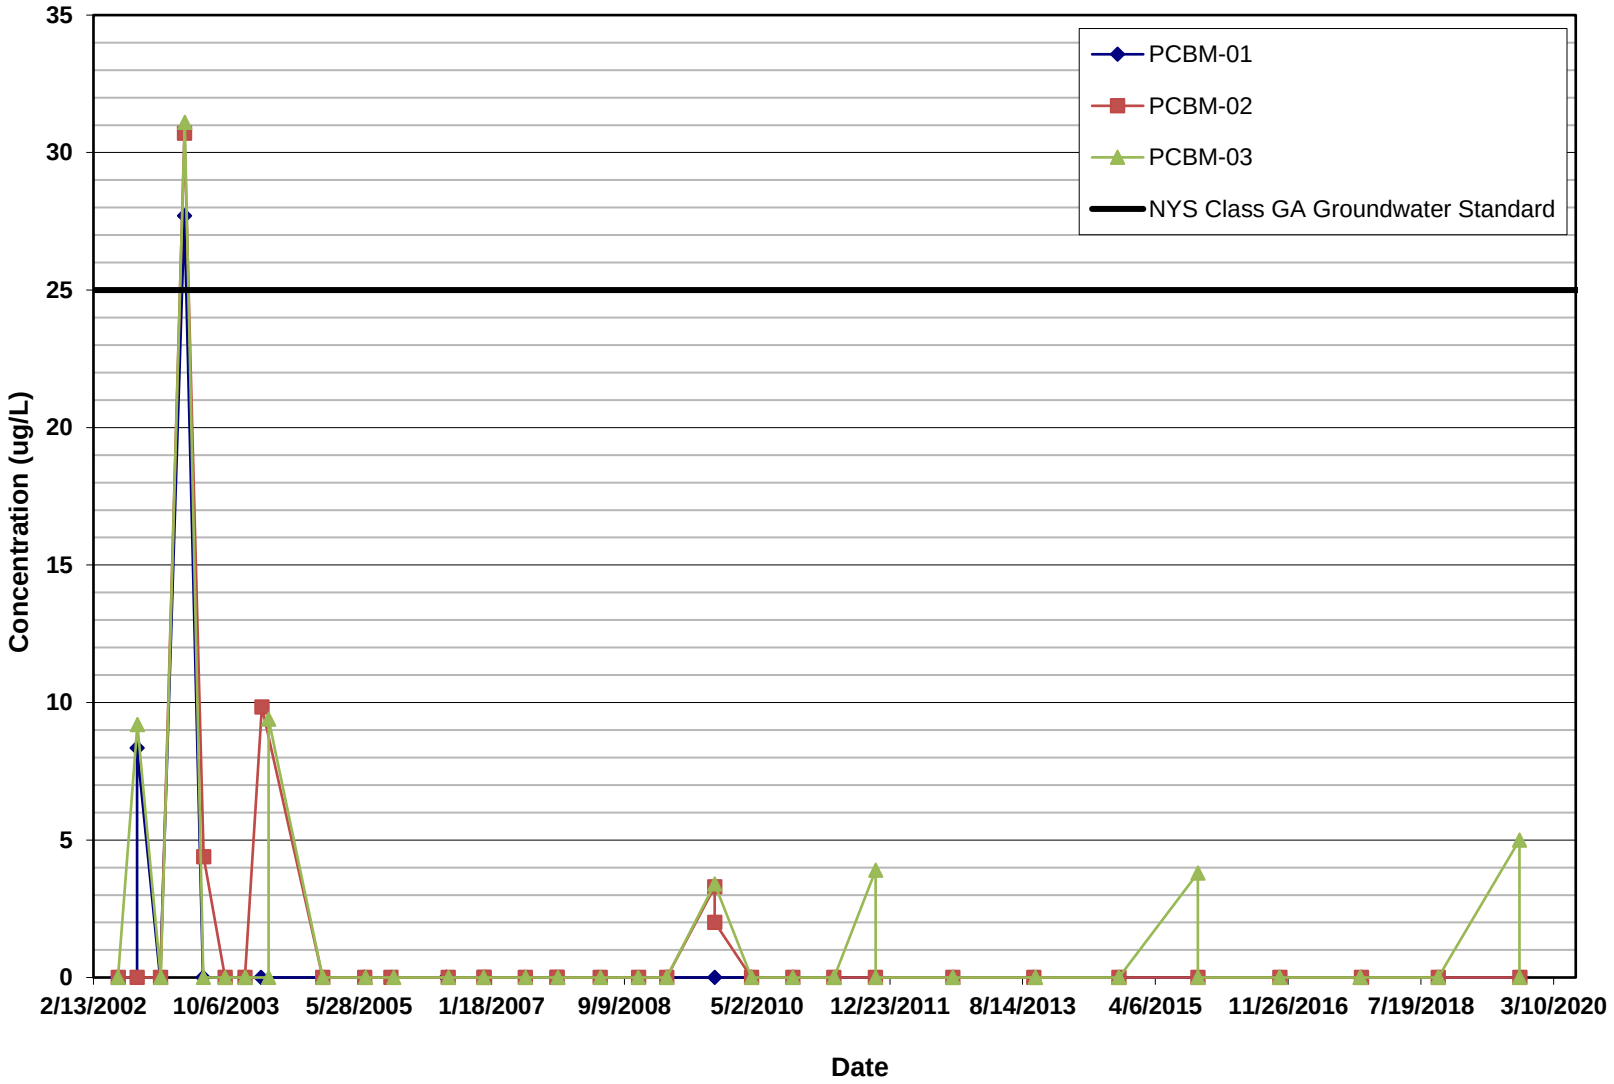
figure G.5
CONCENTRATION OF ARSENIC IN BEDROCK WELLS vs. TIME
102ND STREET LANDFILL

The 2018 PRR stated that arsenic has only been detected sporadically at concentrations above NYS Groundwater Standards in the bedrock groundwater since groundwater monitoring commenced, and mercury has never been detected above reporting limits. As recommended by NYSDEC in its letter dated April 9, 2019, arsenic concentration trend plots have been developed to further evaluate arsenic concentration trends in bedrock groundwater over time. The concentration trend plots, as well as a summary of arsenic and mercury concentrations, are presented in Appendix G.

Based on the sporadic, low concentrations of arsenic detected in the bedrock wells and lack of mercury detected in the bedrock wells during historical sampling events, it is recommended to remove arsenic and mercury from the list of analytes for future bedrock annual monitoring events, starting with the 2020 annual monitoring event.
