ENGINEERING INVESTIGATIONS AT INACTIVE HAZARDOUS WASTE SITES

PHASE II INVESTIGATION

Niagara Sanitation Company
(Nash Road Landfill)

Site No. 932054

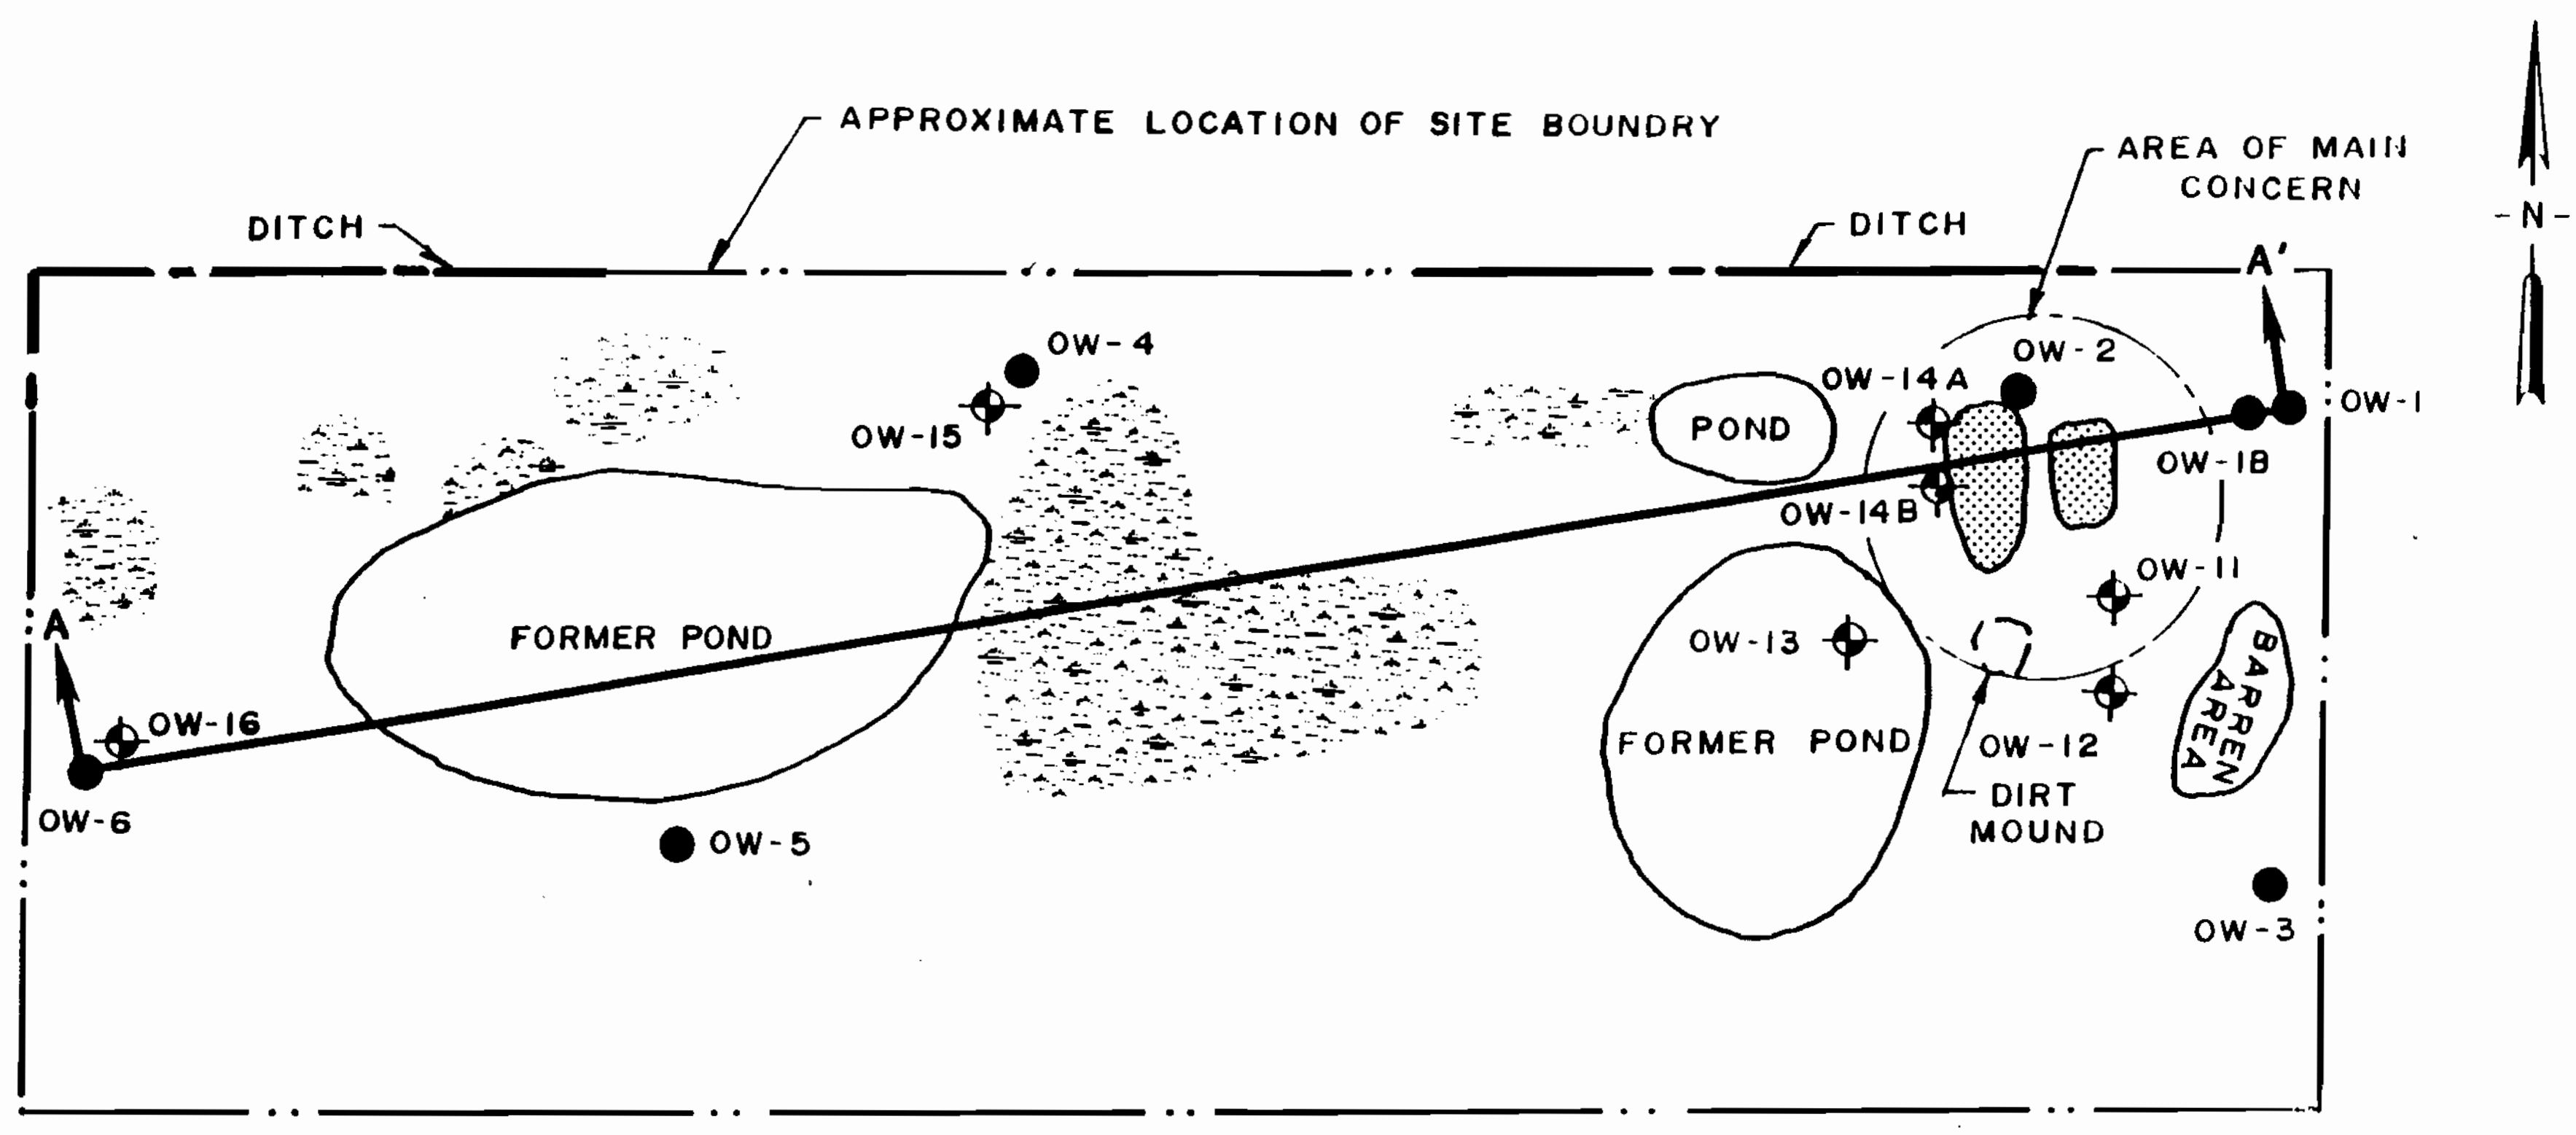
FIGURE IV-7

Water level data shown in Figure IV-7 suggest that water levels in the upper sand and clay are highest in the vicinity of the ponds over the reported disposal trench in the northeastern part of the site. There is insufficient data to draw water level elevation contour lines or to determine the relationship between groundwater and the ponds. It appears the groundwater is flowing eastward toward Sawyer Creek. The fact that the area was swampy before development suggests that local groundwater discharged to the swamp under natural conditions, and discharged from the area by evaporation or by surface water runoff to Sawyer Creek when the swamps were full. The persistence of the ponds, even during dry seasons, supports the suggestion that shallow groundwater flows to the ponds and discharged by evaporation and surface runoff when the ponds are full. It is unlikely, given the climate of the area, that the swamps could evaporate all of the inflow, suggesting that pathways for lateral movement of groundwater to Sawyer Creek must exist.

WATER LEVEL ELEVATIONS IN THE UPPER SAND AND CLAY NASH ROAD

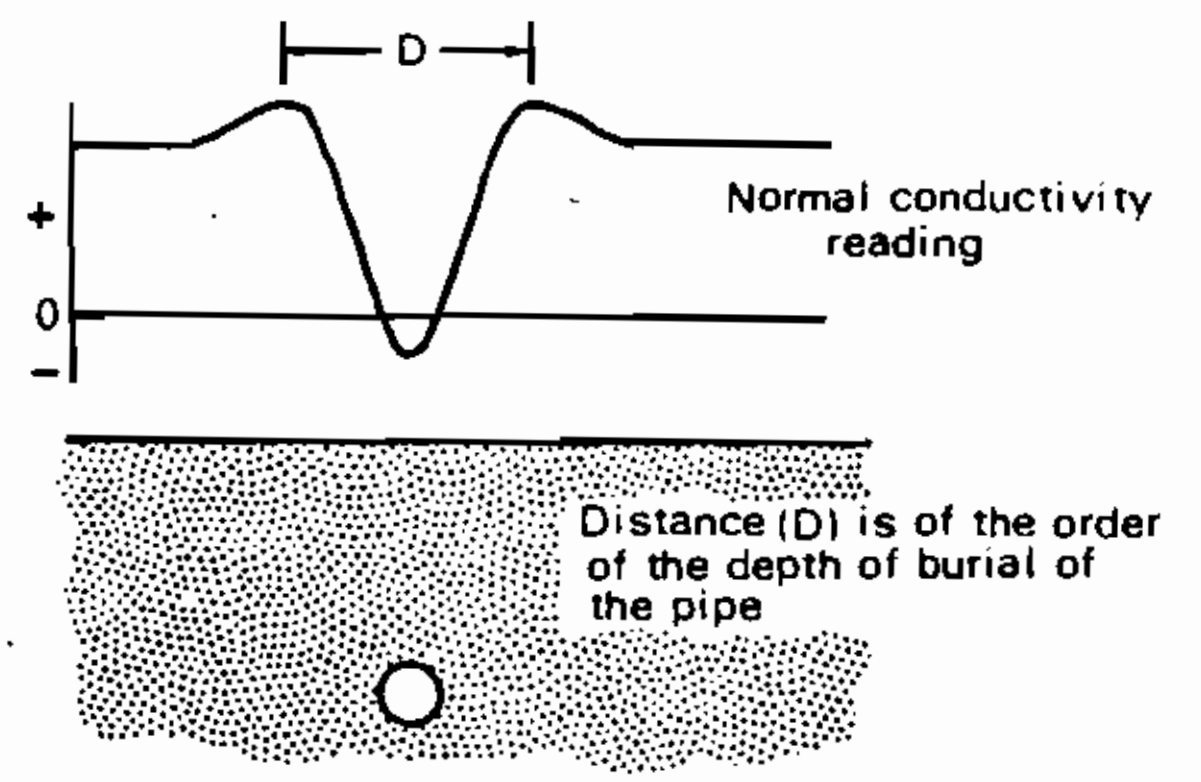
Figure B-10. Effect of buried pipe on electromagnetic-conductivity reading.

Electromagnetic survey.--The Geological Survey ran an electromagnetic survey with eight traverses in November 1982; locations are shown in figure B-9. The effect of buried pipe is evident in the stripchart in fig. B-10.

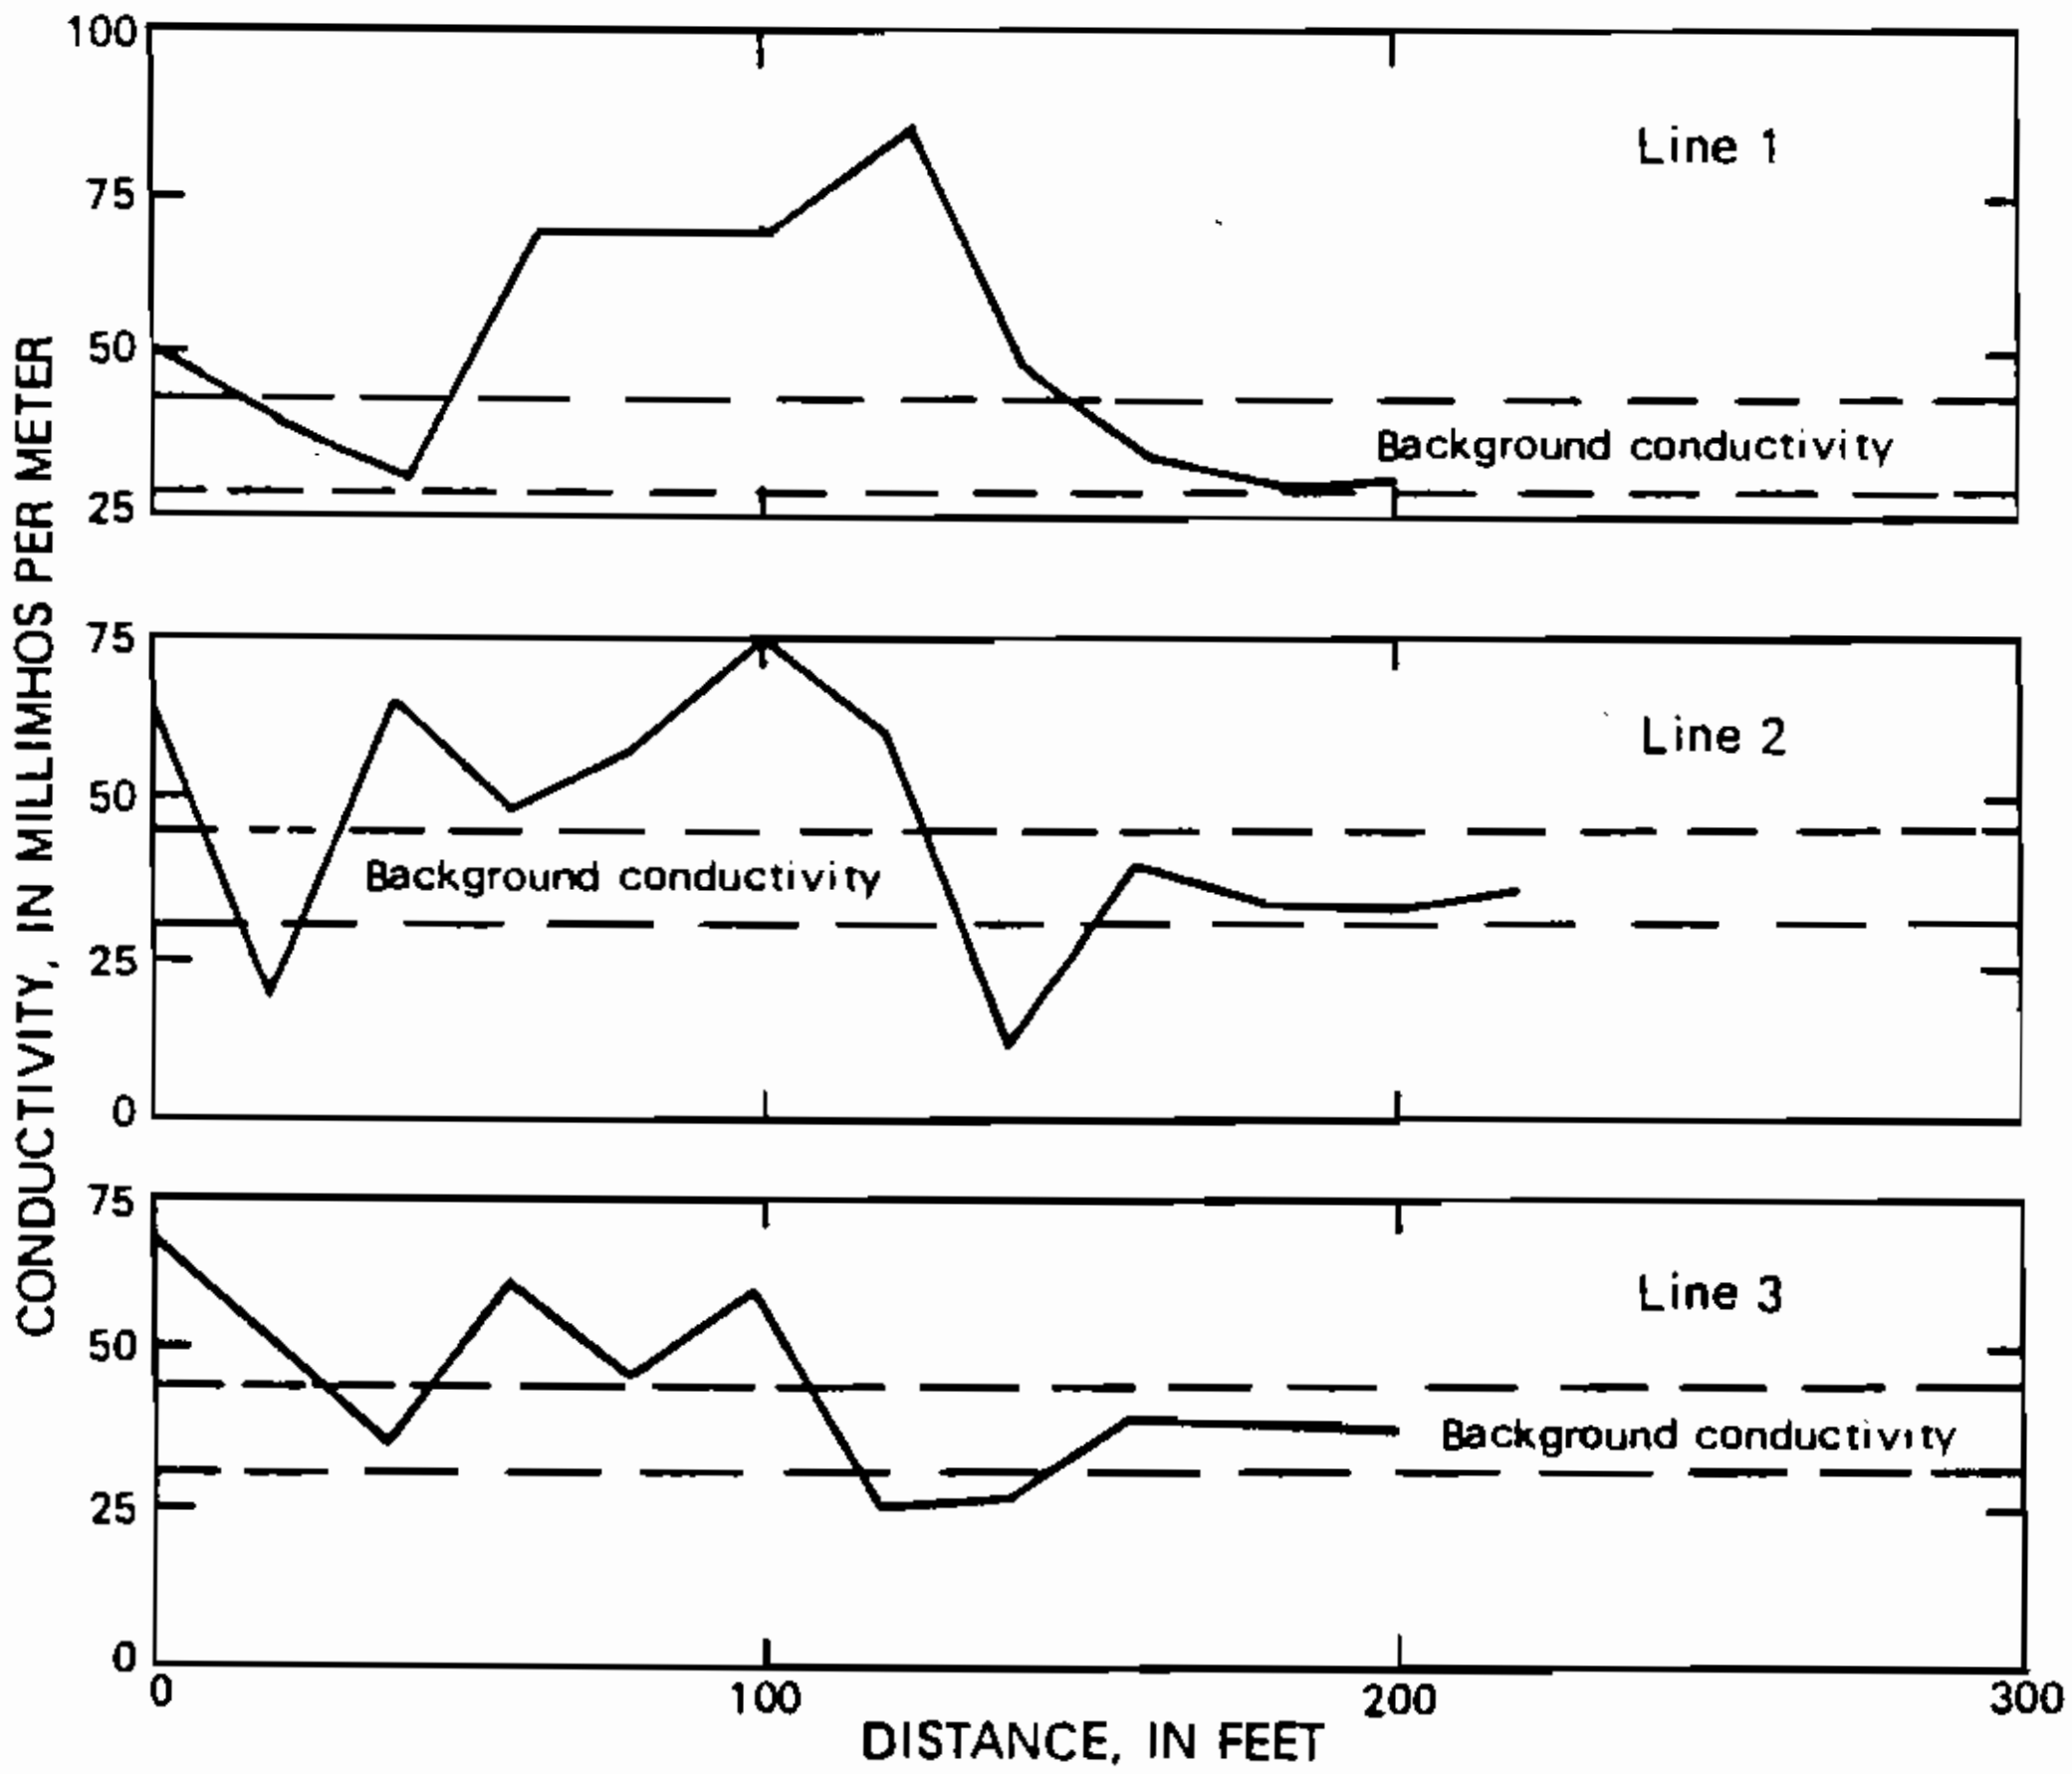
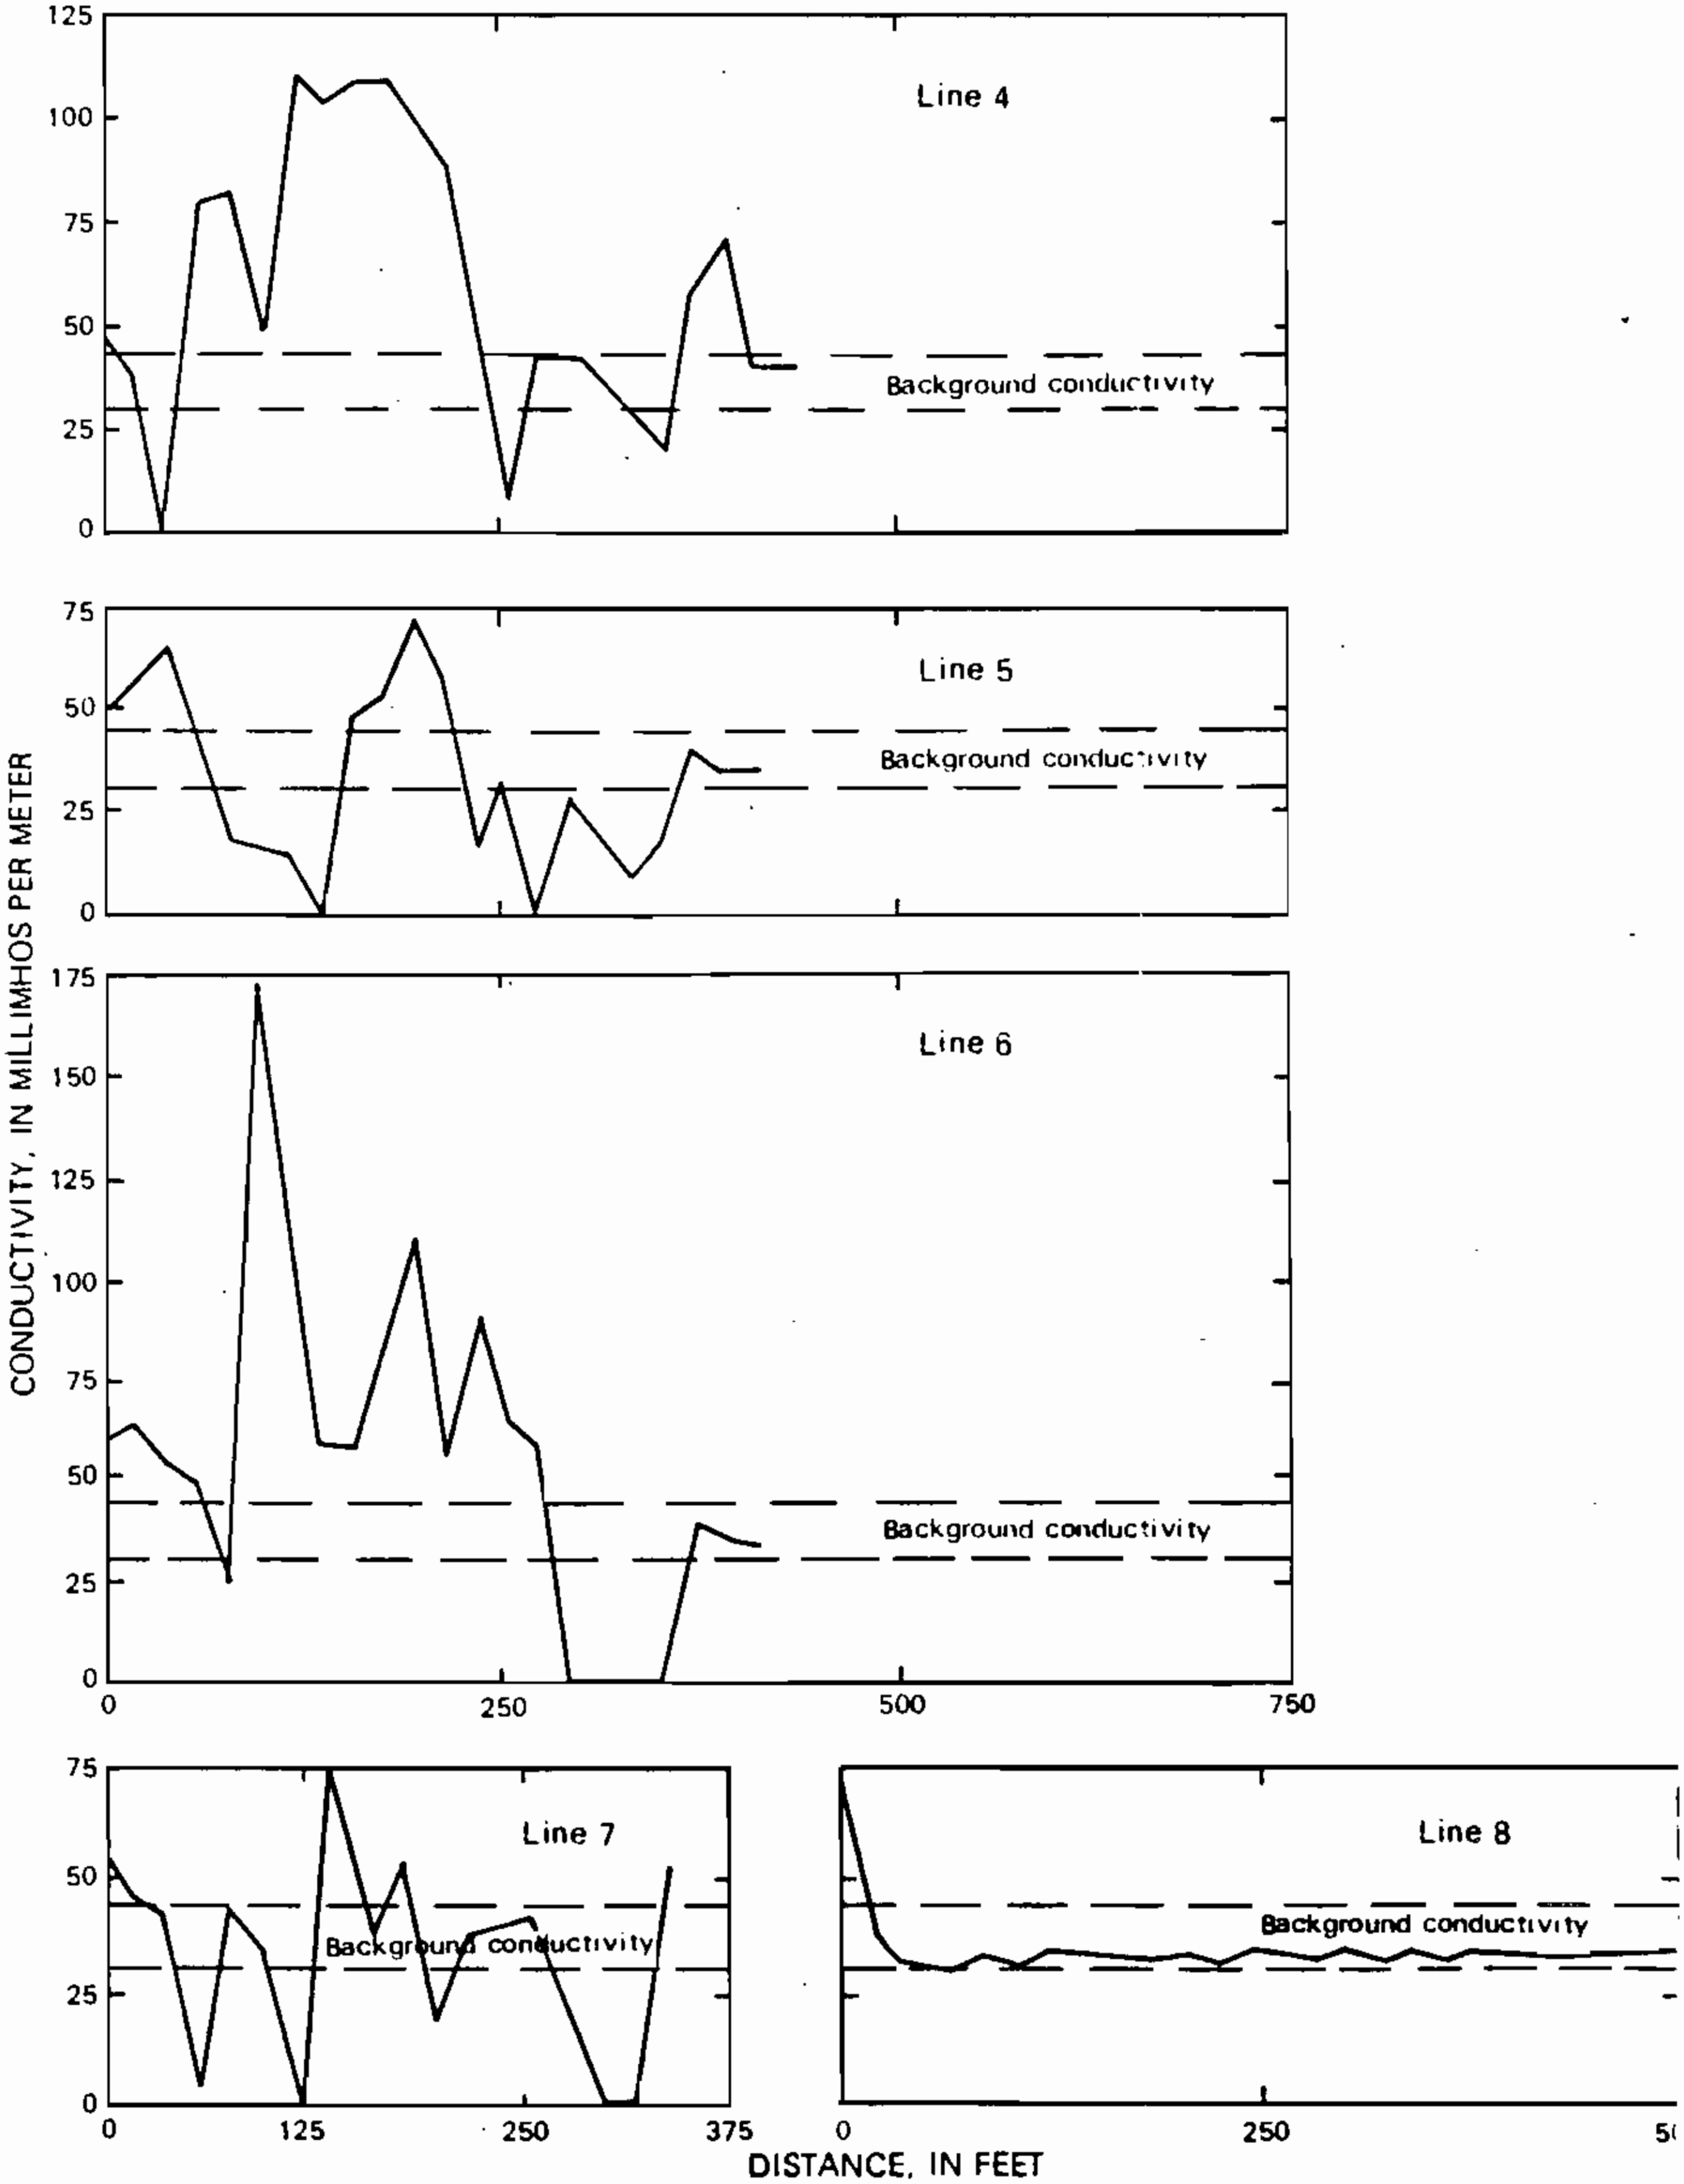
Figure B-11. Results of electromagnetic-conductivity survey at Nash Road, site 93, Wheatfield. (Locations of lines are shown in fig. B-10.)

The southern parts of lines 1 through 8 (fig. B-11) show the effects of interference by a series of high-power electrical transmission lines. These powerlines and a housing development south of them made it impossible to begin the southern end of each line in a waste-free area.

Lines 1, 2, and 3 show an irregular pattern of conductivity values within the disturbed area. Beyond the trees that form the northern border of the site, the conductivity values are within the background range.

No definite conclusions could be made from the survey. Variability of fill and interferences make data interpretation questionable.
