ENGINEERING INVESTIGATIONS AT INACTIVE HAZARDOUS WASTE SITES

PHASE I INVESTIGATIONS

DIAMOND SHAMROCK, SITE NUMBER 932071
CITY OF LOCKPORT, NIAGARA COUNTY

January 1990

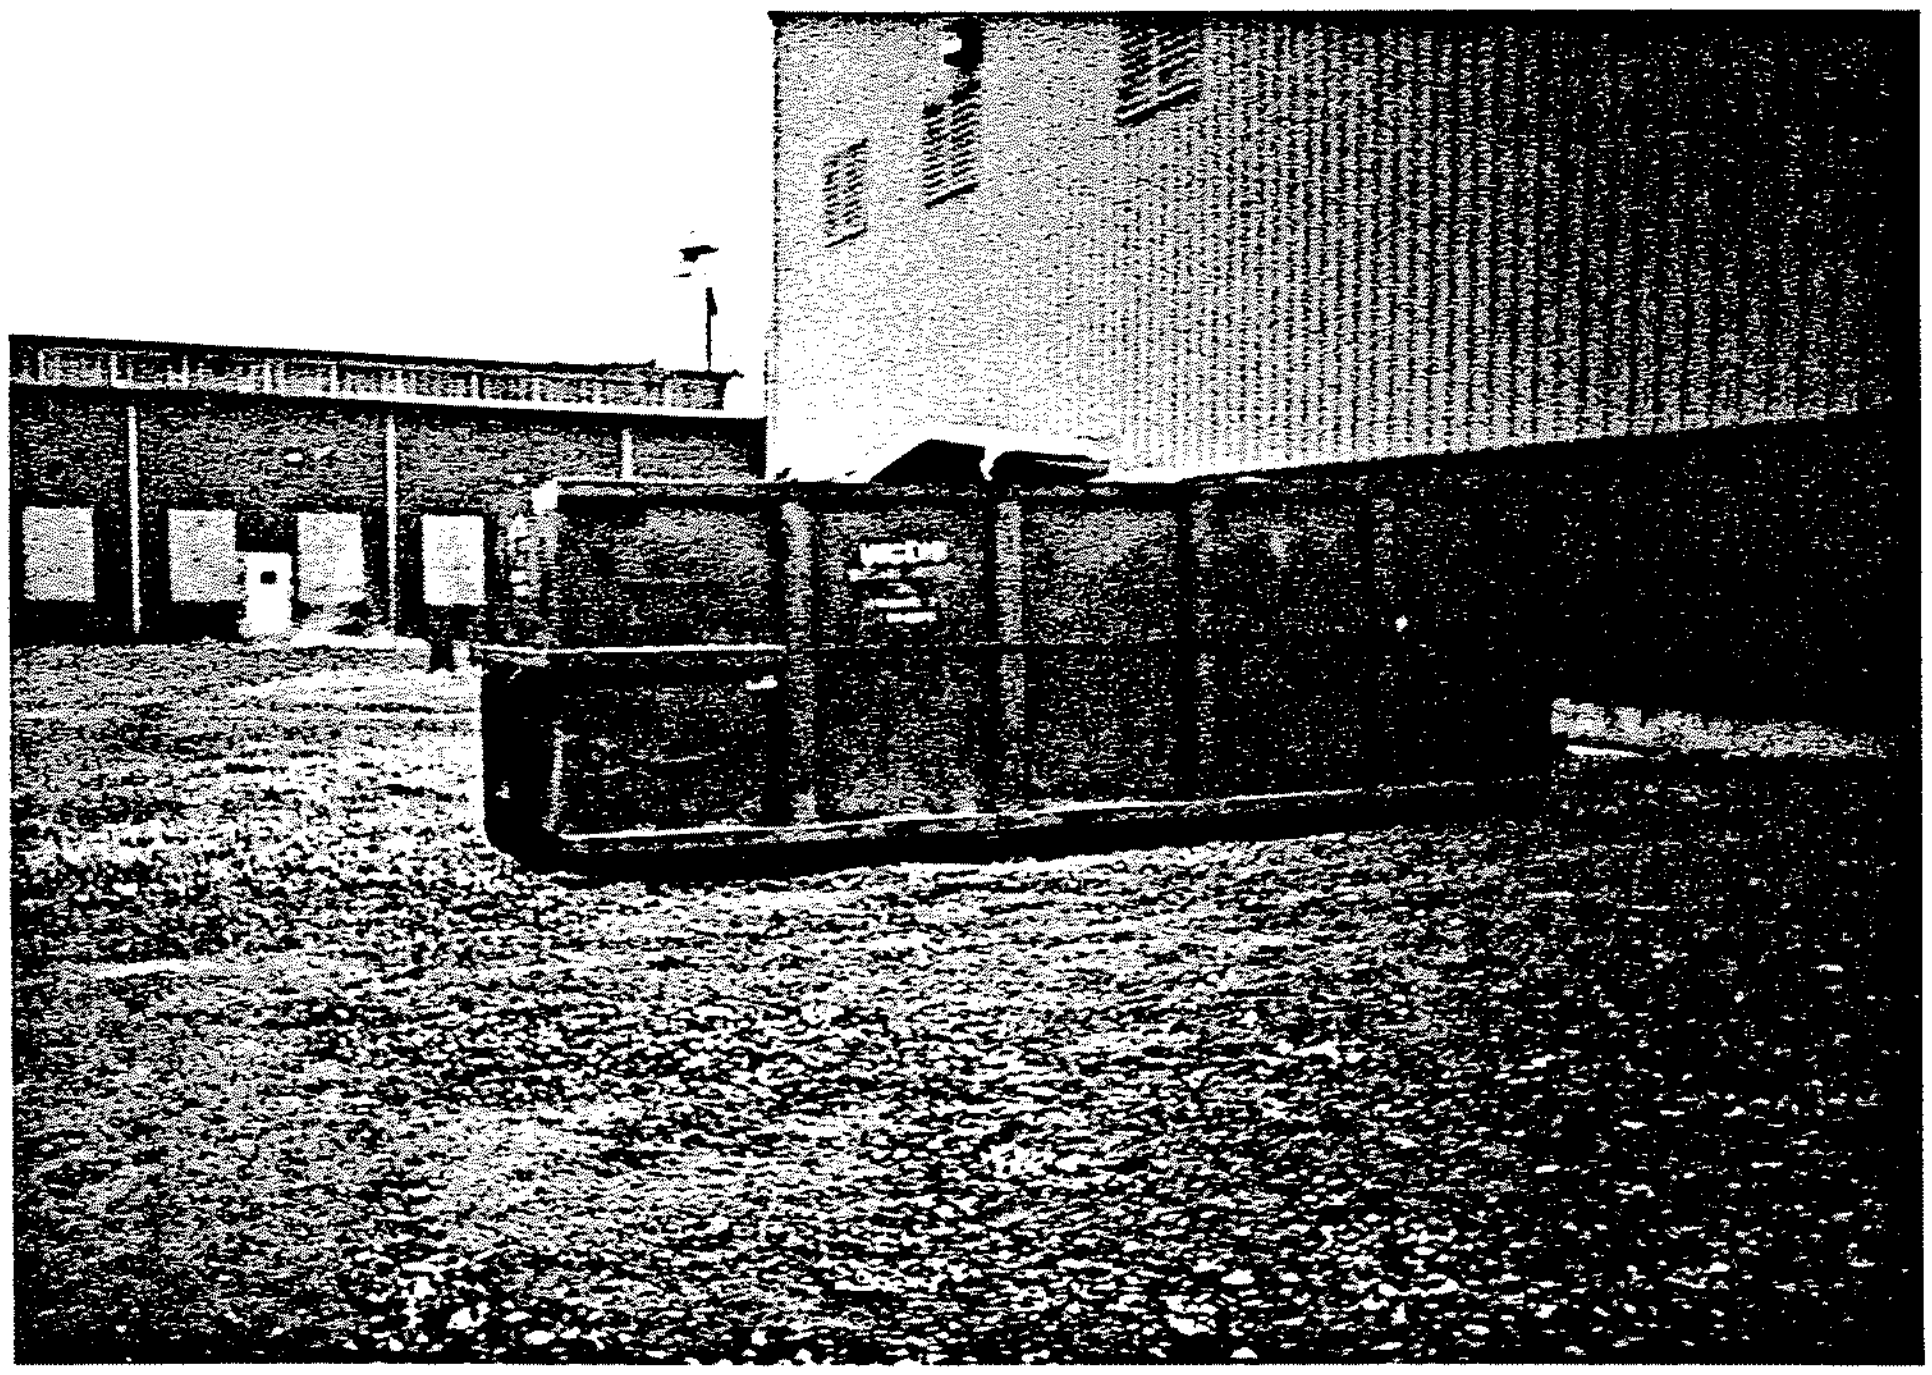
Frame No.: 1

Comments*: parking area, aboveground tanks located near the east side of the maintenance building

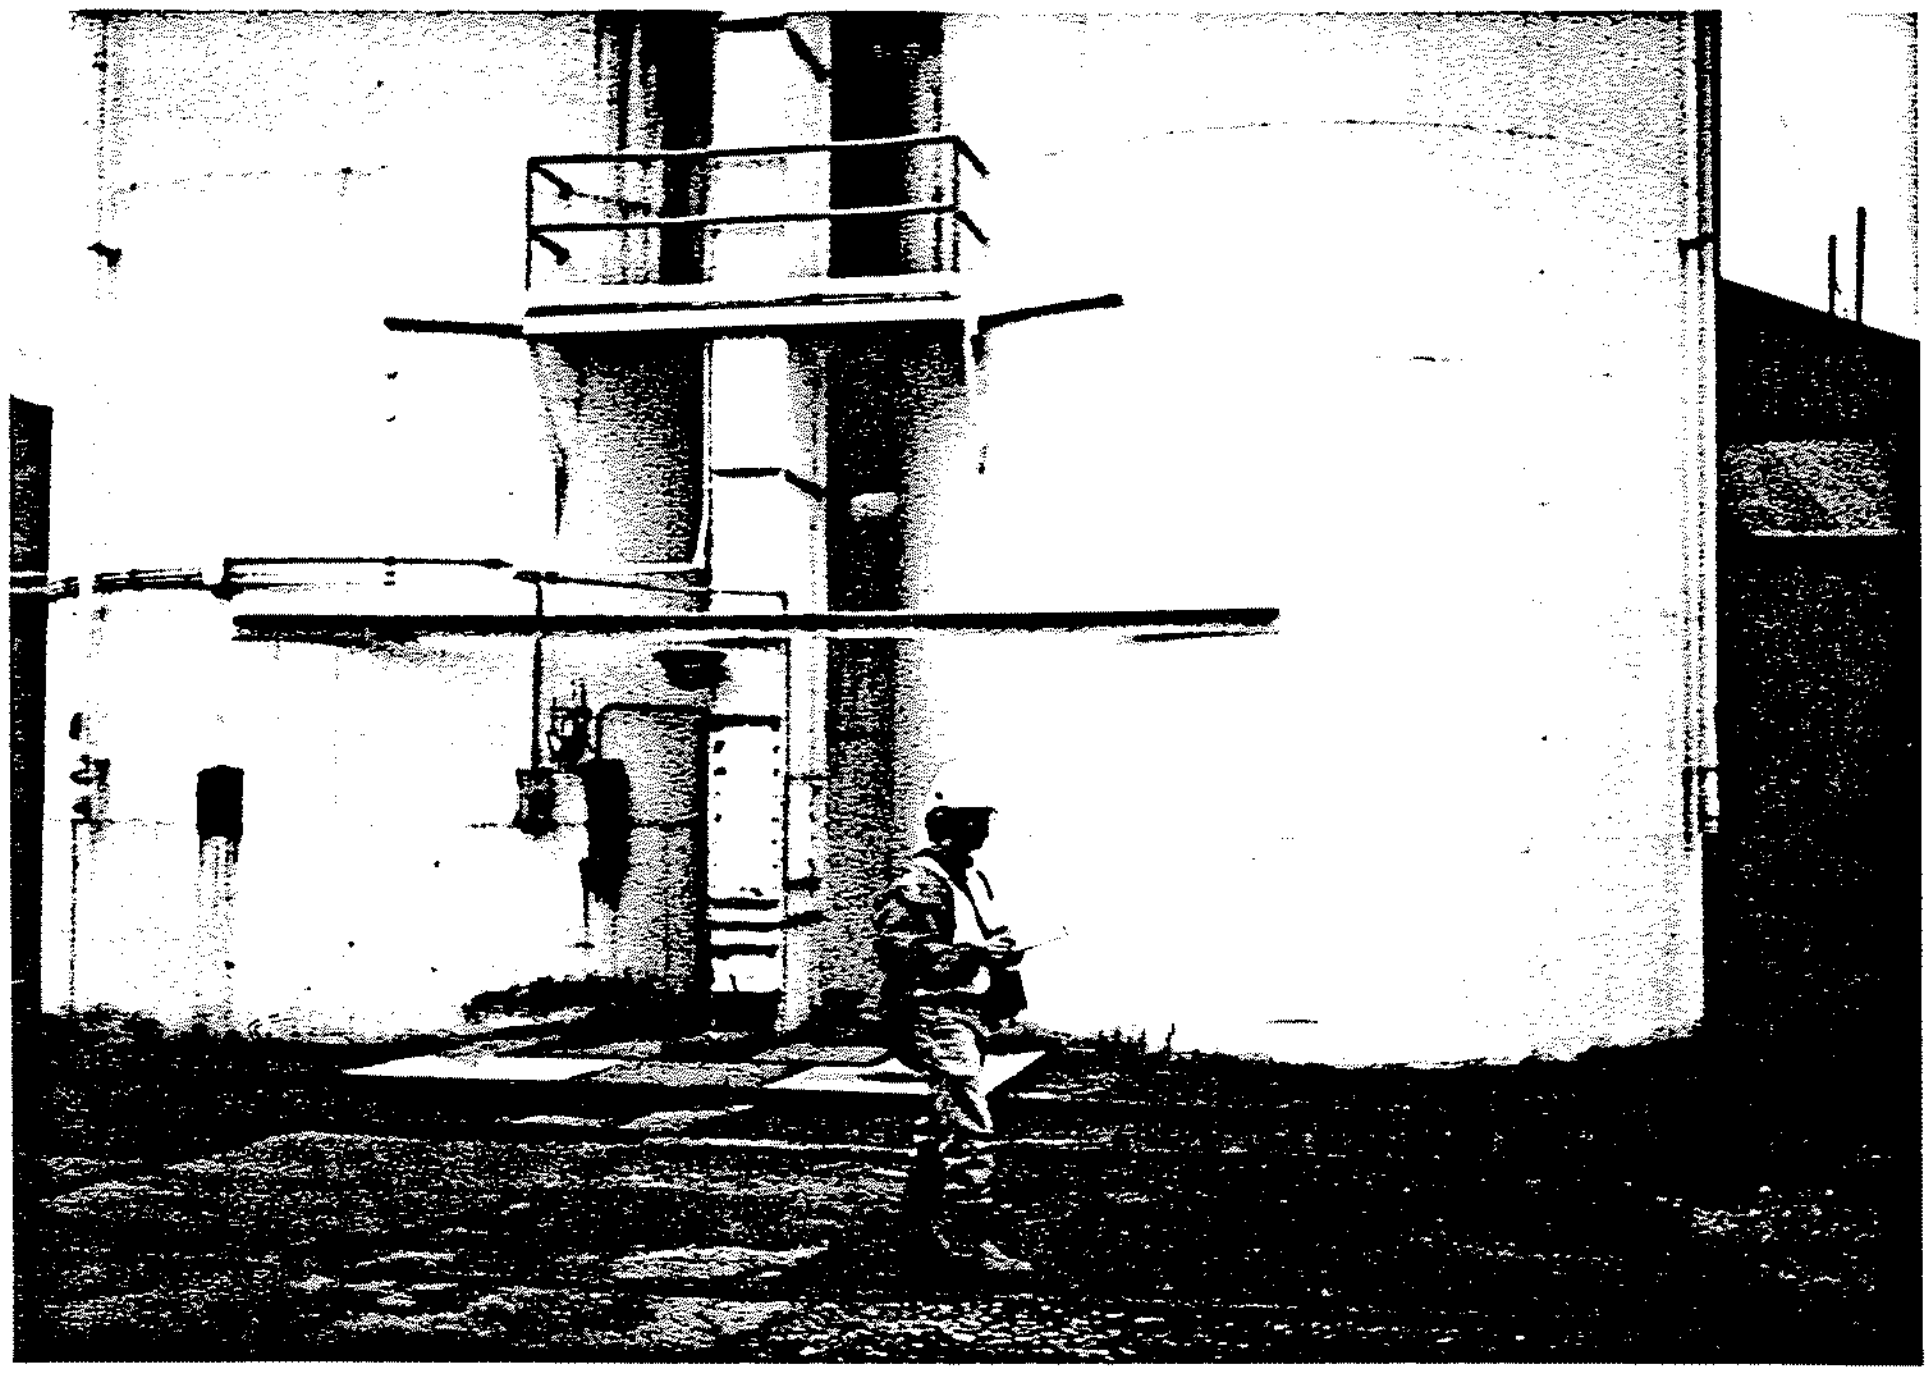
Frame No.: 5

Comments*: Former underground storage tank located behind the furnace building, adjacent to the RR tracks on site
