ENGINEERING INVESTIGATIONS AT INACTIVE HAZARDOUS WASTE SITES IN THE STATE OF NEW YORK

PHASE II INVESTIGATIONS

97th Street Methodist Church (Site Number 932084A)
City of Niagara Falls, Niagara County

December 1990

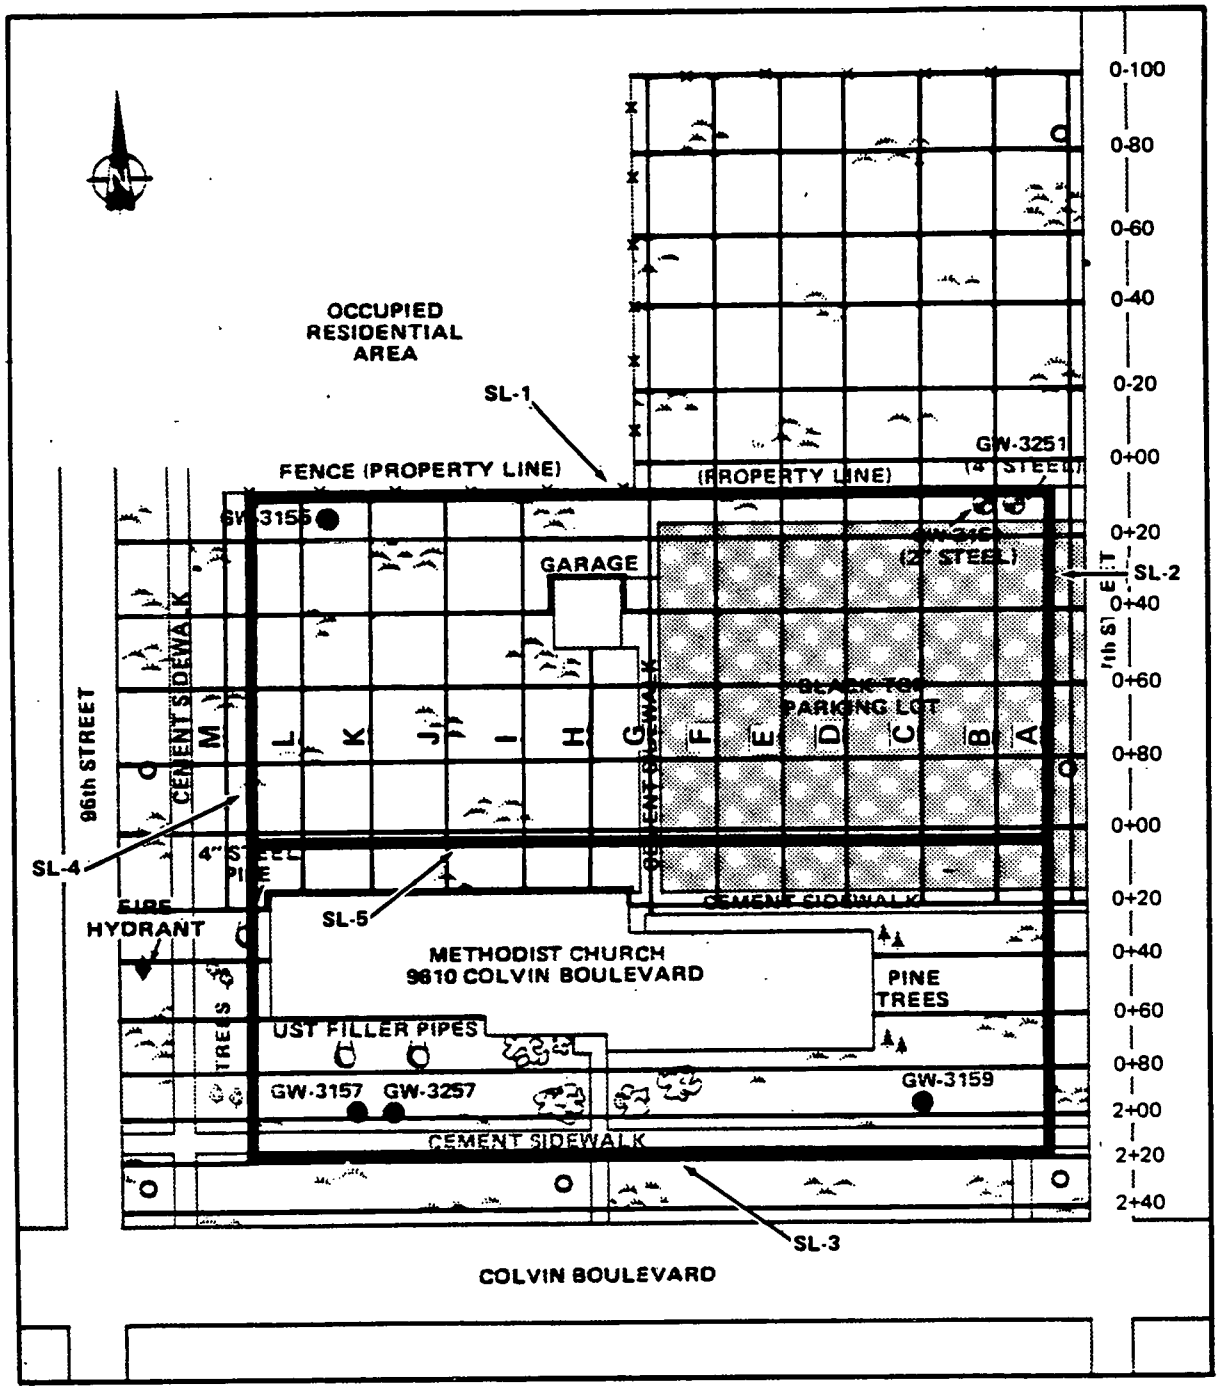
Figure 3–1
GEOPHYSICAL SURVEY AND PROPOSED GROUNDWATER MONITORING WELL LOCATIONS

A geophysical survey consisting of shallow seismic refraction and GPR was performed at the site on October 24 and 25, 1989. These surveys were conducted across the entire site (see Figure 3-1). The results were used to determine site geological conditions (i.e., subsurface stratigraphy, depth to bedrock), locate buried materials (i.e., utilities, concrete reactor cells), and verify proposed monitoring well locations. The geophysical survey methods and results are presented in Appendix B.

Three shallow overburden wells and one deep bedrock monitoring well were installed on the site between November 29 and December 7, 1989, by Buffalo Drilling Company, Inc. under the supervision of E & E. The wells were installed up- and downgradient of the site (see Figure 3-1 and Table 3-2). The upgradient well, GW-3155, and the downgradient wells GW-3157 and GW-3159 monitor shallow water while the probable downgradient well, GW-3257, monitors groundwater in the bedrock. The existing well, GW-3151, monitors upgradient shallow water and GW-3251 monitors probable upgradient groundwater in bedrock.

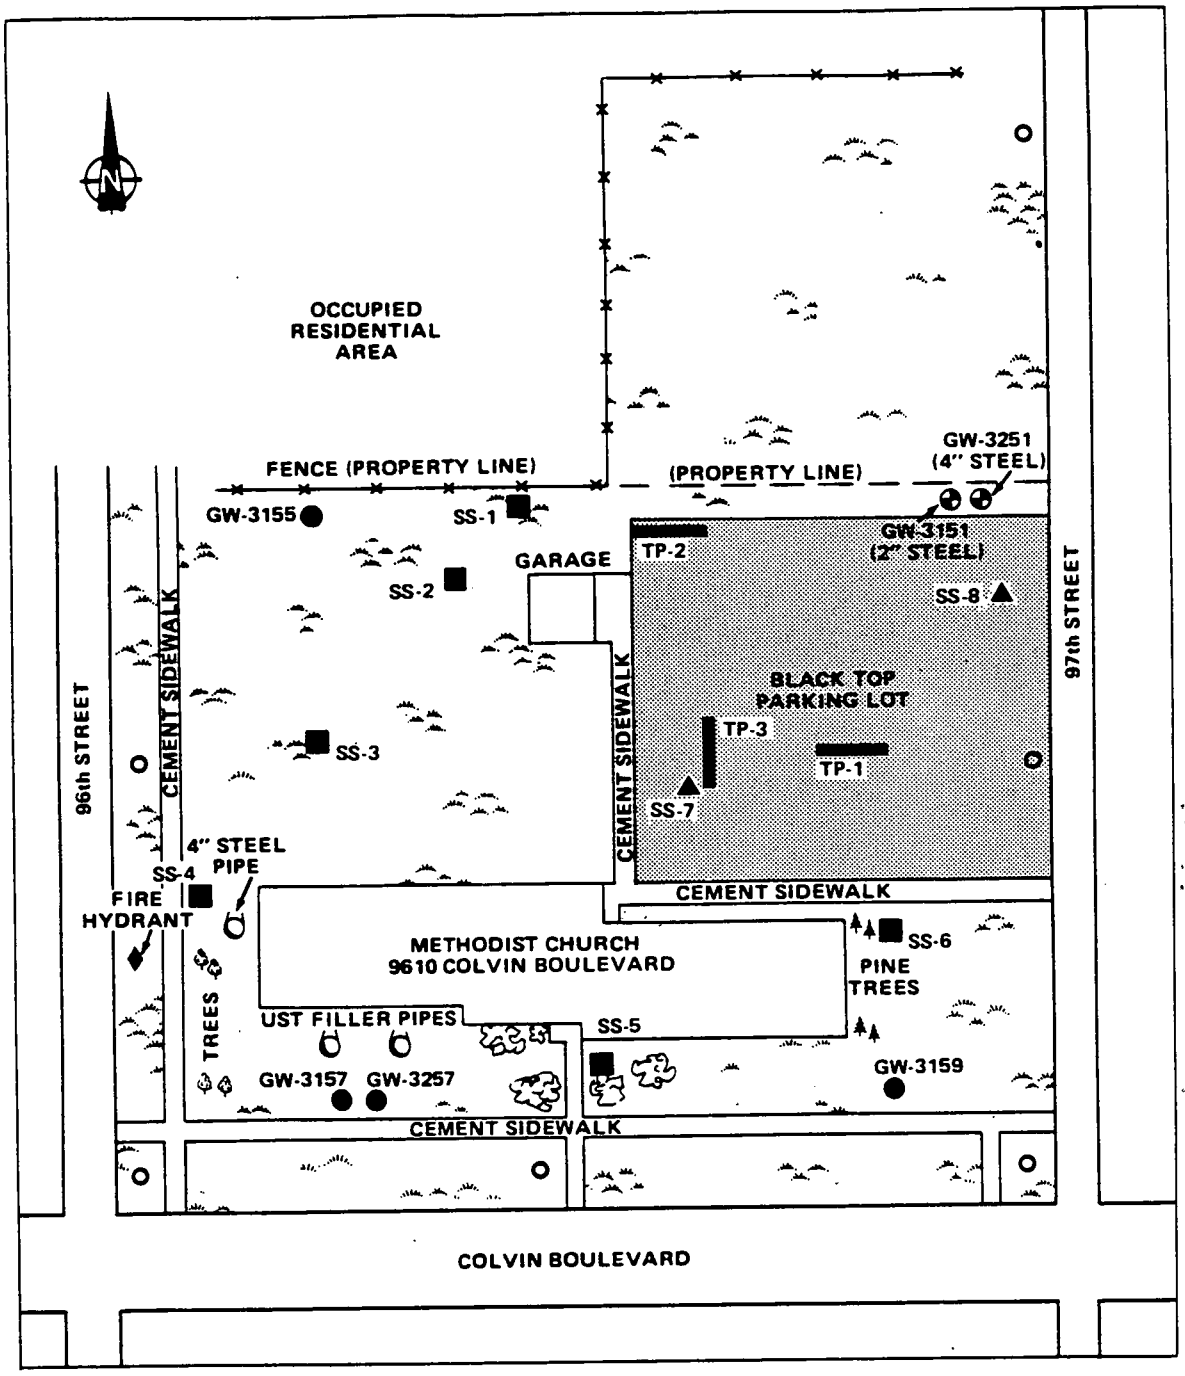
Figure 3–2
MONITORING WELL AND SURFACE AND SUBSURFACE SOIL SAMPLING LOCATIONS

In addition to the borehole samples, two subsurface soil samples (SS-7 and SS-8) were collected on December 4, 1989, beneath the blacktop parking lot at a depth of 2 feet below the surface (see Figure 3-2 and Table 3-3). The samples were analyzed for TCL organics and inorganics by E & E's Analytical Services Center (ASC). In addition, quality assurance/quality control (QA/QC) samples consisting of two matrix spike/matrix spike duplicate (MS/MSD) samples (SS-5MS/SS-5MSD and SS-8/MS/SS-8MSD) were analyzed for the compounds mentioned above. Analyses and reporting were performed following the NYSDEC Contract Laboratory Protocol (CLP).

Six surface soil samples (0-6 inches) were collected from various locations surrounding the church building on November 29, 1989 (see Figure 3-2 and Table 3-3). These samples were analyzed for TCL organics and inorganics by E & E's ASC. In addition, QA/QC samples consisting of two MS/MSD samples (SS-5MS/SS-5MSD and SS-8MS/SS-8MSD) were analyzed for these parameters. Field procedures for surface soil sampling are presented in Appendix E. Analytical results are discussed in Section 4.5 and raw data summary sheets are included in Appendix F. Actual sample locations are shown on the site survey map in Appendix H. Copies of field logbooks are included in Appendix I.

Three test pits were excavated in the blacktop parking lot area on December 18, 1989, by Green Environmental Specialists, Inc. under the supervision of E & E (see Figures 3-1 and 3-2 and Table 3-4). The excavated soils were screened with an OVA. In Test Pit No. 1, one part per million (ppm) of total organic vapors above background was noted at a depth of 3 feet below ground surface; in Test Pit No. 2 at 3 ppm at 4 feet; and at 1 ppm at 2 feet in Test Pit No. 3. No readings were recorded in the breathing zone. Table 3-5 provides a detailed description of each test pit.

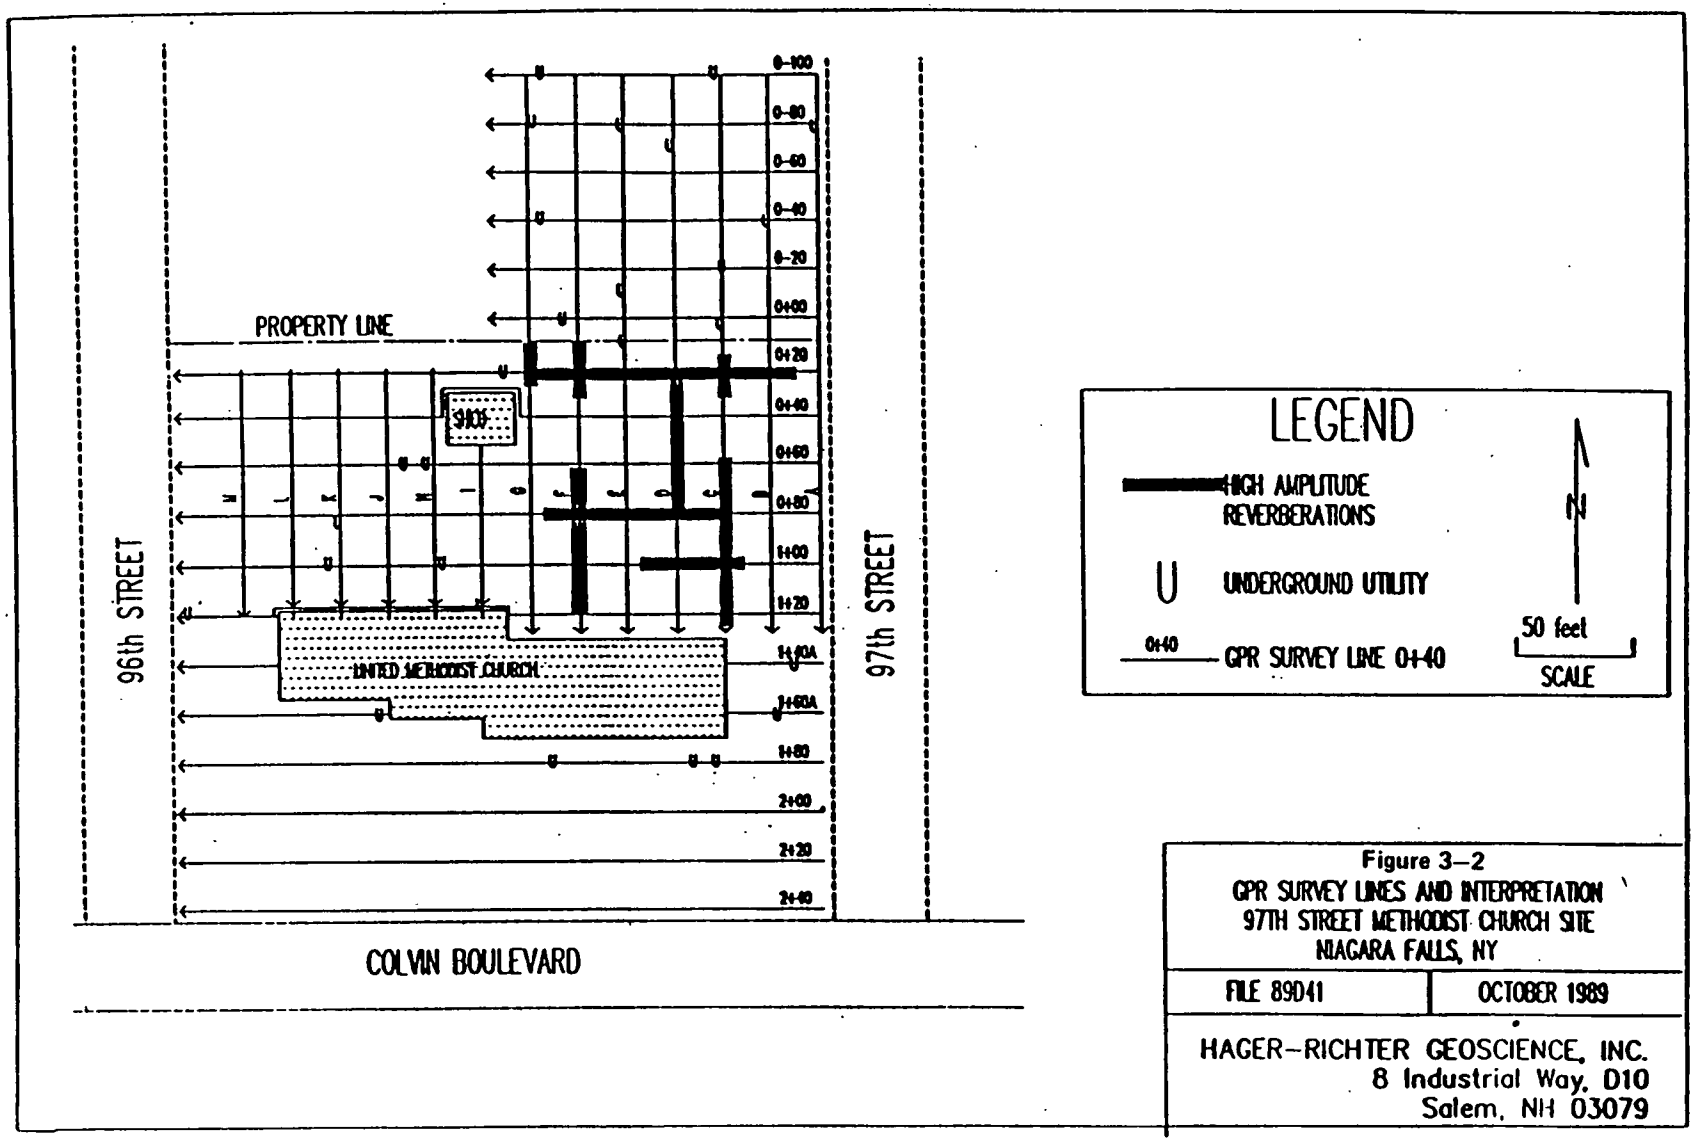
Figure 3–2
GPR SURVEY LINES AND INTERPRETATION
97TH STREET METHODIST CHURCH SITE
NIAGARA FALLS, NY

One might expect that broken concrete reactor cells would have electrical properties very different from the ground in which they are buried. If the reactor cells are reinforced concrete, we expect that they would produce strong reverberating reflections of the radar signal, similar to the reverberations observed when crossing the GPR over the concrete sidewalks at the site. If the reactor cells were broken or crushed, we would expect the reverberations to be somewhat jumbled or distorted. There are a few GPR records of the asphalt parking area that have strong high amplitude reverberations generated from objects near the surface. An example of the reverberations is shown in the right side of Figure 3-1 (Appendix B-3) and the lines along which they are found are shown in Figure 3-2. It is possible, but unlikely, that these reverberations are caused by reinforced concrete reactor cells whose tops are buried less than 5 feet deep. Because of the flat, undistorted nature of the reverberations, it is more likely that they are caused by concrete slabs or sidewalks underlying the asphalt. Trenching these few areas would determine the origin of the reverberations.

Underground utilities generate characteristic tight hyperbolas (see Figure C-2). Potential locations at the 97th Street Methodist Church Site of underground utility lines identified in the GPR data are shown in Figure 3-2.

4. Several possible utility lines at the site are identified in Figure 3-2.

E & E recommends that a test pit(s) be dug in the vicinity of the GPR reverberations beneath the asphalt parking lot in order to determine whether they were caused by the presence of reactor cells, or concrete slabs and/or sidewalks.

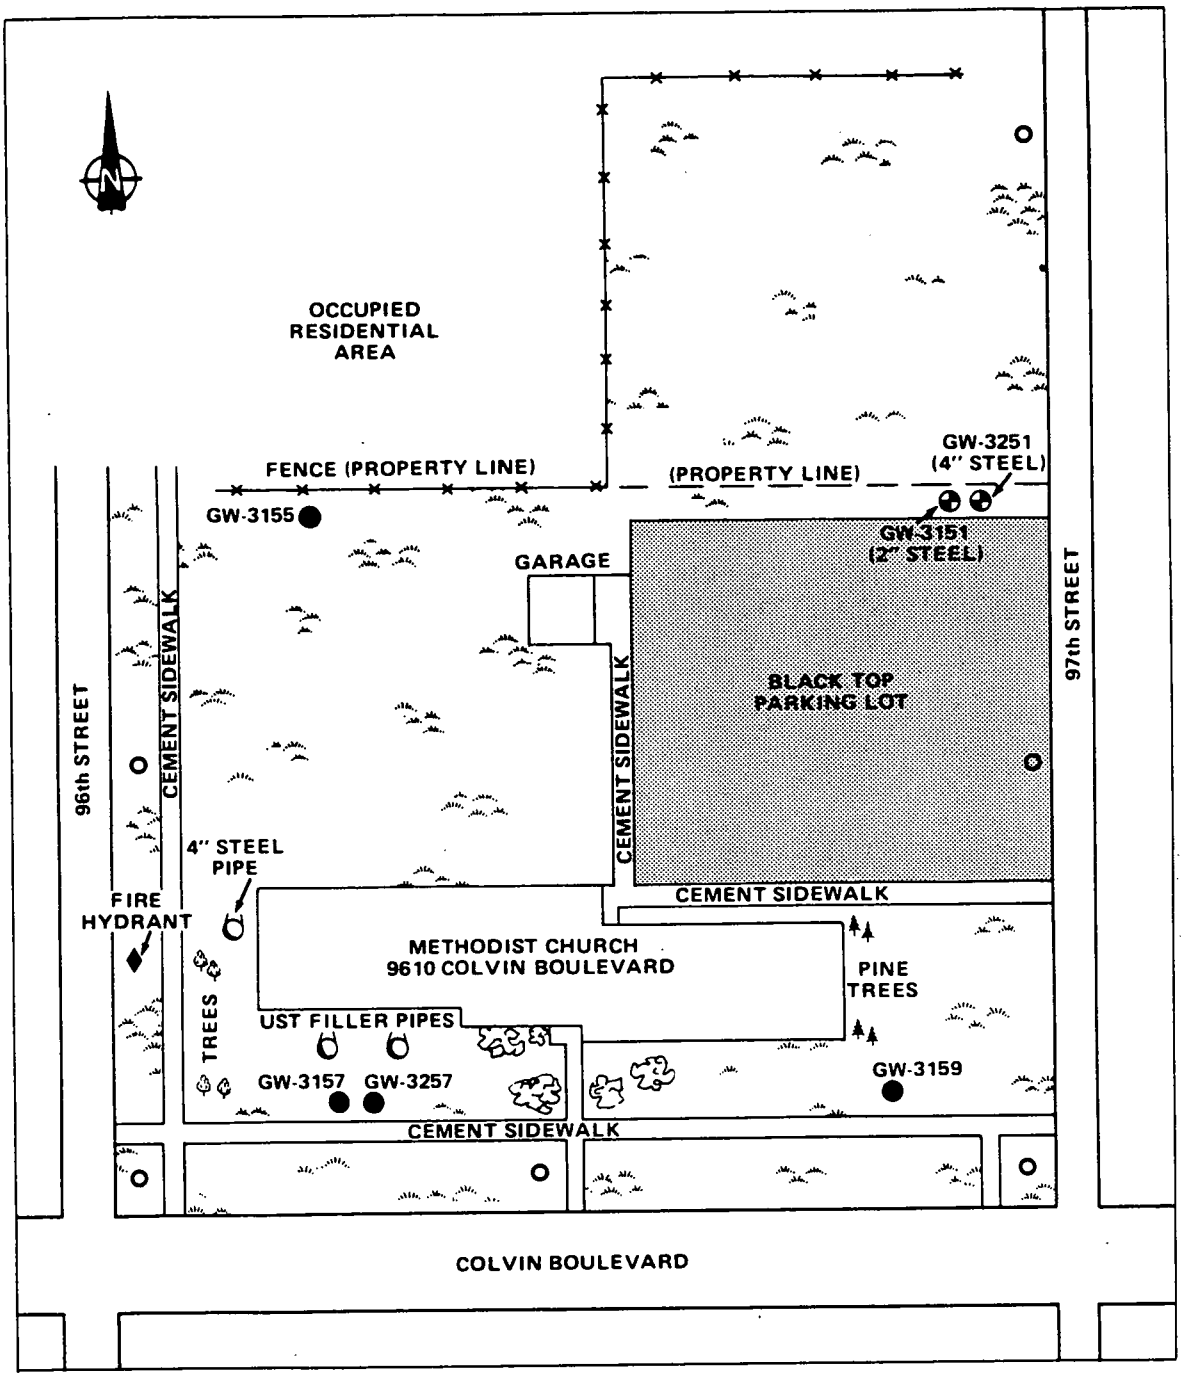
Figure 5–1

The results of this survey indicate that the placement of the four monitoring wells as suggested in the work plan can be completed without impacting any buried objects (see Figure 5-1).

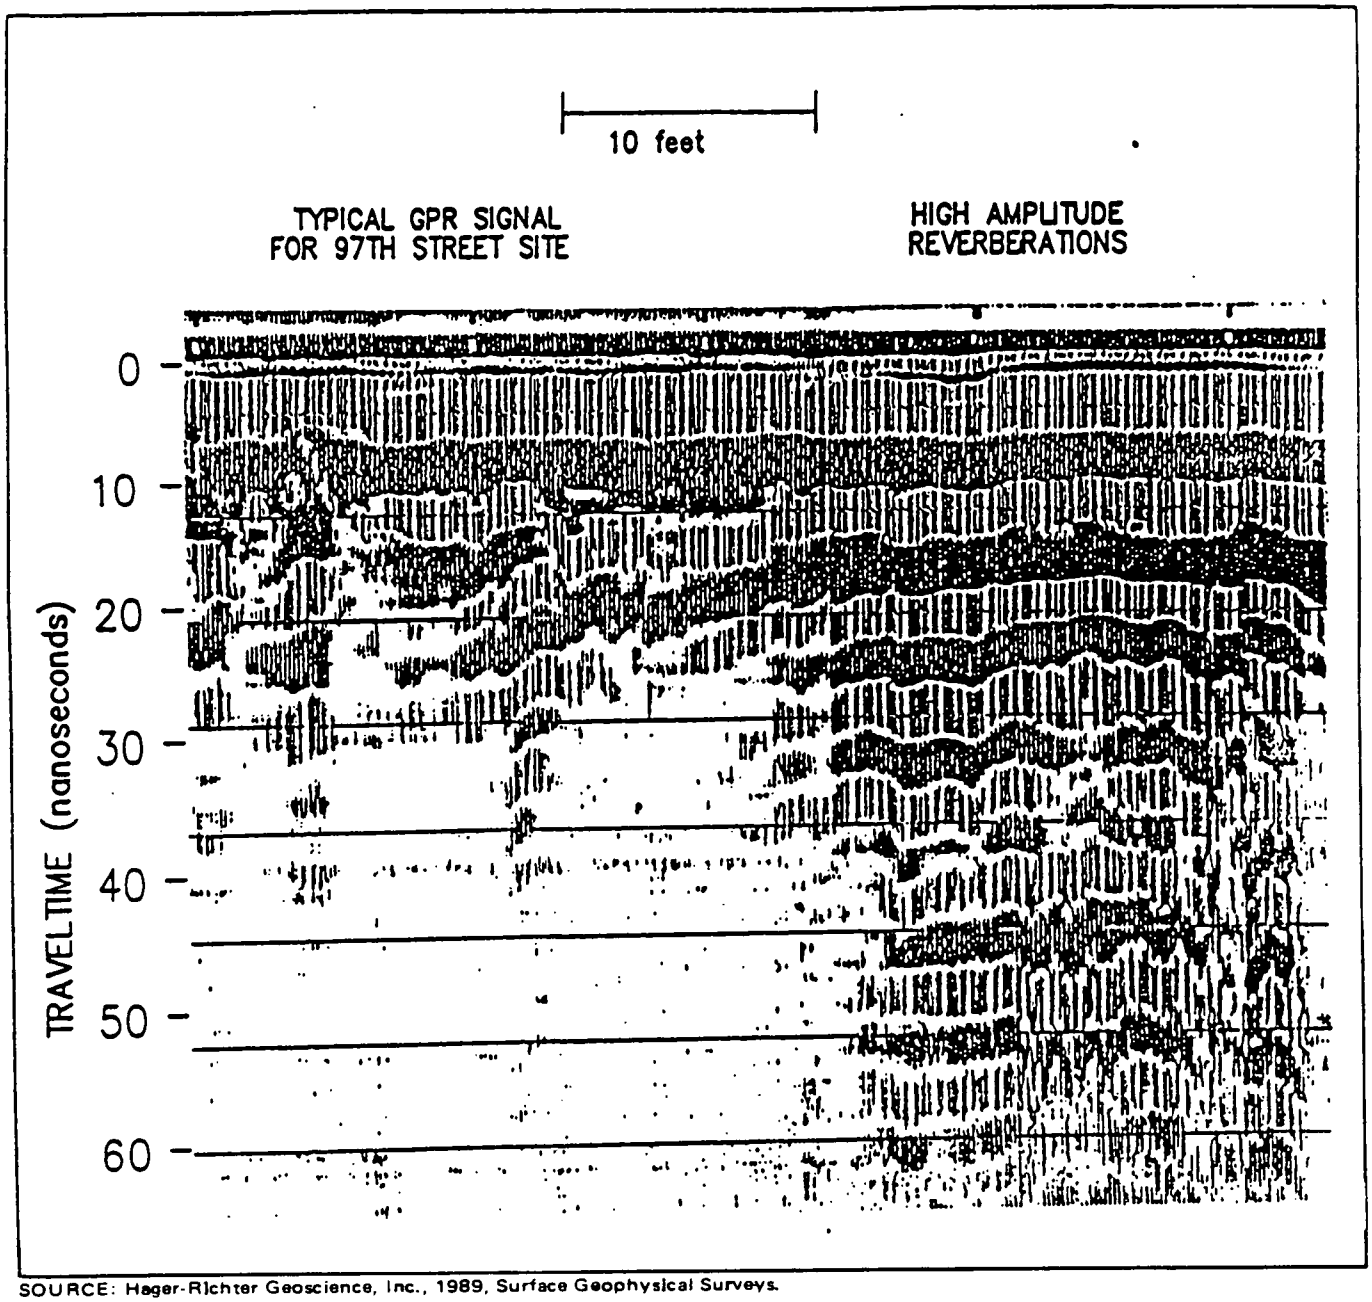
Figure C–1 GPR SIGNAL TYPICAL OF THE SITE AND AN EXAMPLE OF HIGH AMPLITUDE REVERBERATIONS. SHOWN IS LINE C 0+90 TO 1+35.

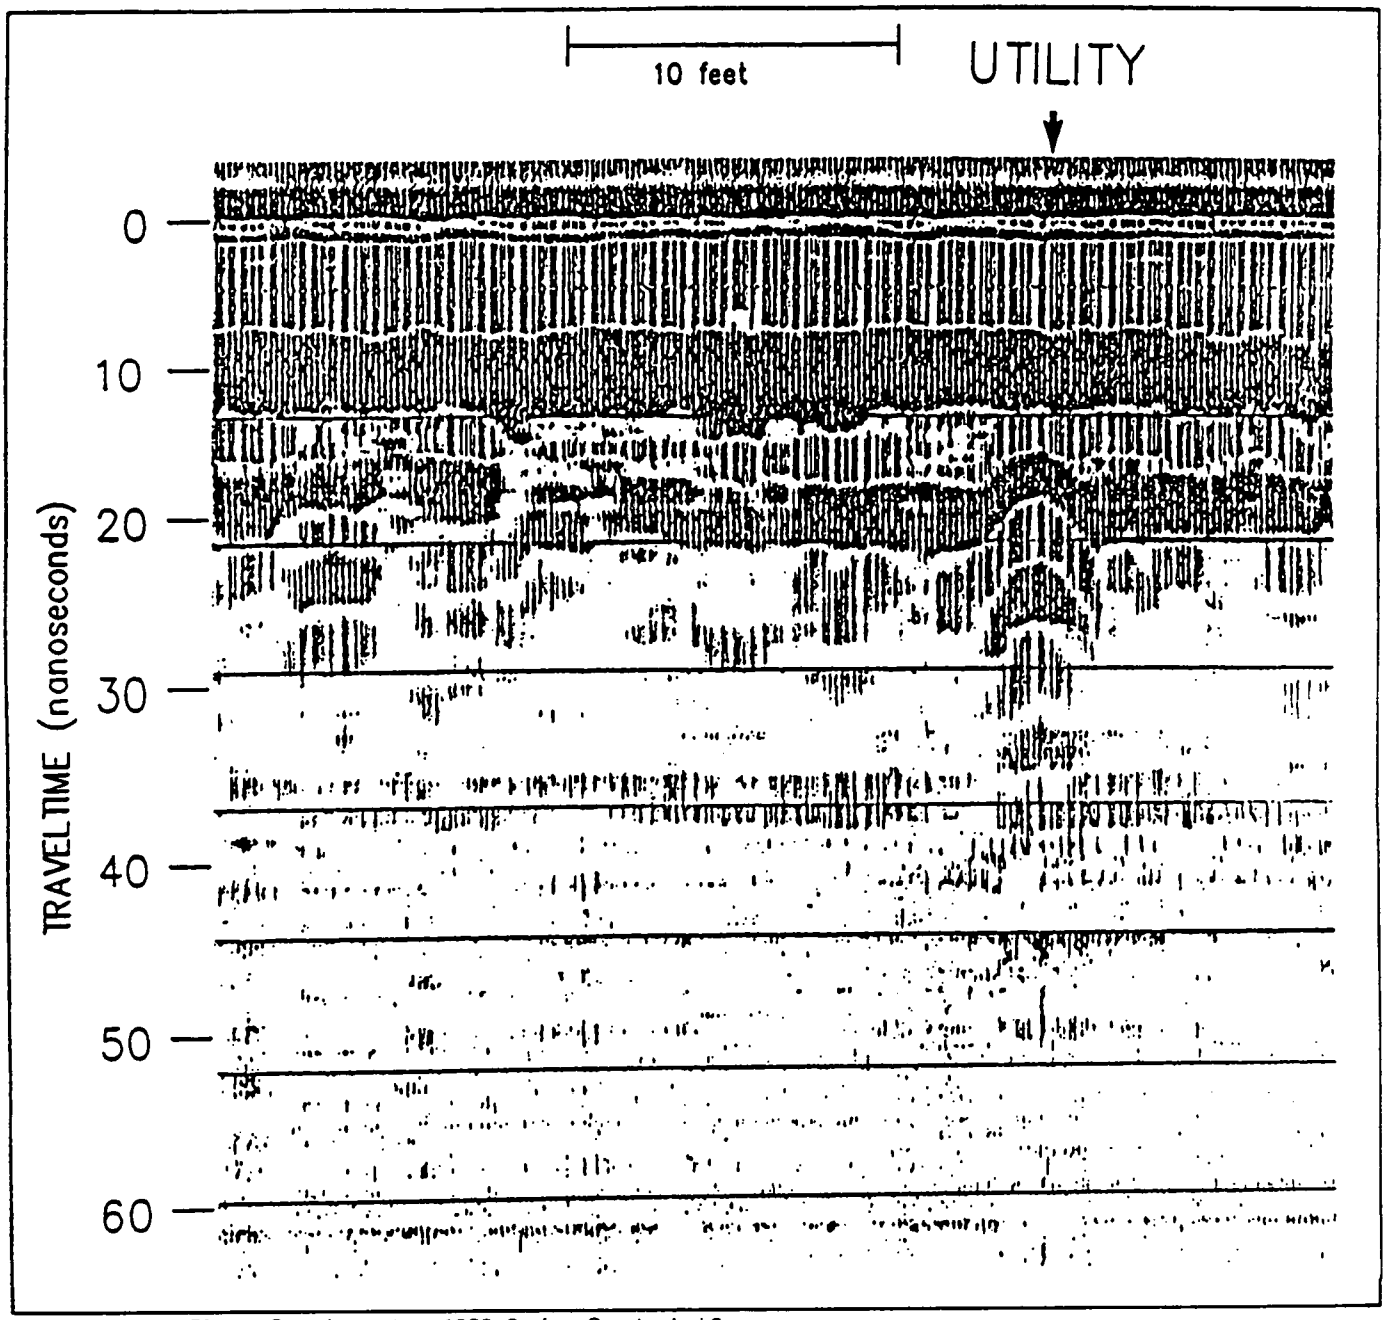
Figure C–2 GPR SIGNATURE CHARACTERISTIC OF BURIED UTILITIES. SHOWN IS LINE D 0+15 TO 0+35; 97TH STREET METHODIST CHURCH SITE, NIAGARA FALLS, NEW YORK.

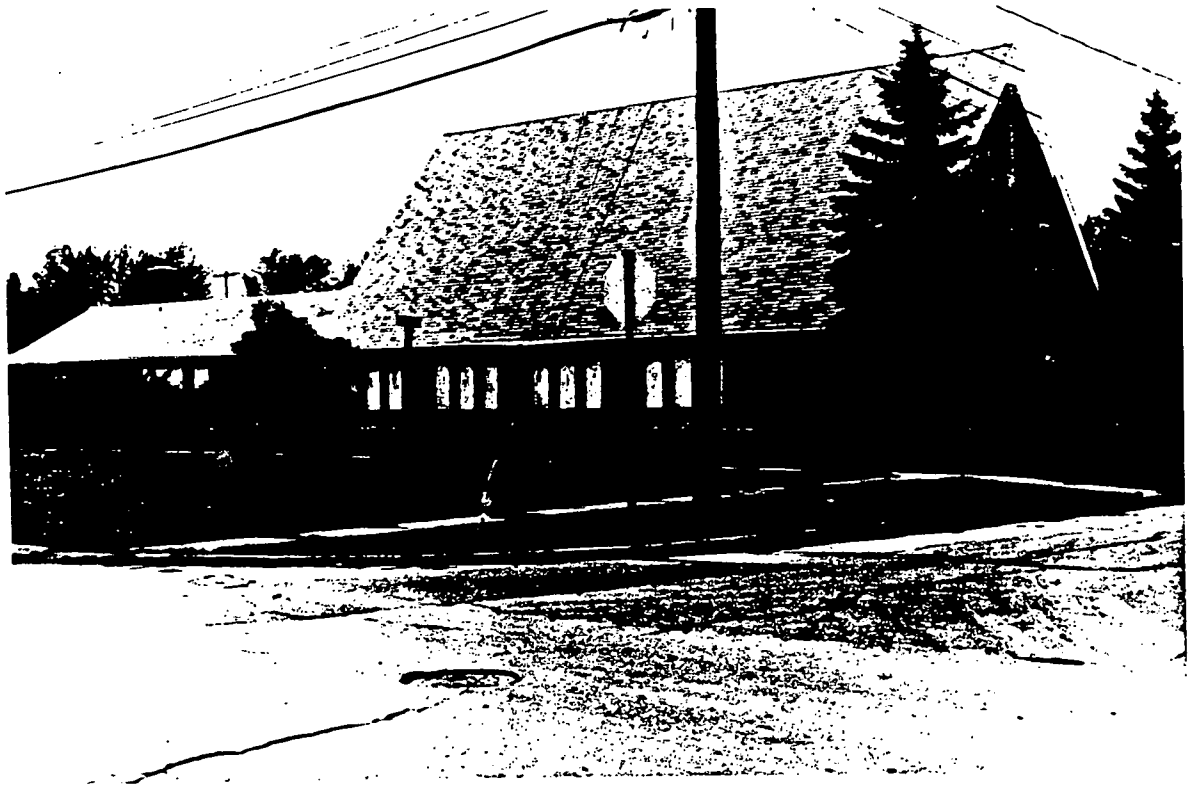
Comments: View to northwest of southeast corner of site (Colvin Blvd. in foreground and 97th Street to right).

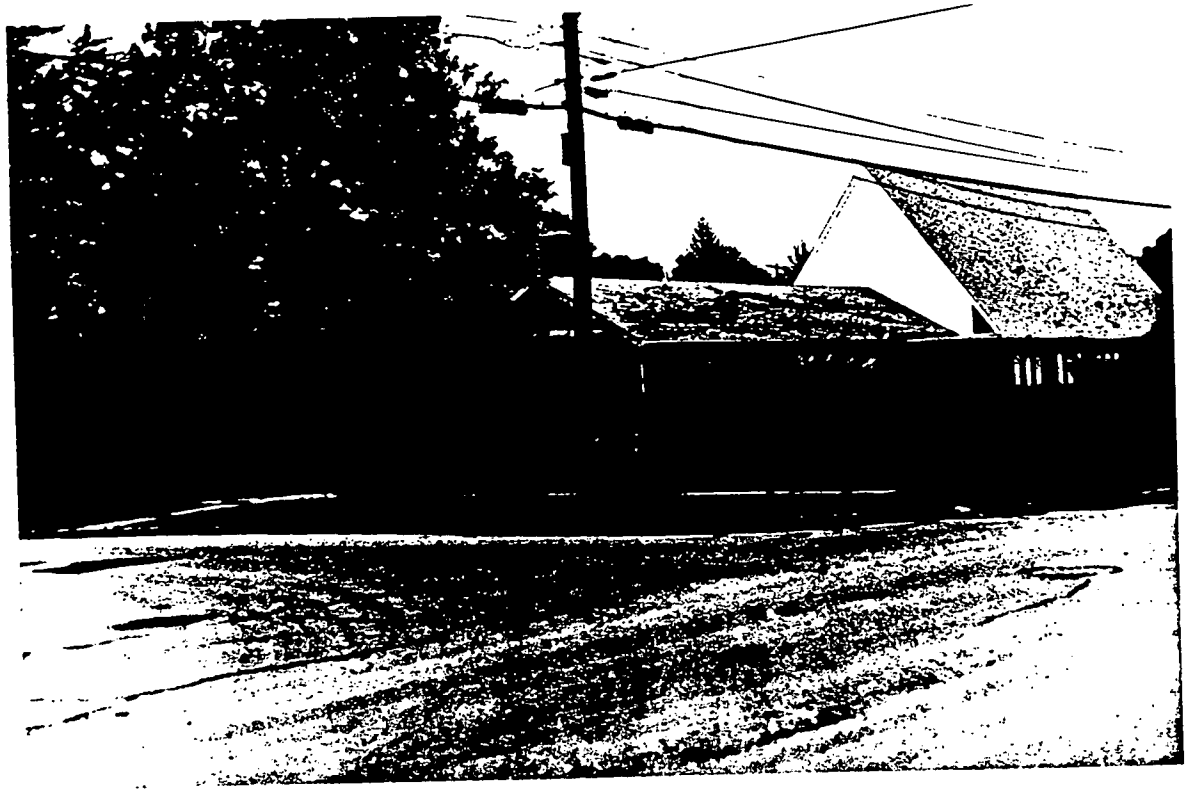
Comments: View to northeast of southwest corner of site (Colvin Blvd. in foreground and 96th Street to left).

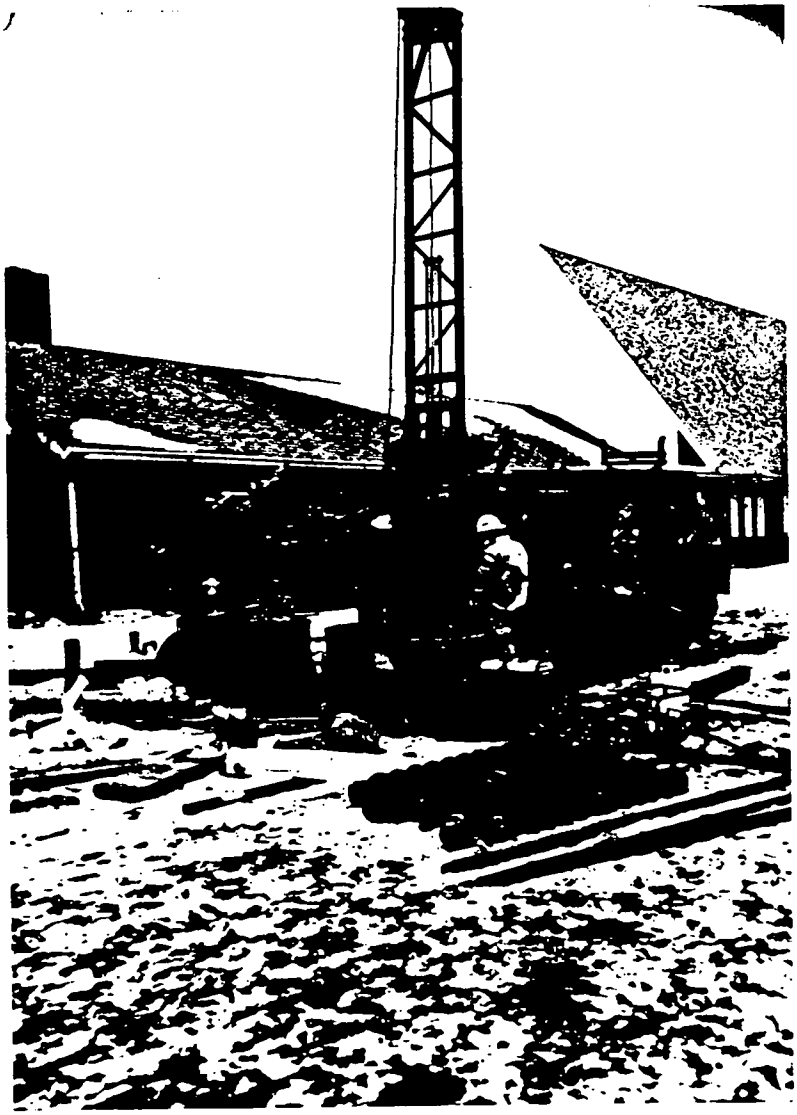
Comments: View of northeast of rock coring GW-3257.

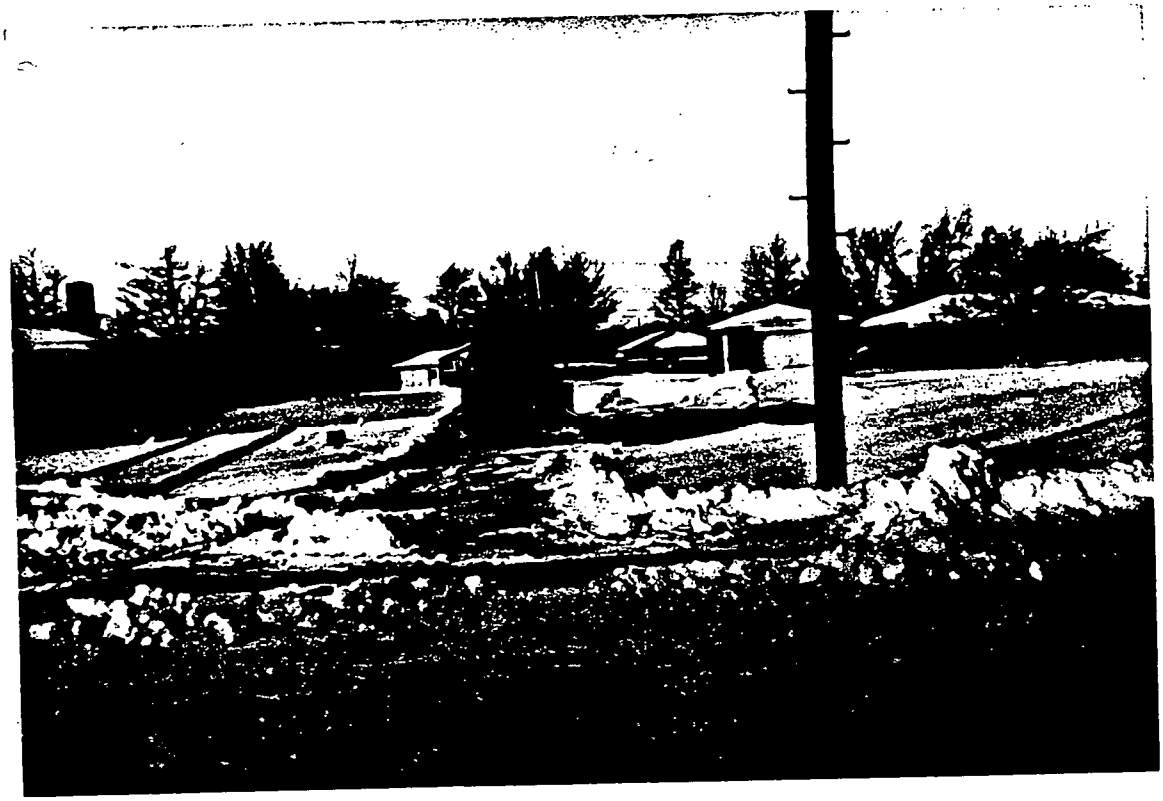
A 4-inch clay pipe trending north-south was ruptured during the excavation of Test Pit No. 1, causing water to flow into the test pit. The pipe is believed to be part of the roof drainage system of the church building carrying runoff to the local storm sewer system due to the close proximity of a manhole in line with the pipe in the parking lot. Soil was backfilled over the pipe to stop the water flow. The pipe was repaired on August 1, 1990 by Green Environmental Specialists, Inc., under the supervision of E & E prior to repaving the test pits. All three test pits were repaved with blacktop cold-patch on the above mentioned date. Soil samples TP-1 and TP-2 were analyzed by E & E's ASC for TCL organics and inorganics. The concrete fragment sample TP-3 was only tested for mercury. In addition, a QA/QC sample consisting of one MS/MSD sample (TP-2MS/TP-2MSD) was analyzed for these parameters.

Comments: View to west of Test Pit No. 1 (blacktop area of parking lot).
