ENGINEERING INVESTIGATIONS AT INACTIVE HAZARDOUS WASTE SITES IN THE STATE OF NEW YORK

PHASE II INVESTIGATIONS

97th Street Methodist Church (Site Number 932084A)
City of Niagara Falls, Niagara County

December 1990

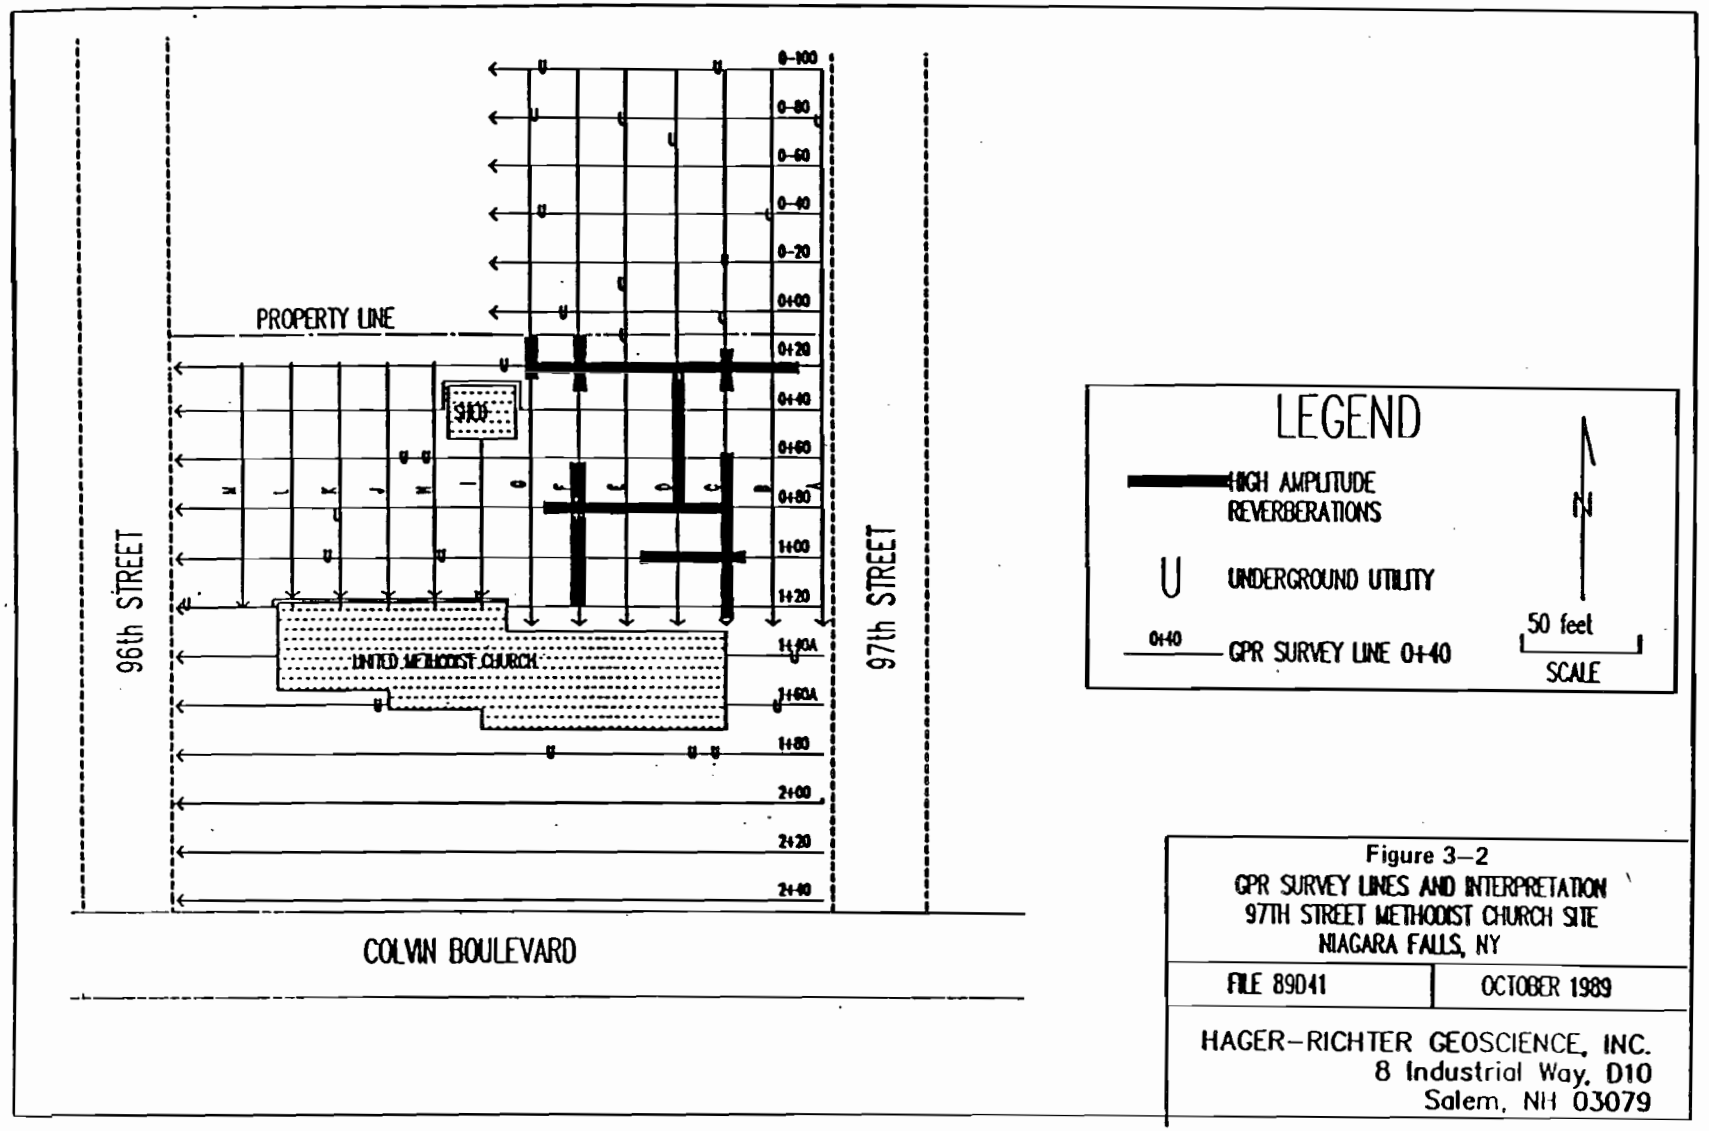
Figure 3–2
GPR SURVEY LINES AND INTERPRETATION
97TH STREET METHODIST CHURCH SITE
NIAGARA FALLS, NY

One might expect that broken concrete reactor cells would have electrical properties very different from the ground in which they are buried. If the reactor cells are reinforced concrete, we expect that they would produce strong reverberating reflections of the radar signal, similar to the reverberations observed when crossing the GPR over the concrete sidewalks at the site. If the reactor cells were broken or crushed, we would expect the reverberations to be somewhat jumbled or distorted. There are a few GPR records of the asphalt parking area that have strong high amplitude reverberations generated from objects near the surface. An example of the reverberations is shown in the right side of Figure 3-1 (Appendix B-3) and the lines along which they are found are shown in Figure 3-2. It is possible, but unlikely, that these reverberations are caused by reinforced concrete reactor cells whose tops are buried less than 5 feet deep. Because of the flat, undistorted nature of the reverberations, it is more likely that they are caused by concrete slabs or sidewalks underlying the asphalt. Trenching these few areas would determine the origin of the reverberations.

Underground utilities generate characteristic tight hyperbolas (see Figure C-2). Potential locations at the 97th Street Methodist Church Site of underground utility lines identified in the GPR data are shown in Figure 3-2.

4. Several possible utility lines at the site are identified in Figure 3-2.

E & E recommends that a test pit(s) be dug in the vicinity of the GPR reverberations beneath the asphalt parking lot in order to determine whether they were caused by the presence of reactor cells, or concrete slabs and/or sidewalks.

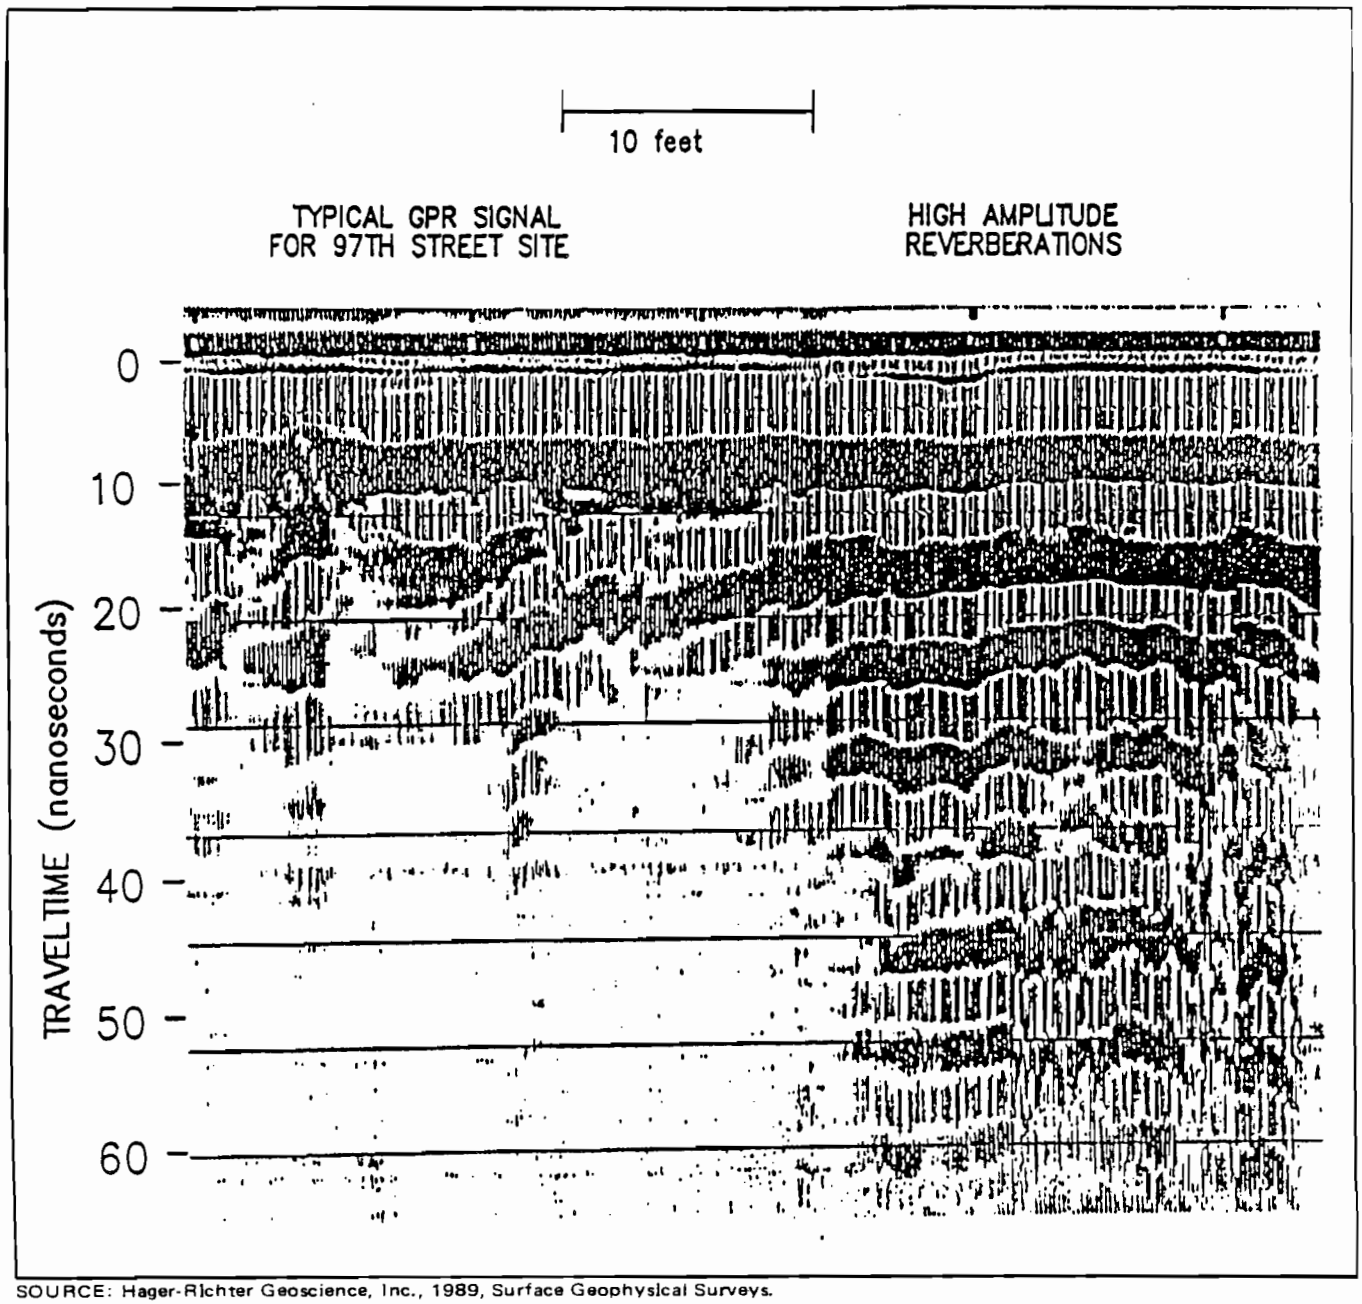
Figure C–1 GPR SIGNAL TYPICAL OF THE SITE AND AN EXAMPLE OF HIGH AMPLITUDE REVERBERATIONS. SHOWN IS LINE C 0+90 TO 1+35.

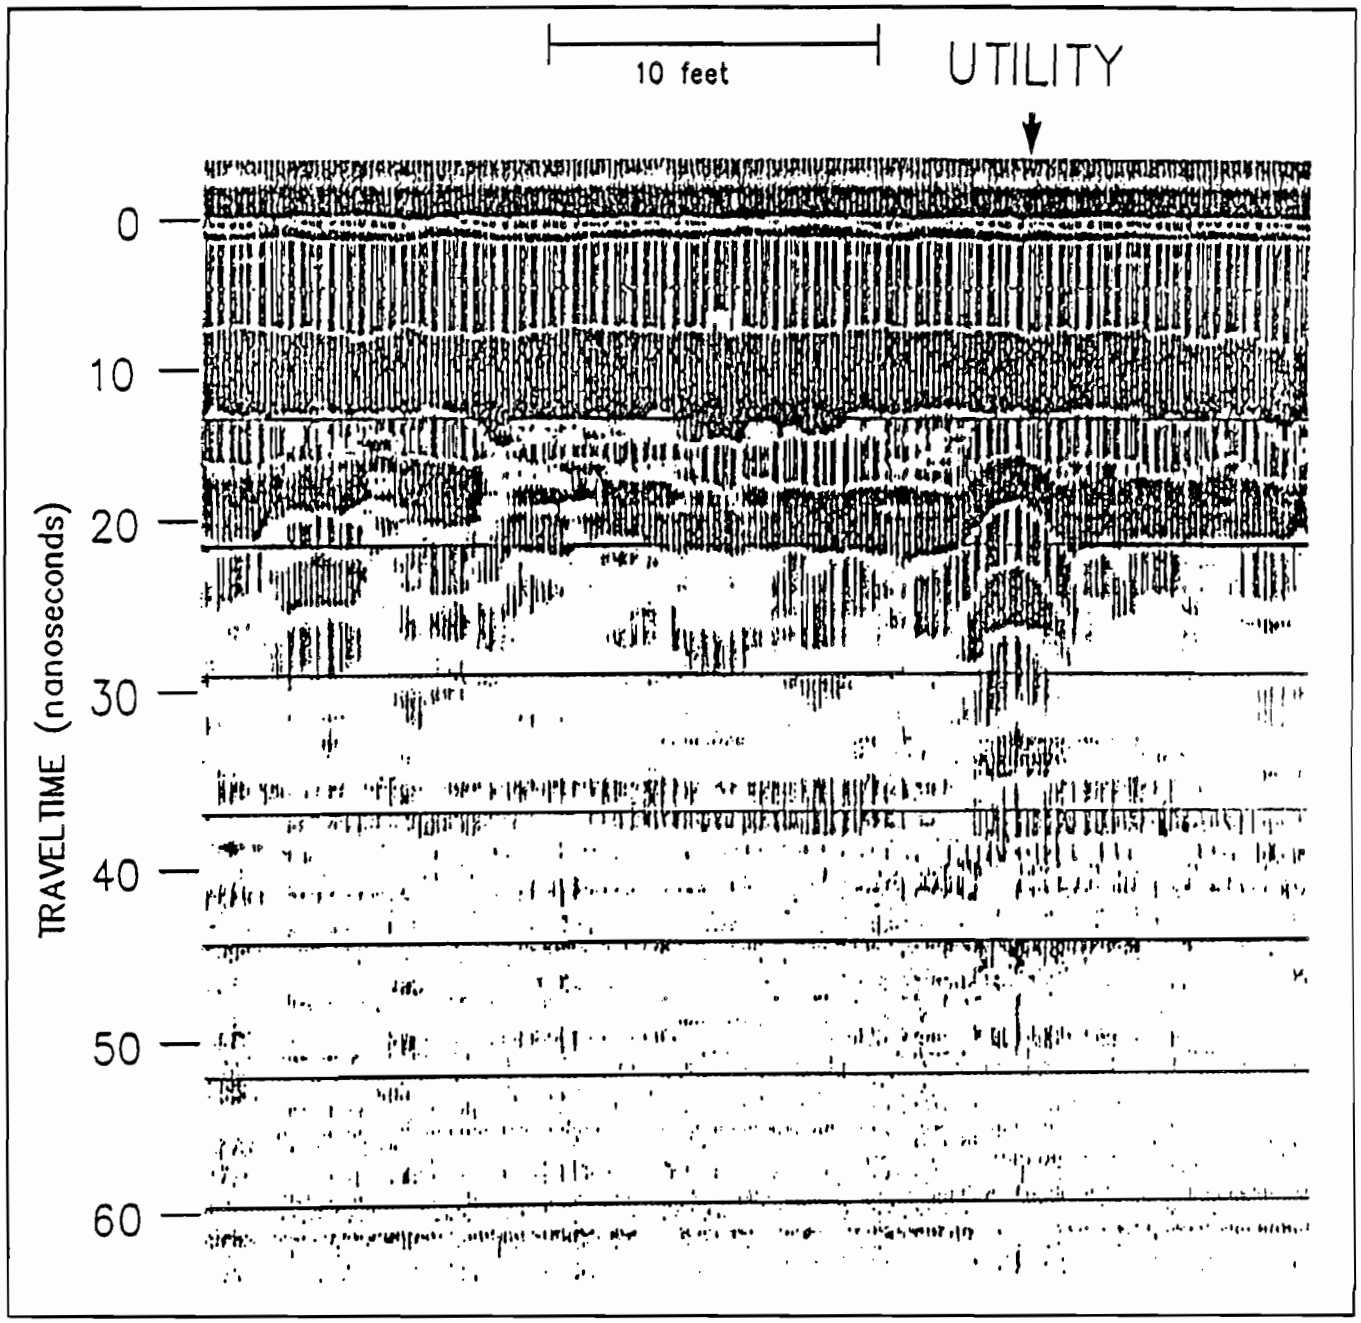
Figure C–2 GPR SIGNATURE CHARACTERISTIC OF BURIED UTILITIES. SHOWN IS LINE D 0+15 TO 0+35; 97TH STREET METHODIST CHURCH SITE, NIAGARA FALLS, NEW YORK.
