PERIODIC REVIEW REPORT 2020

SOLVENT CHEMICAL SITE
NIAGARA FALLS, NEW YORK
SITE # 9-32-096

TRC Environmental Corporation
Wannalancit Mills
650 Suffolk Street
Lowell, Massachusetts

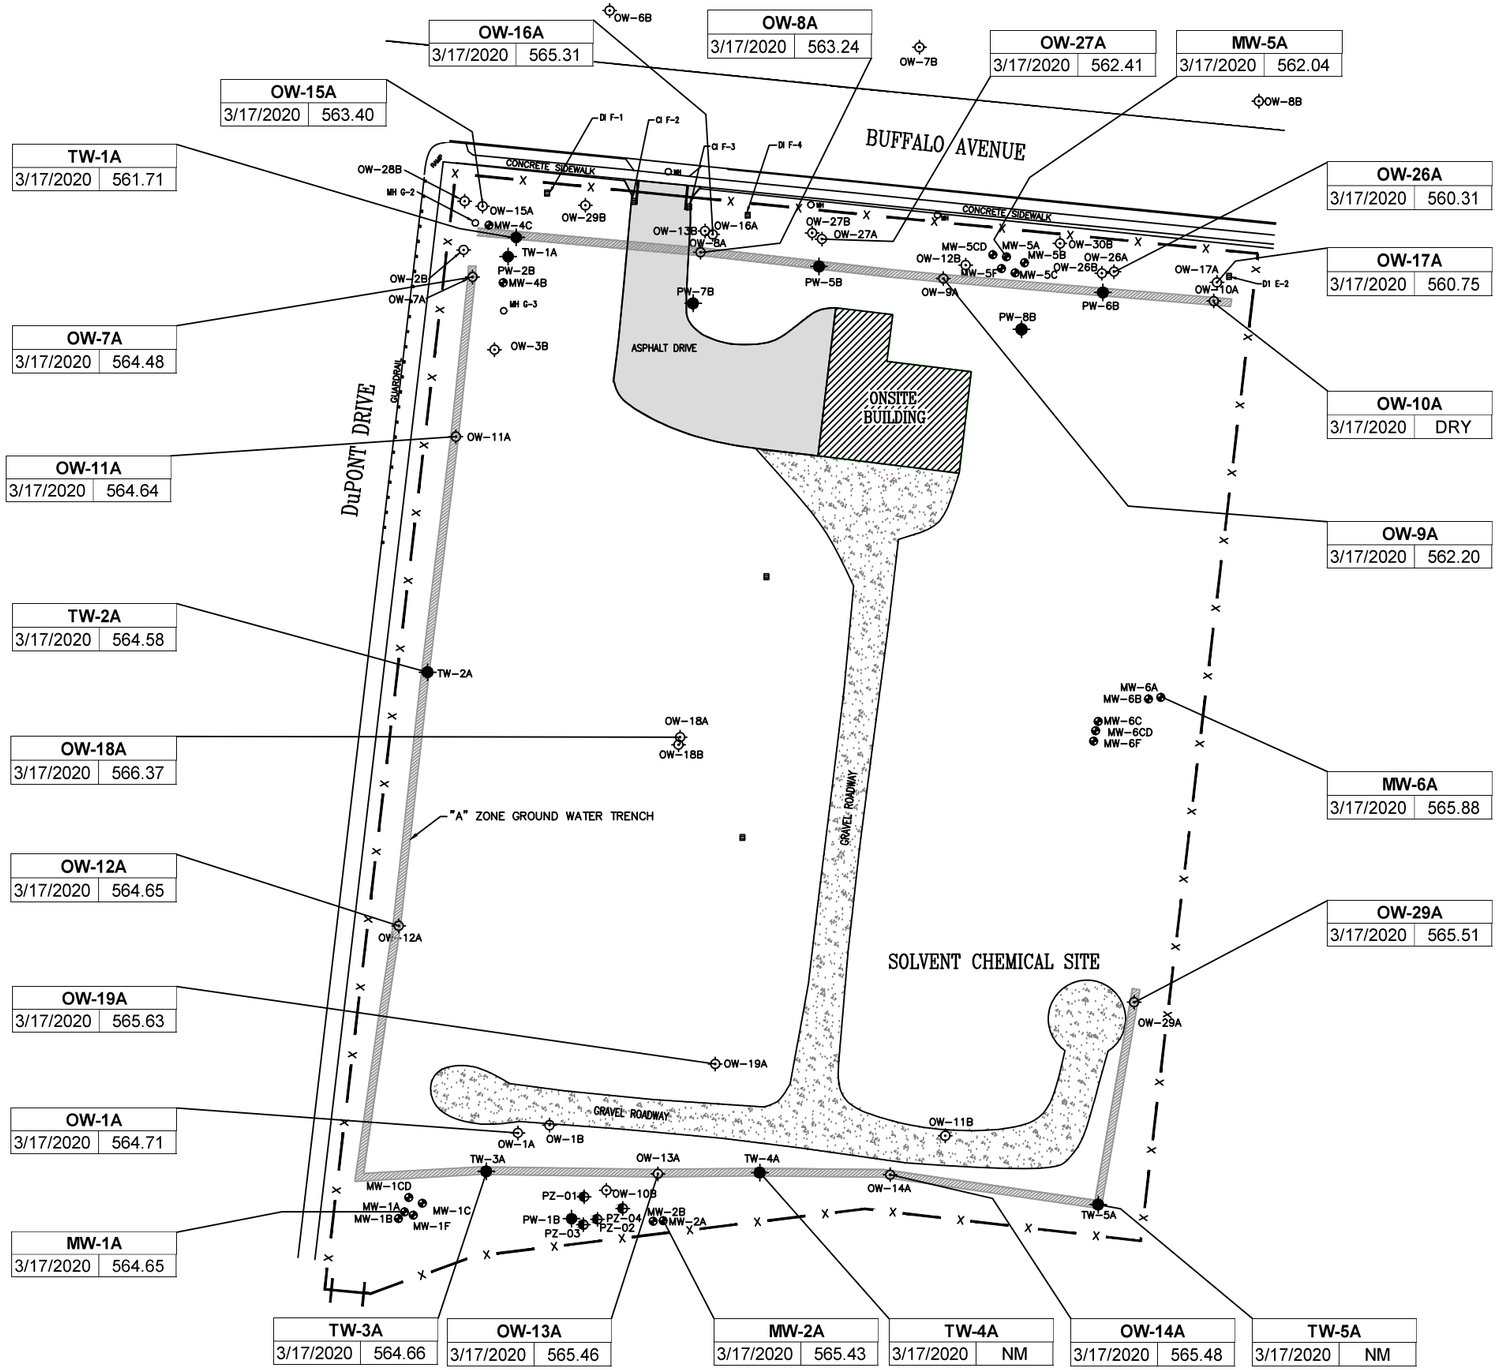
Figures 3 and 4 present overburden water levels for the Solvent Chemical Property and document that the piezometric elevations of all the observation wells in the central portions of the Site are higher than the piezometric elevations encountered in the trench observation wells, indicating an overburden flow path towards the ground water extraction trench. Figures 5 through 8 present ground water contours for B-zone wells on the Solvent Chemical Site and Olin Hot Spot properties. The contours show that ground water extraction system pumping rates are achieving hydraulic capture. Figures 9 through 12 present graphical depictions of CoC concentrations versus time for the wells currently sampled. Additional discussions regarding these figures, where appropriate, are provided in the applicable sections of this report.

Water level measurements were collected both within and outside of the ground water extraction trench. Figures 3 and 4 provide ground water piezometric surface elevations for the overburden observation wells on the Solvent site. As shown on these figures, the piezometric elevations of all the observation wells in the central portions of the Site are higher than the piezometric elevations encountered in the trench observation wells indicating an overburden flow path towards the ground water extraction trench.

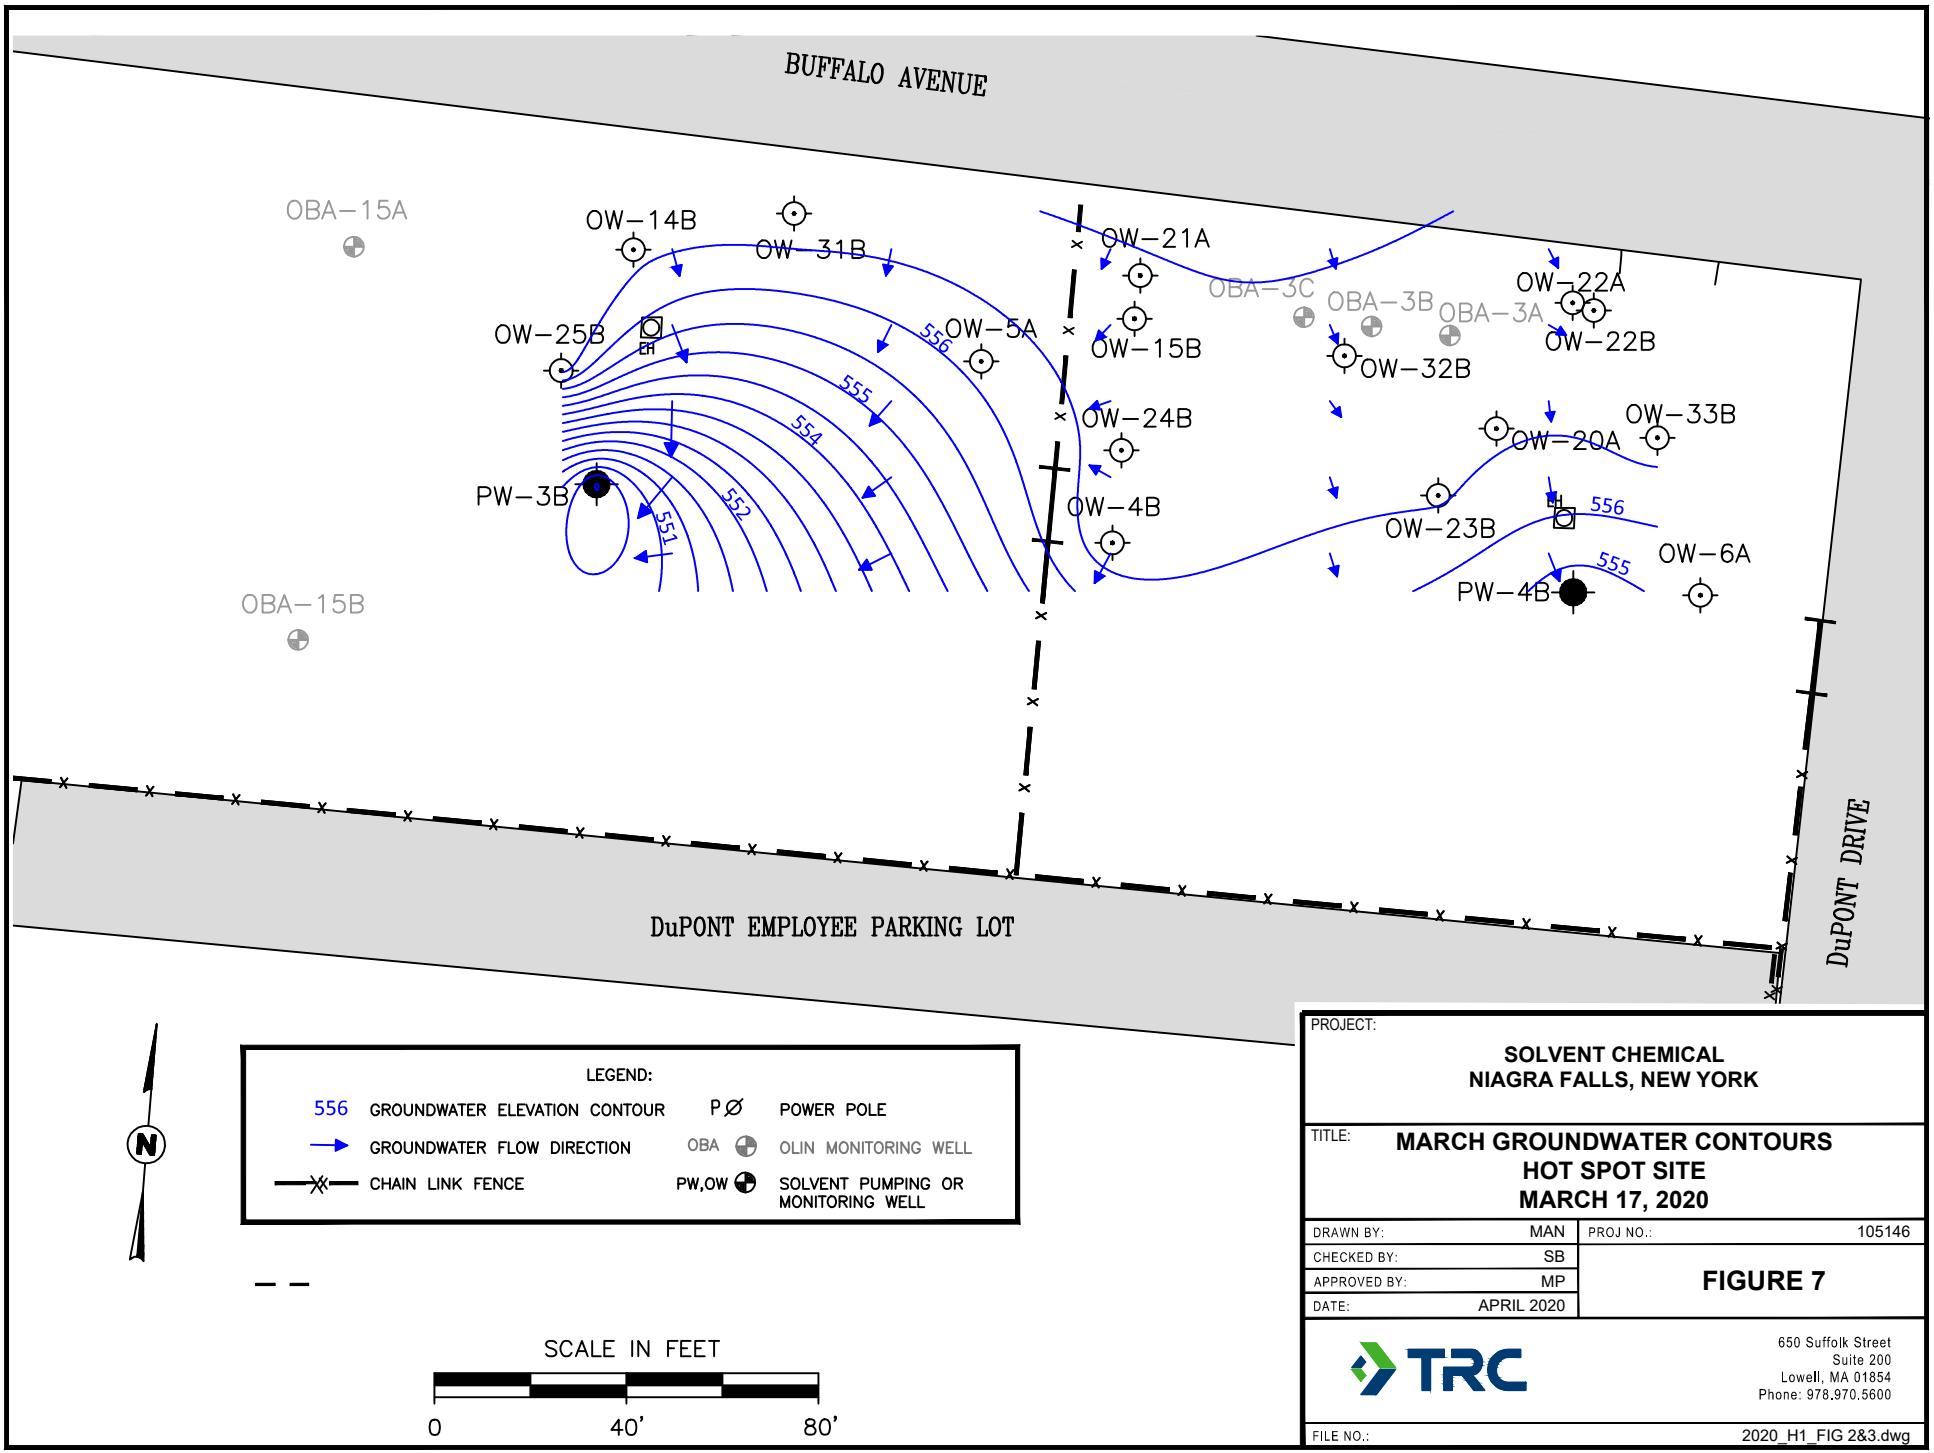
TITLE:
MARCH GROUNDWATER CONTOURS
HOT SPOT SITE
MARCH 17, 2020

Figures 5 through 8 present semi-annual water level contours for both the Solvent Site and Hotspot for 2020. The figures indicate that the B-zone pumping wells are achieving capture consistent with the baseline hydraulic conditions approved by NYSDEC, included as Appendix A of the PMP, with the exception of the occasions listed in Section 6.2 below.
