INDUSTRIAL WASTE AND SOIL REMOVAL ACTION FINAL REPORT

SCHRECK'S SCRAPYARD

North Tonawanda, New York

Dated:
June 2, 1991

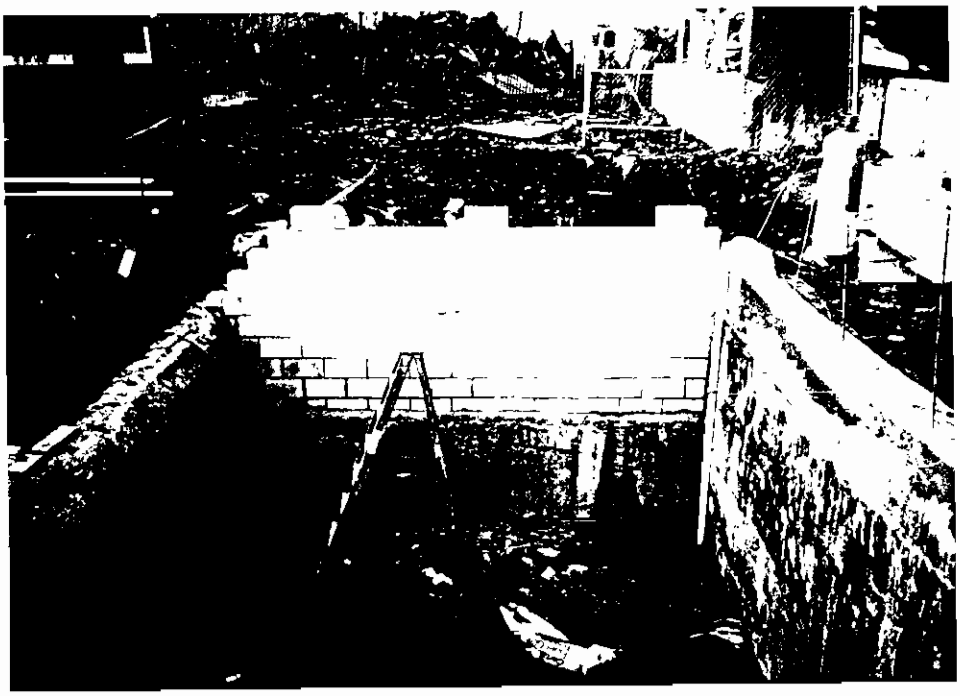
Photograph 4

The concrete blocks of the west wall and the western end of the north and south walls on the ledge are in deteriorated condition and are two feet to four feet below existing grade. The floor of the Pit is poured concrete, with exposed reinforced bars and steel pipes. The thickness of the floor and the ledge was not determined. At several locations, vertical steel pipes were exposed at the top of the wall. The function of these pipes is unknown.

An existing sump is located in the concrete floor on the north side of the Pit near the ledge. It is 1.13 feet deep and 1.8 feet in diameter. A two inch diameter pipe/conduit extends into the sump from the southeast just below the floor surface. Whether the pipe traverses in or under the concrete floor could not be determined. The purpose for this pipe is unknown, but is probably an electrical conduit or a drain/discharge pipe.

This photo was taken from inside the Pit looking west.
Note the block west wall, sump location and ledge.

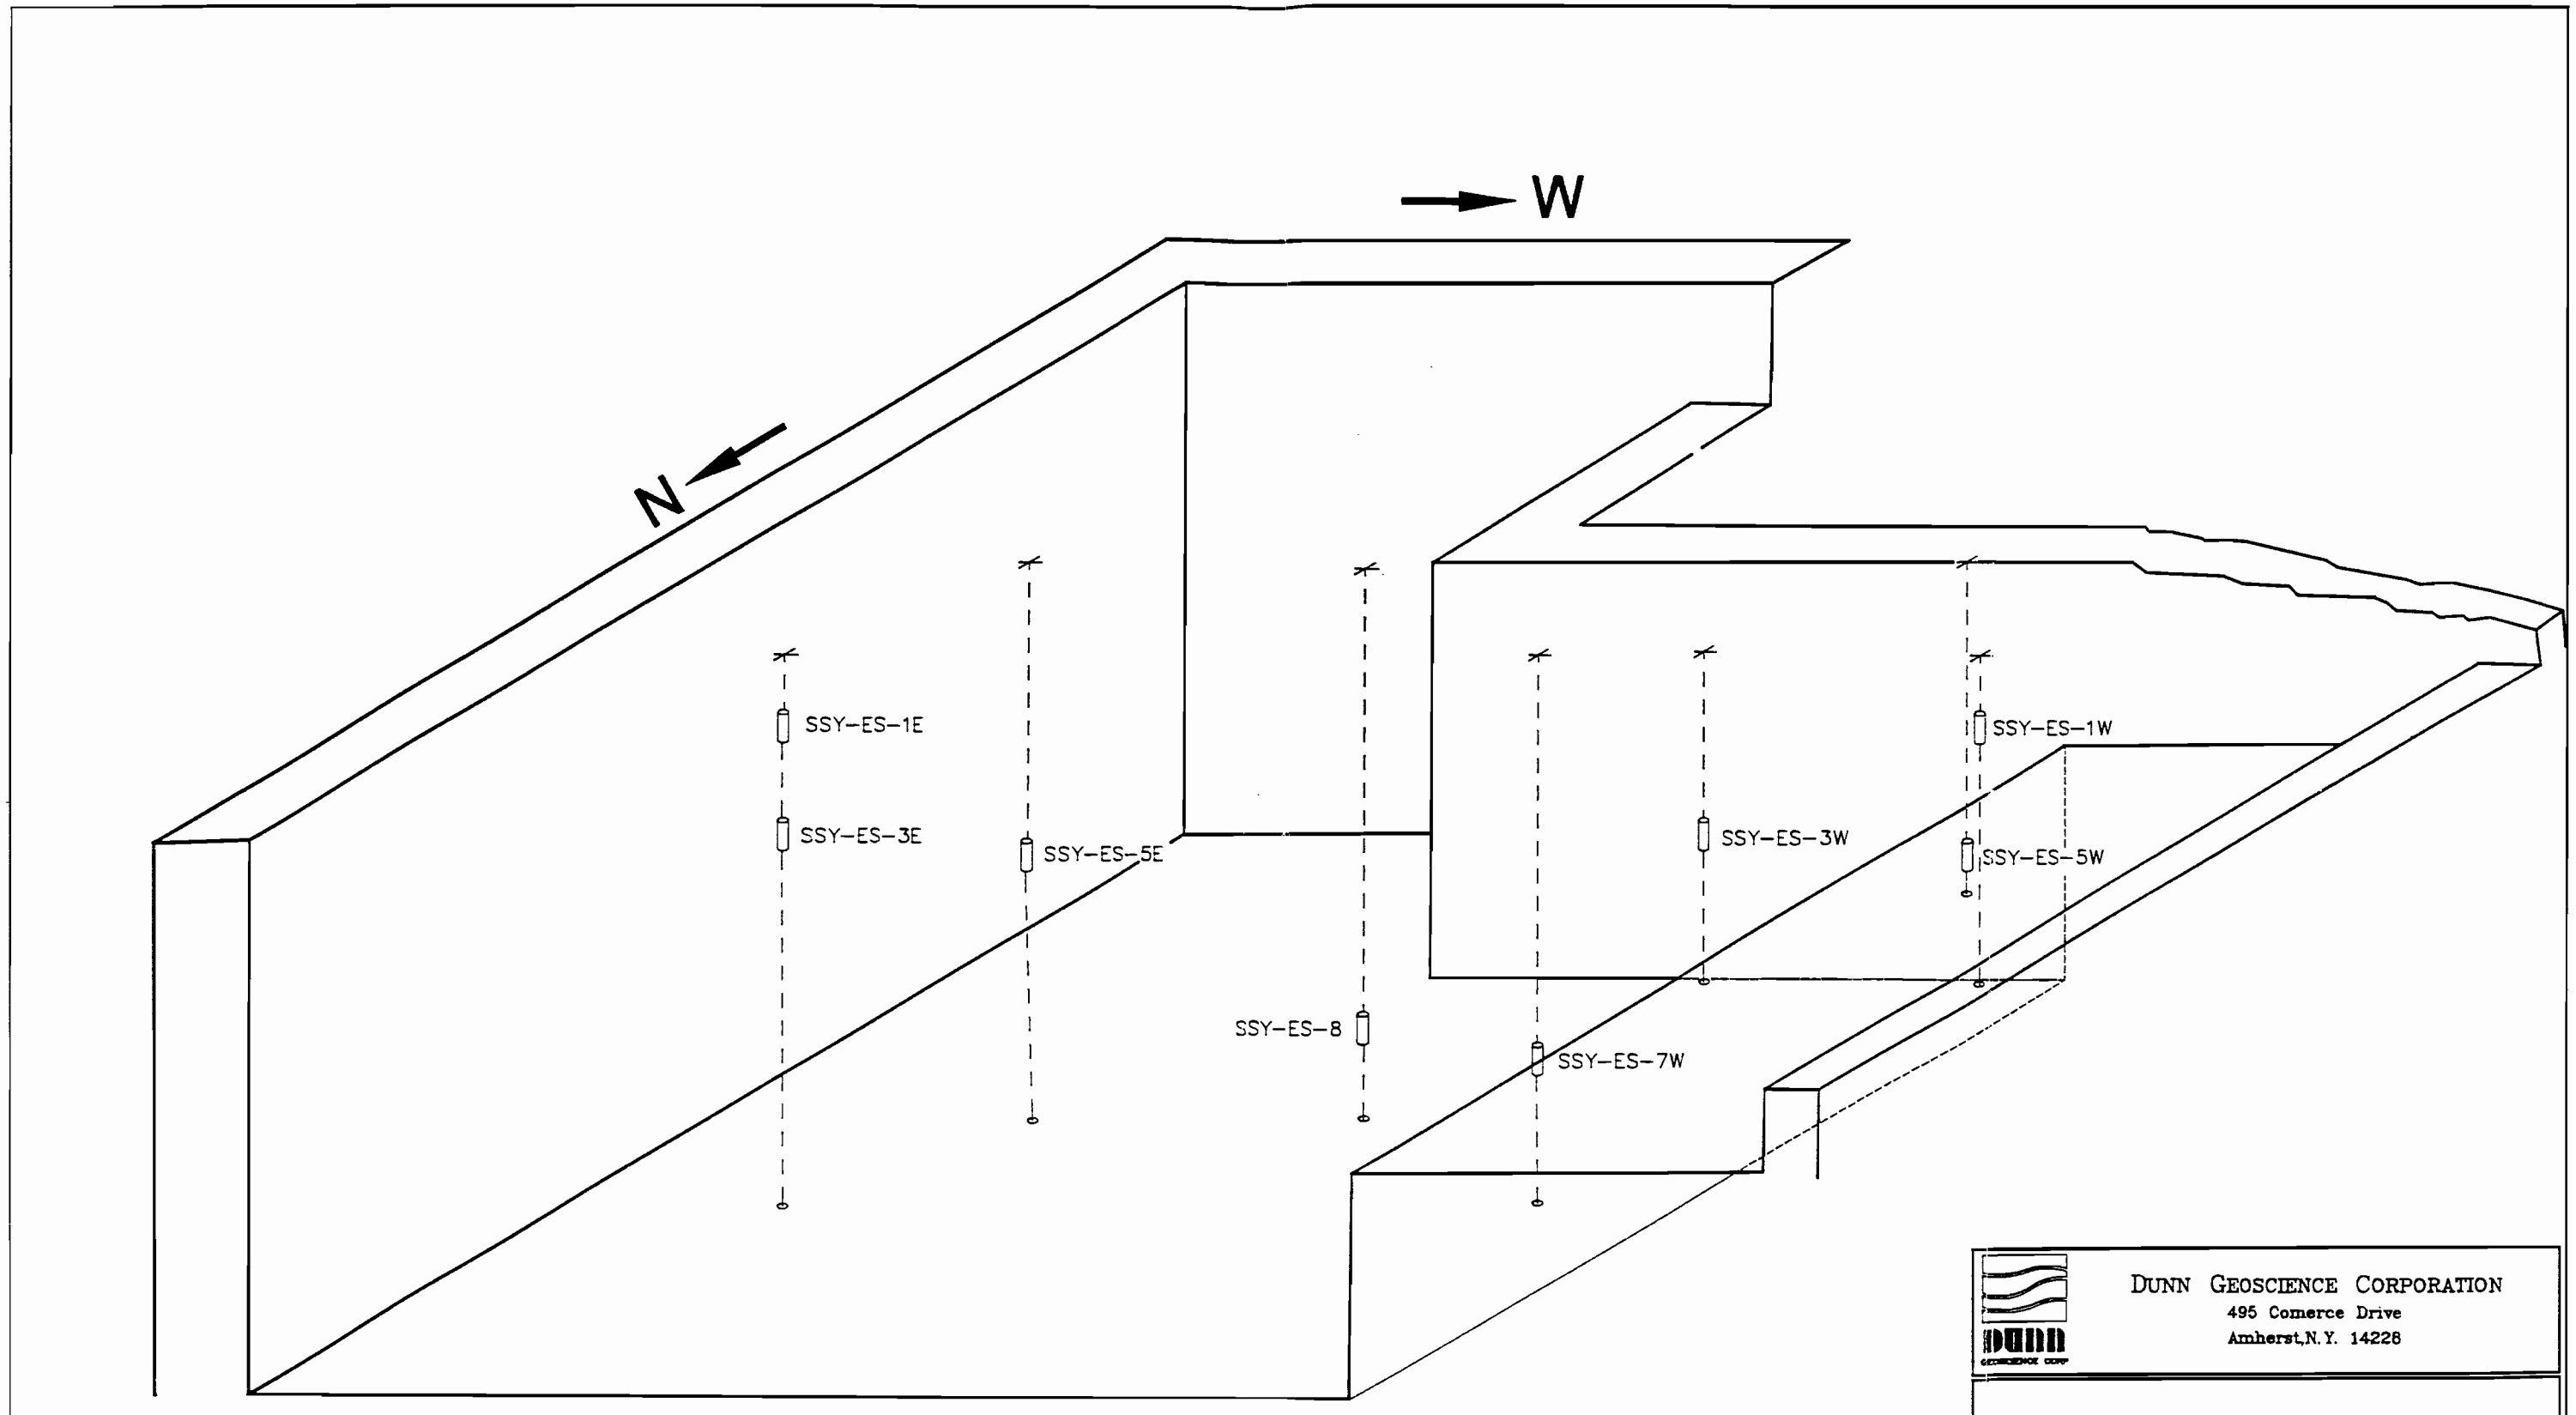
PROJECT NO. 00348-00074		DWG. NO. 2M08925
SCALE: 1" = 3'	DATE 3/11/91	FIGURE NO. 3

Pit samples were collected by using the excavator bucket to excavate a small portion of the Pit material from selected locations. A total of eight (8) discrete soil samples were collected at depths of one, three, five, seven, and eight feet. Soil sample locations are diagrammed on Figure 3. The excavator bucket was then placed beside the excavation and a portion of the material in the bucket was placed in a decontaminated stainless steel bowl with a stainless steel spoon as called forth in the Work Plan. The procedure was repeated at the same elevation at three more locations (sub-samples) in the Pit. Four sub-samples were collected for each half of the Pit. Once the four sub-samples were collected for each half of the Pit, the material in the bowl was thoroughly mixed and transferred in the appropriately labelled sample containers. Therefore, two composite samples were collected at each specified depth within the Pit. The samples were kept cool and the proper Chain-of-Custody procedures, pursuant to the QAPP, were utilized. The samples were subsequently analyzed under U.S. EPA Contract Laboratory Protocols for Target Compound List semi-volatiles and PCB isomers at Recra Environmental, Inc. The analytical results revealed that besides the detection of semi-volatiles, PCBs were also detected at levels as high as 70 ppm (total PCBs). The solid waste analytical results are summarized in Appendix C of this report. The total PCB concentrations are also diagrammed in Figure 4.

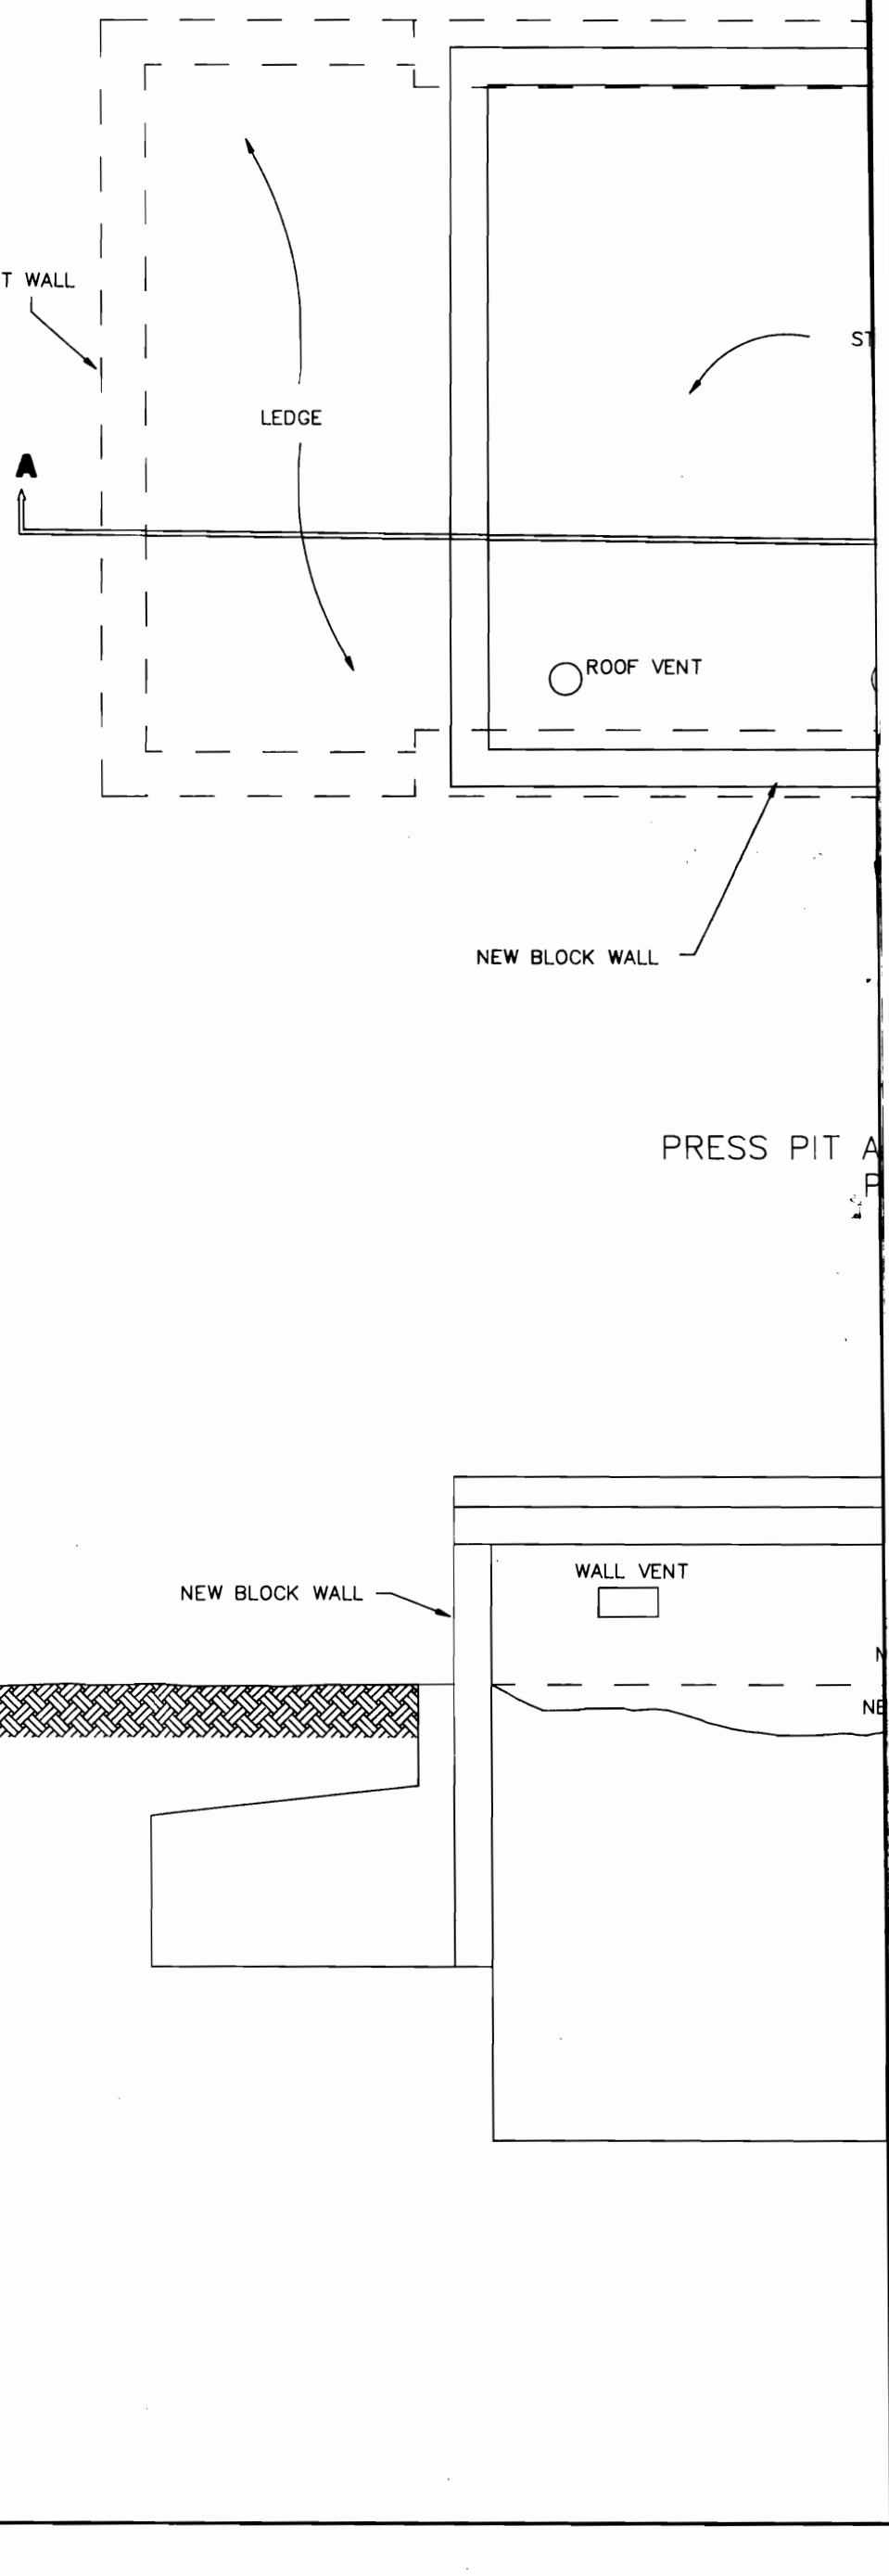
PROJECT NO. 00348 – 00074		DWG. NO. 2M08938.
SCALE: 1"=4'	DATE 3/27/91	PLATE 3

quarter inch CDX exterior grade plywood. The roofing material was 90 pound mineral coated, rolled roofing with tarred and nailed seams. The roof sloped to the north, with the exception of the southeast corner which sloped to the south. In the southeast corner, an entrance hatch and ladder were installed to allow access to the bottom of the Pit. Three turbine roof vents were installed and 12 side vents were installed in the masonry wall at evenly spaced intervals around the entire perimeter. (Refer to Plate 3 and Photograph number 6 of Appendix B of this report.)

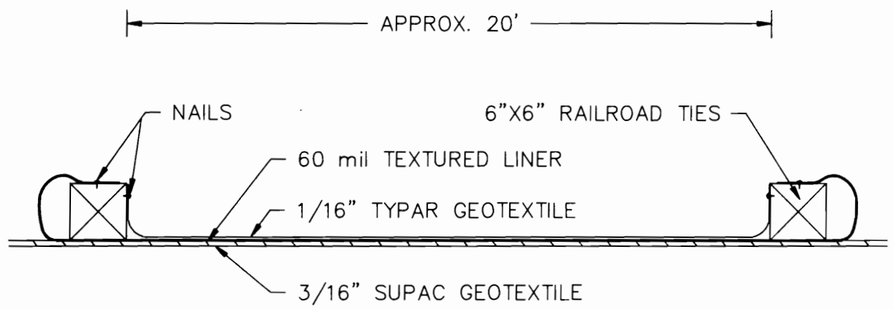
CROSS-SECTIONAL VIEW OF ACCESS ROAD

Historically, oils containing PCBs were drained from transformers onto the ground, and subsequently, most of the surface area of the site has become contaminated. Therefore, a temporary access road was constructed by OCC to prevent the waste removal trucks from picking up PCB contaminated soils on their tires and inadvertently carrying contaminated soil beyond the Site. The access road was constructed on the Site parallel to the eastern property fence from the entrance gate at Schenck Street to the south end of the Pit, a distance of 260 feet. The road was 30 feet in width, but flared at the south end to 40 feet in width to accommodate handling, loading, storing and staging areas. The location of the access road is shown on Plate 1.
