Newsday
235 Pinelawn Road
Melville, New York 11747

PHASE I ENVIRONMENTAL SITE ASSESSMENT

OCTOBER 8, 2018

VERTEX PROJECT NO: 51921

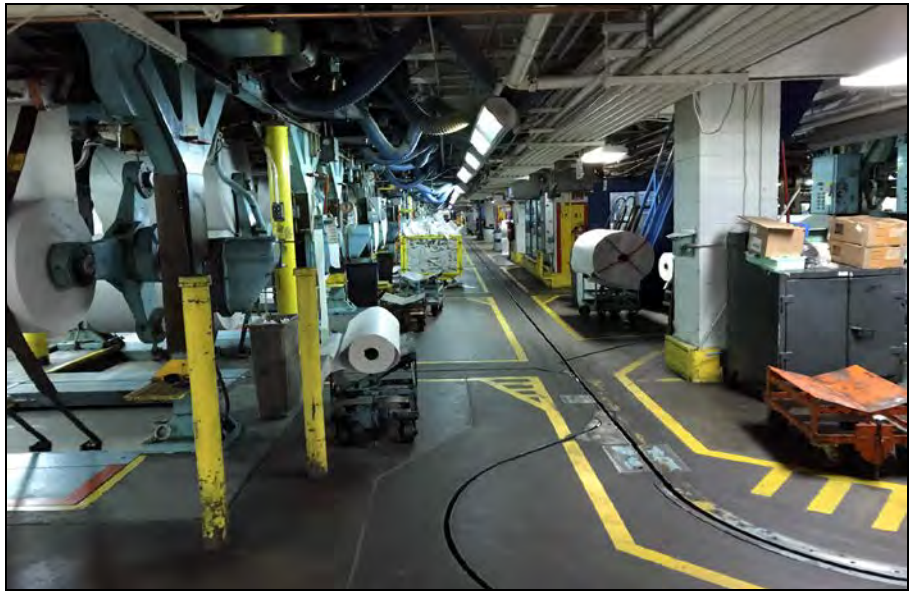
Photo 2: Reel room (first floor of the press room).

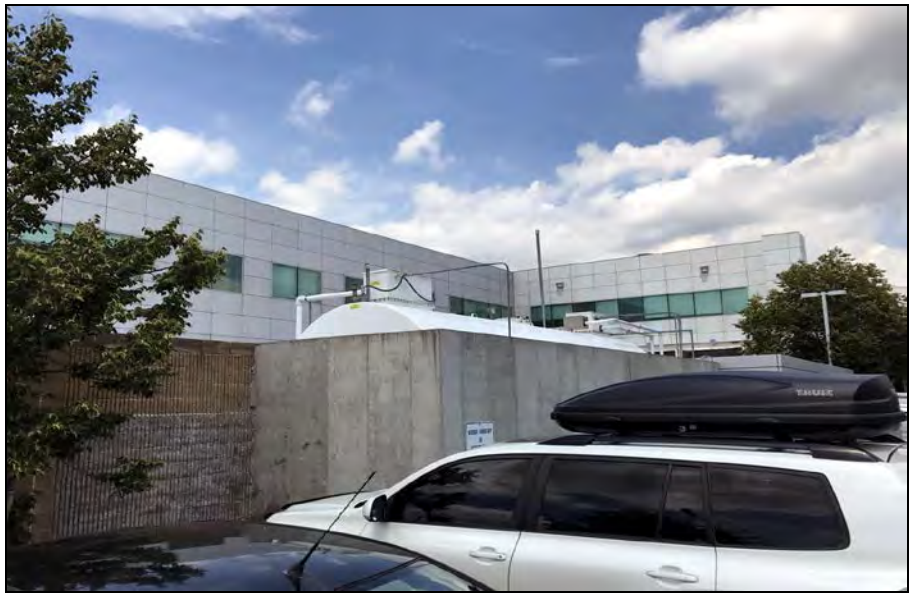
Photo 12: 15,000-gallon diesel AST east of the building.

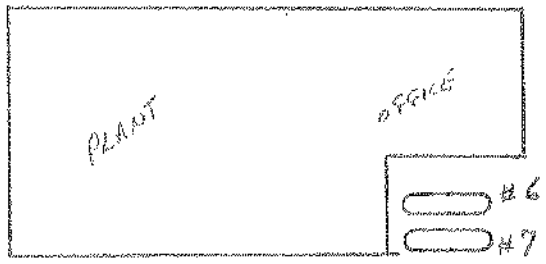
TANK #	LOCATION	CAPACITY	CONTENTS	MATERIAL
6	UPRIGHT	25000	#2 FUEL OIL	PLW STL
7	LAYDOWN	25000	#2 FUEL OIL	PLW STL

1. CONDITION OF TANK AND PIPING: (Note any holes) CLEAN BTL LININGS AND SLUDGES REMOVED

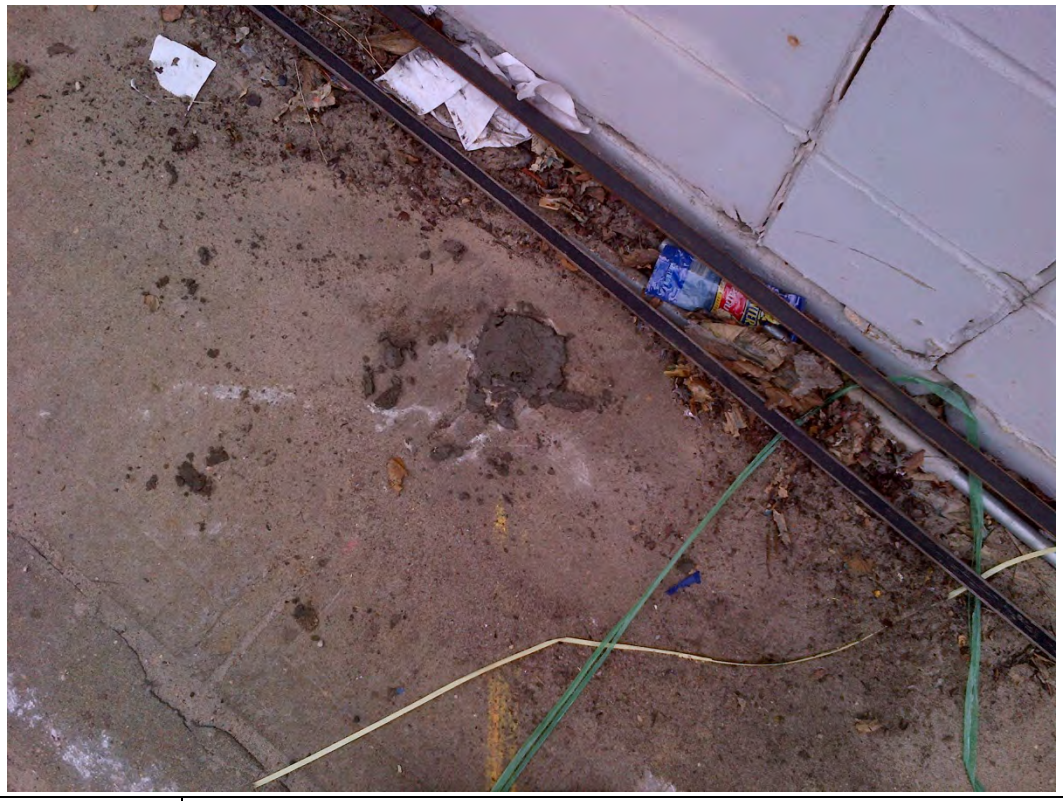
Photograph: *10*	Vent lines filled with concrete	
Tribune Company	***ERM***	*235 Pinelawn Road* *Melville, NY*

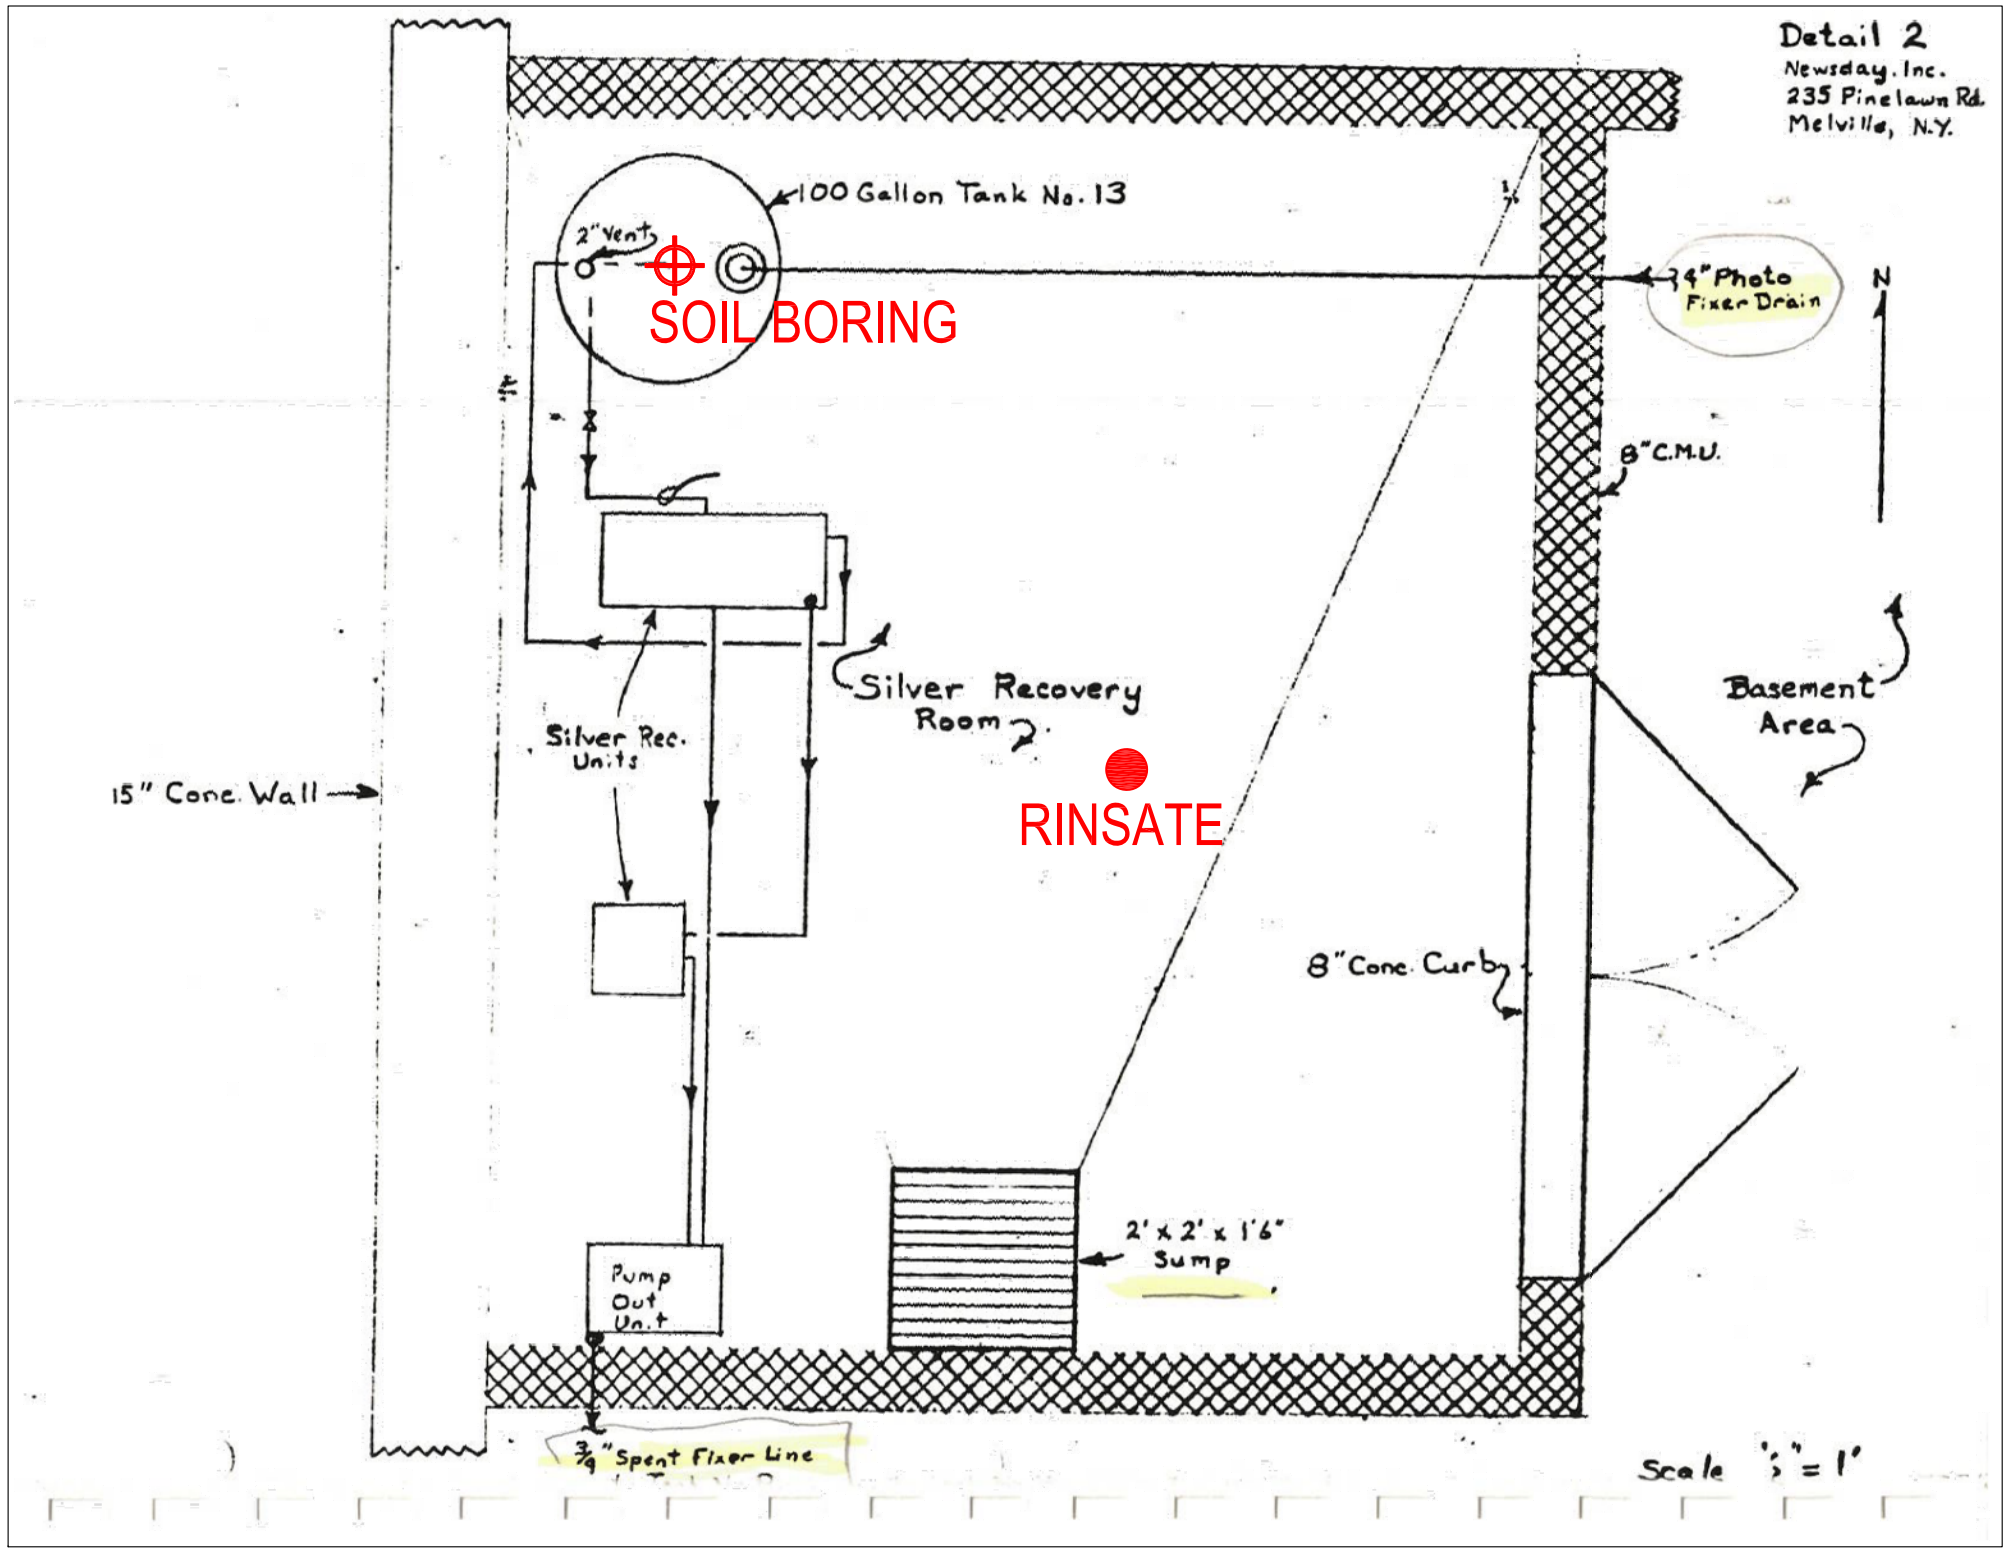
Client	SHEET #		
Newsday **235 Pinelawn Road, Melville, NY 11747** **RCRA Closure**	**Figure 6**	**PROPOSED SAMPLING OF FORMER SILVER RECOVERY ROOM**	H2M architects + engineers
	DATE: **MAY 2018**	**NEWD1803**

tank (SCDHS Tank No. 13) located in the Former Silver Recovery Room in the basement. The layout of the Former Silver Recovery Room is shown on **Figure 6**. The spent fixer solution was then circulated through a cathode/anode type electroplating unit to separate the entrained silver before being pumped into the 4,000-gallon UST, mixing with the developer waste. The silver was sold to a reclaimer on a monthly basis.

3. Collect one (1) rinsate sample from each room. The proposed rinsate sampling locations in the Former Silver Recovery Room and Former Photo Waste Room are shown on **Figures 6 and 8**, respectively. The rinsate sample shall be collected and analyzed according to the Rinsate Sample Collection Protocol, the Closure Performance Standards as detailed in Section 2.2, and the site-specific Quality Assurance Project Plan (QAPP) provided in **Appendix A**. Should the sampling results exceed the Closure Performance Standards, decontamination of the floors will be repeated until subsequent confirmatory rinsate samples meet the standard.

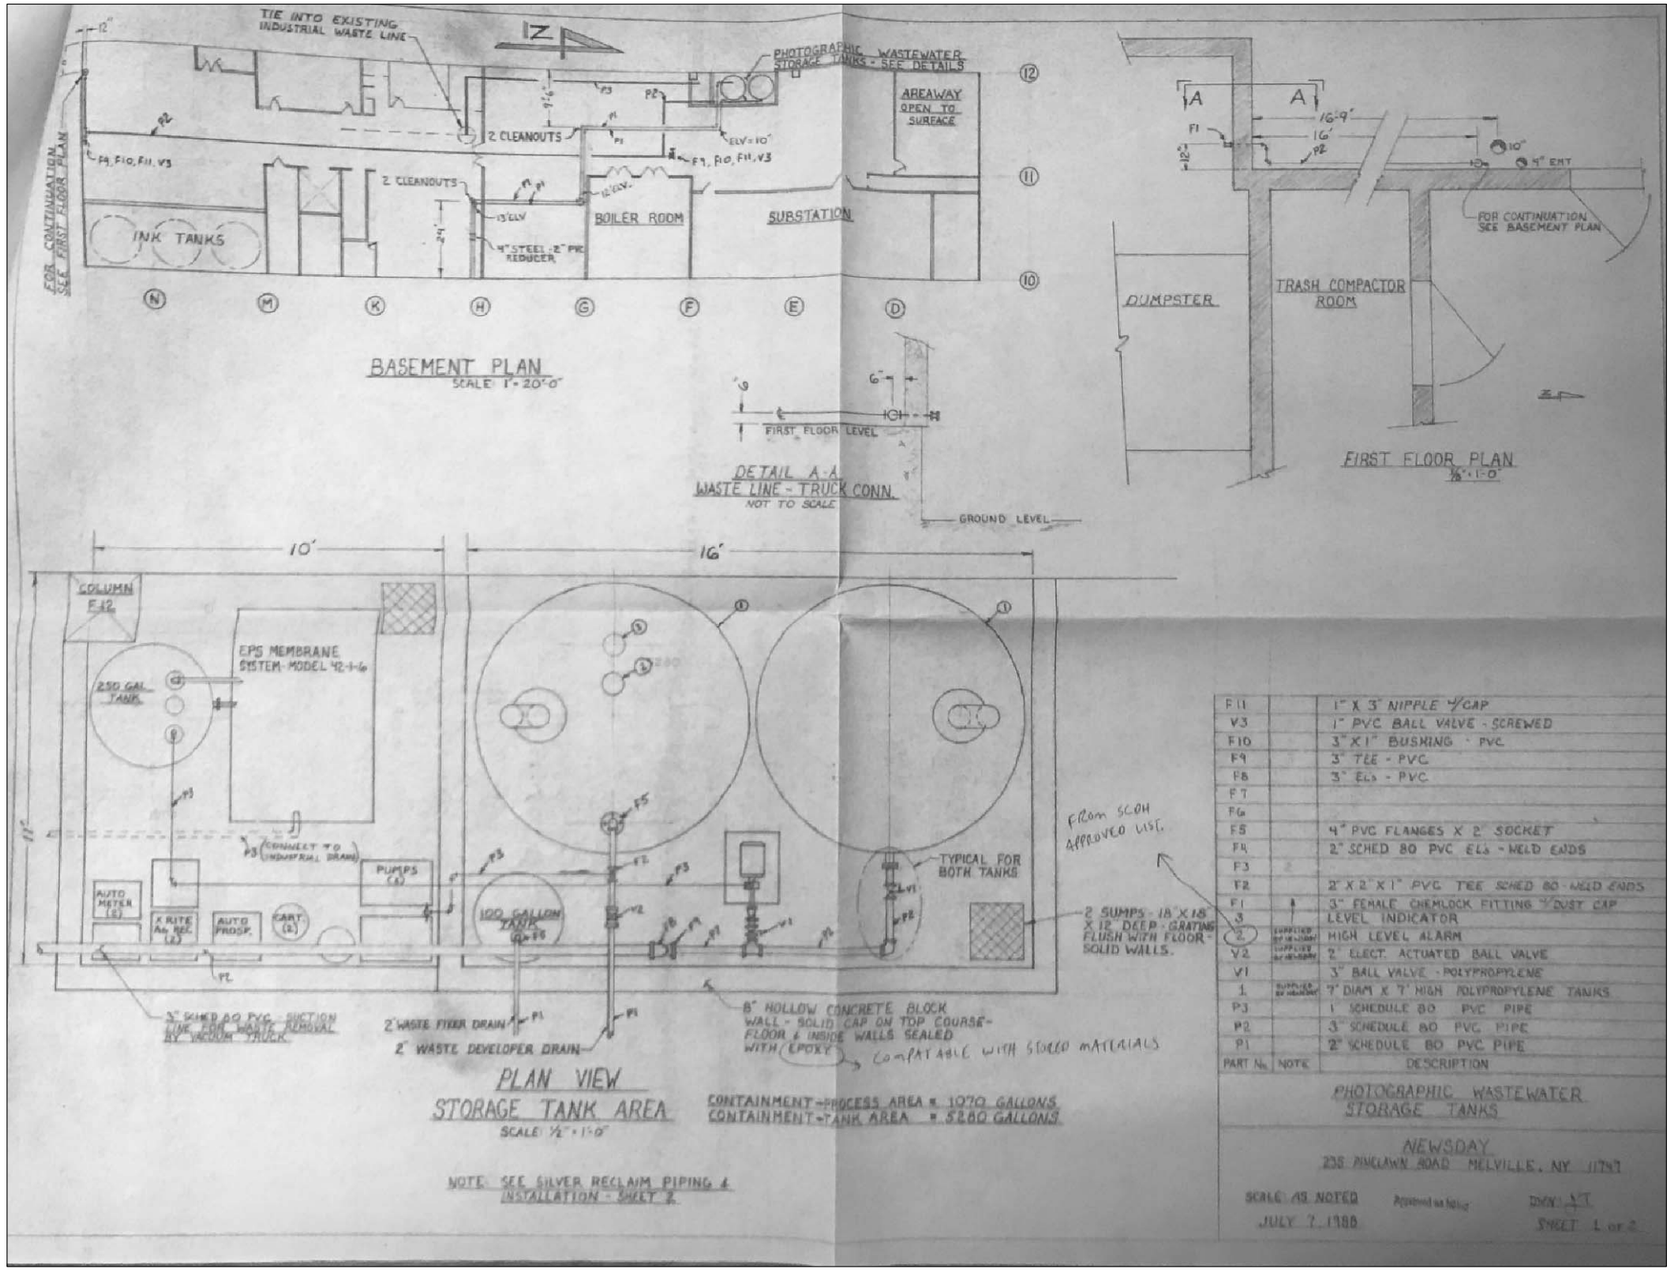
Client **Newsday** **235 Pinelawn Road, Melville, NY 11747** **RCRA Closure**	**SHEET #** **Figure 7a** **DATE:** **MAY 2018**	**FIRST LAYOUT OF FORMER PHOTO WASTE ROOM (PLAN VIEW)** **NEWD1803**	H2M architects + engineers

The 4,000-gallon UST was subsequently removed in June 1989, and the waste stream was subsequently redirected to two 2,000-gallon polyethylene aboveground storage tanks (ASTs, SCDHS Tank Nos. 26 and 27) located in a Former Photo Waste Room that was constructed circa 1989, shown in **Figures 7a and 7b**. One of the two 2,000-gallon ASTs was for emergency use only. The Former Photo Waste Room also consisted of a 100-gallon holding tank (SCDHS Tank No. 43) which held fixer solution that processed through silver reclamation equipment prior to being pumped into the 2,000-gallon ASTs. The developer solution drained directly into the ASTs. When the Former Photo Waste Room was first set up, the fixer/developer waste was pumped out two or three times a month and disposed of at a permitted disposal facility. The fixer/developer mixture that was stored in the ASTs contained elevated levels of cadmium and silver with traces of mercury and selenium. This waste was considered hazardous due to EP Toxicity; however, exact concentrations depended upon composition and silver recovery efficiency. Eventually, in an effort to reduce the volume of wastes, the waste solutions from the two 2,000-gallon ASTs were pumped into a 250-gallon holding tank (SCDHS Tank No. 28) which was then processed through wastewater treatment equipment and discharged through the industrial drain to the on-site wastewater treatment plant (WWTP).

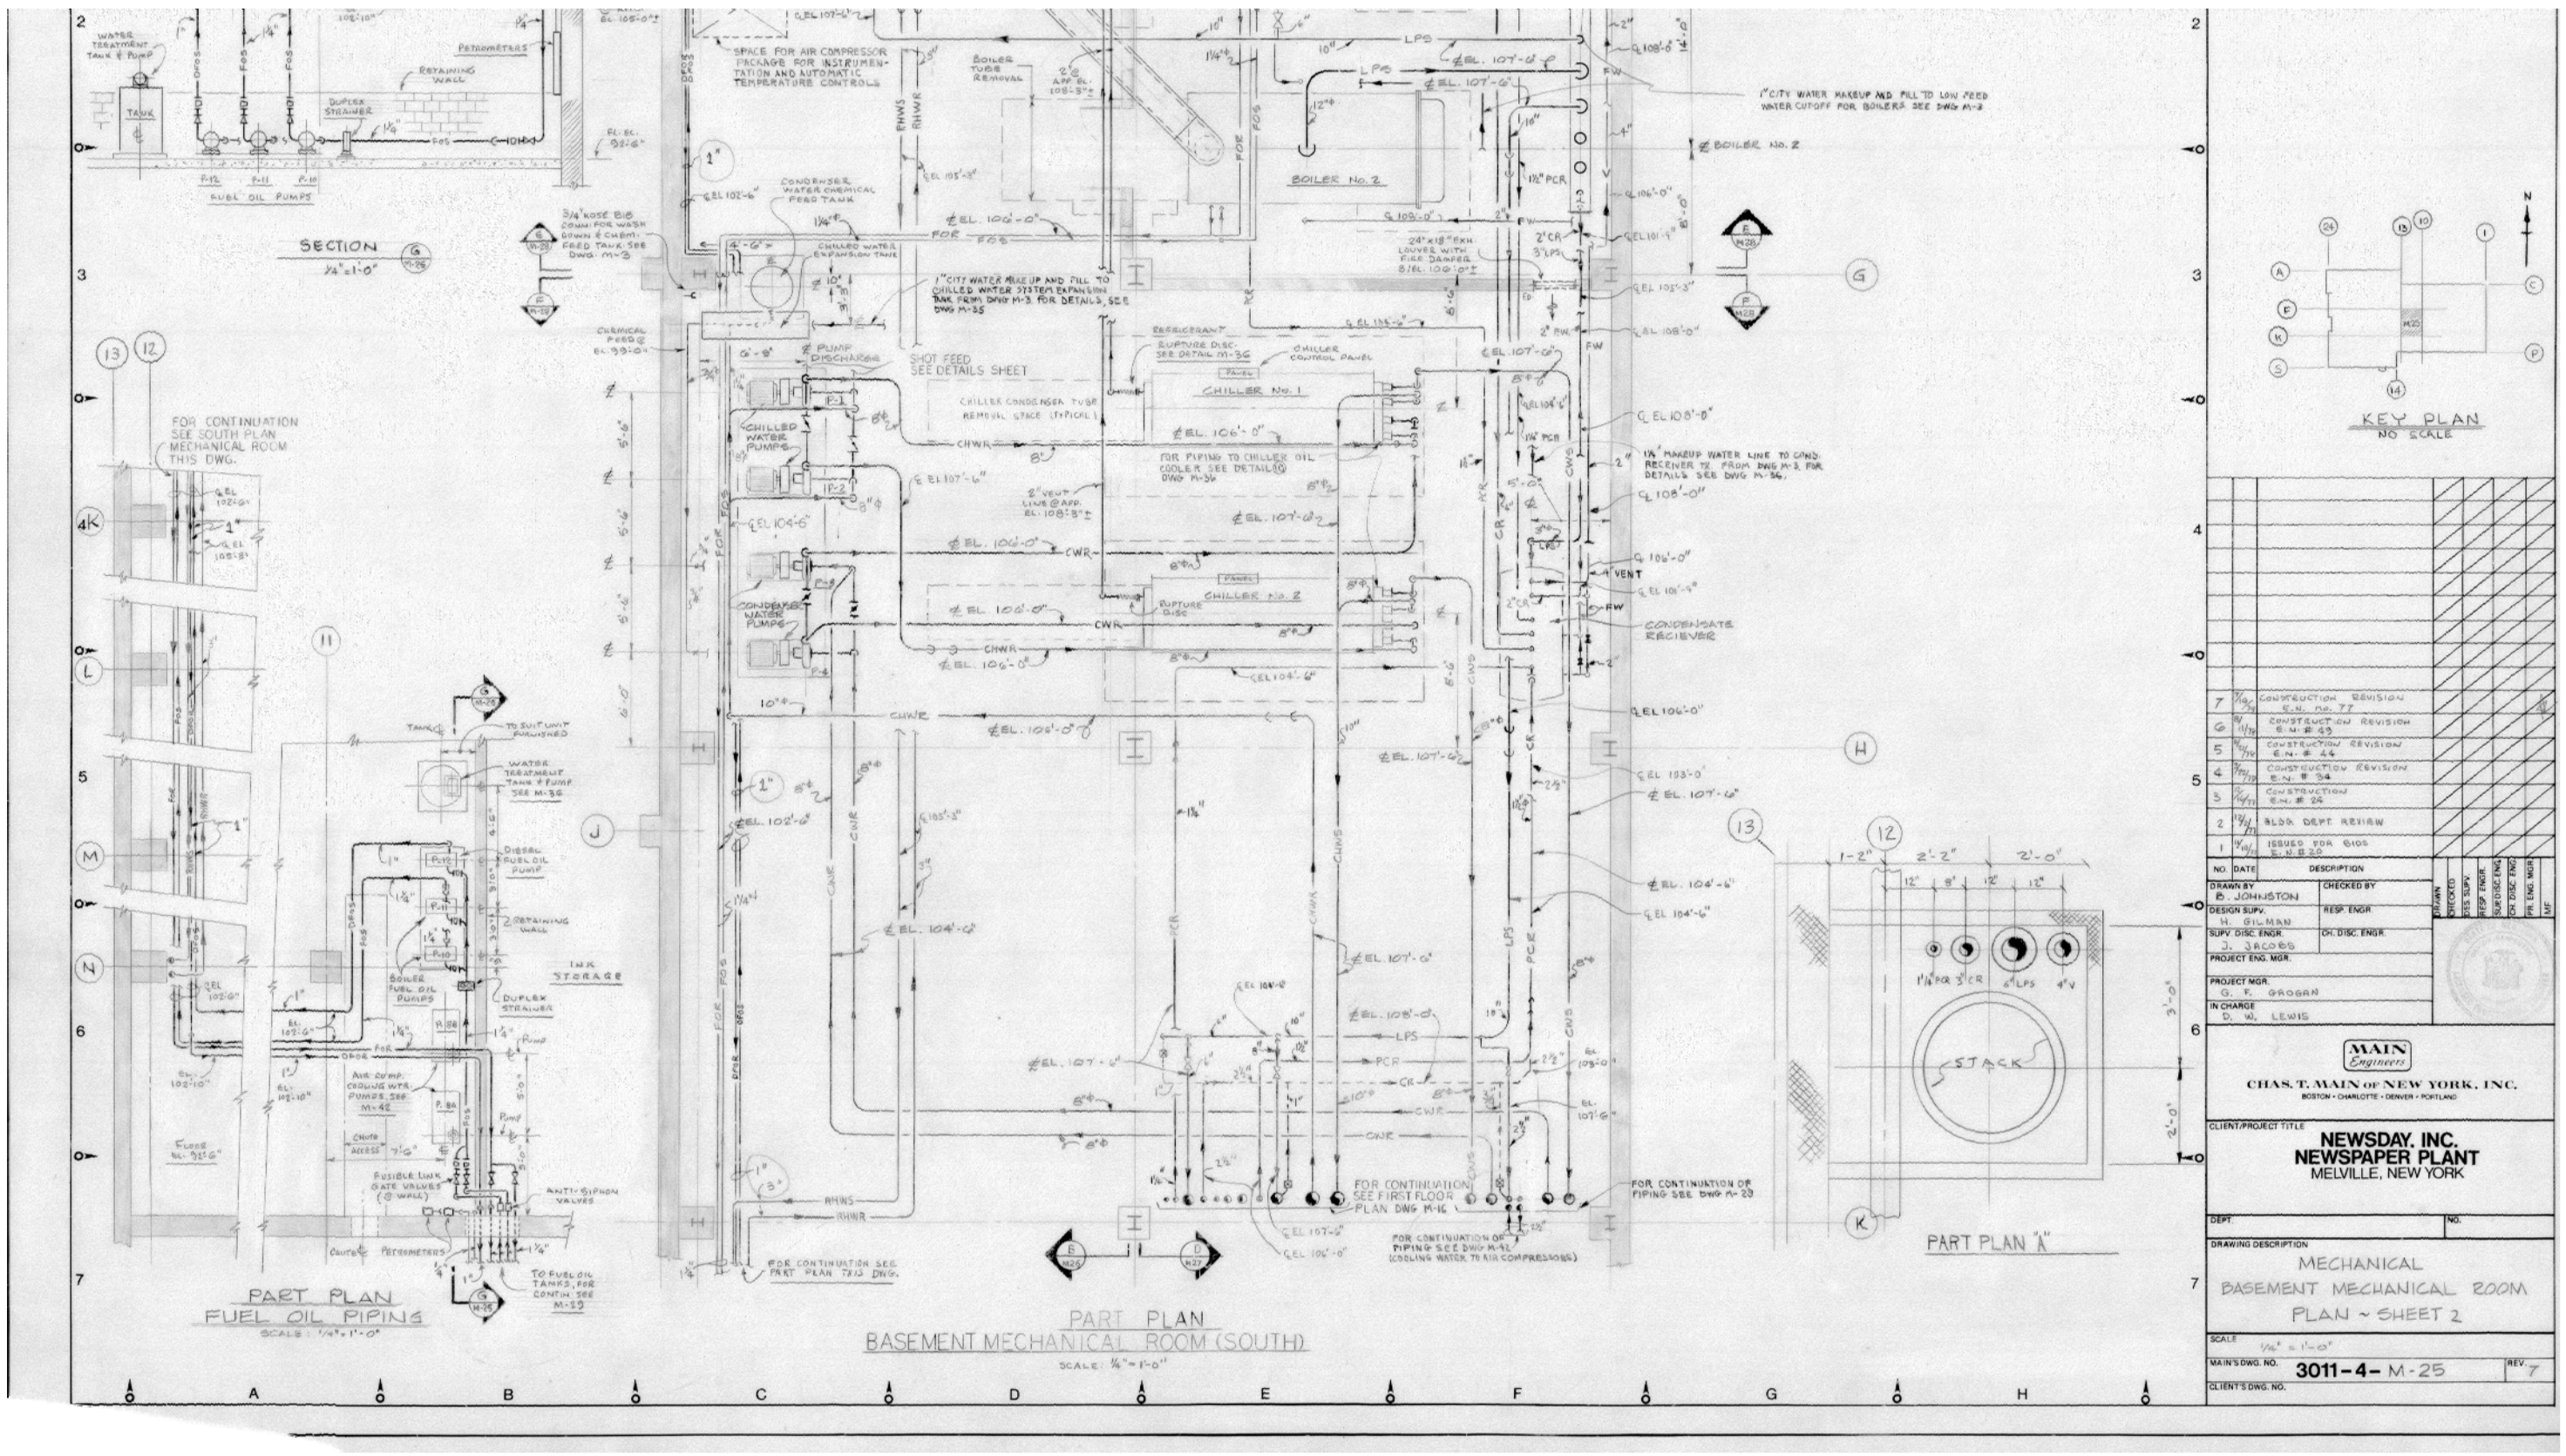
SHEET #
Figure 9

Ink waste is derived from the cleaning of the presses at the end of each day's press run. The waste is collected in pails and transferred to 55-gallon drums stored in the Ink Recovery Room. The location of the Ink Recovery Room on the second floor of the facility is shown in **Figure 9**. Closure of The Ink Recovery Room shall include decontamination and power washing of the floors, and collecting rinsate samples. Specific tasks include the following:

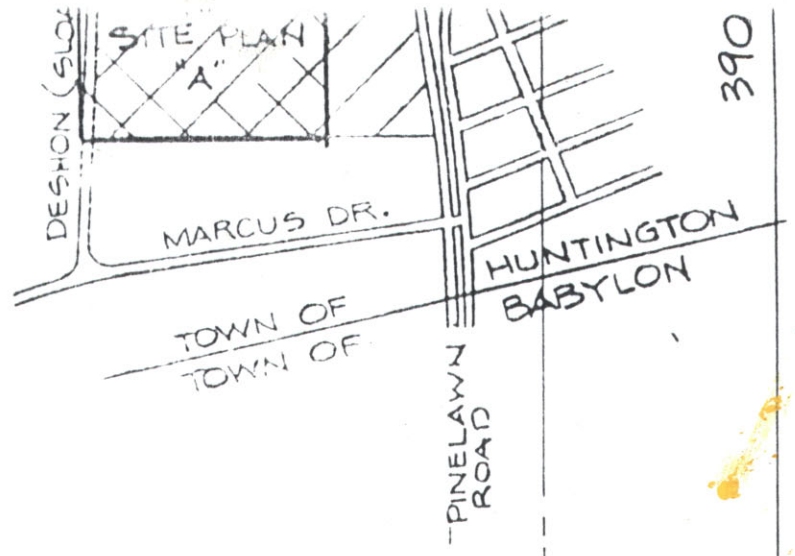
Date	Time	Inspection Narrative
11/10/00	1340	- RCAMPORA ON SITE.
		- MET W/ ABOVE REPS. REP.
		- DISCUSSED SITE & MADE FOLLOW-UP INSPECTION.
		- ALL DRAINS APPEAR SATISFACTORY EXCEPT FOR
		TWLB #117. ABSORBANT PADS STILL PRESENT
		IN DRAIN.
		- INSTRUCTED STEVE TO HAVE PADS REMOVED &
		FRESH ONES DEPLOYED. CONTINUE UNTIL CLEAN.
		- OTHER DRAINS APPEAR O.K.
		- STEVE PROVIDED DISPOSAL RECEIPTS.
		- WILL MAKE FOLLOW-UP NEXT WEEK.
	1355	- LEFT SITE.
11/14/00	1130	- RCAMPORA HAD TELECON W/ STEVE @ NEWSDAY.
		- TWLB #117 PUMP OF ALL LIQUID, &
		REMOVED APPROX 3 YDS OF BOTTOM SEDIMENTS.
		ALSO SAMPLED.
		- WILL RE-INSPECT THURSDAY TO CONFIRM.

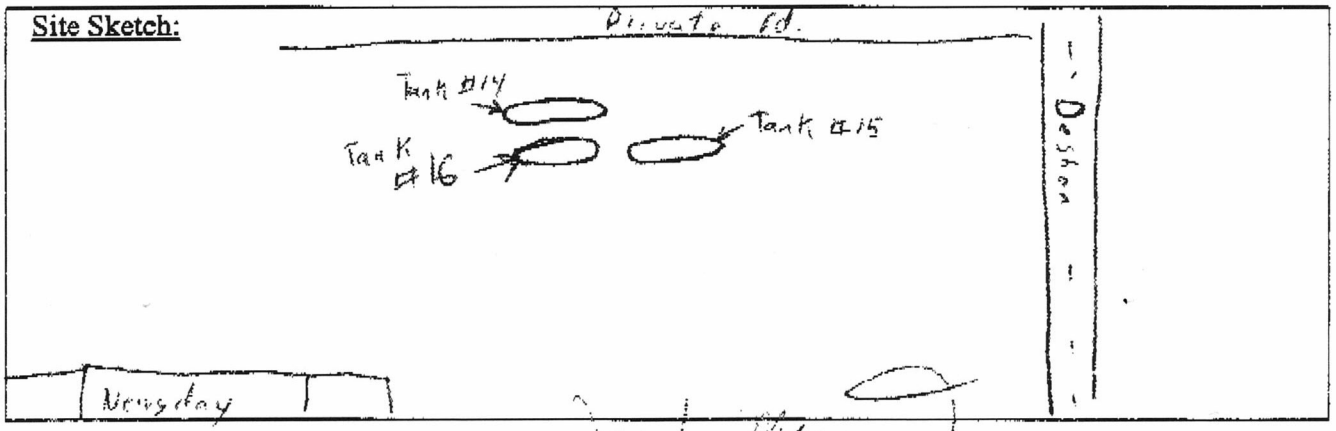
TANK #	LOCATION	CAPACITY	CONTENTS	MATERIAL
14	Underlout	20000 gal	Diesel	FRP
15	Underlout	20000 gal	Diesel	FRP
16	Underlout	20000 gal	Diesel	FRP

1. CONDITION OF TANK AND PIPING: (Note any holes) No holes or stains noted
Tanks appear to be in good condition.

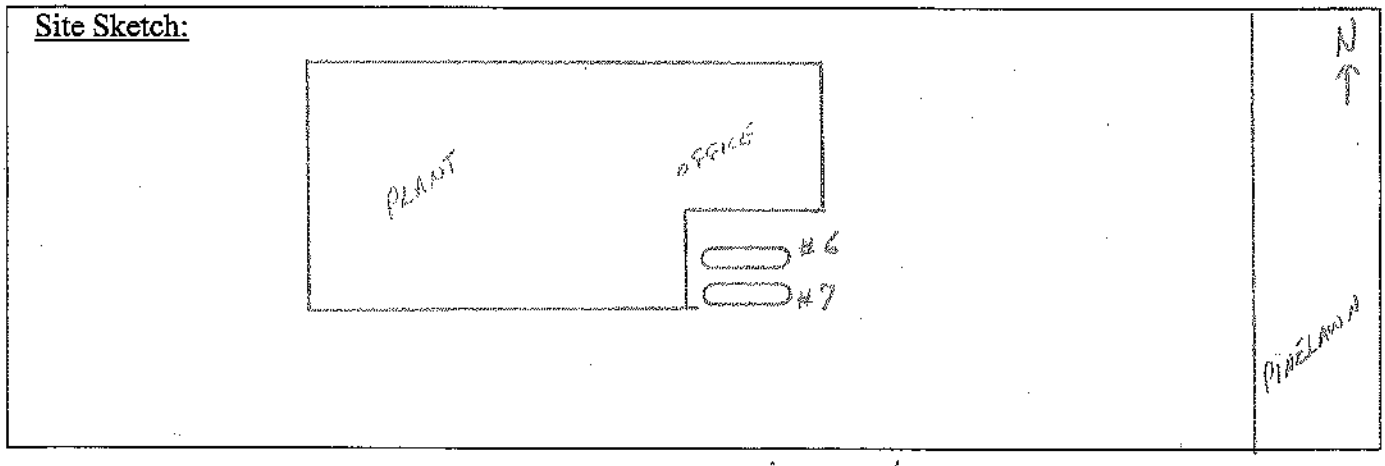
TANK #	LOCATION	CAPACITY	CONTENTS	MATERIAL
6	UPRIGHT	25000	#2 FUEL OIL	PLW STL
7	INSIDE OUT	25000	#2 FUEL OIL	PLW STL

1. CONDITION OF TANK AND PIPING: (Note any holes) CLEAN W/L LIQUIDS AND SLUDGES REMOVED

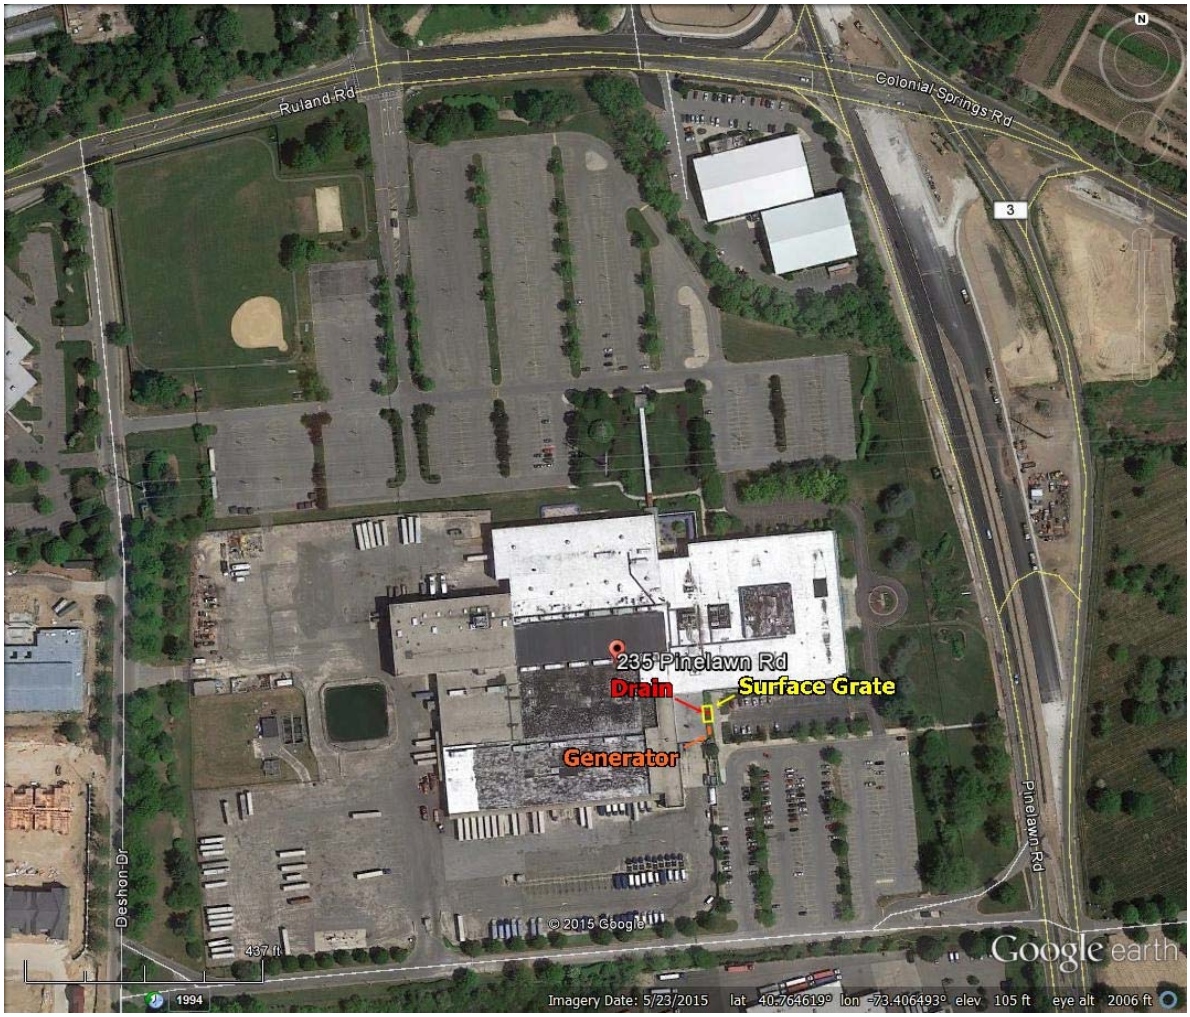
Date	Time	Narrative
12/2/15	1135	RJP on location. Release of 50-60 gallons of coolant from generator. Hose fitting failed during routine maintenance, system was powered down immediately. Impact to floor drain. Spill location is approx 15' below grade, and is open to air. Removable grates allow access of large equipment to mechanical room. Coolant is 50% concentration of MacGuard 2792 ethylene glycol mixture. SDS states water-miscible solution is biodegradable and has low ecotoxicity. No recoverable product remaining on location, liquid drained through sand base of floor drain. Surface spill was cleaned with absorbents. USGS DTW 42'. No DEC action, SDS and product information available on D2. RJP.
	1200	RJP off location.

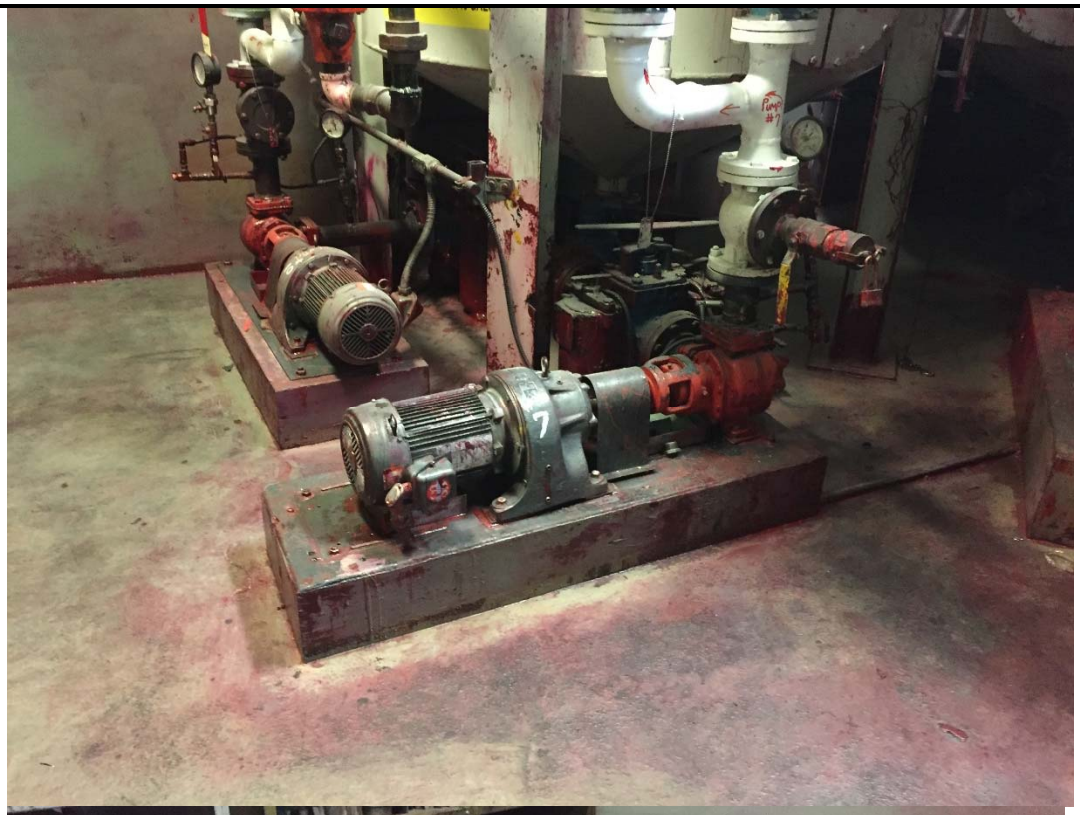
Robert Poczkalski, Joe Marino- Newsday		
Date	Time	Narrative
3/9/17	1045	RJP on location with Joe Marino of Newsday. Failure of valve on pump associated with 2000 gal holding tank, now repaired and back in operation. Release of non-toxic majenta ink to concrete containment. Room constructed to contain product, no drains or cracks. Material collected, filtered, and replaced into tank. No release of ink out of containment, no materials sent for disposal. No further Action. RJP off location. RJP.
	1115

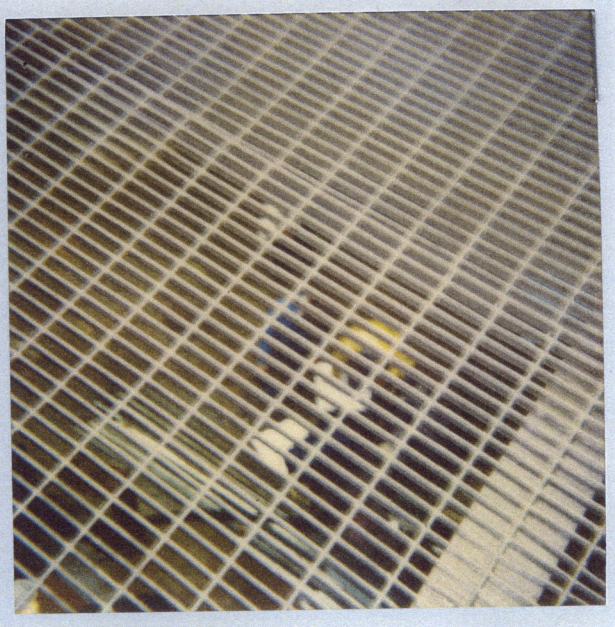
07/01/17 -10:00 Nh spoke with Joe Marino..operator failed to close valve causing waste water to spill out.. some went into dra which an individual drain. Drain was pumped out. NH will refer to water unit via e-mail.

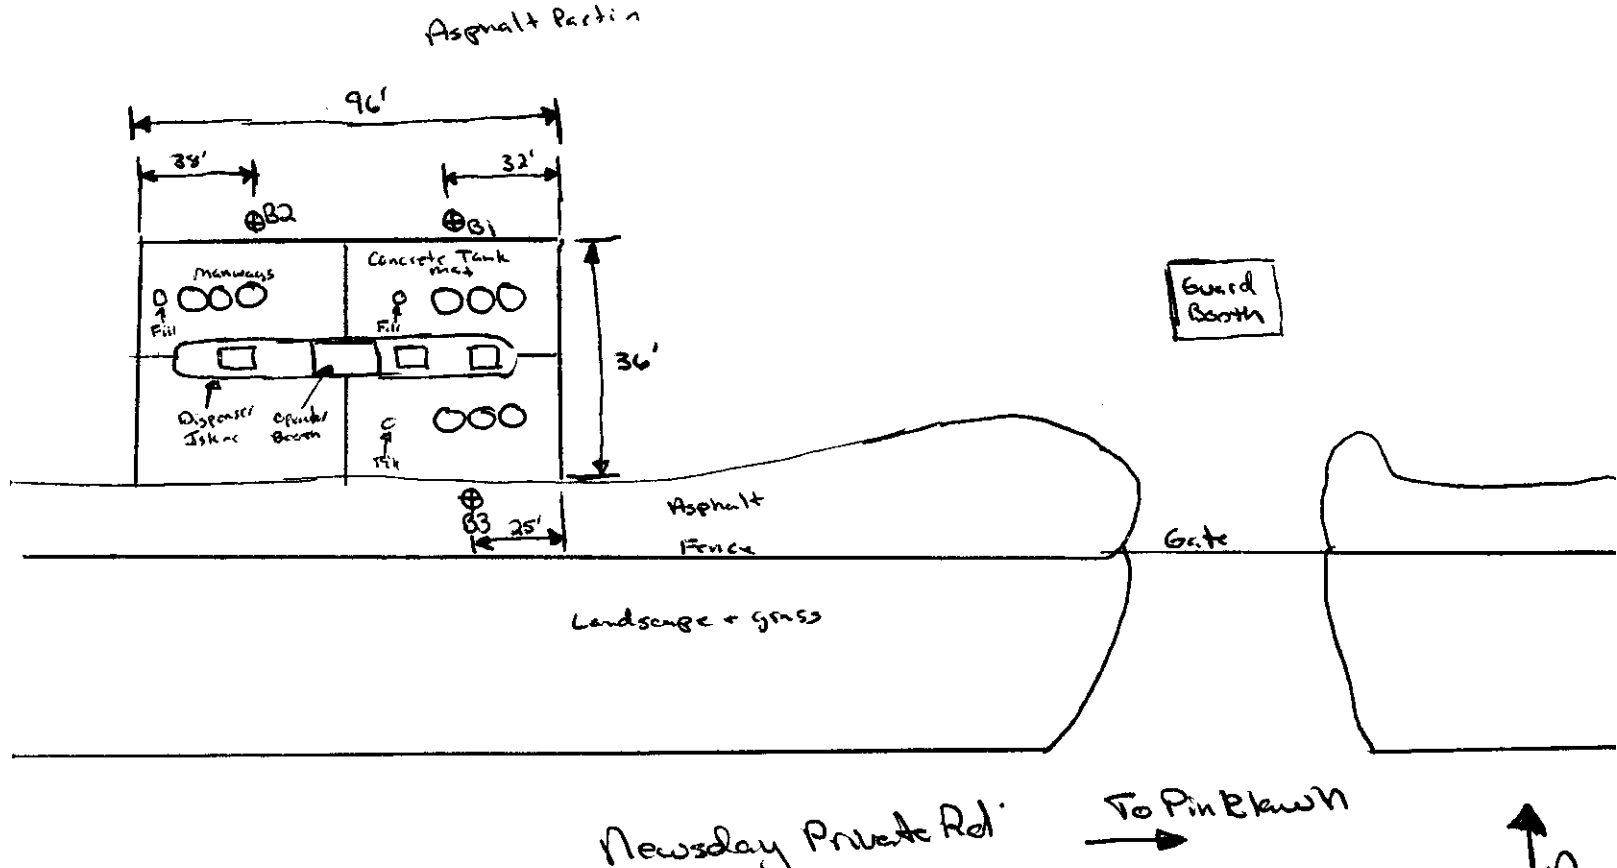
Newsday Bldg
Waste Water Treatment Facility
Leaching Pools
Fire Suppression Water storage

Asphalt Parking
96'
38'
32'
B2
B1
Manways
Concrete Tank
Fill
Fill
36'
Dispenser Island
Operator Booth
Fill
B3
25'
Asphalt
Fence
Gate
Guard Booth
Landscape + grass
Newsday Private Rd.
To Pinelawn
To Deer Park Rd
N
MSD 6/26/98

The results of the soil borings indicate that the soils in the immediate vicinity of the underground storage tanks has not been impacted by the petroleum-contaminated soil identified on top of the underground storage tanks. Furthermore, the results of soil boring B-01 indicate that the petroleum-contaminated soil has not impacted the ground water beneath the site.
