Elton Crossing (Melrose C - Family)
432 East 162nd Street (899 Elton Avenue)
BRONX, NEW YORK

Periodic Review Report

NYSDEC Brownfield Cleanup Program Site Number: C203073
AKRF Project Number: 11901

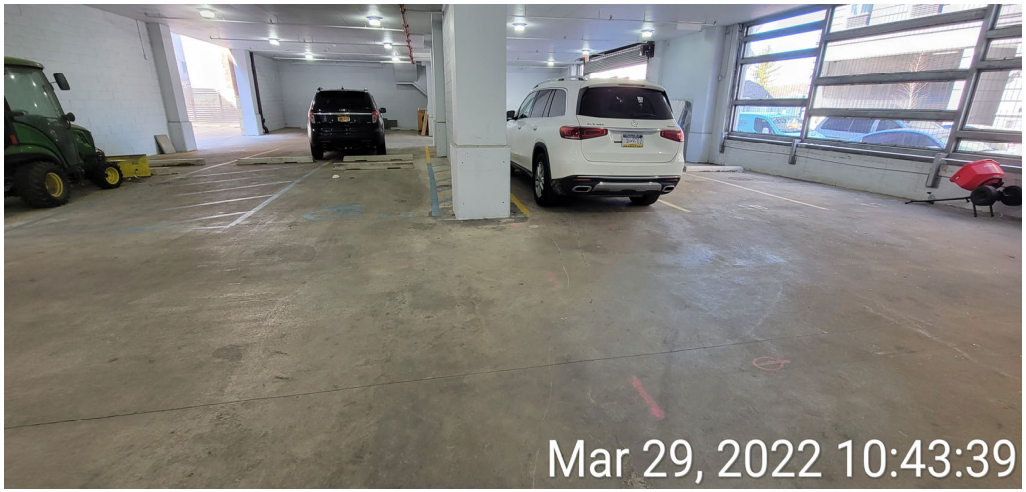
NO UNUSUAL CONDITIONS WERE OBSERVED. NO CORRECTIVE ACTIONS ARE RECOMMENDED.

Photograph 1: Ground floor parking area on the southwestern portion of the Site.

Photograph 2: Parking area on the west-central portion of the Site, facing north.

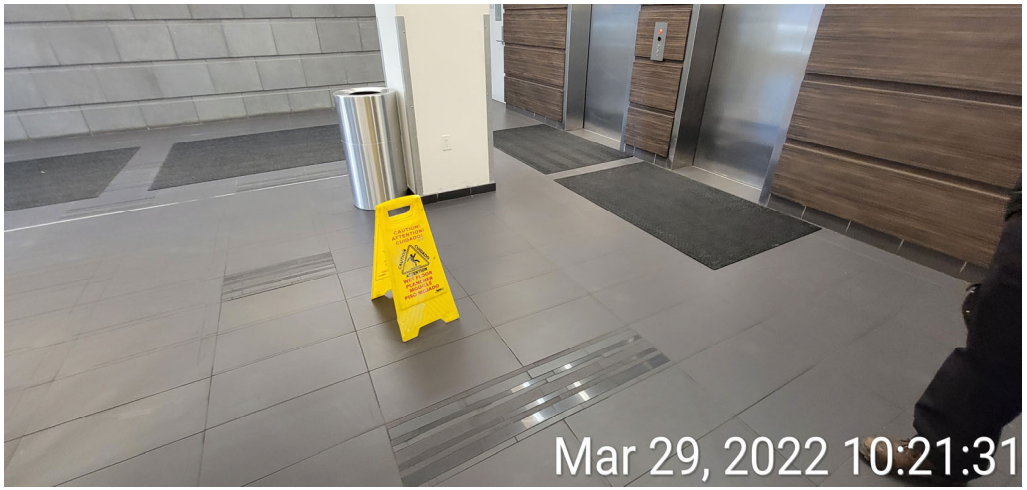
Photograph 7: Ground-level building lobby on the northeastern portion of the Site.

Photograph 8: Typical partial cellar slab in the cellar-level electric room.
