ASTM PHASE I ENVIRONMENTAL SITE ASSESSMENT
101 EAST KINGSBRIDGE ROAD
BRONX, NEW YORK

by
H & A of New York Engineering and Geology, LLP
New York, New York

File No. 213081
May 2025

Subject: ASTM Phase I Environmental Site Assessment
101 E. Kingsbridge Road, Bronx Development
Bronx, New York

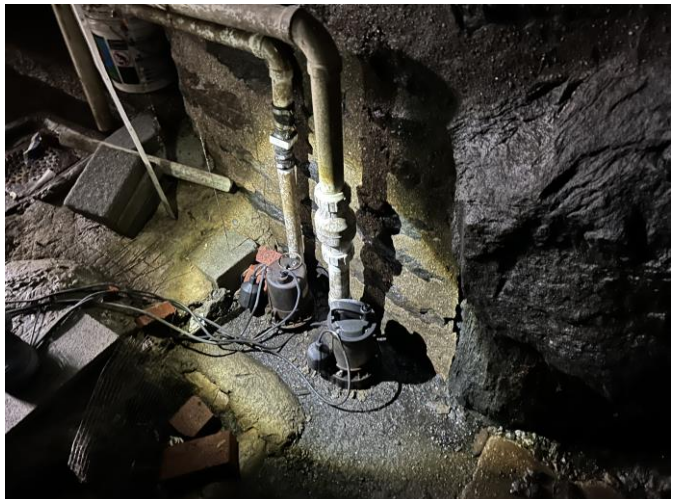
Photo 11: View of standing water in a hole in the partial cellar slab and sump pump, facing east.

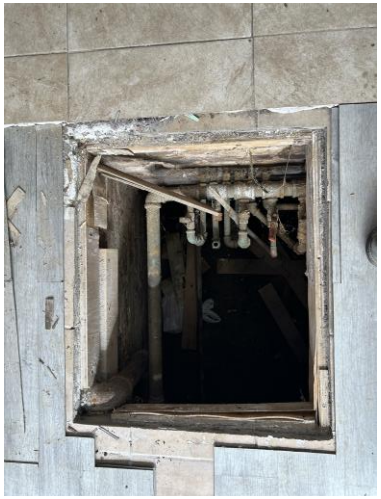
Photo 15: View of pipes in a sub-slab access hatch space, facing east.
