388 Bridge Street
Brooklyn, New York

NYSDEC BCP Site No. C224134

ANNUAL PERIODIC REVIEW REPORT AND ENGINEERING CERTIFICATION

FEBRUARY 2021

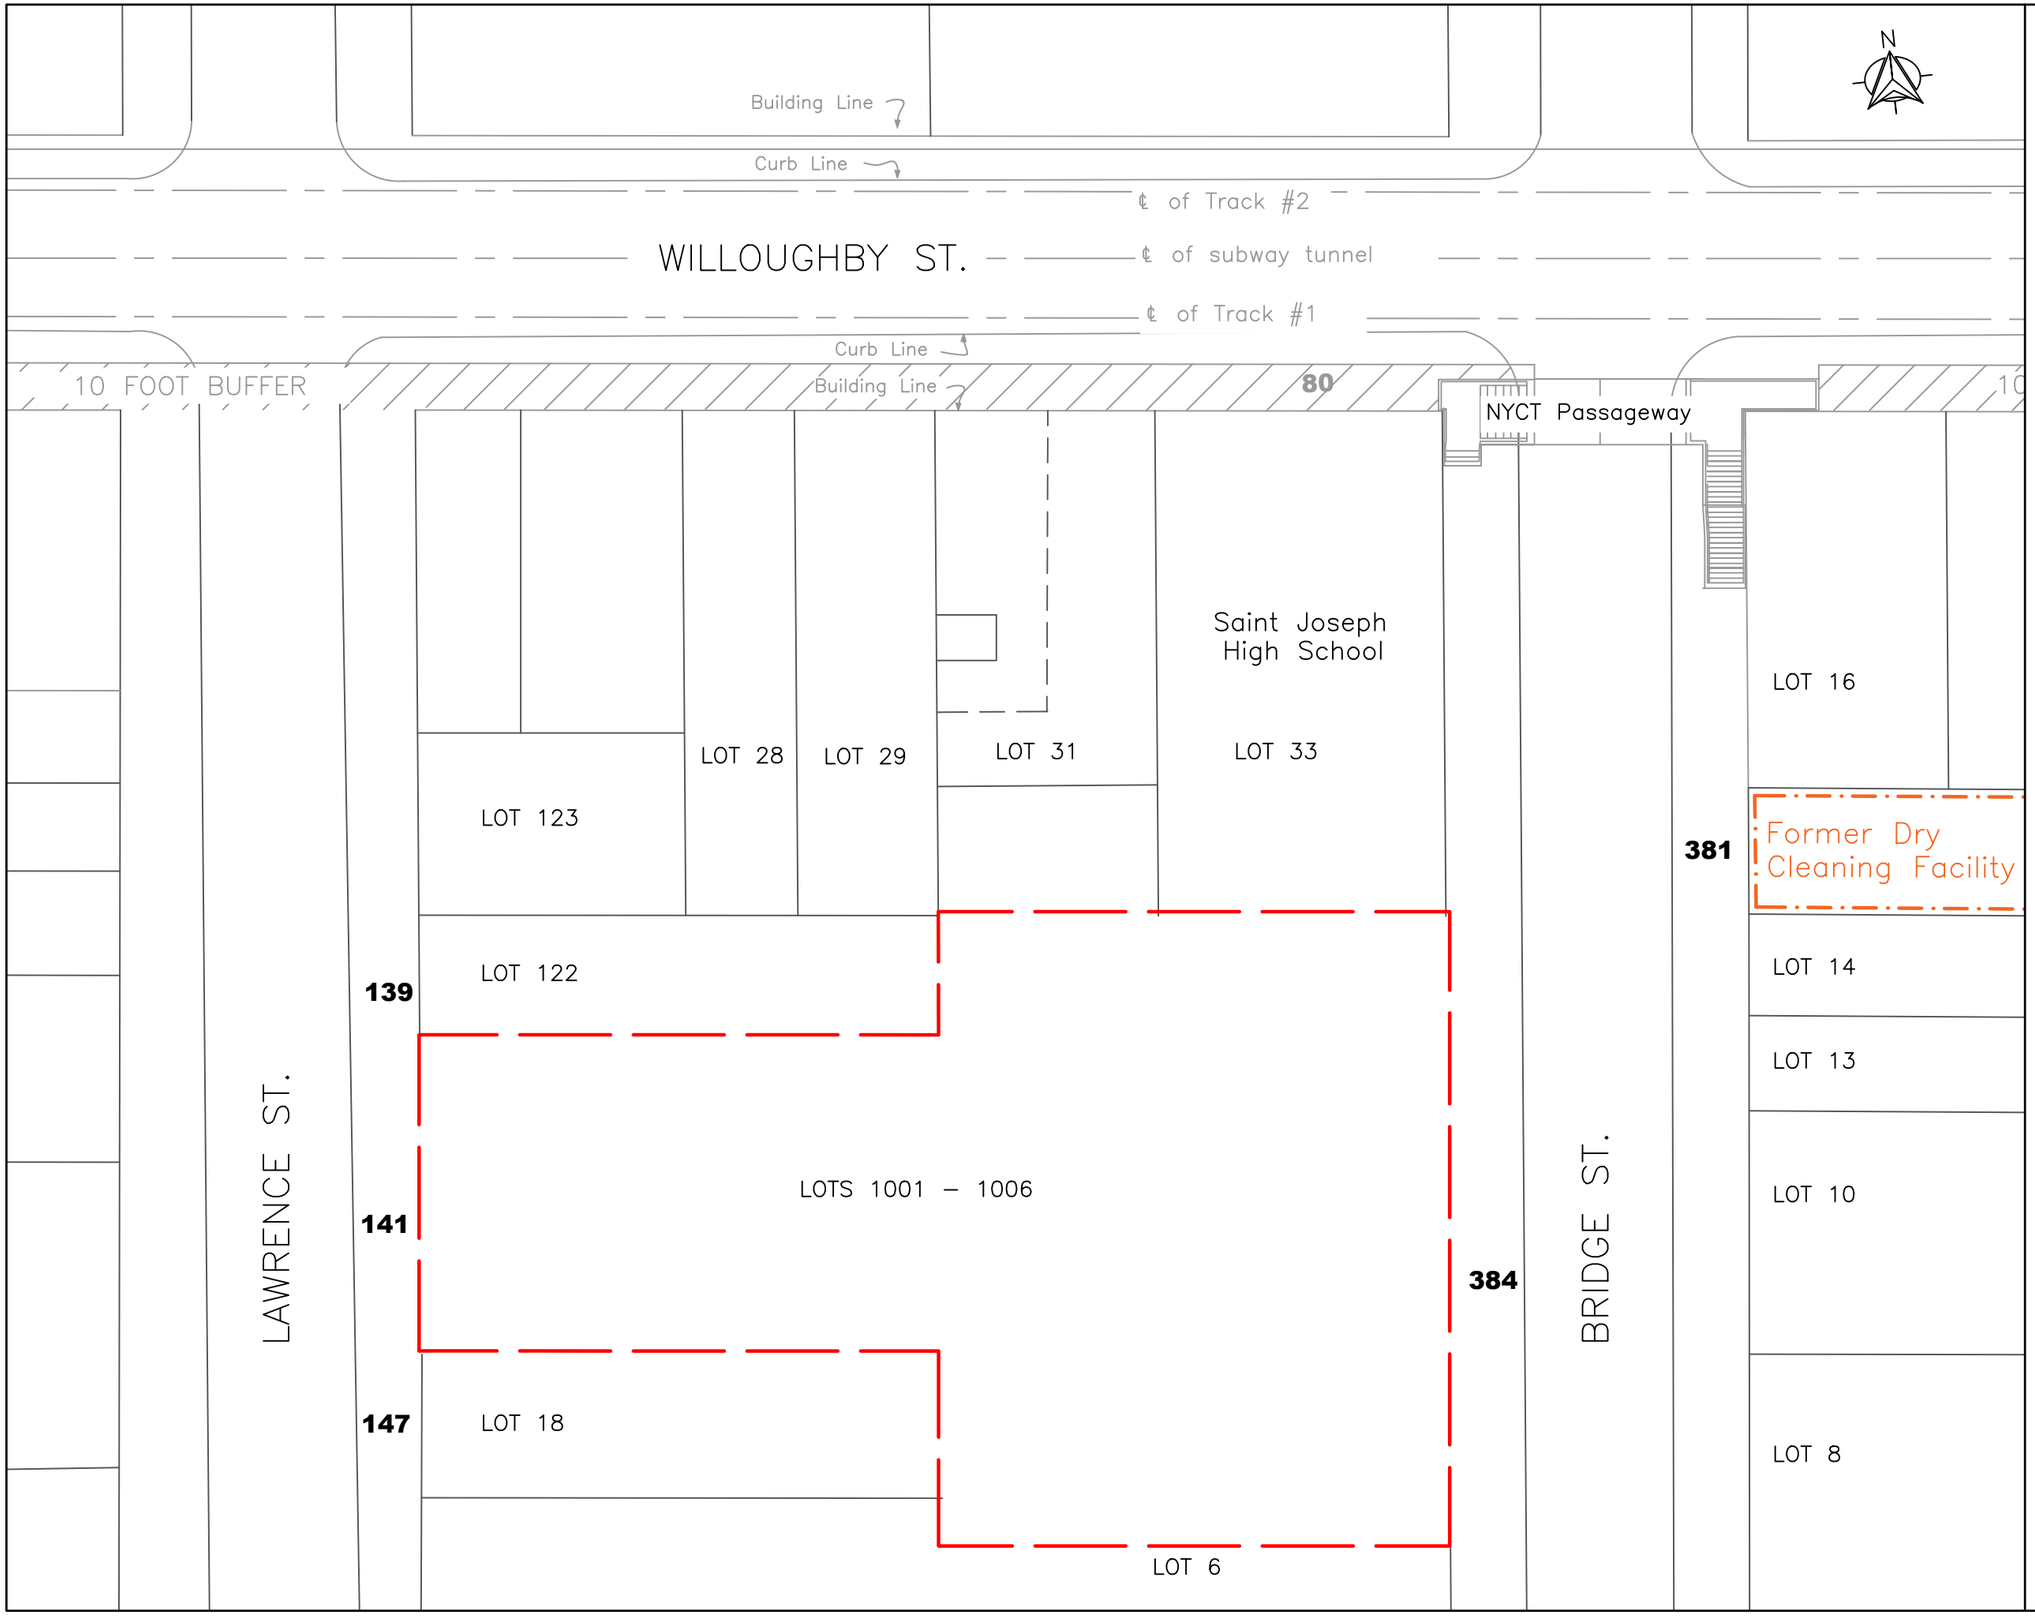
Figure 2

The development on the Site includes the 53-story residential building with retail spaces on the ground floors and parking from the sub cellar to the 3rd floor of the building. Overall building construction on the Site has been completed since the 2017 PRR submittal. The development footprint is a lot line-to-lot line building as shown in Figure 2.

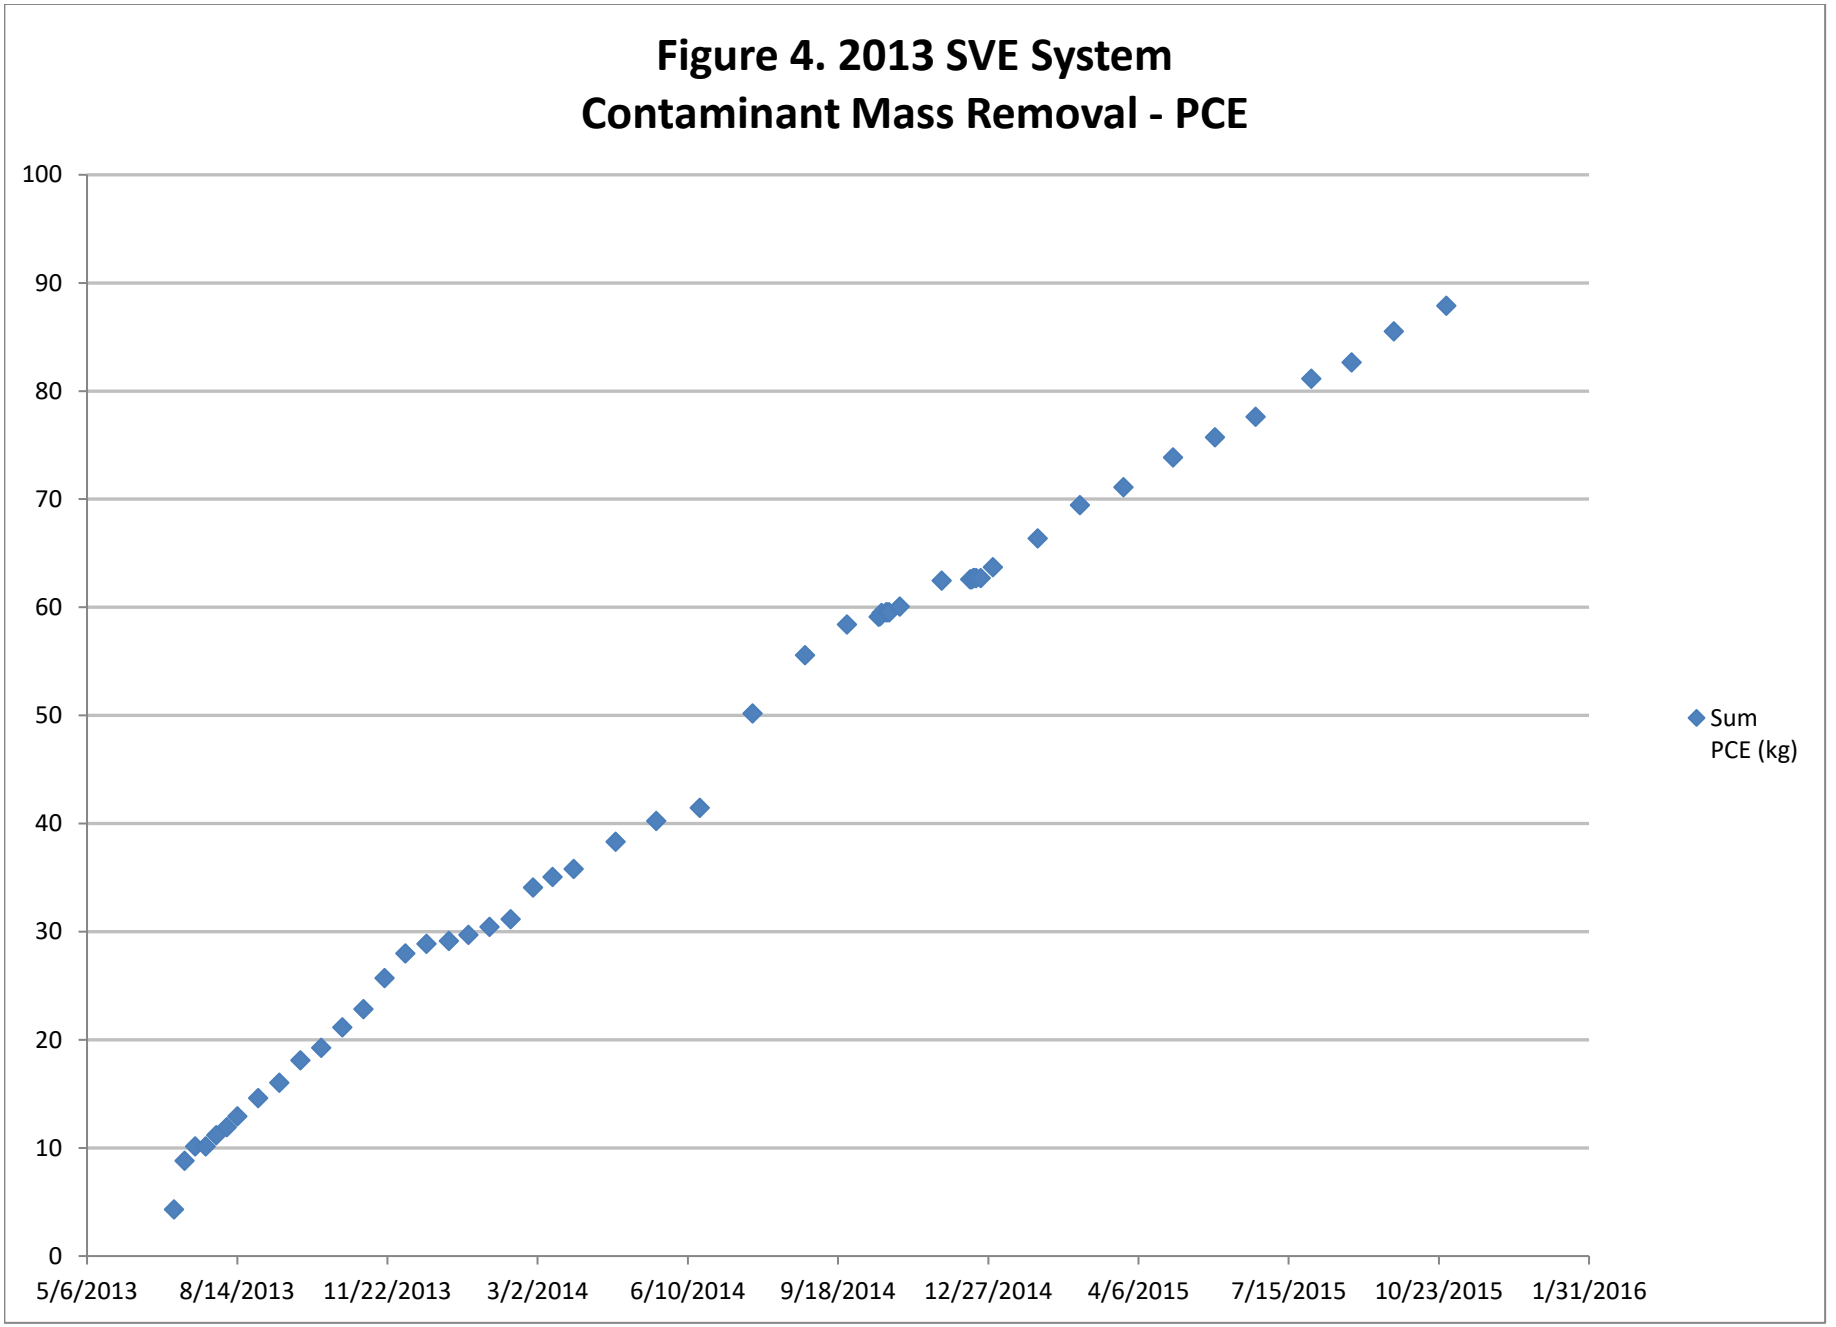
Figure 4. 2013 SVE System
Contaminant Mass Removal - PCE

- Overall, the system installed in 2013 effectively removed 87.88 kg of PCE and 0.30 kg of TCE from June 2013 through October 2016. Graphs showing the cumulative mass removal for PCE and TCE are presented in Figure 4 and 5, respectively.

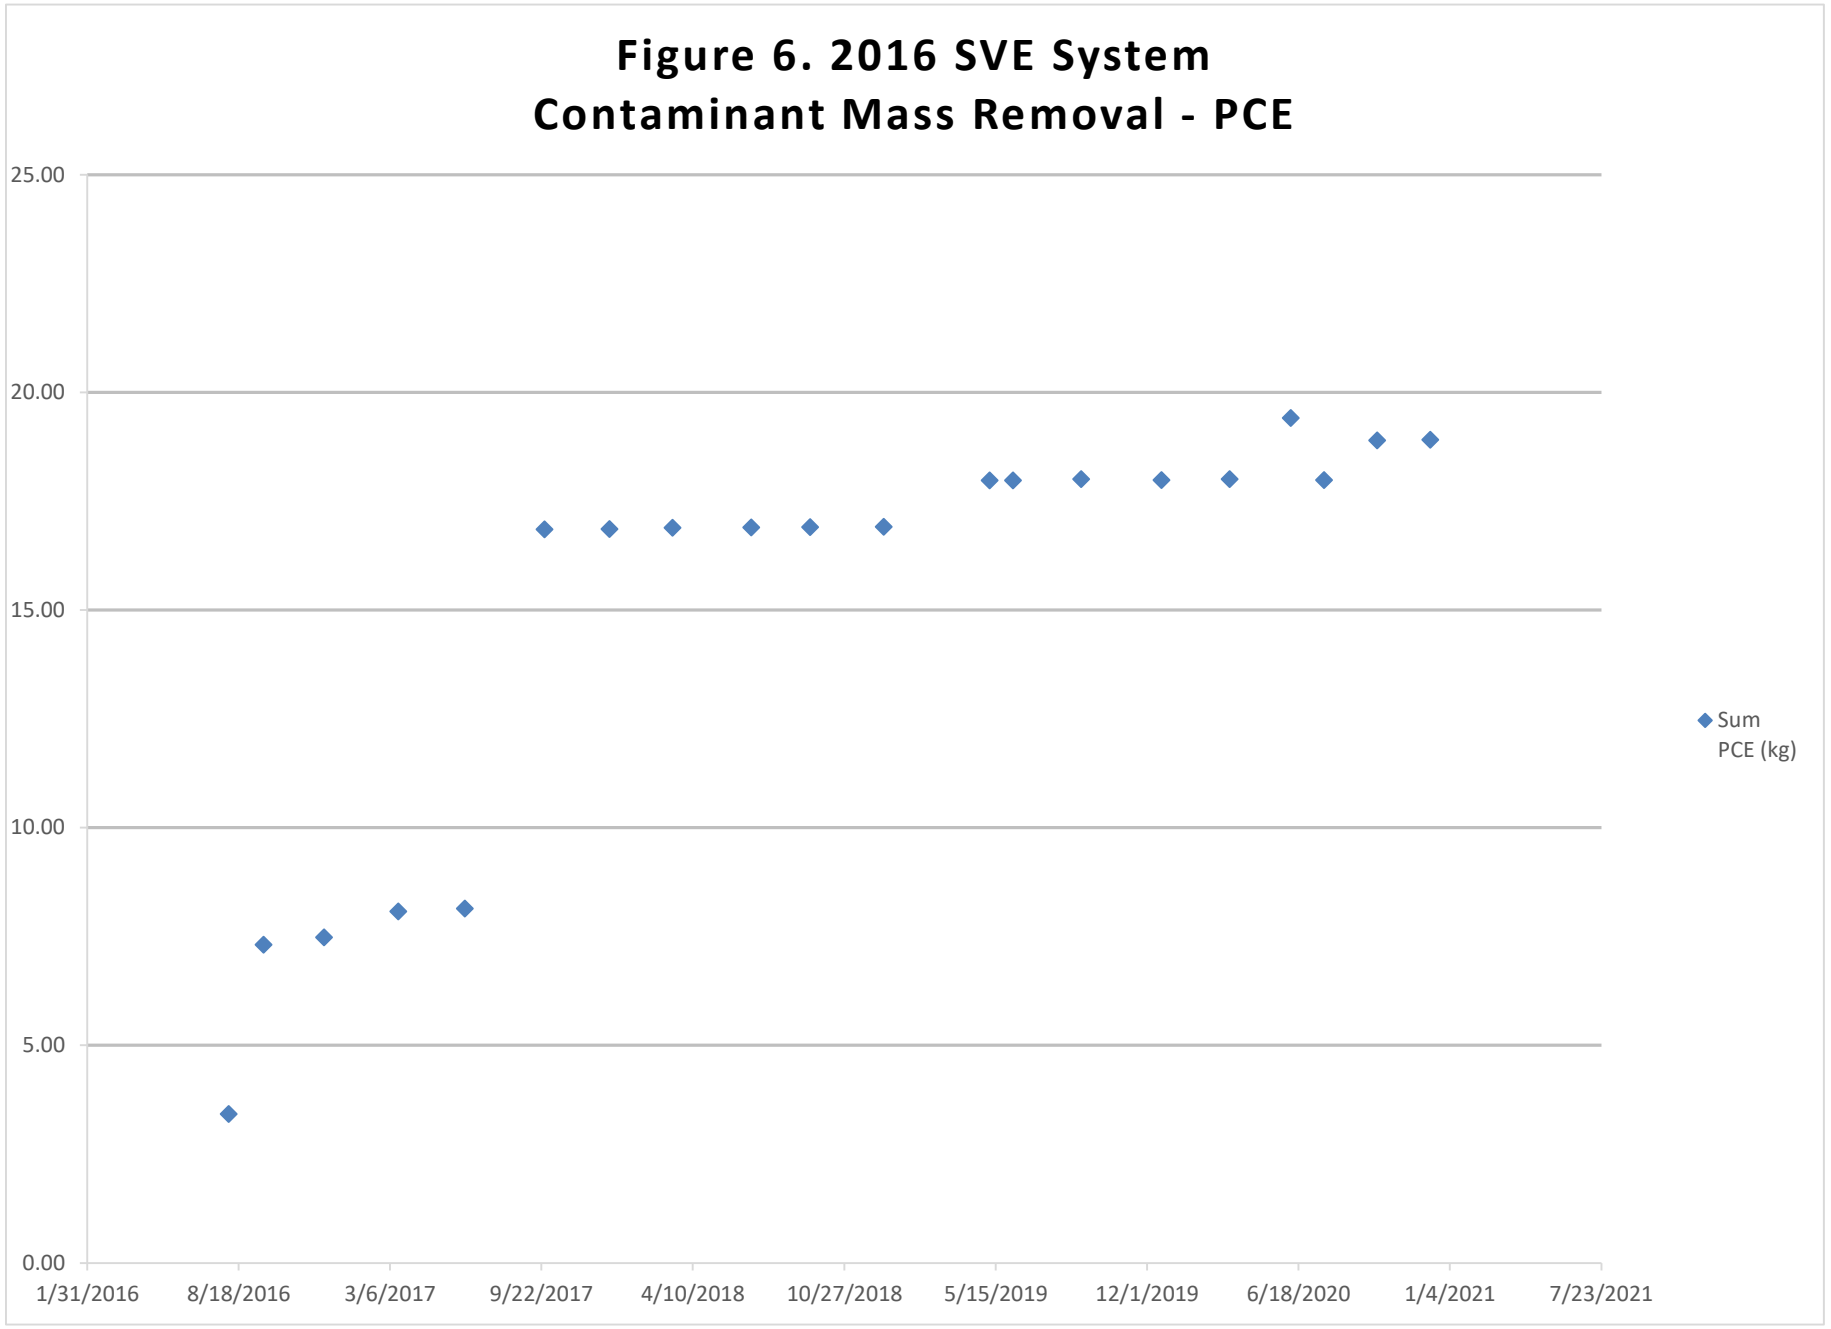
Figure 6. 2016 SVE System
Contaminant Mass Removal - PCE

- As of the date of the last SVE sampling event, December 9, 2020, the modified SVE system has removed a total of 21.24 kg of PCE and 0.10 kg of TCE since 2016 (Figure 6 and 7).

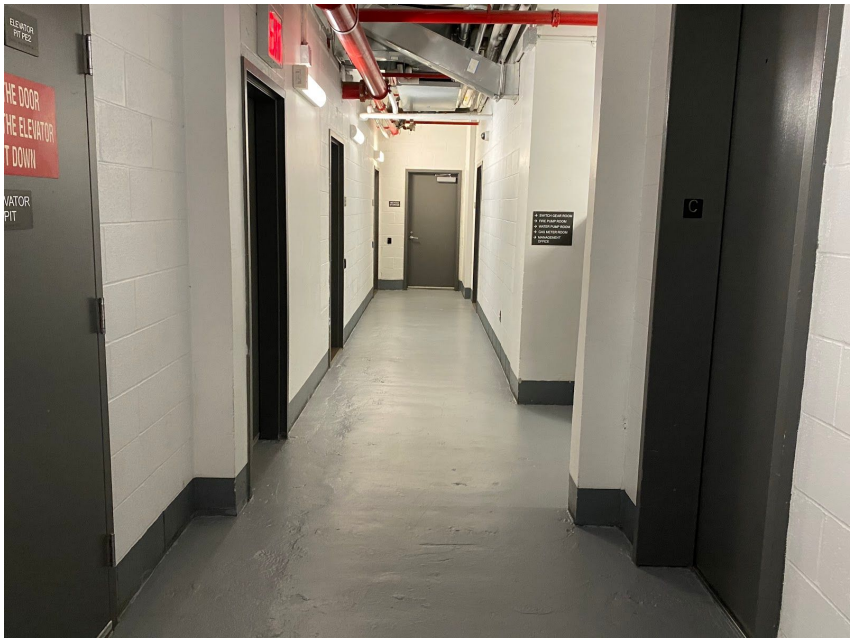
Photo 1: Cellar Hallway Slab (facing north).

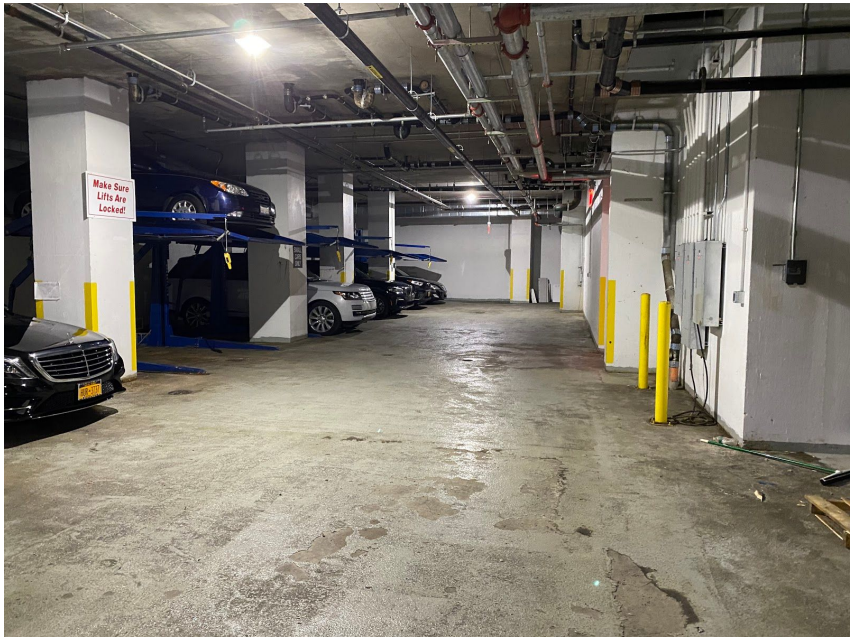
Photo 3: Sub-cellar slab (facing east).

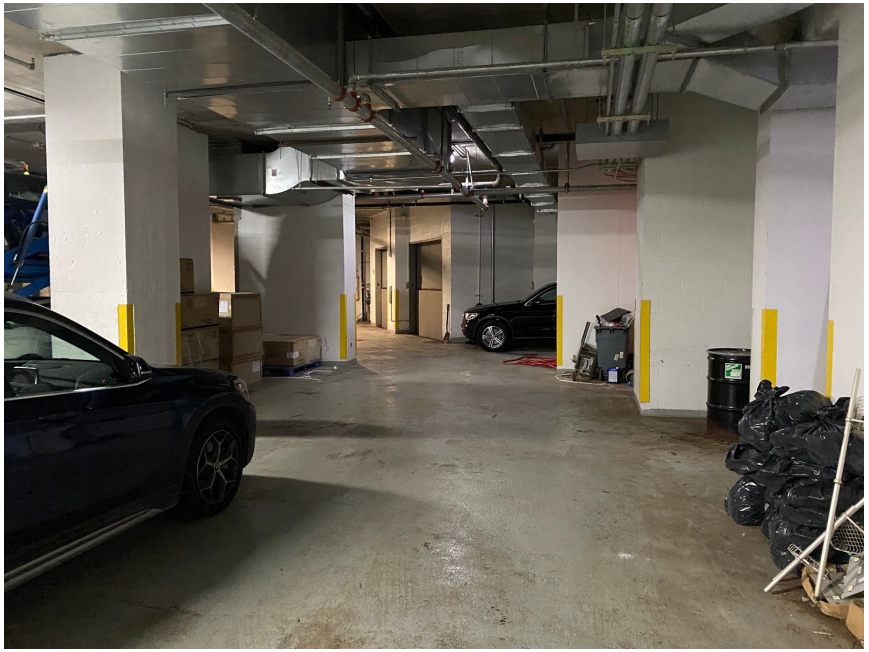
Photo 4: Sub-cellar slab (facing west).

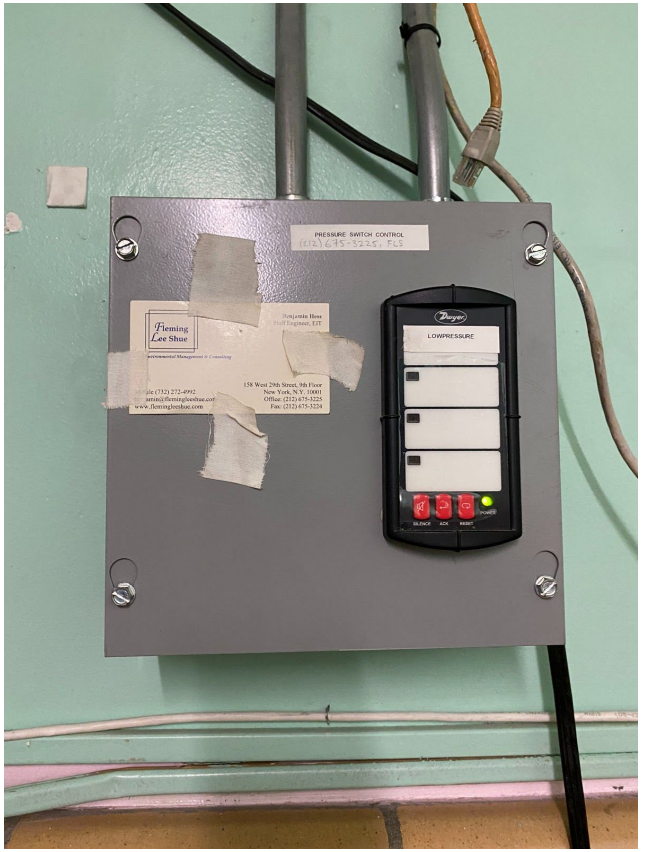
Photo 8: SJHS telemetry box.

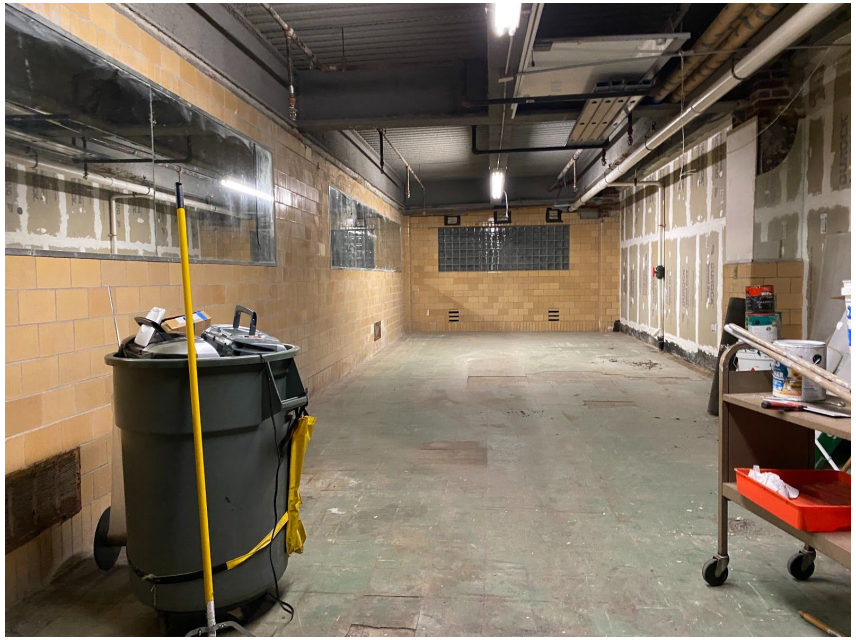
Photo 12: SJHS basement slab in storage area (facing south).
