DAILY ACTIVITIES REPORT

PROJECT: Site No.C224260A Former El Puente
CONTRACTOR:
AECOM JOB No.: 60754071
AECOM PROJECT MANAGER: C. Friedman
EPA SITE ID NO.: NYR000280818
LAB CALL OUT ID NO.: 153290

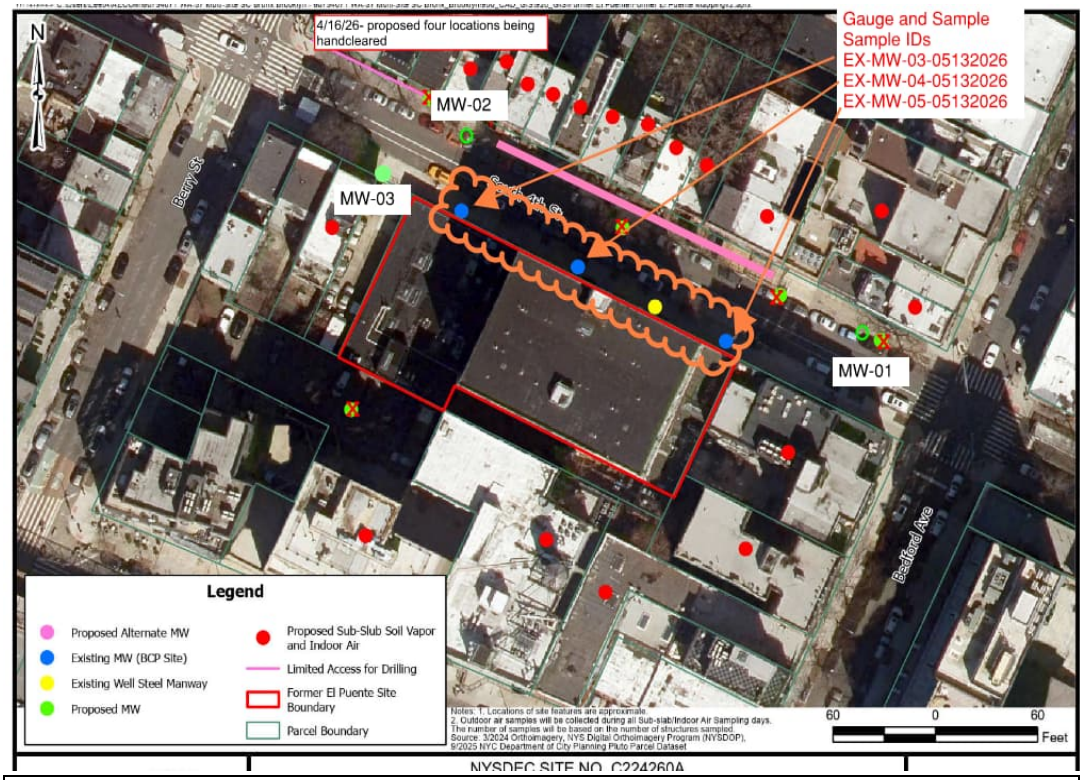
Set up for EX-MW-05-20260514
