LANGAN SITE OBSERVATION REPORT – Pile Installation Oversight – Day 09

PROJECT No.:	170390001	**CLIENT:**		**DATE:**	Tuesday, 19 September 2023
PROJECT:	141 3rd Street		Third Street Owner LLC and 155 Third St., LLC	**WEATHER:**	Sunny, 59-75 ^{0}F Wind: W @ 1-4.5 mph
LOCATION:	Brooklyn, New York			**TIME:**	7:00 a.m. – 3:30 p.m.
BCP SITE ID:	C224336

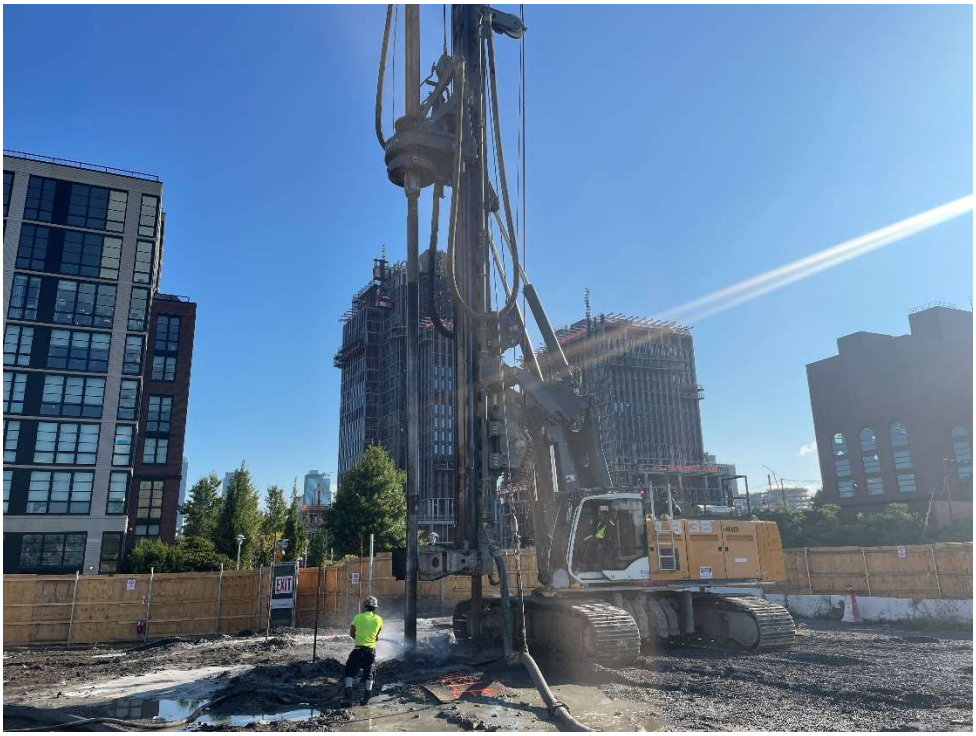
Photo 1: New Leaf advancing a displacement pile to the southeast of pile cap 13 (facing northeast).
