LANGAN SITE OBSERVATION REPORT – Pile Installation Oversight – Day 15

PROJECT No.:	170390001	**CLIENT:**	Third Street Owner LLC and 155 Third St., LLC	**DATE:**	Monday, 2 October 2023
PROJECT:	141 3rd Street			**WEATHER:**	Sunny, 63-78 ^{0}F Wind: SE @ 0.6–2.3 mph
LOCATION:	Brooklyn, New York			**TIME:**	6:30 a.m. – 9:30 a.m.
BCP SITE ID:	C224336

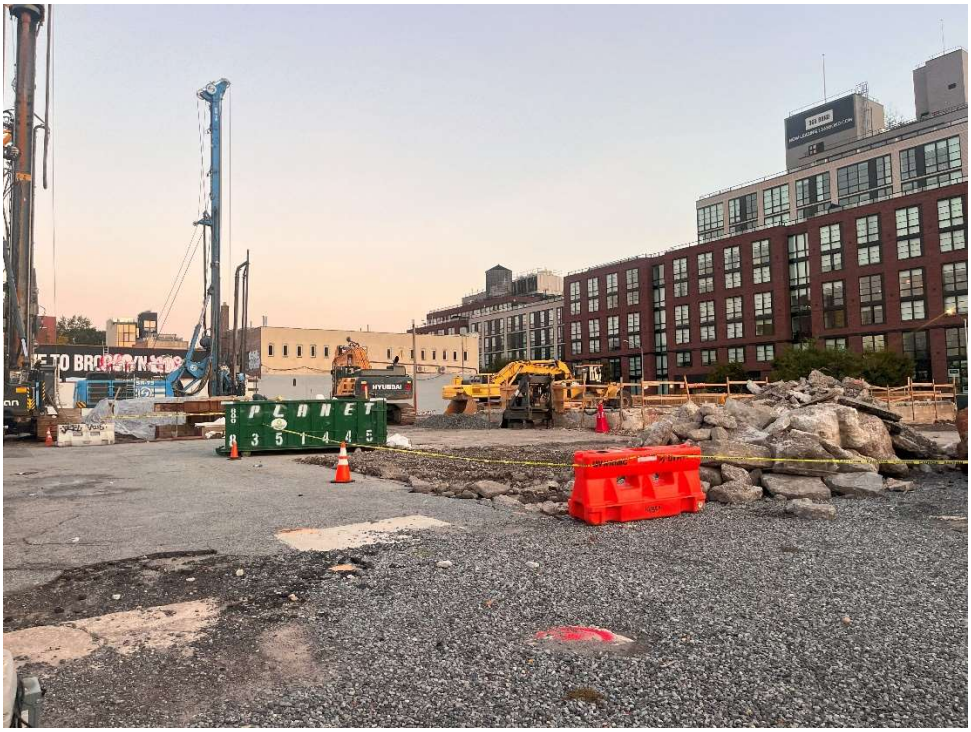
Photo 1: New Leaf preparing to cover the fill stockpile with poly sheeting in the central-southwest part of the site (facing north).
