SITE OBSERVATION REPORT – RAWP Implementation – Day 42

PROJECT No.:	170390001	**CLIENT:**		**DATE:**	Monday, March 17, 2025
PROJECT:	141 3rd Street			**WEATHER:**	Sunny, 48-54 ^{0}F Wind: ENE @ 0.2 – 7.8 mph
LOCATION:	Brooklyn, New York		Third Street Owner LLC and 155 Third St., LLC	**TIME:**	7:00 a.m. – 3:45 p.m.
BCP SITE ID:	C224336			**MONITOR:**	Adam R. Spaulding, Savannah Walters

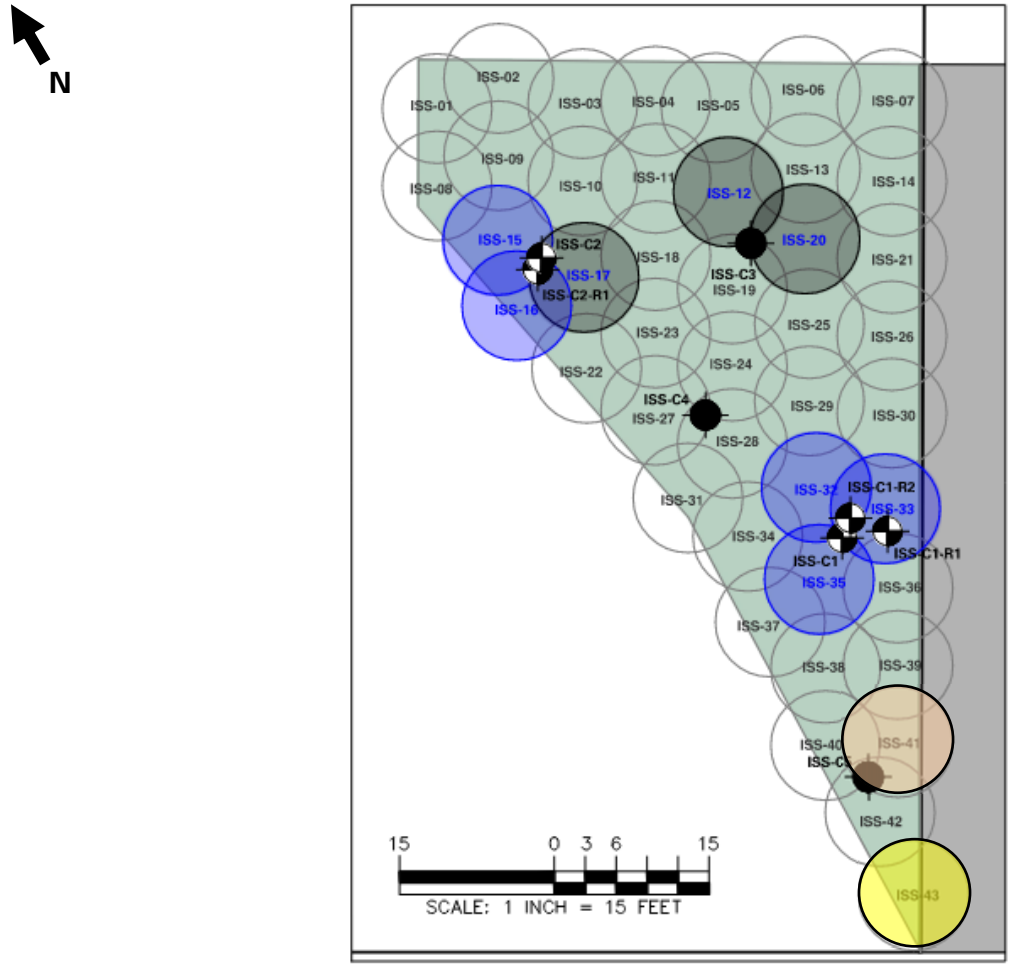
FIGURE 3 - ISS PROGRESS MAP:

- New Leaf began ISS implementation and mixed column ISS-43 to about 31 feet bgs (elevation [el] -26.5±). Generated grout spoils were staged in the eastern/central part of the site on polyethylene sheeting at the end of the workday and sprayed with Atmos® AC-645 odor/vapor suppressing foam.

ISS-43	35.19, 230.66	10.6	2	-26.5±	382	8.1*	781.47*	8*	45*	14*	0.26*	No

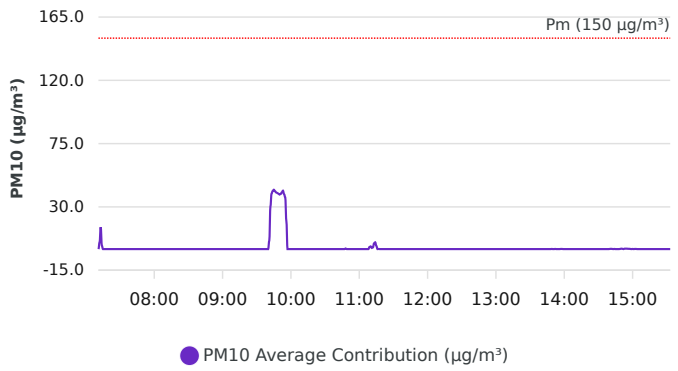
PM10 Average Contribution (µg/m³)

- Langan performed continuous air monitoring for volatile organic compounds (VOC) and particulate matter smaller than 10 microns in diameter (PM10) using two perimeter air monitoring stations at upwind and downwind locations. The PM10 and VOC action levels were not exceeded during the monitoring period. Recorded air monitoring data is presented on CAMP summary data sheet appended to the end of this Daily Field Report.

Daily Monitoring Summary	PM10 (µg/m³)	Time	VOC (ppm)	Time
Min Contribution (15 min avg.) - 3/17/2025	0.0	07:11	0.00	07:14
Max Contribution (15 min avg.) - 3/17/2025	42.2	09:45	0.01	14:16
