SITE OBSERVATION REPORT – RAWP Implementation – Day 44

PROJECT No.:	170390001	**CLIENT:**		**DATE:**	Wednesday, March 19, 2025
PROJECT:	141 3rd Street			**WEATHER:**	Sunny, 39-57 ^{0}F Wind: ENE @ 0.4 – 3.6 mph
LOCATION:	Brooklyn, New York		Third Street Owner LLC and 155 Third St., LLC	**TIME:**	7:00 a.m. – 3:30 p.m.
BCP SITE ID:	C224336			**MONITOR:**	Savannah Walters

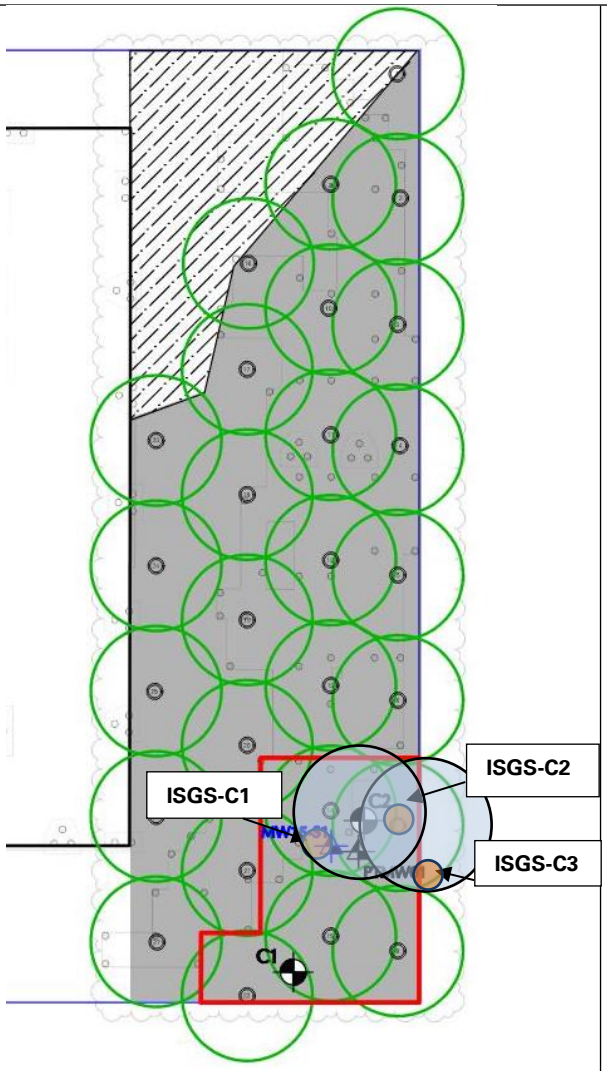
FIGURE 2 - ISGS PROGRESS MAP

- ISGS injection point completed today
- ISGS injection point previously completed
- Core location completed today
- Core location previously completed

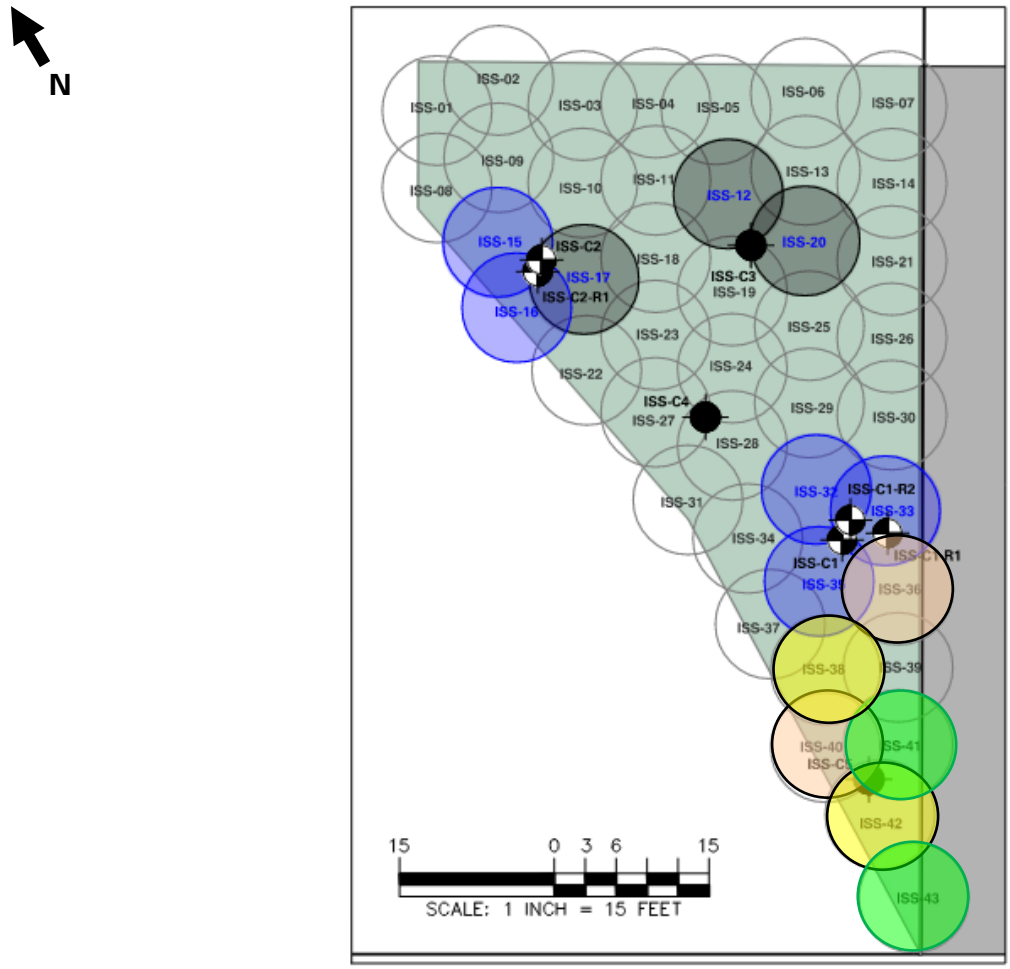
FIGURE 3 - ISS PROGRESS MAP:

- Completed ISS Pilot Test Columns
- Columns to be re-mixed
- Completed Full-Scale ISS Columns
- ISS Columns mixed today
- Columns to be mixed tomorrow
- Collected core today
- Previously collected sample location
