SITE OBSERVATION REPORT – RAWP Implementation – Day 47

PROJECT No.:	170390001	**CLIENT:**		**DATE:**	Monday, March 24, 2025
PROJECT:	141 3rd Street			**WEATHER:**	Rainy, 39-54 ^{0}F Wind: S @ 0.2 – 5.2 mph
LOCATION:	Brooklyn, New York		Third Street Owner LLC and 155 Third St., LLC	**TIME:**	7.00 a.m. – 5:15 p.m.
BCP SITE ID:	C224336			**MONITOR:**	Savannah Walters

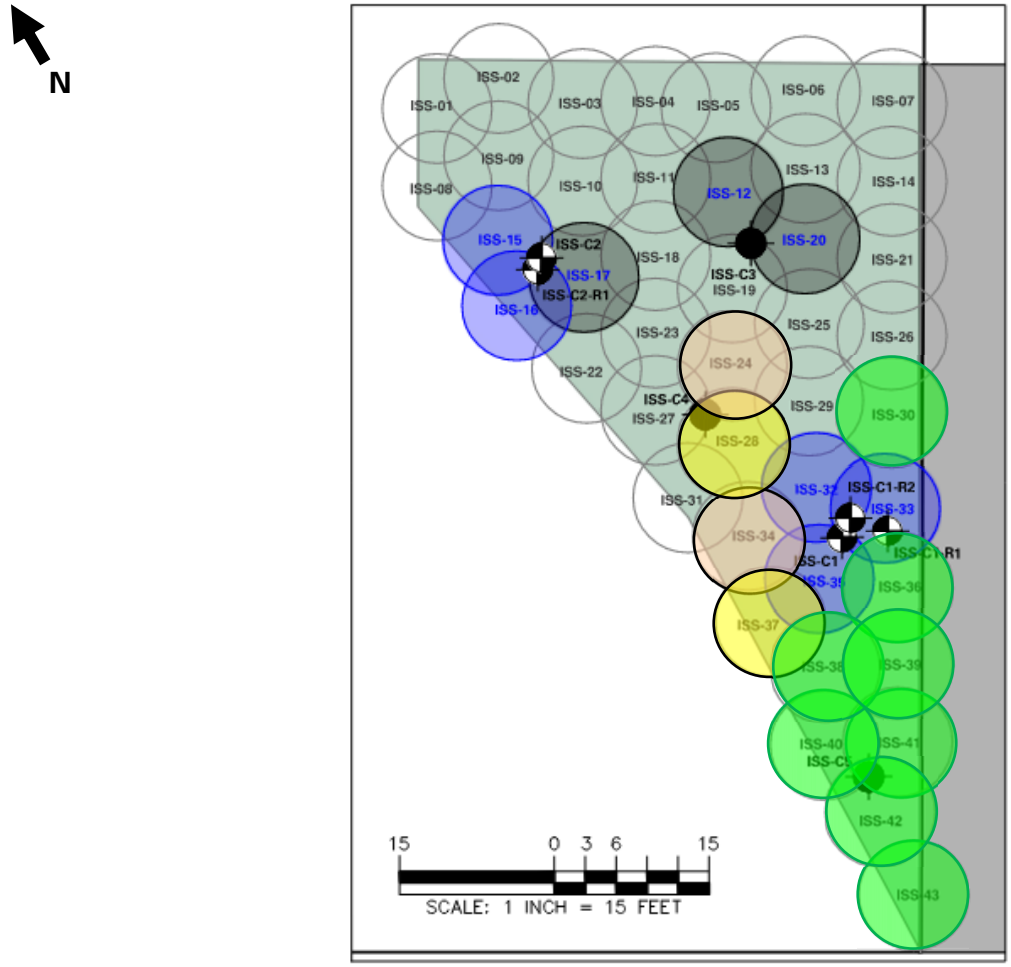
FIGURE 3 - ISS PROGRESS MAP:

- New Leaf pre-excavated two about 10-foot-long by 10-foot-wide areas to about 2 feet below grade surface (bgs) (elevation [el] 4.5 ±) in the ISS area in preparation for mixing ISS columns ISS-28 and ISS-34. Excavated soil/fill was screened for odors, staining, and organic vapors using a photoionization detector (PID). Evidence of impacts was not observed, and the soil/fill was graded into the adjacent surrounding area to create a level surface for the drill rig.
- New Leaf continued ISS implementation and mixed columns ISS-28 and ISS-37 to about el -26.5±. Generated grout spoils were staged in the eastern/central part of the site on polyethylene sheeting at the end of the workday and sprayed with Atmos® AC-645 odor/vapor suppressing foam.
