SITE OBSERVATION REPORT – RAWP Implementation – Day 49

PROJECT No.:	170390001	**CLIENT:**		**DATE:**	Wednesday, March 26, 2025
PROJECT:	141 3rd Street			**WEATHER:**	Sunny, 37-53 ^{0}F Wind: ENE @ 0.3 – 6.2 mph
LOCATION:	Brooklyn, New York	Third Street Owner LLC and 155 Third St., LLC		**TIME:**	7.00 a.m. – 7:15 p.m.
BCP SITE ID:	C224336			**MONITOR:**	Savannah Walters

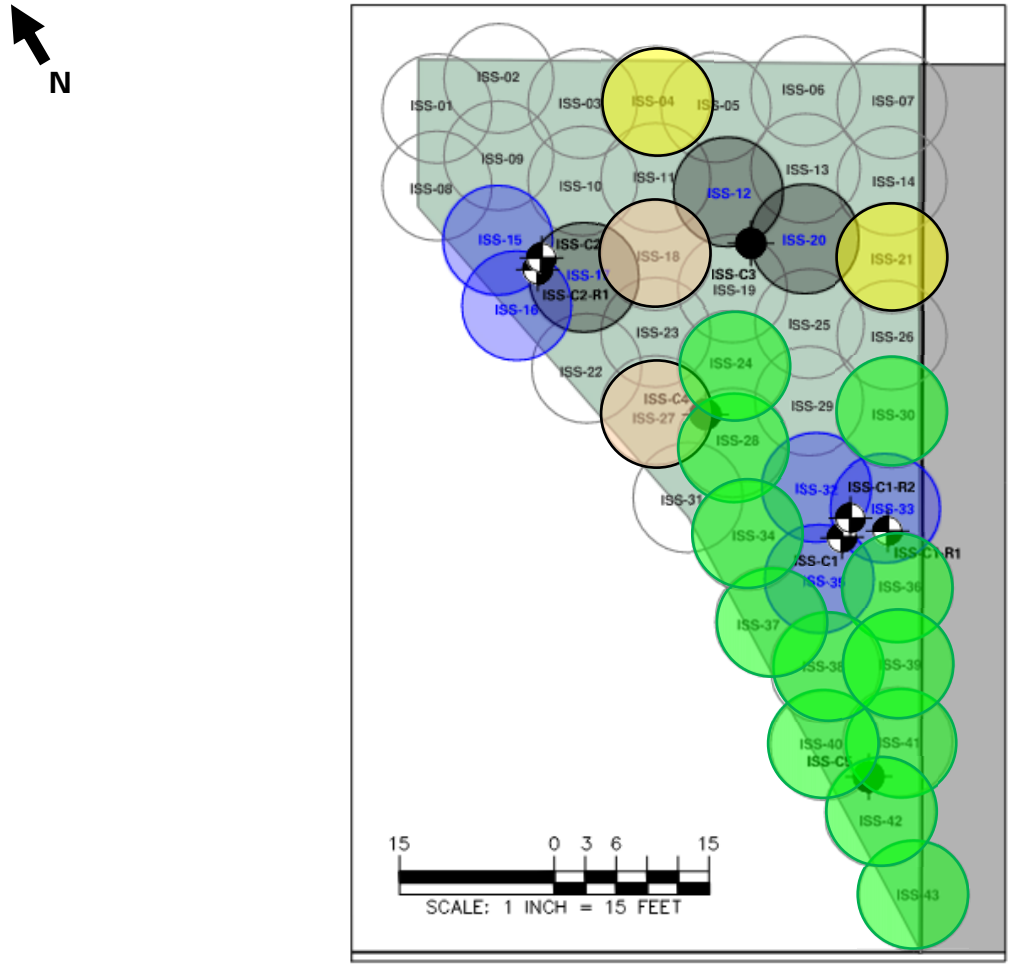
FIGURE 3 - ISS PROGRESS MAP:

- New Leaf continued ISS implementation and mixed columns ISS-04 and ISS-21 to about el -26.5±. Generated grout spoils were staged in the eastern/central part of the site on polyethylene sheeting at the end of the workday and sprayed with Atmos® AC-645 odor/vapor suppressing foam.

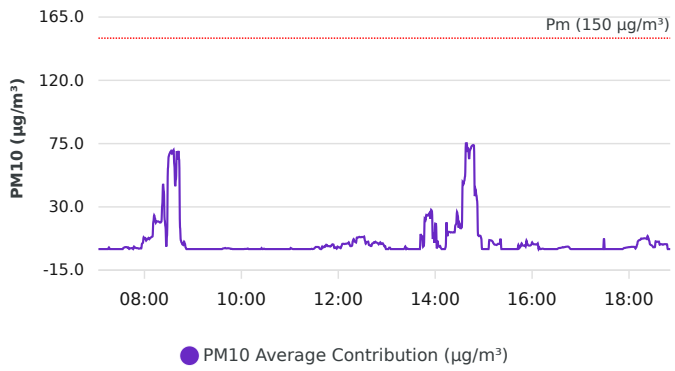
PM10 Average Contribution (µg/m³)

Daily Monitoring Summary	PM10 (µg/m³)	Time	VOC (ppm)	Time
Min Contribution (15 min avg.) - 3/26/2025	0.0	07:03	0.0000	07:06
Max Contribution (15 min avg.) - 3/26/2025	75.3	14:39	0.0100	16:26

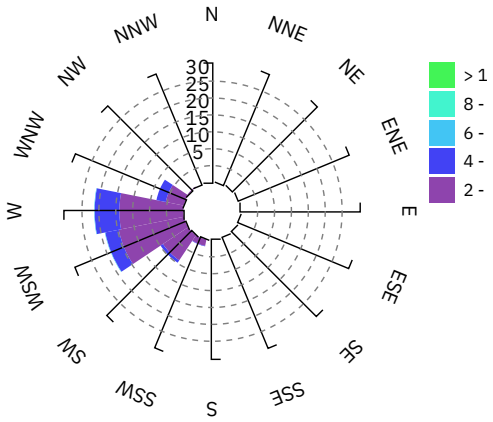
Contribution wind rose (mph)

Daily Environmental Summary	Temp (°F)	Relative Humidity (%)	Barometer (hPa)	Windspeed (mph)	Prevailing wind direction
3/26/2025	-	-	-	0.3-6.2	WSW
