SITE OBSERVATION REPORT - RAWP Implementation – Day 147

PROJECT No.:	170390001	**CLIENT:**	**DATE:**	Tuesday, February 10, 2026	
PROJECT:	141 3rd Street	Third Street Owner LLC and 155 Third St., LLC	**WEATHER:**	Sunny, 8 – 34^{0}F Wind: E @ 0.4 – 7.8 mph	
LOCATION:	Brooklyn, New York		**TIME:**	7:00 a.m. – 4:00 pm	
BCP SITE ID:	C224336

OBSERVATIONS, DISCUSSIONS, TEST RESULTS, ETC.:
Langan was onsite to document implementation of the New York State Department of Environmental Conservation (NYSDEC)-approved Remedial Action Work Plan (RAWP) dated 12 December 2023 and the Source Removal Work Plan dated 02 October 2025.

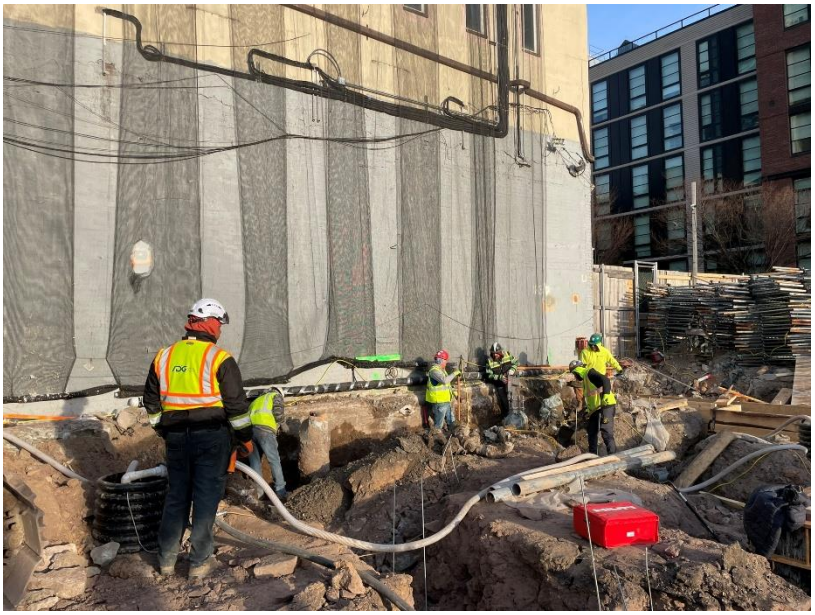
- *SR-008:* The casings were incrementally advanced from surface grade to 33 feet bgs (corresponding to el 5.5 and el -27.5, respectively). Soil/fill was periodically extracted from about el 5.5 to about el -23. Flowable fill was placed from el -23 to el -2.16 (the mean low water level). The column is currently in progress and will be backfilled and completed on the next work day.

Photo 3: New Leaf extracting soil from Column No. SR-008 (facing northeast).

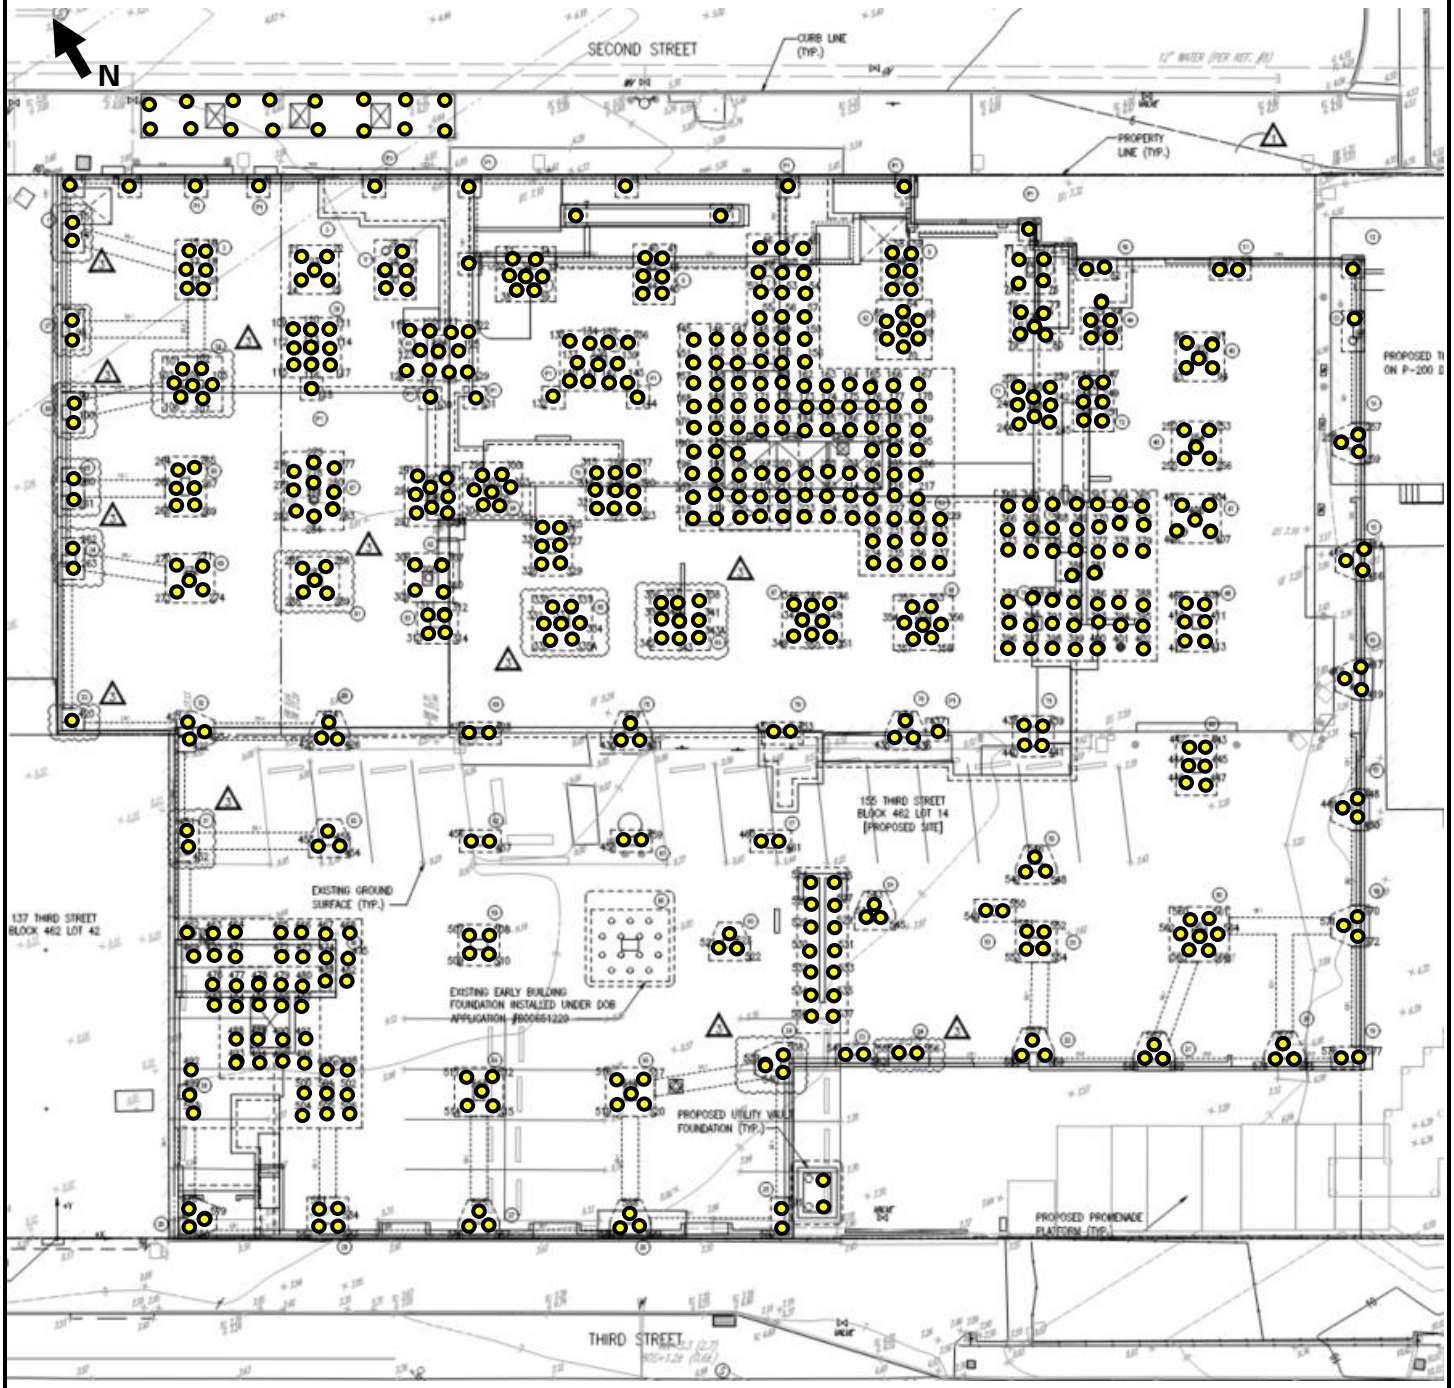
FIGURE 2 – DISPLACEMENT PILE PLAN:

- Approximate Location of Displacement Pile Advanced Today
- Approximate Location of Displacement Pile Advanced Previously

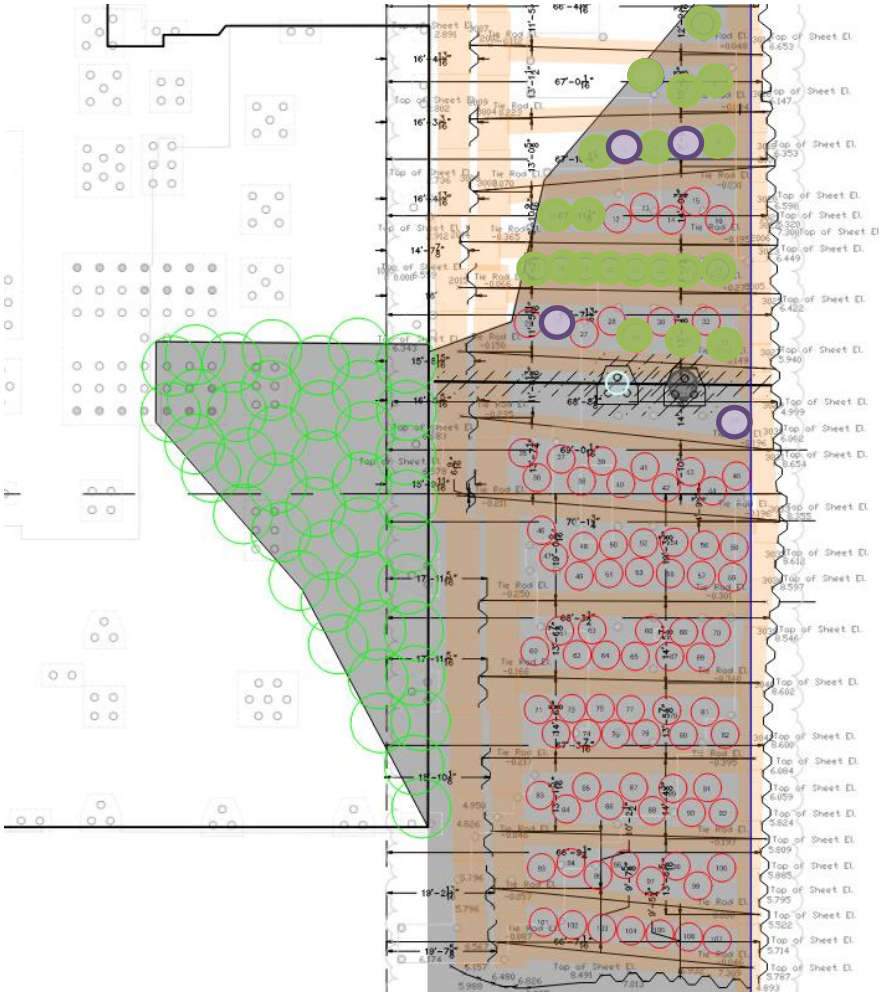
FIGURE 3 – SOURCE REMOVAL PLAN:

- Approximate location of completed source removal column
- Approximate location of source removal column in progress
