SITE OBSERVATION REPORT - RAWP Implementation – Day 166

PROJECT No.:	170390001	**CLIENT:**		**DATE:**	Tuesday, March 10, 2026
PROJECT:	141 3rd Street	Third Street Owner LLC and 155 Third St., LLC		**WEATHER:**	Sunny, 46 – 70^{0}F Wind: SE @ 0.4 – 9.2 mph
LOCATION:	Brooklyn, New York			**TIME:**	7:00 a.m. – 3:45 p.m.
BCP SITE ID:	C224336

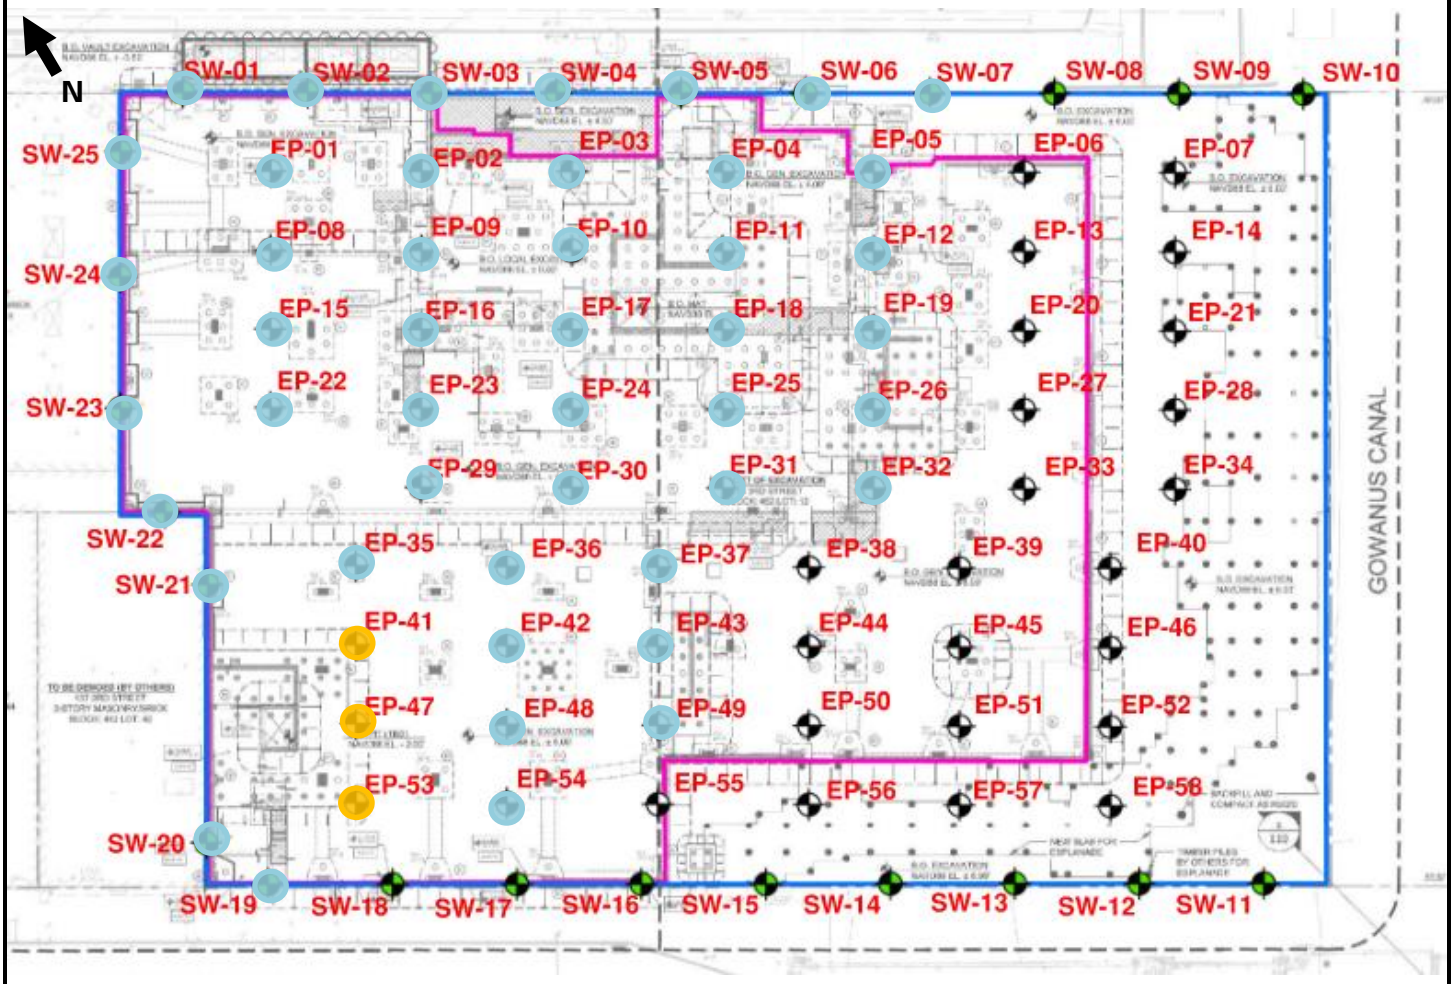
FIGURE 2 – ENDPOINT SAMPLE TRACKCING MAP:

- Bauer Structures excavated three approximately 5-foot-long by 3-foot-wide test pits to about 3 feet bgs in the western part of site to collect endpoint samples.
  - Excavated material consisted of soil/fill. Langan screened the excavated material for odors, staining, and organic vapors using a PID. No evidence of impacts was observed.
  - The ground surface was surveyed prior to test pit excavation and a post-excavation survey was completed to confirm a two-foot cut. Excavated material was temporarily stockpiled adjacent to the excavation area on poly sheeting during sample collection. Prior to backfilling the test pits, poly sheeting was laid at the base of each test pit to serve as a demarcation layer.

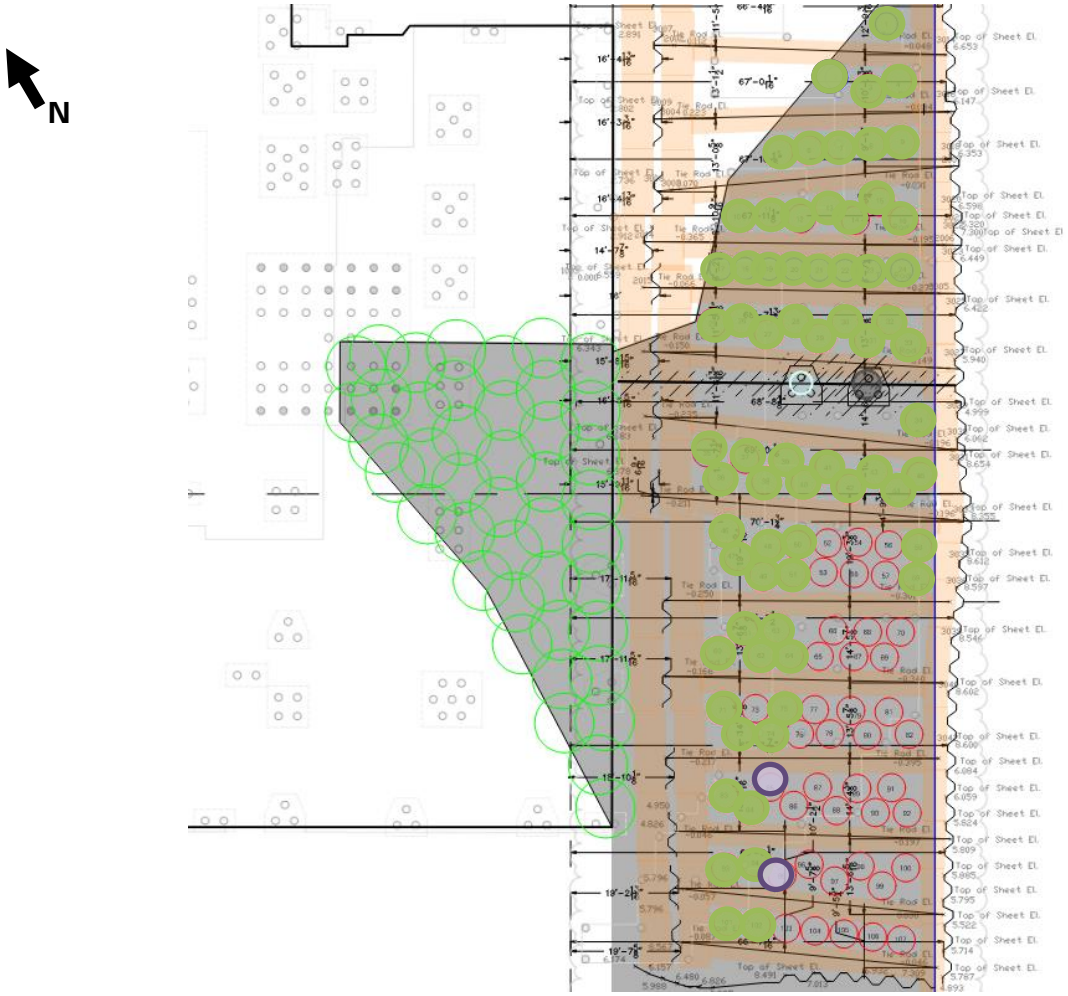
FIGURE 3 – SOURCE REMOVAL PLAN:

- *SR095:* The column is in progress and will be further advanced and completed on the next work day.
    - Extracted soil/fill was temporarily staged on polyethylene (poly) sheeting adjacent to each work area. Langan screened the extracted soil/fill for evidence of environmental impacts using visual, olfactory, and instrumental (PID) methods. A petroleum-like odor was observed and a maximum PID reading of 170.6 parts per million (ppm) was recorded. New Leaf applied ATMOS AC645 odor/vapor suppressing foam to exposed soil/fill during extraction and stockpiling.
