SITE OBSERVATION REPORT - RAWP Implementation – Day 170

LANGAN

PROJECT No.:	170390001	**CLIENT:**	**DATE:**	Monday, March 13, 2026	
PROJECT:	141 3rd Street	Third Street Owner LLC and 155 Third St., LLC	**WEATHER:**	Cloudy, 46 – 53^{0}/F Wind: SSW @ 1.8 – 10.9 mph	
LOCATION:	Brooklyn, New York		**TIME:**	6:45 a.m. – 3:45 p.m.	
BCP SITE ID:	C224336

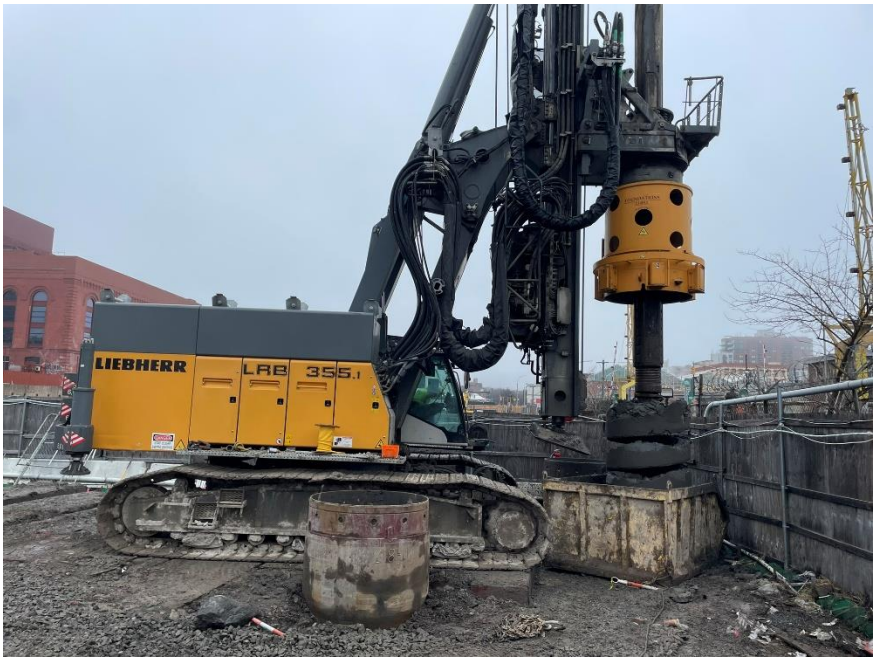
- Extracted soil/fill was temporarily staged on polyethylene (poly) sheeting adjacent to each work area. Langan screened the extracted soil/fill for evidence of environmental impacts using visual, olfactory, and instrumental (PID) methods. A petroleum-like odor was observed and a maximum PID reading of 44.9 parts per million (ppm) was recorded. New Leaf applied ATMOS AC645 odor/vapor suppressing foam to exposed soil/fill during extraction and stockpiling.

Photo 1: New Leaf spraying Atmos® AC-645 odor/vapor suppressing foam on stockpiled soil/fill in the eastern part of the site (facing northeast).
